Heritage Statement re: Burrows Cross Lodge, Burrows Cross, Shere, Guildford, GU5 9QF

1. Burrows Cross Lodge is a Grade II Listed building. List Entry Number 1189432. The official listing entry states:
 - a. *“Lodge. 1885-6 by R. Norman Shaw. Red brick below, tile hung above with plain tiled roof extending down in pentice to return front facing street. Two storeys in gable and one storey and attic behind under pentice roof with leaded casement dormer. Rear ridge stack and stacks to left. Entrance front at right angles to road. Bargeboarded gable projecting to left with one four-light leaded window on first floor. Further gable set back to right with one first floor window. Gable to left jettied on diagonal wood bracing and continuous leaded window on left side and to right flanking ribbed door to left corner in wooden surround with arched entrance. Further six-light window to left in pentice extension. Left hand return front: Facing street, one window to left and further door. Gabled extension to left and further extensions to rear. Included for group value. SAINT: R. Norman Shaw (Yale 1983) pp 110, 155, 243, 429. Listing NGR: TQ0836146357”.*

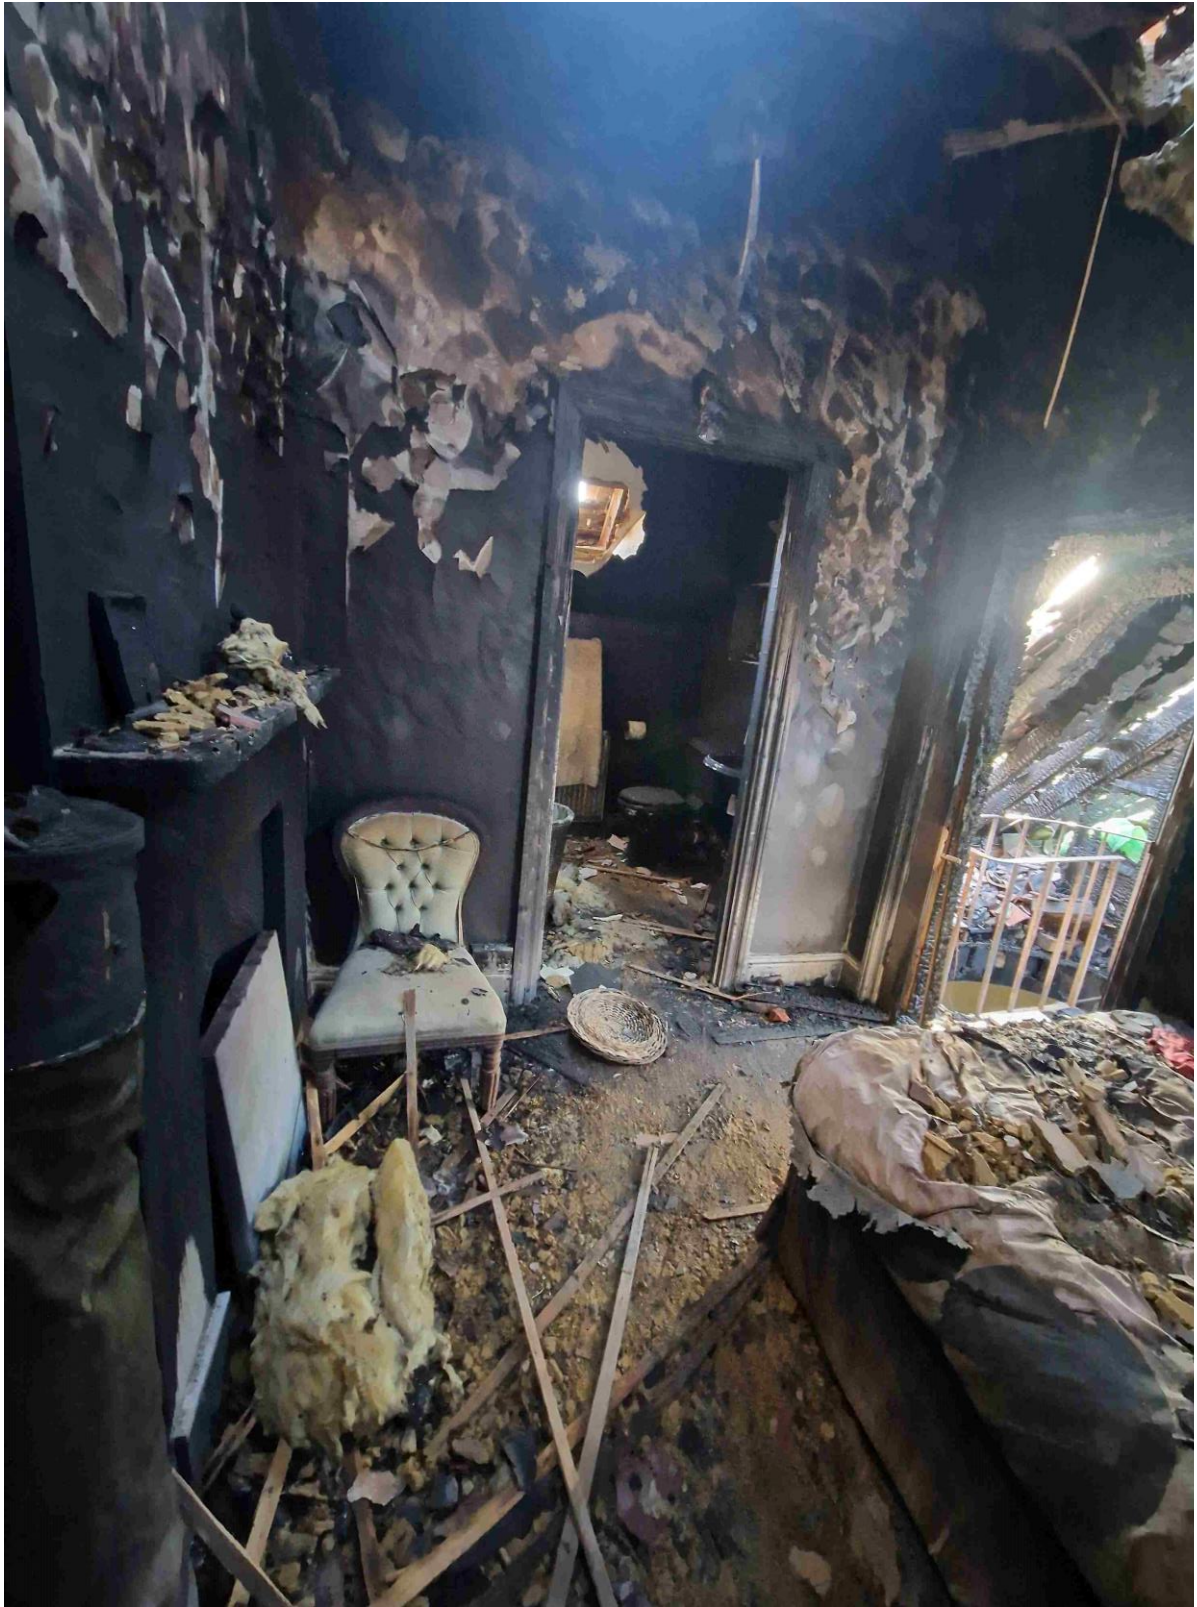
Damaged Bedroom 03 leading to en suite

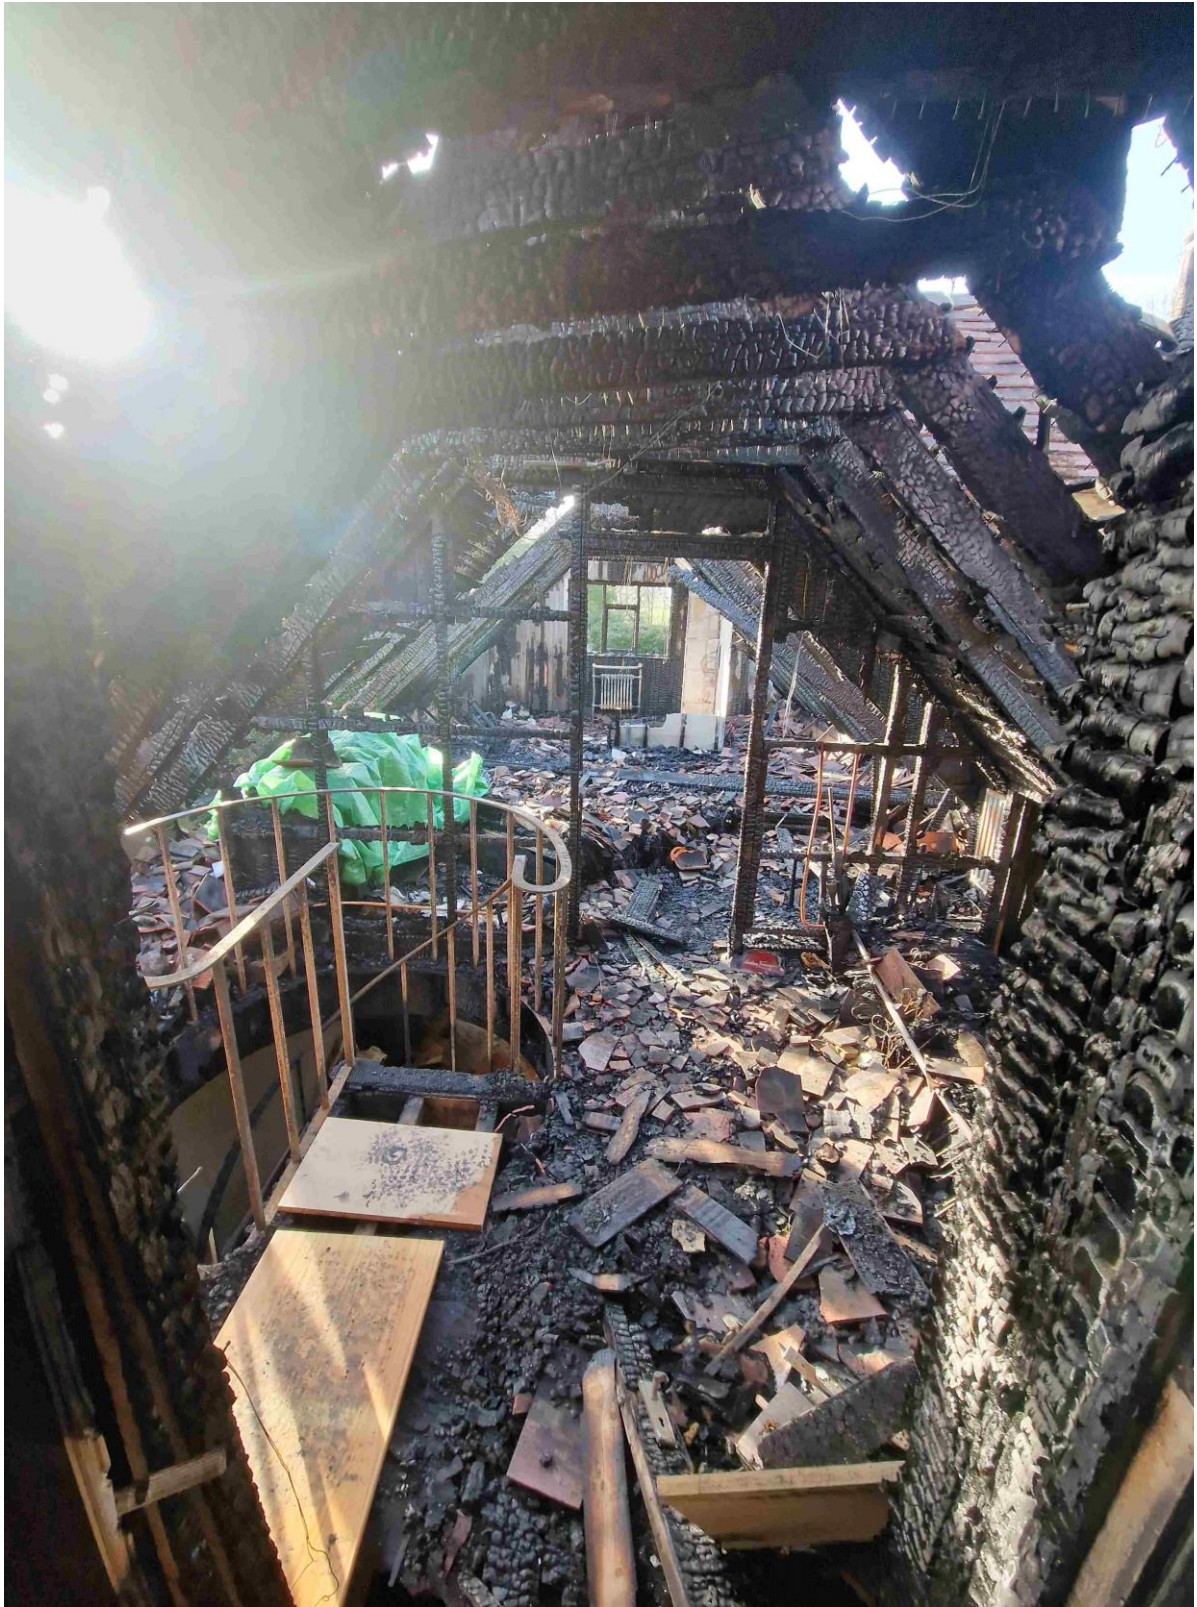
Damaged rooms in Stable section – dressing room, bedroom 04 (rear) and en suite

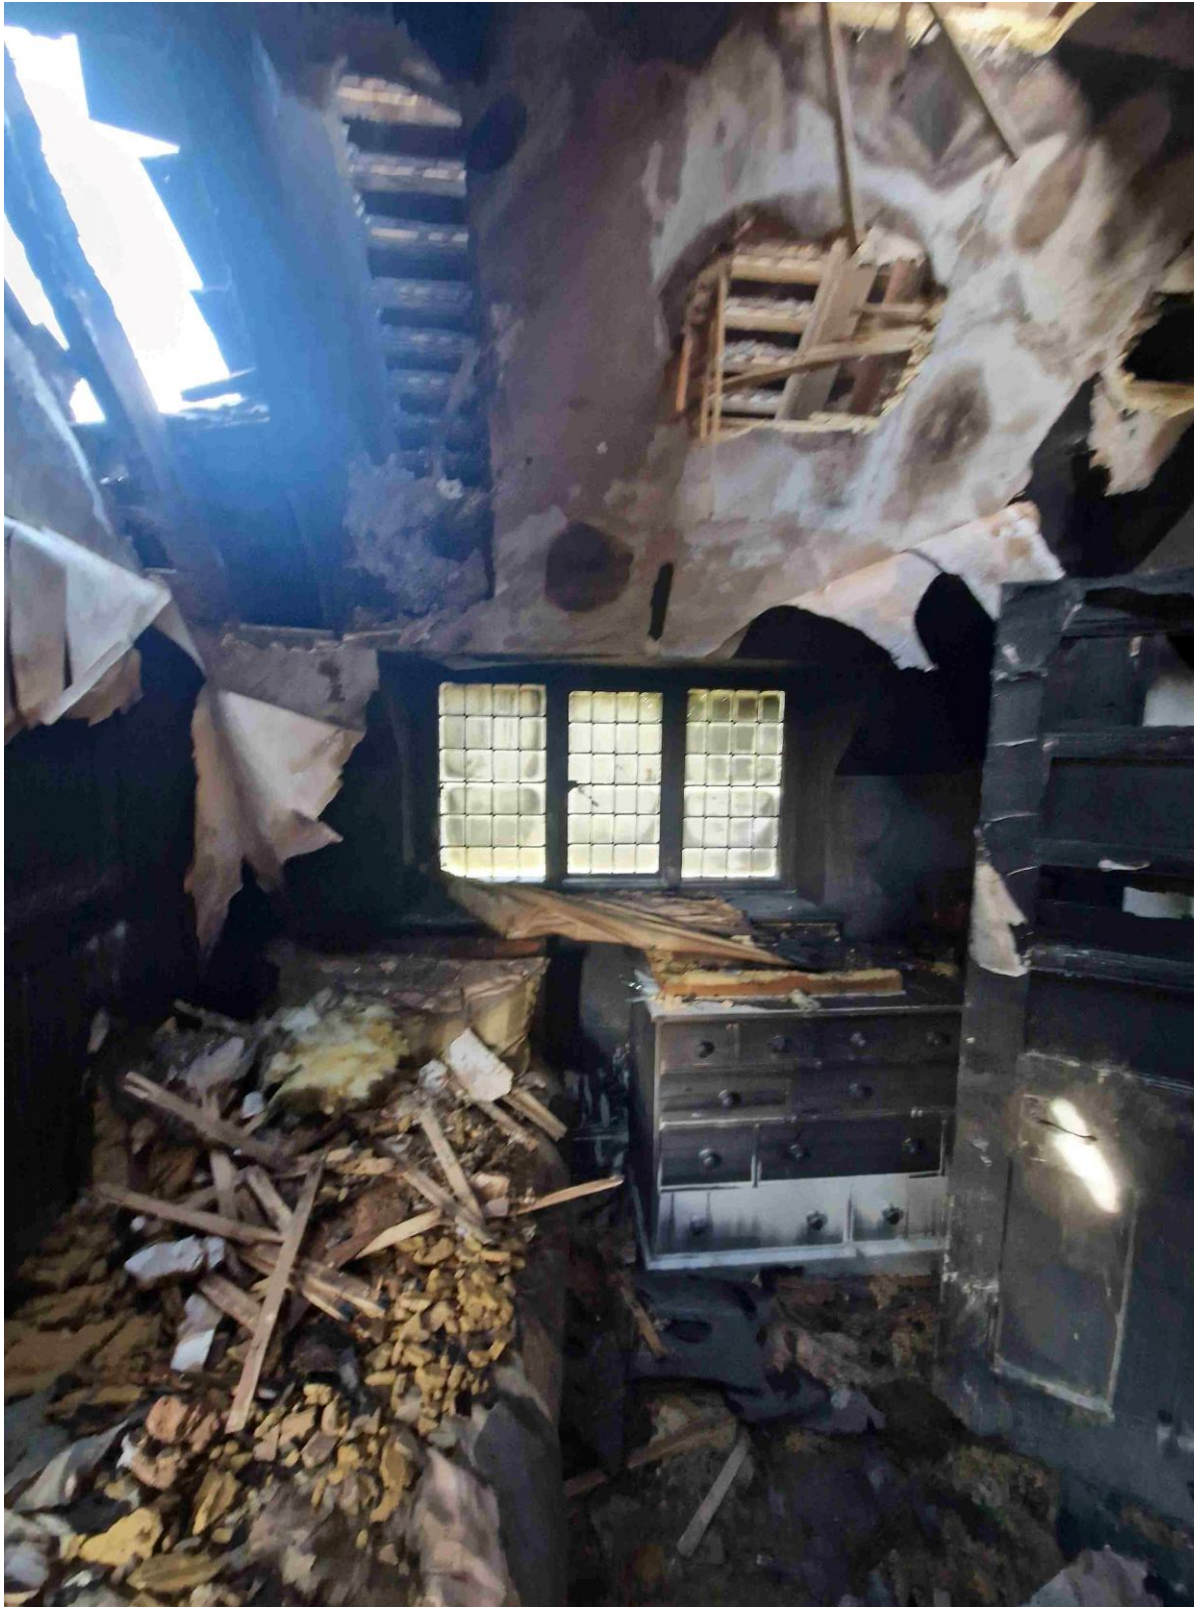
Damaged bedroom 03 (with en suite)

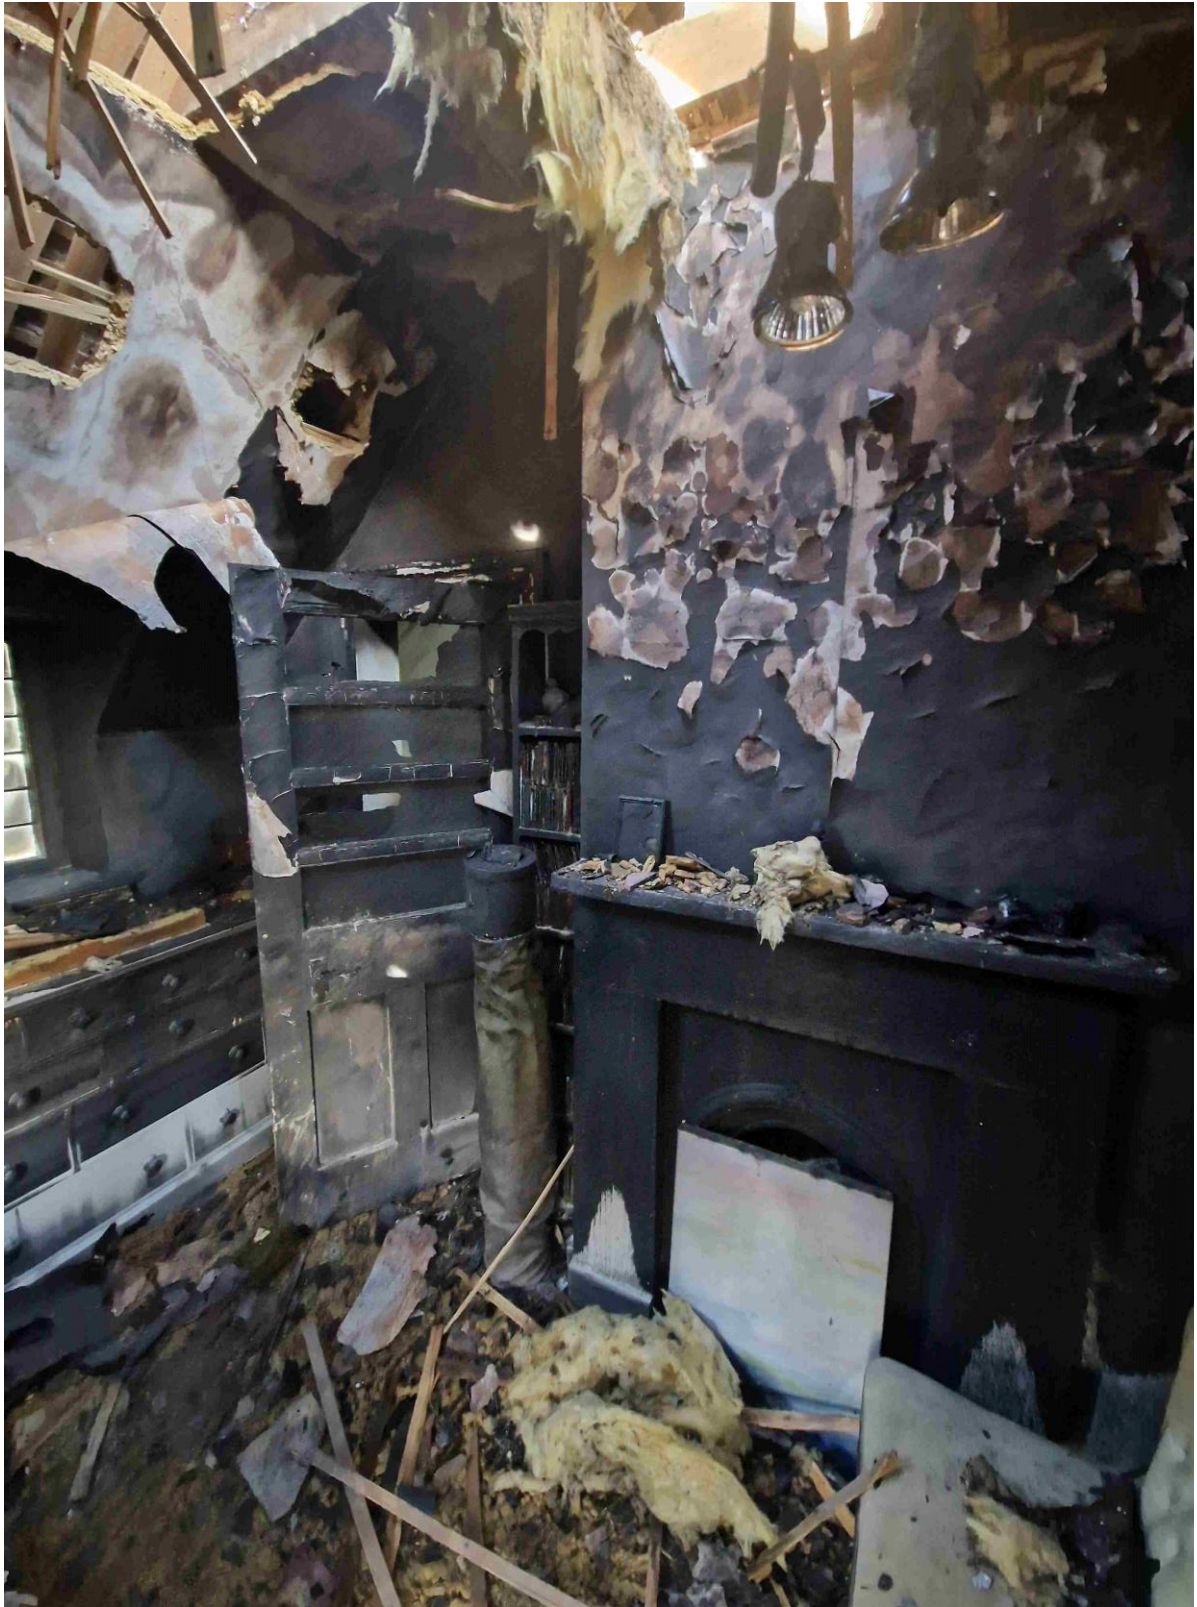
Damaged bedroom 03 (with en suite)

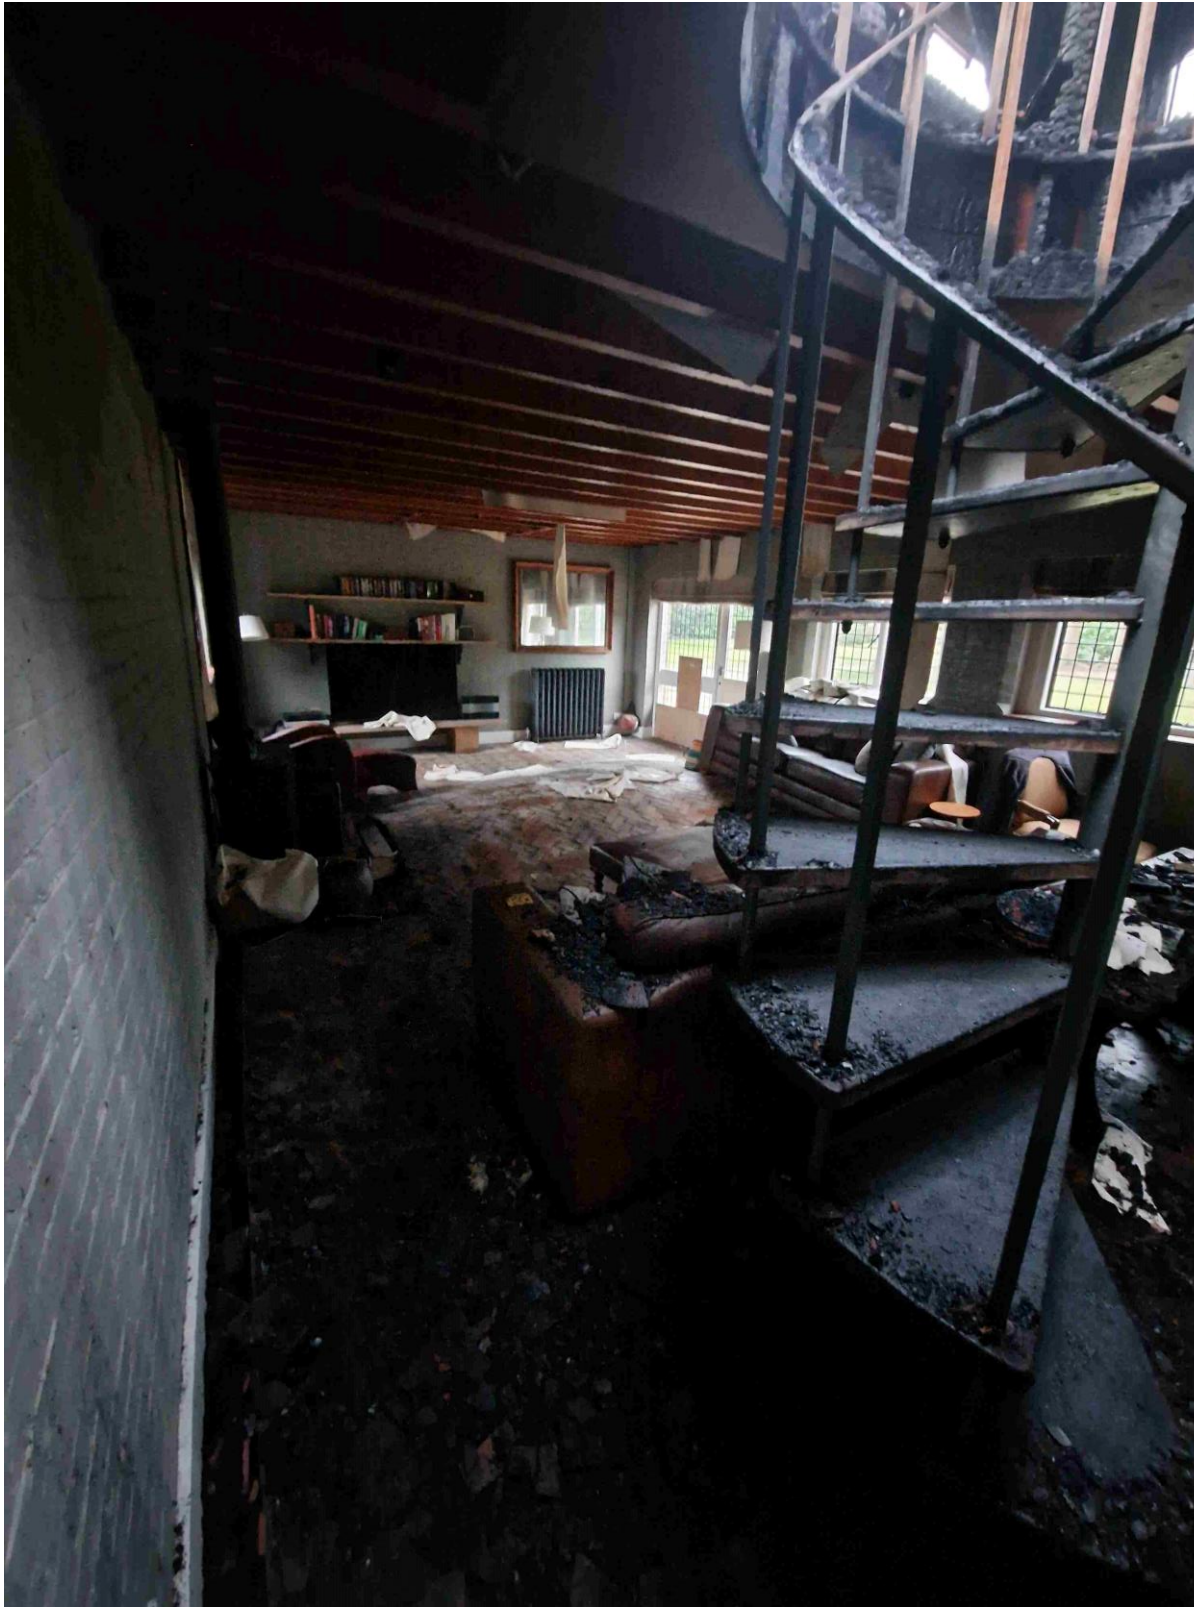
Damaged living room

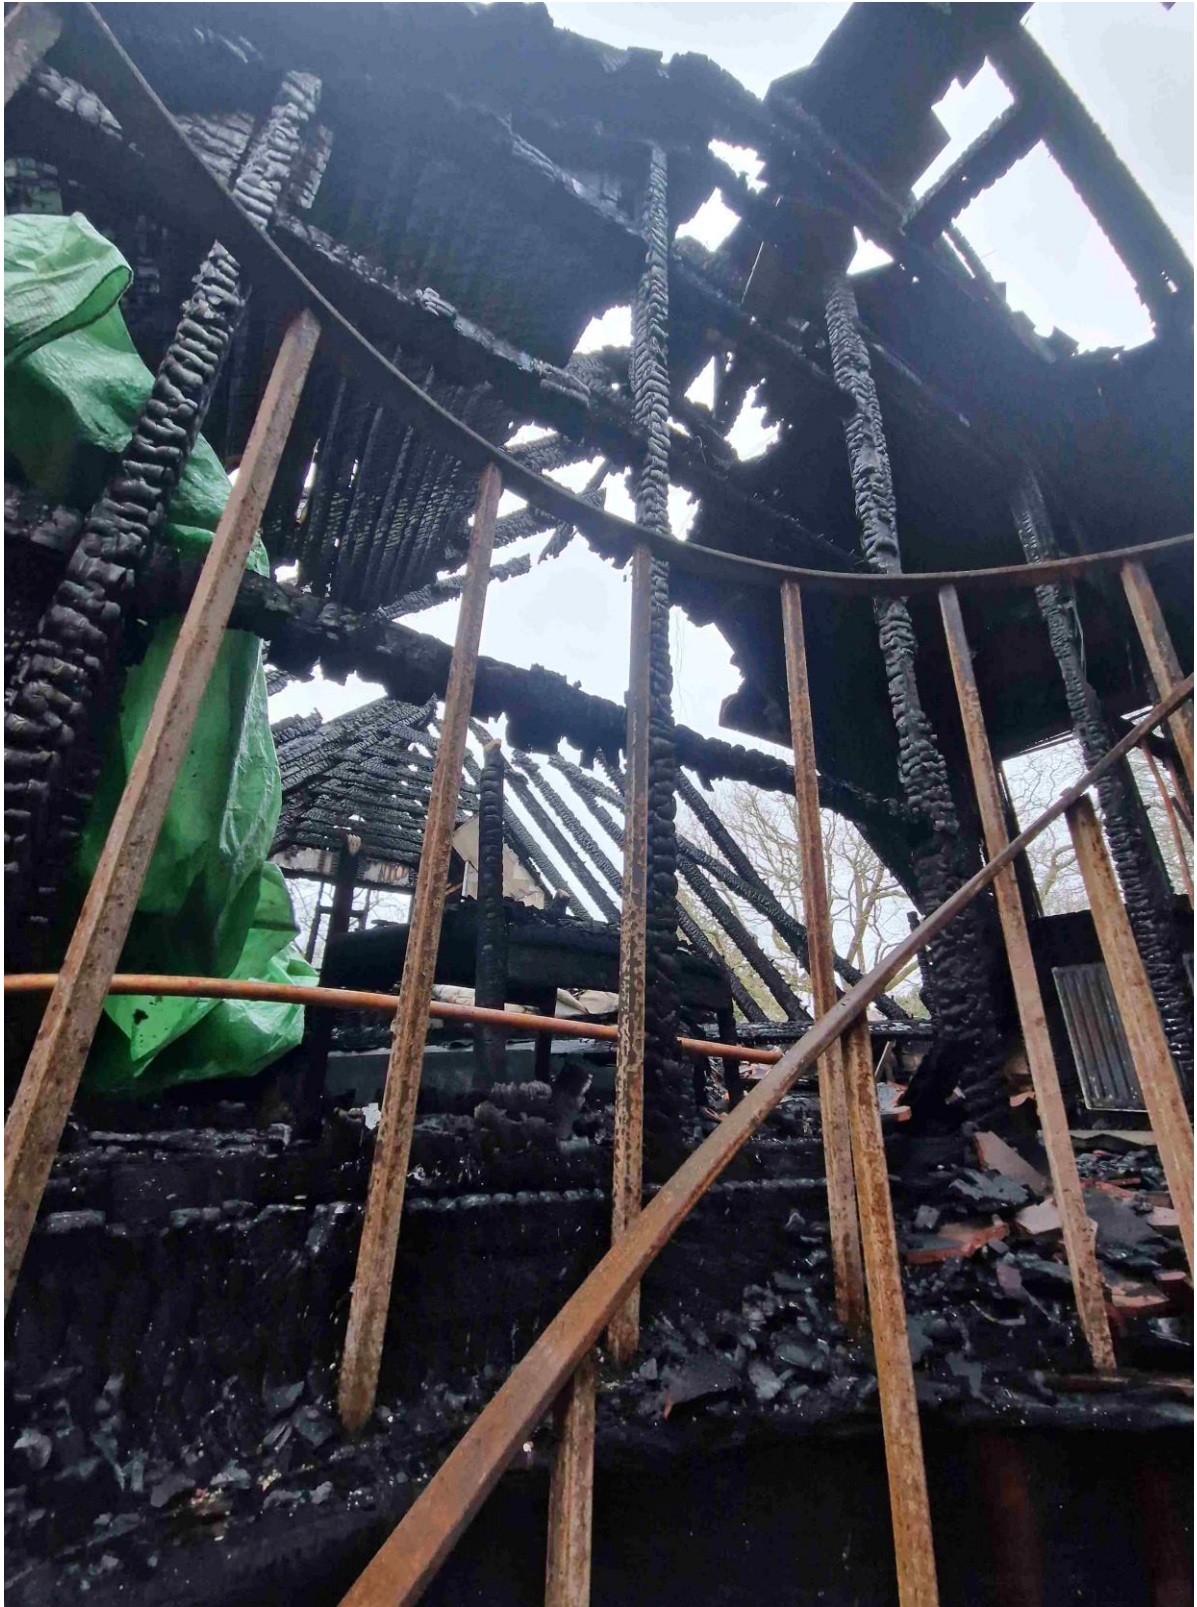
Damaged Stable section

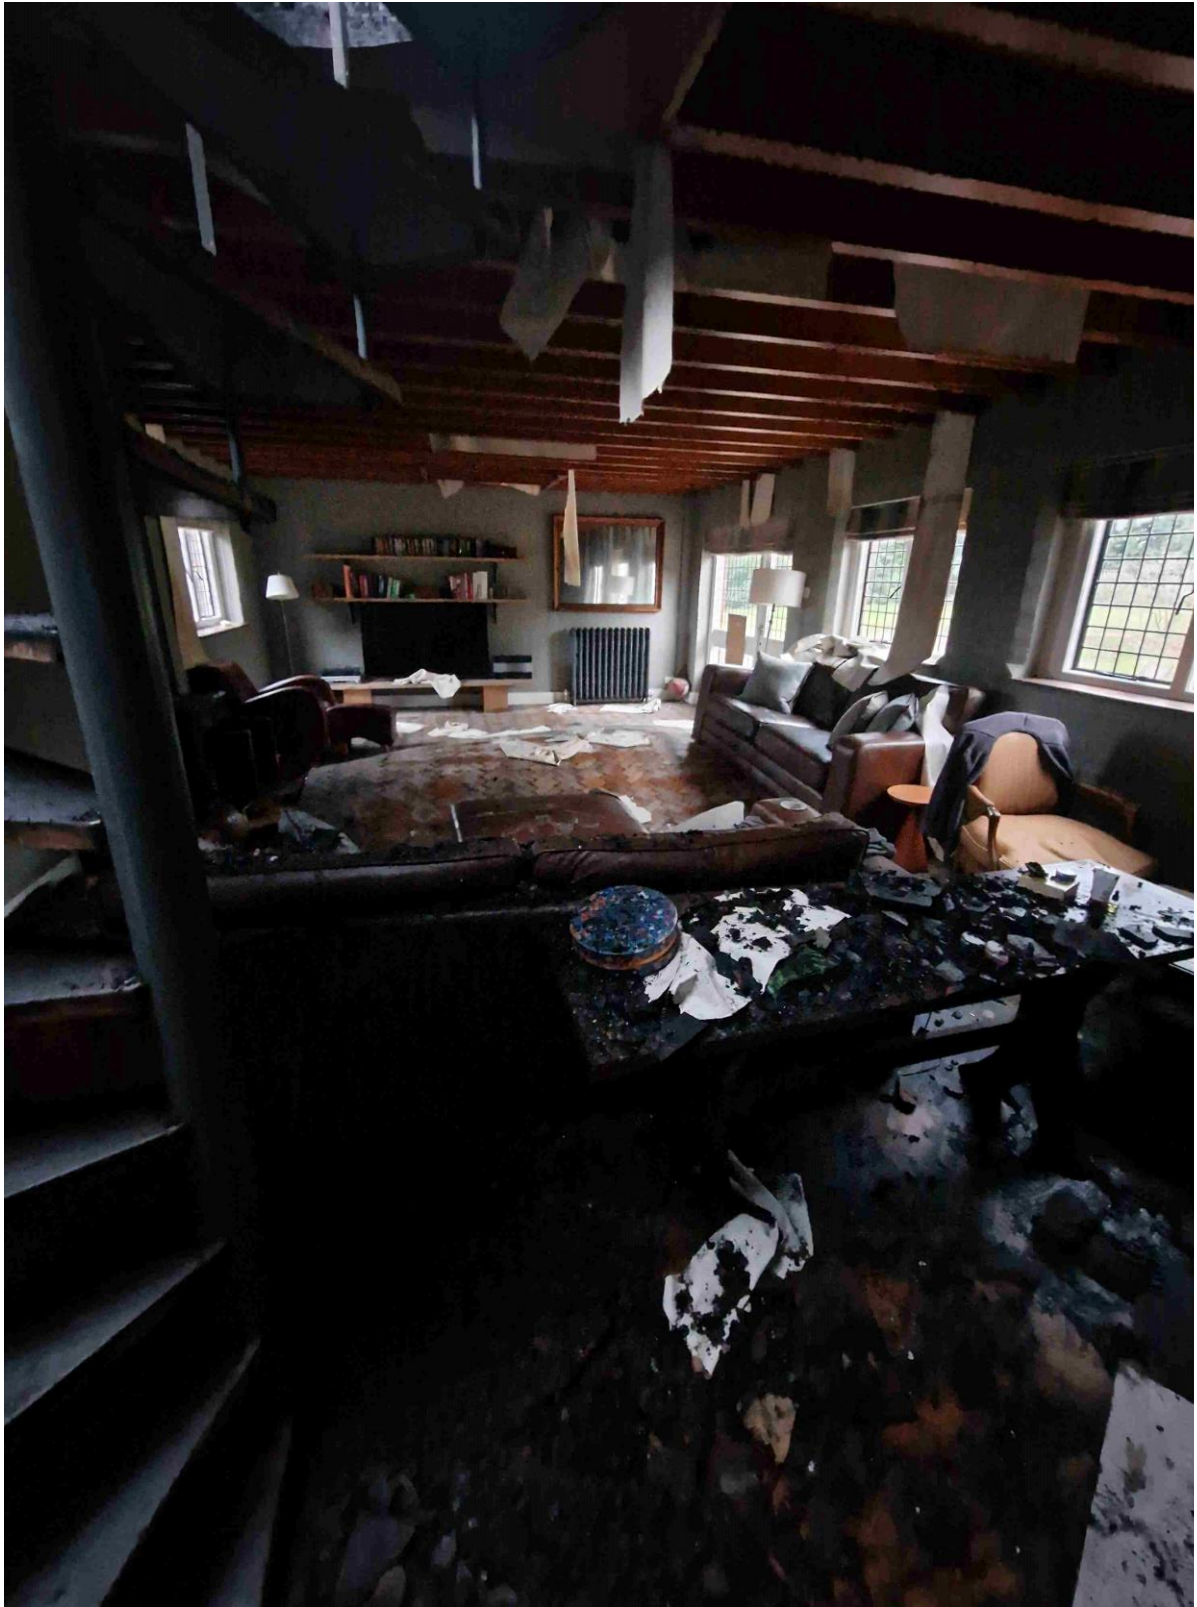
Damaged living room
