Specialist Height Services, Steeplejacks and Industrial Abseiling

HQ. The Pinnacle Works, Station Road, Epworth, Doncaster DN9 1JU

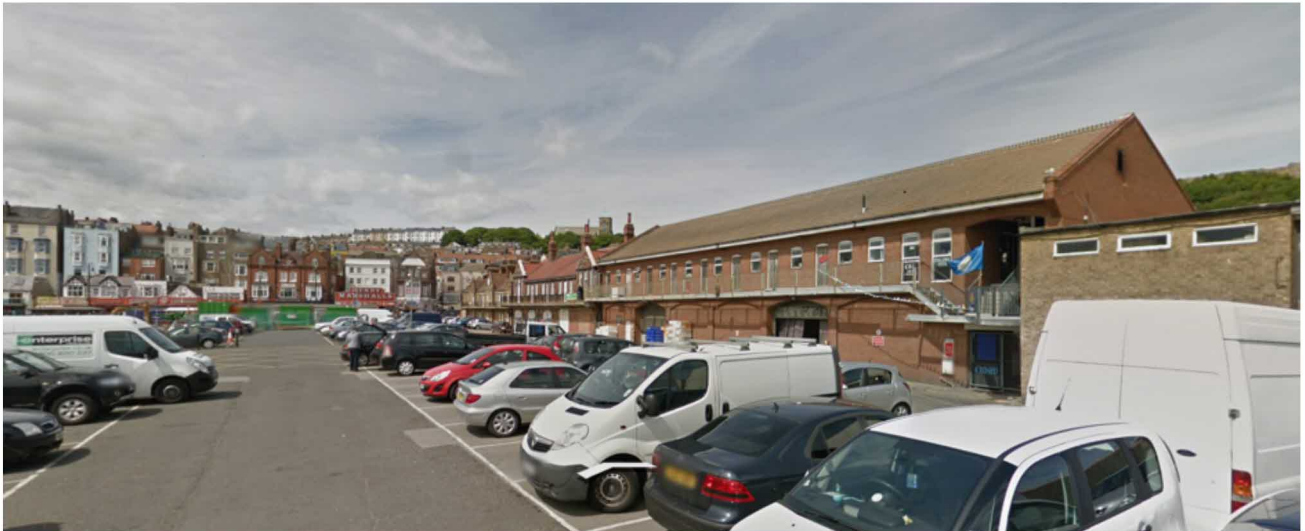
Corrosion and General Investigatory works  
Scarborough West Pier Buildings 1, 2 and 3  
March 2023  
Proteq Northern Limited

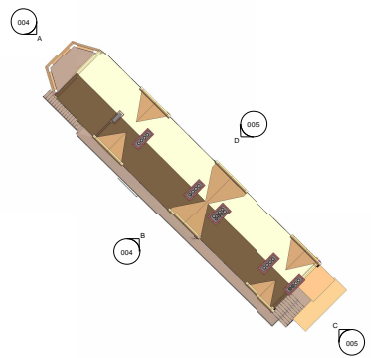
**1** 004 - Key Plan  
Scale: 1:200

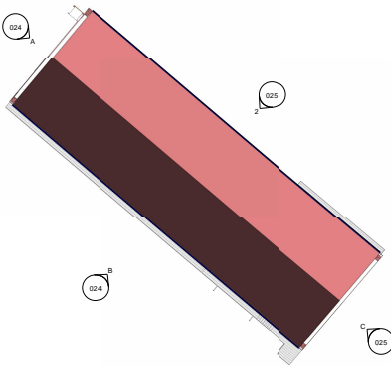
**1 024 - Key Plan**

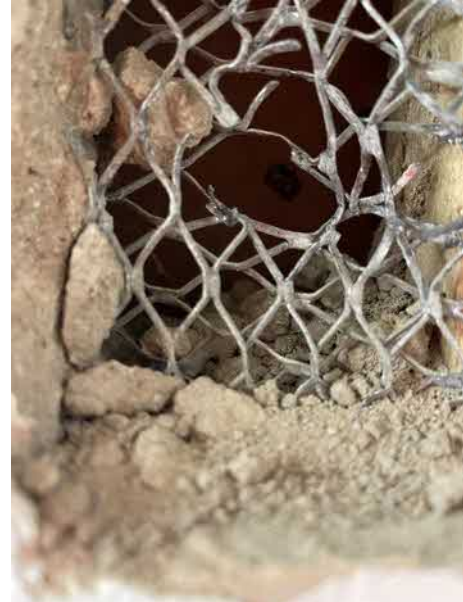
Figure  
Women's toilet location 7

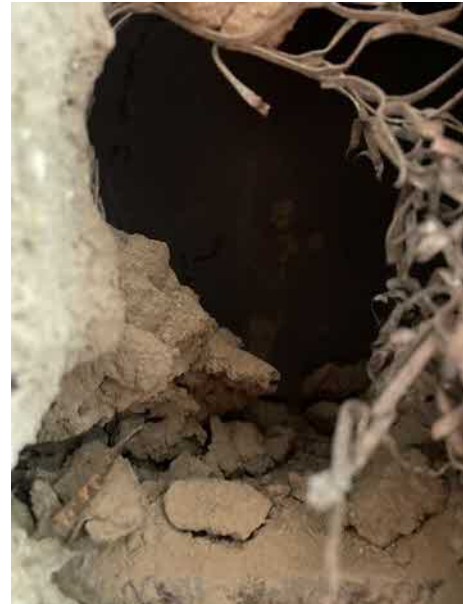
Figure  
Men's toilet location 9

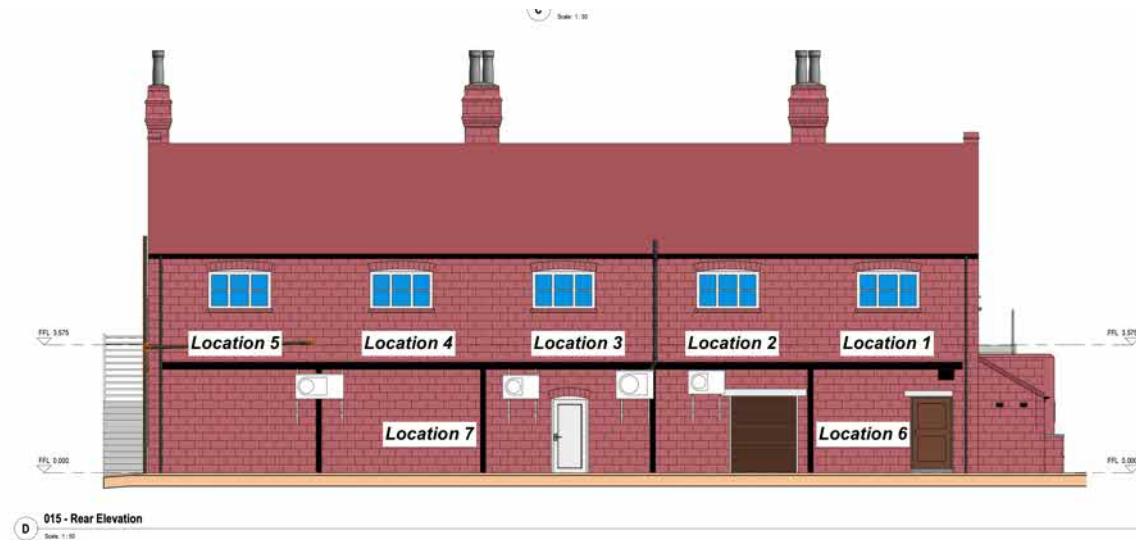
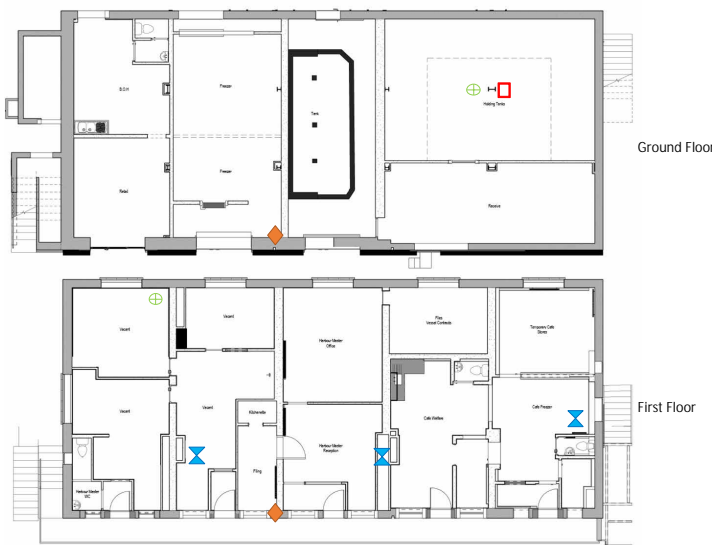
- KEY
- ⊕ 100-200mm dia. slab core / filler joist floor / foundation size check / 1m<sup>2</sup>m concrete surface area required for ferro scan
  - ◆ Breakout construction: identification of masonry wall thicknesses, ceiling construction
  - ✕ Investigate roof voids / walls – sizes of roof and ceiling members / chimney support
  - Measure / corrosion survey / Material testing of all existing internal and external steelwork. Includes balcony

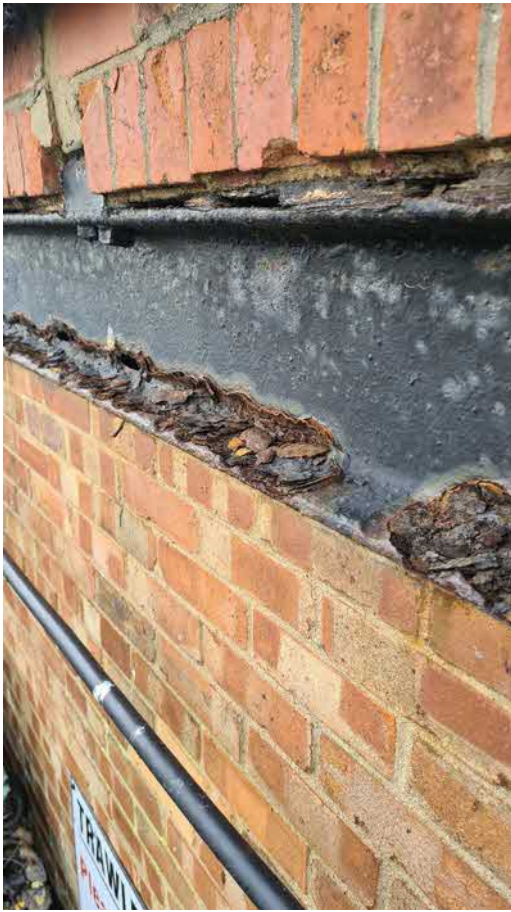
Figure  
Location 4  
I Beam Severe corrosion / delamination

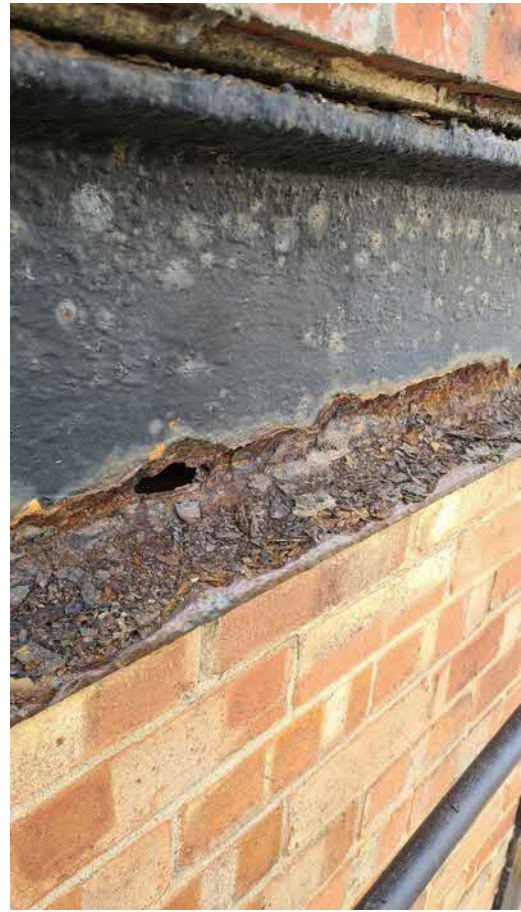
Figure  
Location 4  
I Beam Severe corrosion / delamination

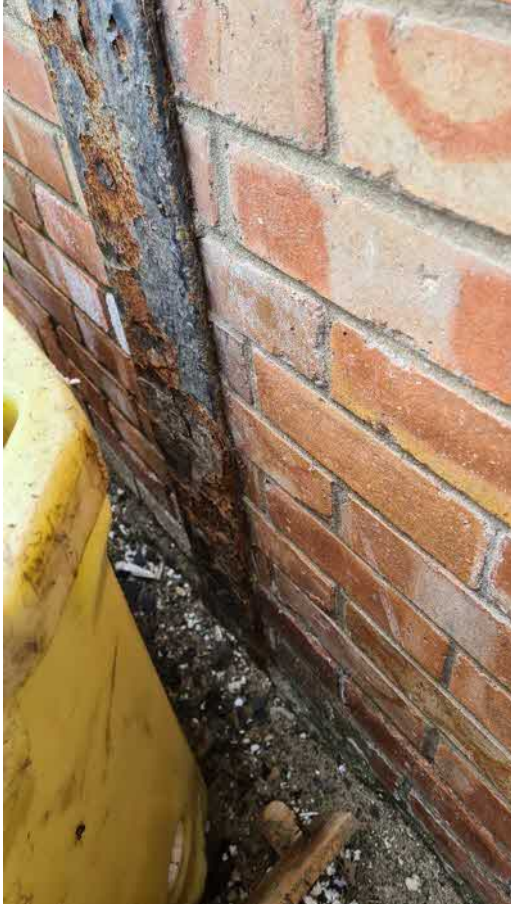
Figure  
General Image Showing the Storage of  
Materials/Equipment  
I Beam Severe corrosion / delamination

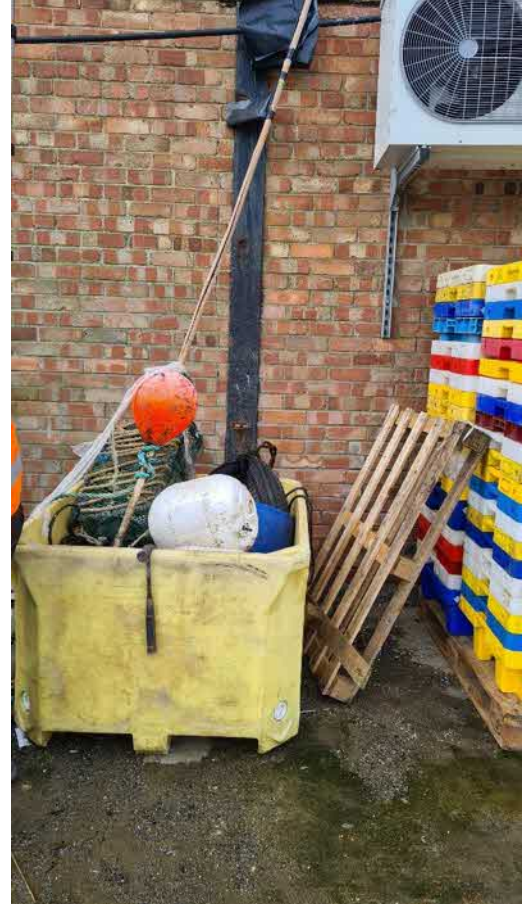
Figure  
General Image Showing the Storage of  
Materials/Equipment  
I Beam Severe corrosion / delamination
