STRUCTURAL DEMOLITION REPORT  
FOR  
SCARBOROUGH HARBOUR WEST PIER REDEVELOPMENT  
WEST PIER  
SCARBOROUGH  
YO11 1PD

Commissioned by  
WILLIAM BIRCH & SONS LTD.

Report 21037-H-RP-001  
01<sup>st</sup> DECEMBER 2022

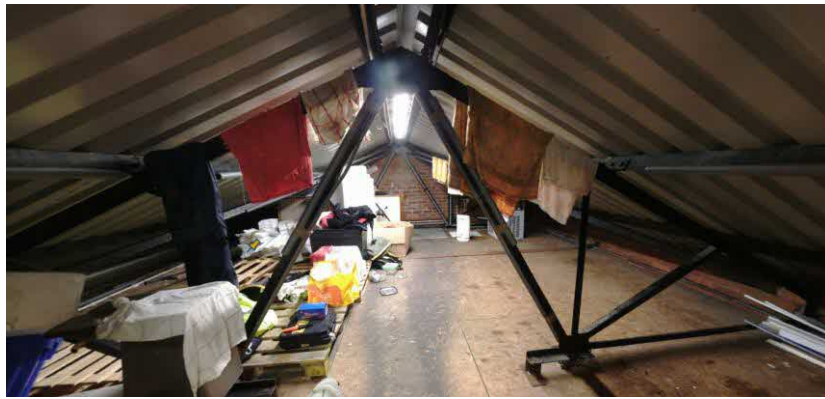
- 3.2.14. For information regarding the condition of Building 4a, refer to the condition report in Appendix C.
- 3.2.15. It was noted that truss bottom chords have been cut in areas, creating an unstable truss arrangement. See figure 2 below. This will need to be addressed by the contractor before demolition, to prevent any unplanned collapse of the structure.

*Figure 2 Building 4a Roof Truss*

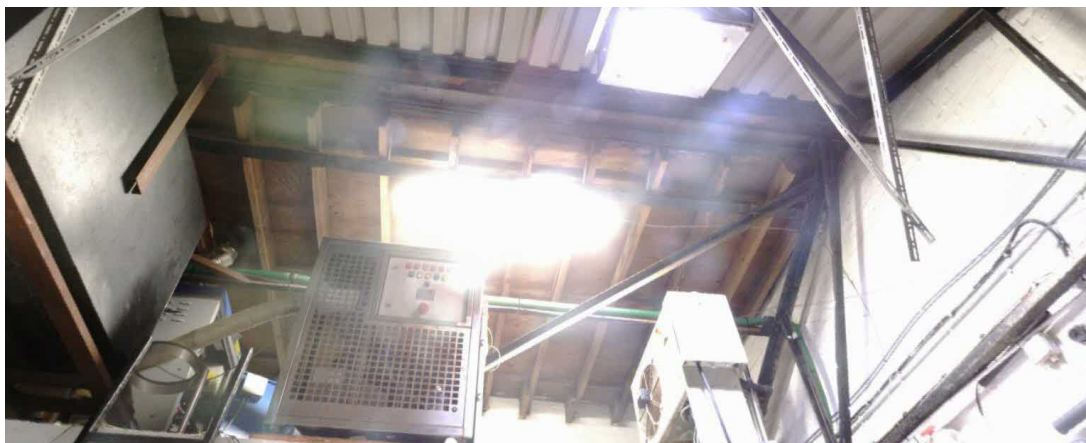
3.2.18. The floor and roof construction is timber. It was noted that the timber roof of Building 4b spans on to one steel angle purlin of Building 4a. This is a significant risk, as likely not a structural designed detail.

*Figure 3 Building 4b Timber Roof Deck Spanning onto Purlins of Building 4a*

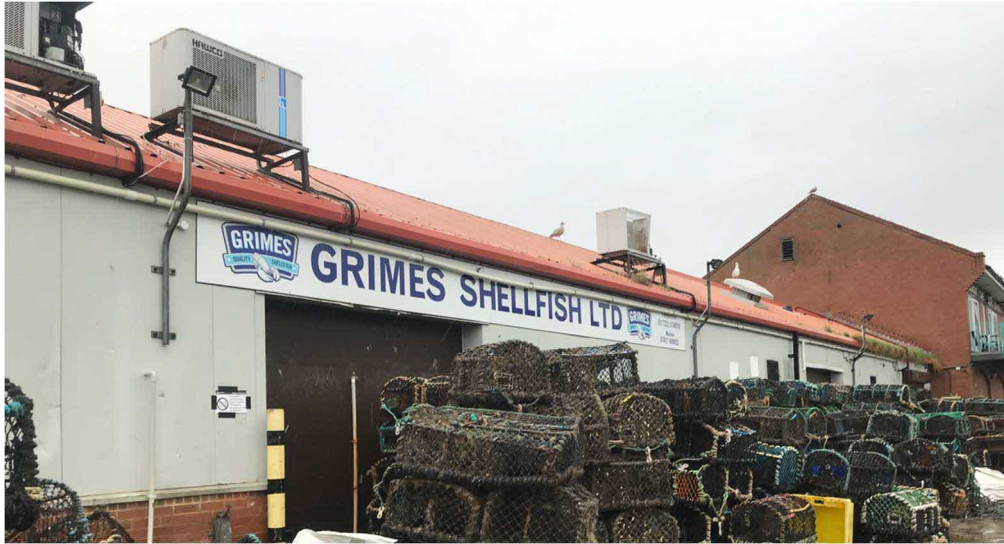
*Photo 3 - North-east elevation of Building 4a adjacent to Building 3*

- 3.2.13. It is noted that Building 4a abuts Building 3 at its north-west gable elevation. The foundations are not known. Further investigation is required to determine if the removal of Building 4 foundations will affect the structural integrity of Building 3's.

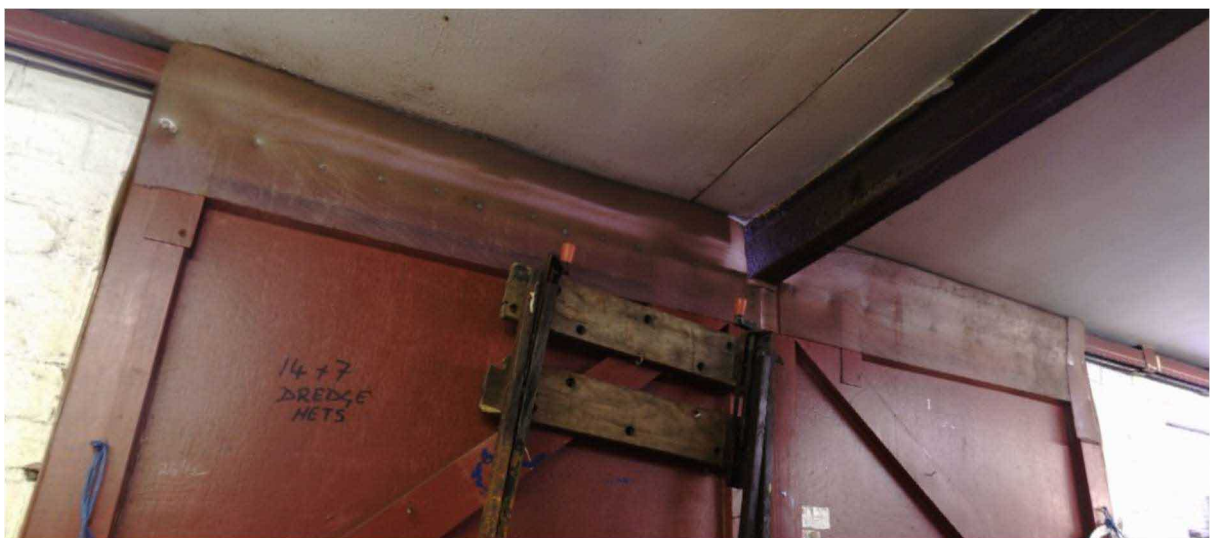
- 3.2.20. There is a 1-ton capacity lifting beam located above an external opening on the second floor. The condition of this lifting beam is heavily corroded, and likely not in commission. It is recommended this is not utilised for demolition methods.

*Photo 8 - Lifting Beam taken from inside Building 4b*

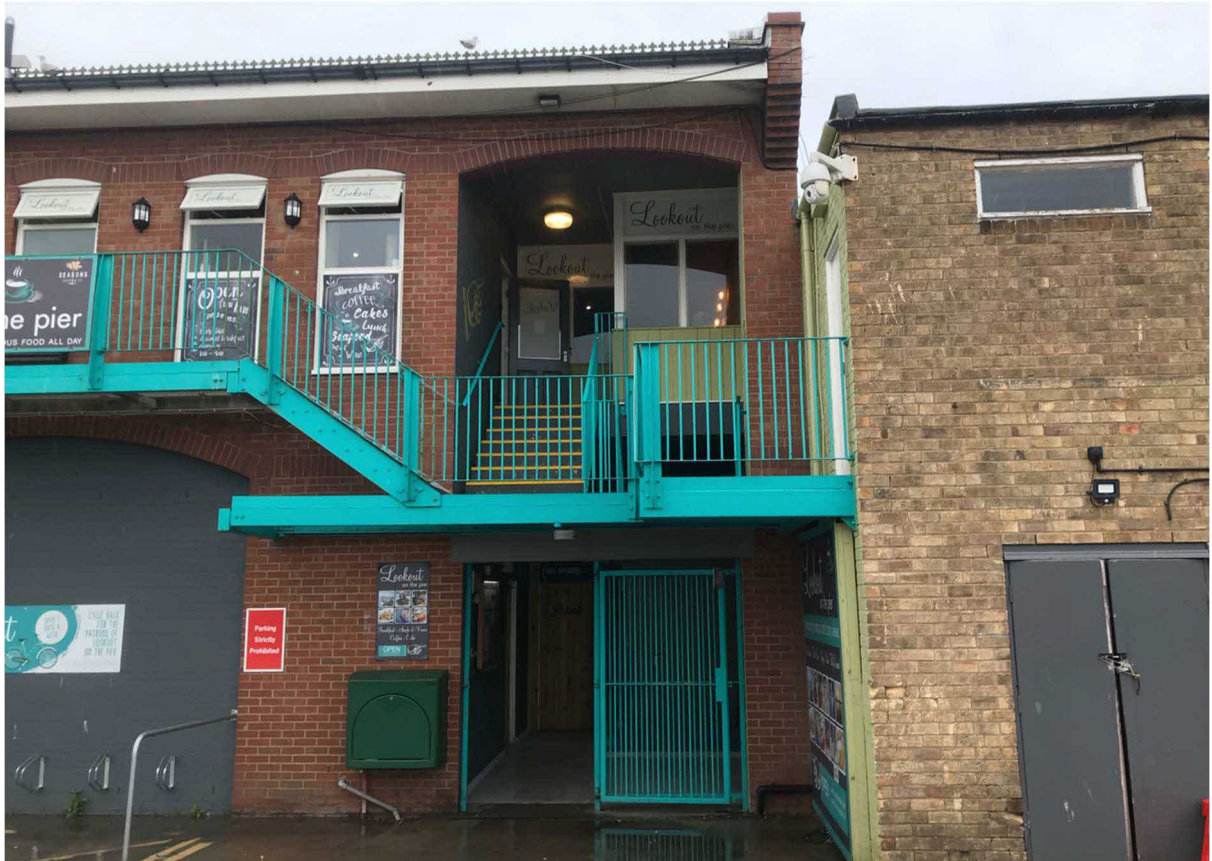
- 3.2.21. The steel frame of the south-west external balcony which serves the Cafe 'Lookout on the Pier' is fixed via steel bolts to Building 4b. Stepped diagonal cracking was identified adjacent to this fixing, suggesting this arrangement is overstressing the masonry bonds between the brickwork.

Photo 9 - Café balcony fixed to Building 4b

2.06	Walls	Building 4b	C. Fair	Cracking present where balcony fixed to west elevation of building 4b. Possibly due to lever arm of handrail connection and floor cantilever beam connection.	S3,	Provide new column and foundation to balcony. Rakeout and repoint masonry	No	1	Item	£ 4,000.00	£ 4,000.00

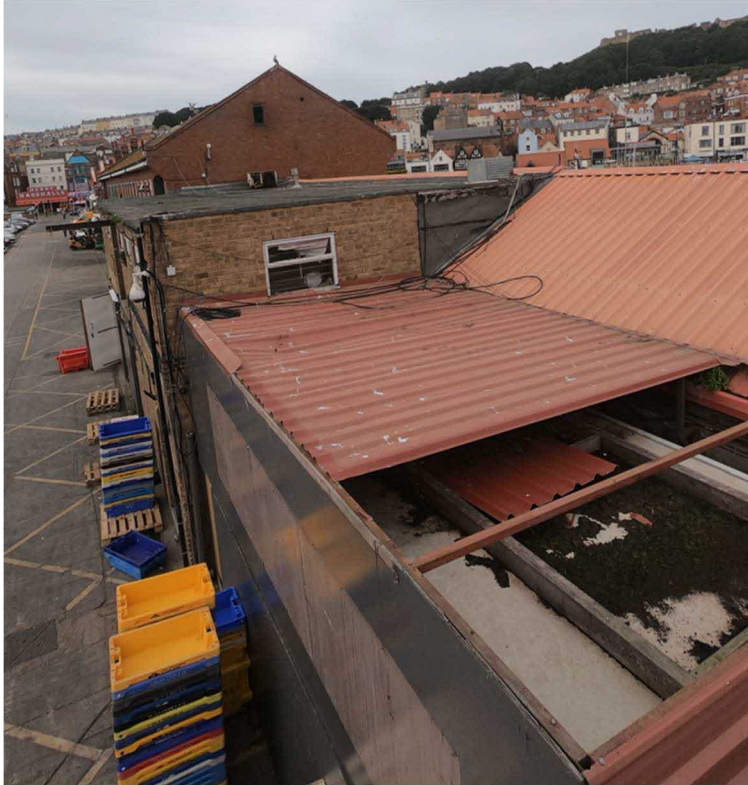
*Photo 12 - Aerial perspective of Building 4c Roof*

- 3.2.25. It was noted that this structure has surface corrosion to TEK screw connections between the cladding and frame, leading to loss of cladding fixity back to the structure.

- 3.2.26. The frame itself is generally surface corroded on each member which was visible.
- 3.2.27. The foundations of Building 4c are unknown and require further investigation to provide comment on form, significant risks, or their conditions.

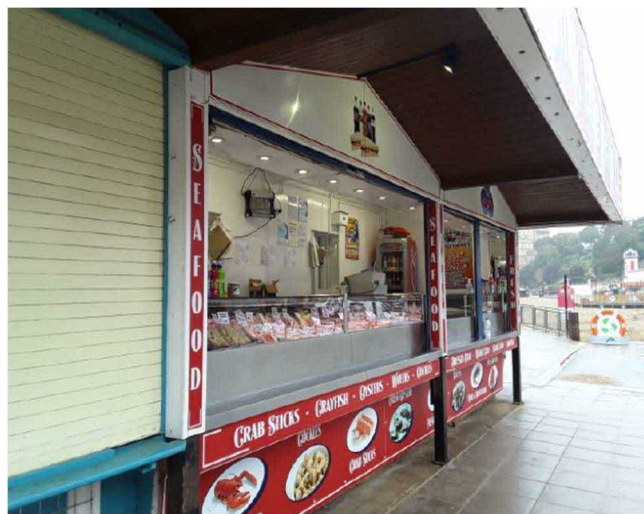
Photo 17 - North-west elevation showing overhang soffit and steel columns of Kiosks

6.18. The demolition sequence of the Kiosks overhang roof needs to be considered to prevent overturning the roof construction.
