REPORT CONTINUATION

Customer: Proteq Ltd.	Date of test: 6 th & 7 th March 2023	Report Number: AM-23.186
--------------------------	---	-----------------------------

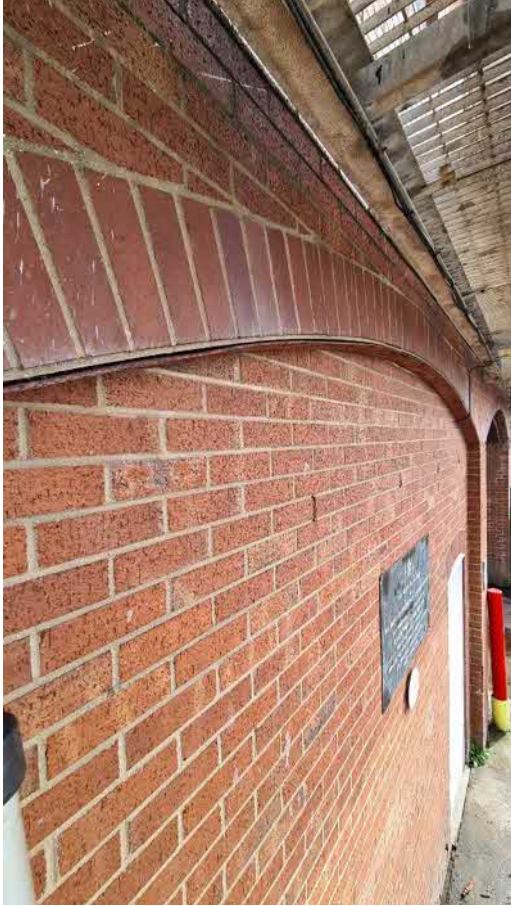
Figure
Steel Lintel distortion

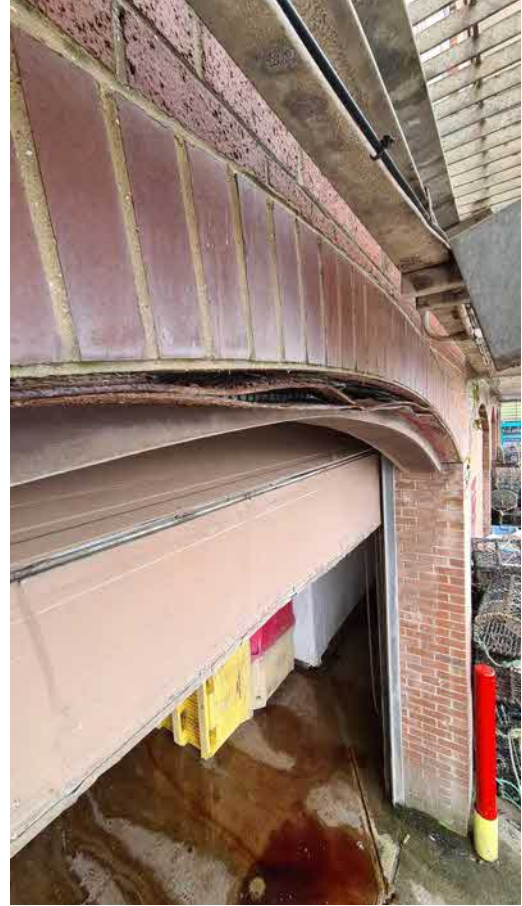
Figure
Steel Lintel distortion & flashing separation

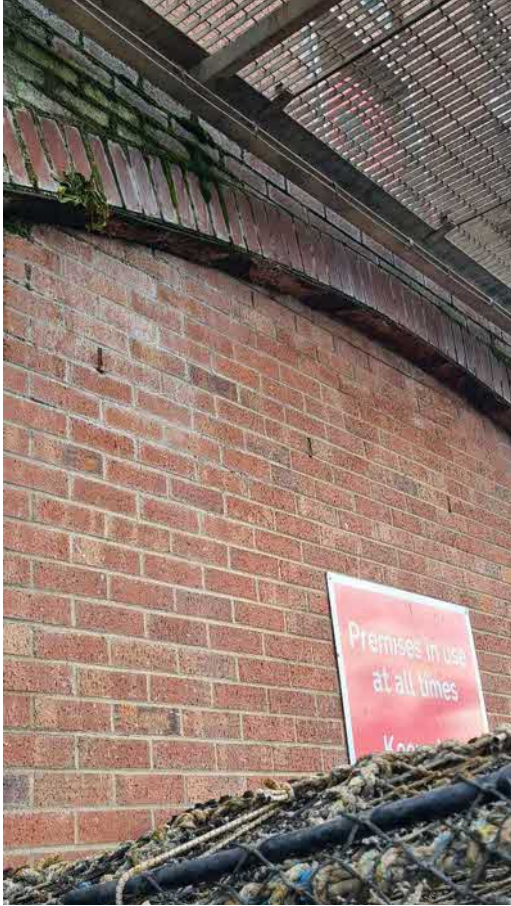
Figure
Steel Lintel distortion & flashing separation

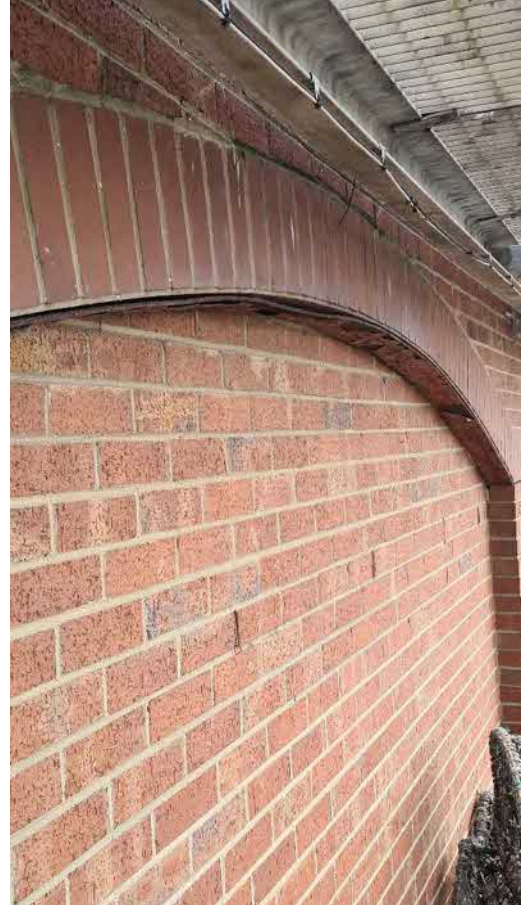
Figure
Steel Lintel distortion & flashing separation

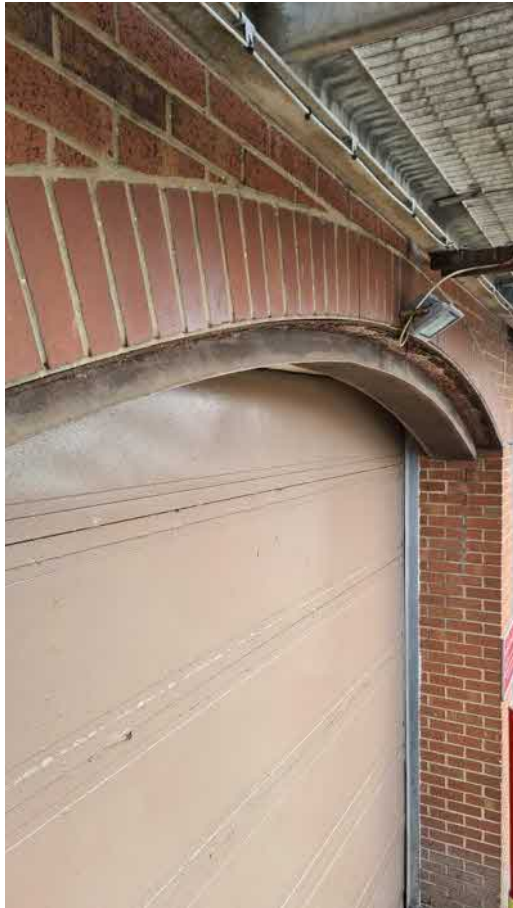
Figure
Steel Lintel distortion & flashing
separation

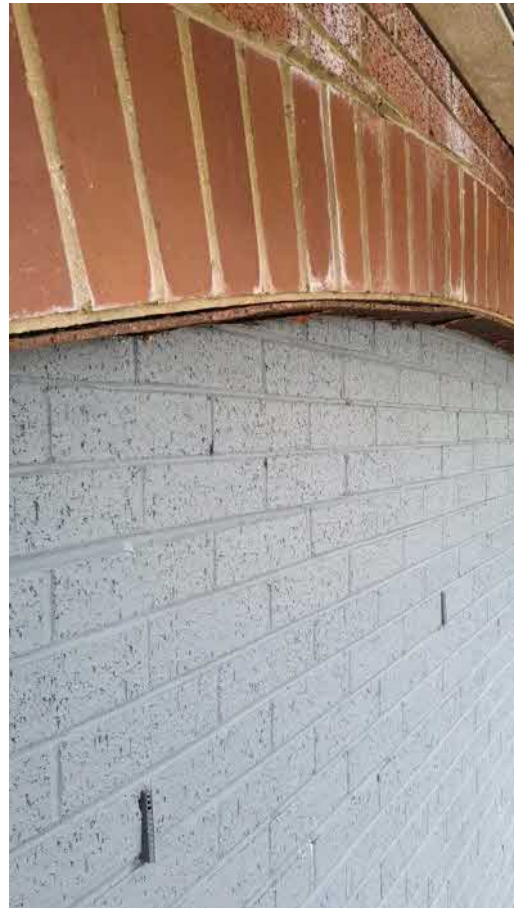
Figure
Steel Lintel distortion

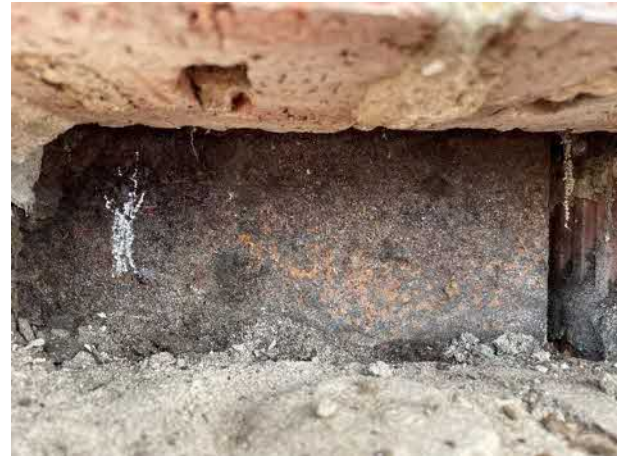
Support structure minor corrosion

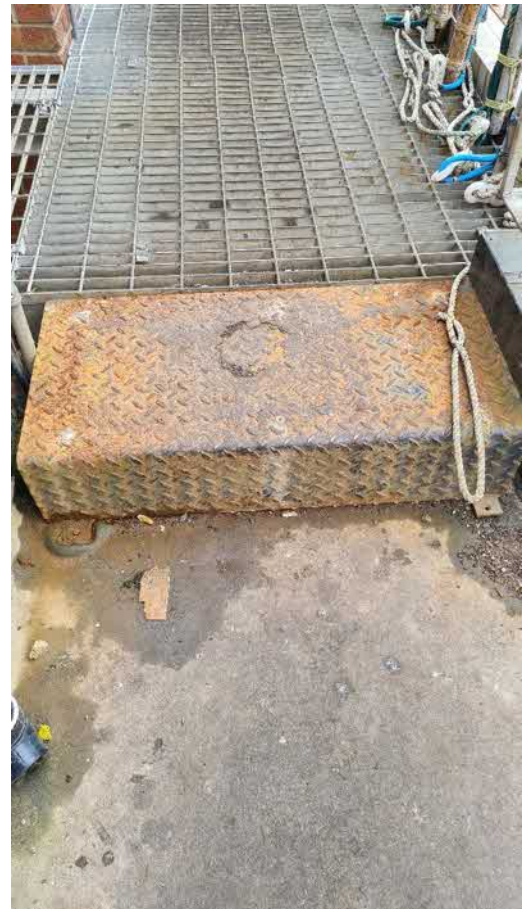
The walkway on the carpark side of building 3 remains in good condition however, the steelwork does show some signs of breakdown to the galvanised coating again this is not a cause for concern at this time. The Mesh flooring has become smooth through use and is now not very grippy and is now not performing as an anti-slip walkway. A step forms the bridge between Building 2 and Building 3's walkways, this step was found to be insecure.

Figure
Front gantry step from building 2 – 3 is loose
