Structural RIBA Stage 3 Report
for
Scarborough West Pier Regeneration Scheme
Foreshore Road
Scarborough
YO11 1PD

Report 21037-H-RP-001-R0
27th April 2023

Mason Clark Associates

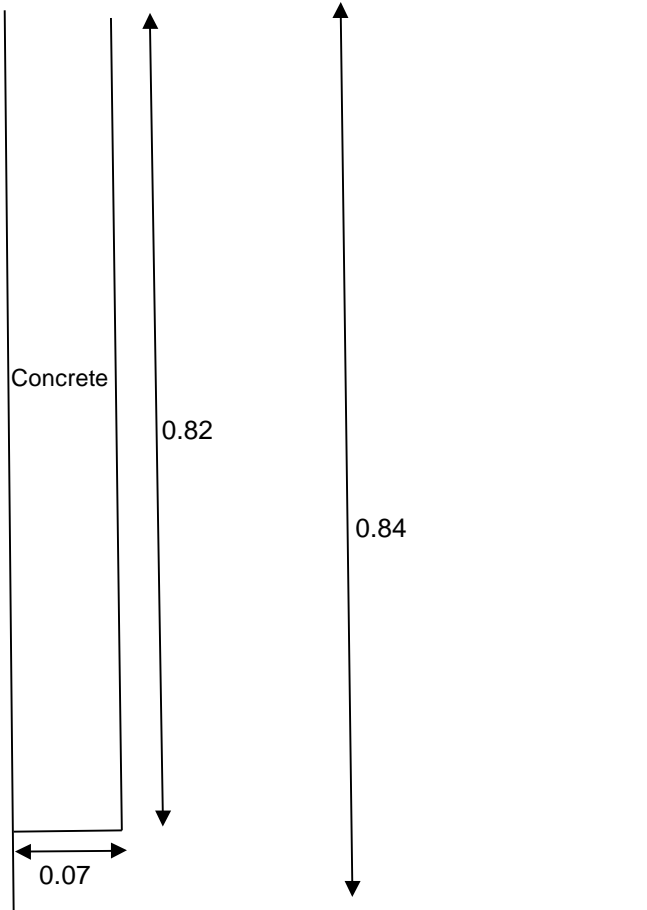
TP03

- 1.4.6 The initial trial pit 03 sketch from Solmek has shown that the existing concrete foundation is 0.82m from EGL. This has allowed design checks of changes to load directly above walls possible.
