Scarborough West Pier

Corrosion and General Investigatory works
Scarborough West Pier Buildings 1, 2 and 3
March 2023
Proteq Northern Limited

Customer: Proteq Ltd.	Date of test: 6 th & 7 th March 2023	Report Number: AM-23.186
Site Address: West Pier, Scarborough	Component: Structural steel elements	Drawing Number: 21037-H-SK-R0-002
	Identification: N/A	Serial / Pattern Number: N/A
	Material: Mild Steel	Surface condition: Galvanised / Painted / Bare
Order Number: Verbal T Mariner	Heat Treatment: N/A	Process: N/A
Calibration procedure No(s): N/A	Dimensions: N/A	Thickness: N/A
Specification: BS EN ISO 17637	Procedure: AMPR-VT-001 ISS 2	Acceptance Standard: Report all in service defects
Equipment Details: N/A	Illumination Equipment: Handheld torch & headlamp	
Magnification Level: N/A	Illumination Level: >500 Lx	
Description of items and test results:		
A Visual Inspection has been carried out on		
Test Results:		
Test Restrictions: None		
Inspection Operator: A Mitchell / J Bateman  	Operator Approval/Level/Number: A Mitchell PCN LEVEL 2: 208243

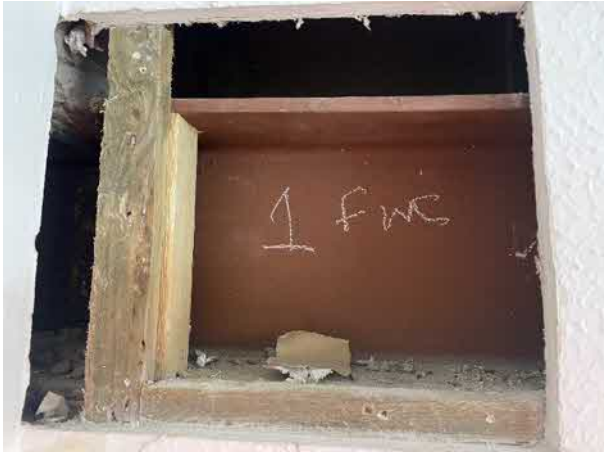
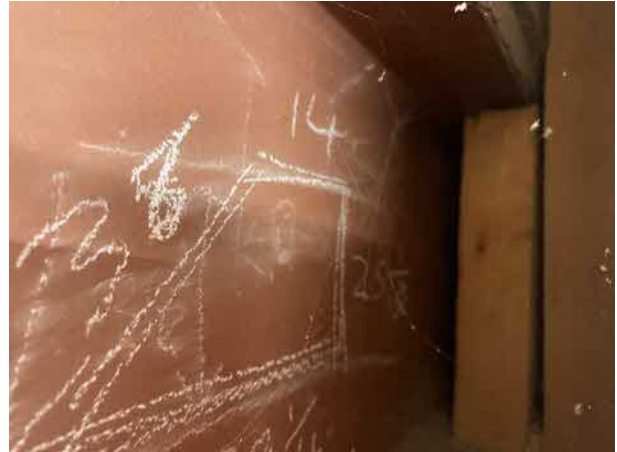
Figure
Women's toilet Location 1

All Steelwork in good condition

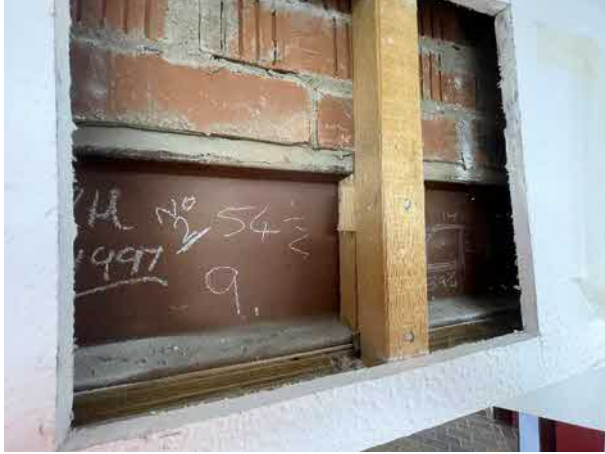
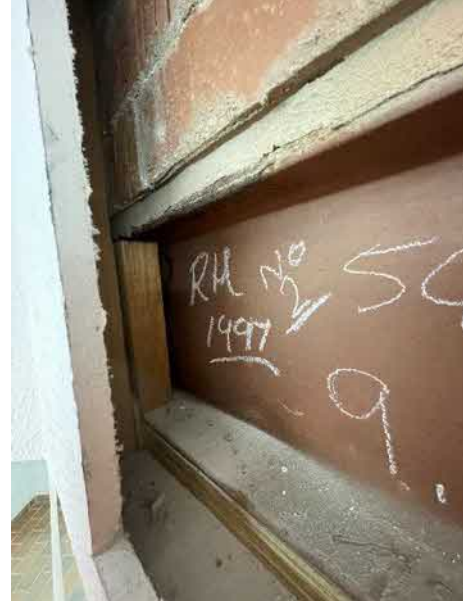
Figure
Women's toilet location 2

All Steelwork in good condition

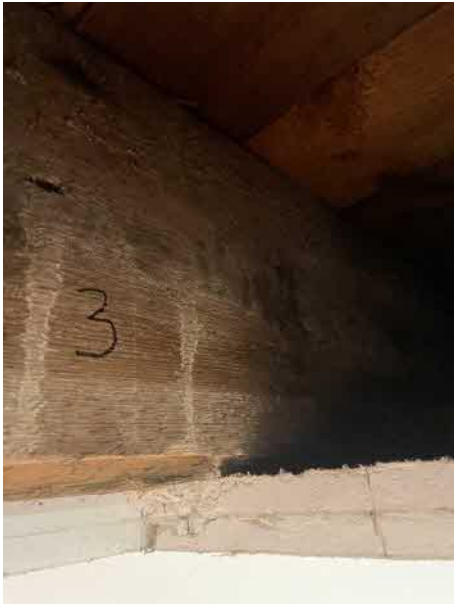
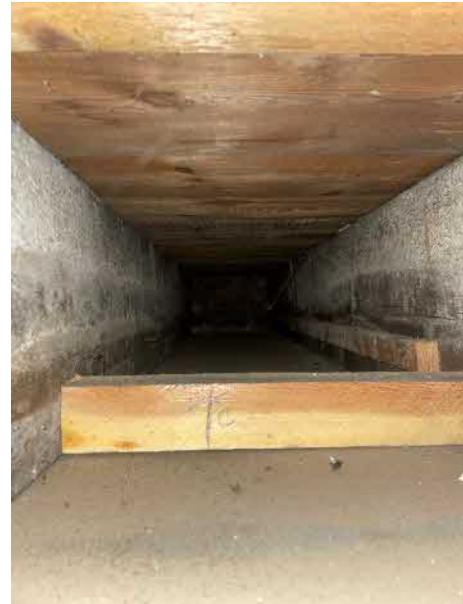
Figure
Women's toilet location 3

No Steelwork. Floor joists sit on steel frame with steels encased in the beams.

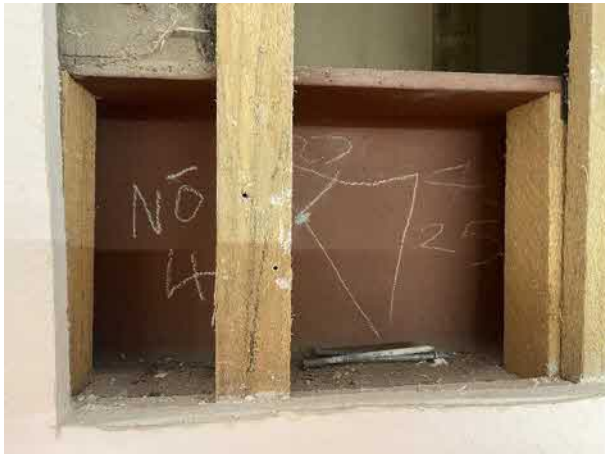
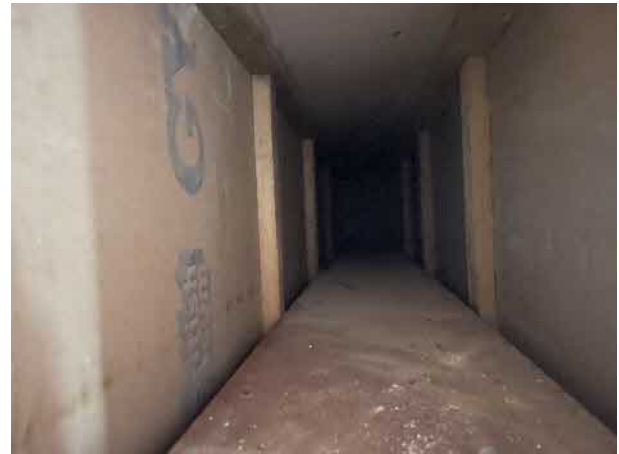
Figure
Women's toilet location 4

All Steelwork in good condition. Minor surface corrosion.

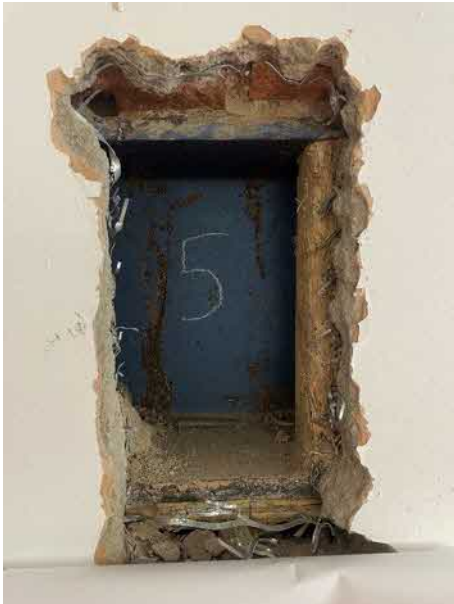
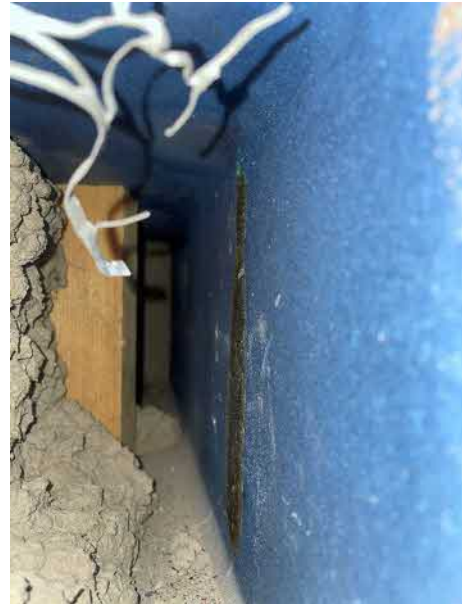
Figure
Women's toilet location 5

All Steelwork in good condition, encased in render.

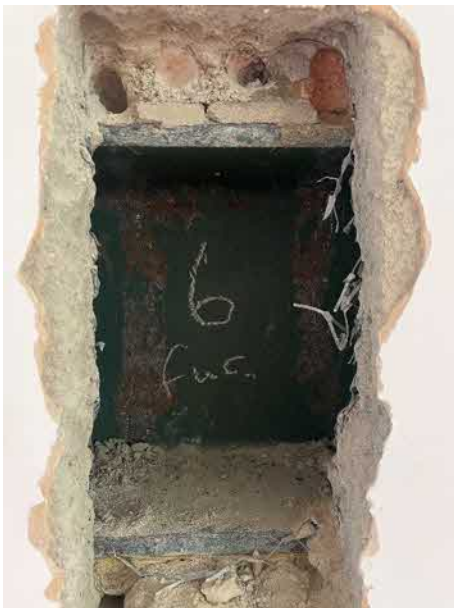
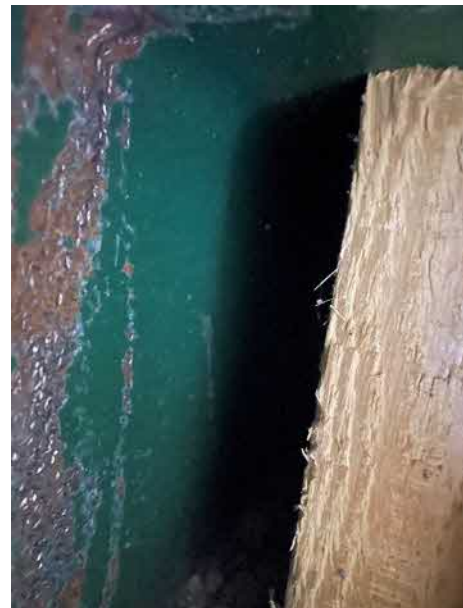
Figure
Women's toilet location 6

All Steelwork in good condition, encased in render.

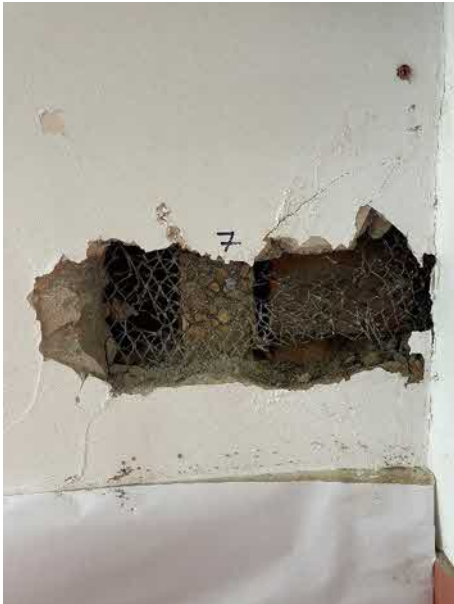
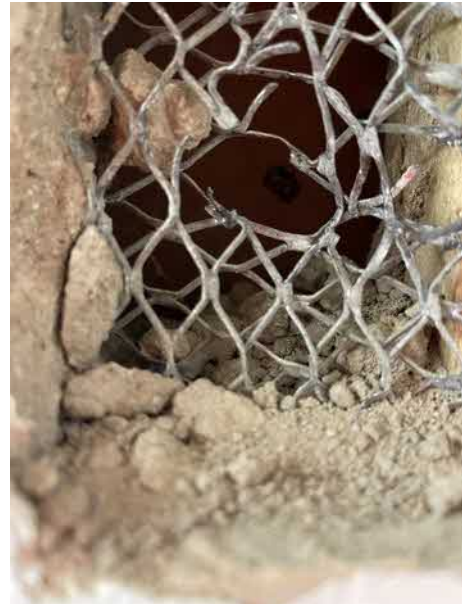
Figure
Women's toilet location 7

All Steelwork in good condition, encased in render and sits on brickwork of outer wall.

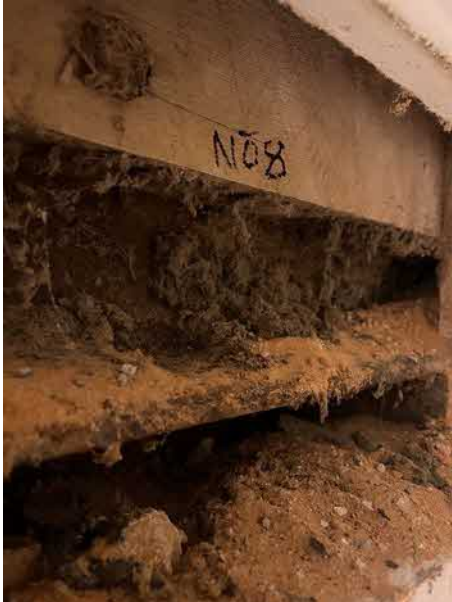
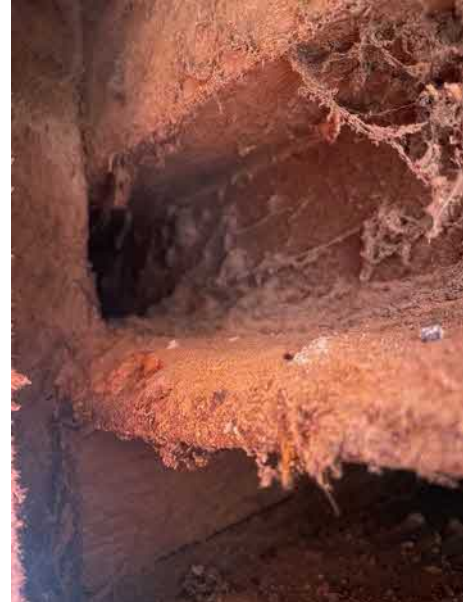
Figure
Men's toilet location 8

All structural elements seem in good condition, timber framework above. Access doesn't allow for measurements.

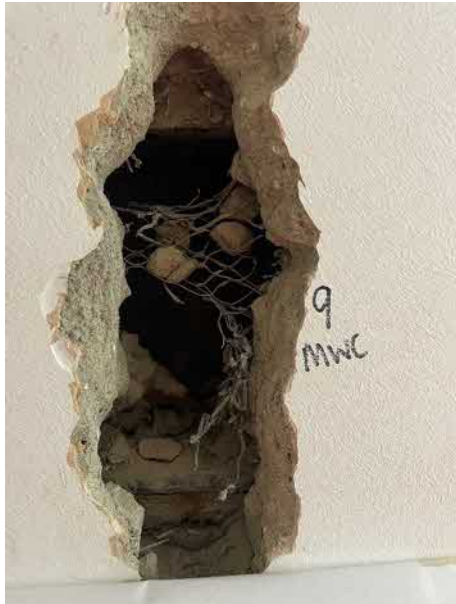
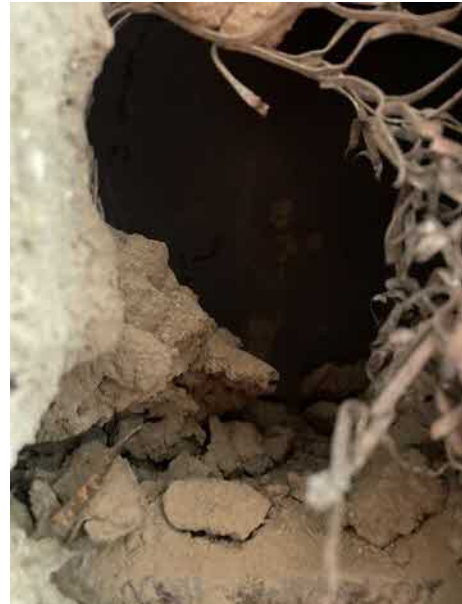
Figure
Men's toilet location 9

All structural elements seem in good condition, timber framework above.
Access doesn't allow for measurements.

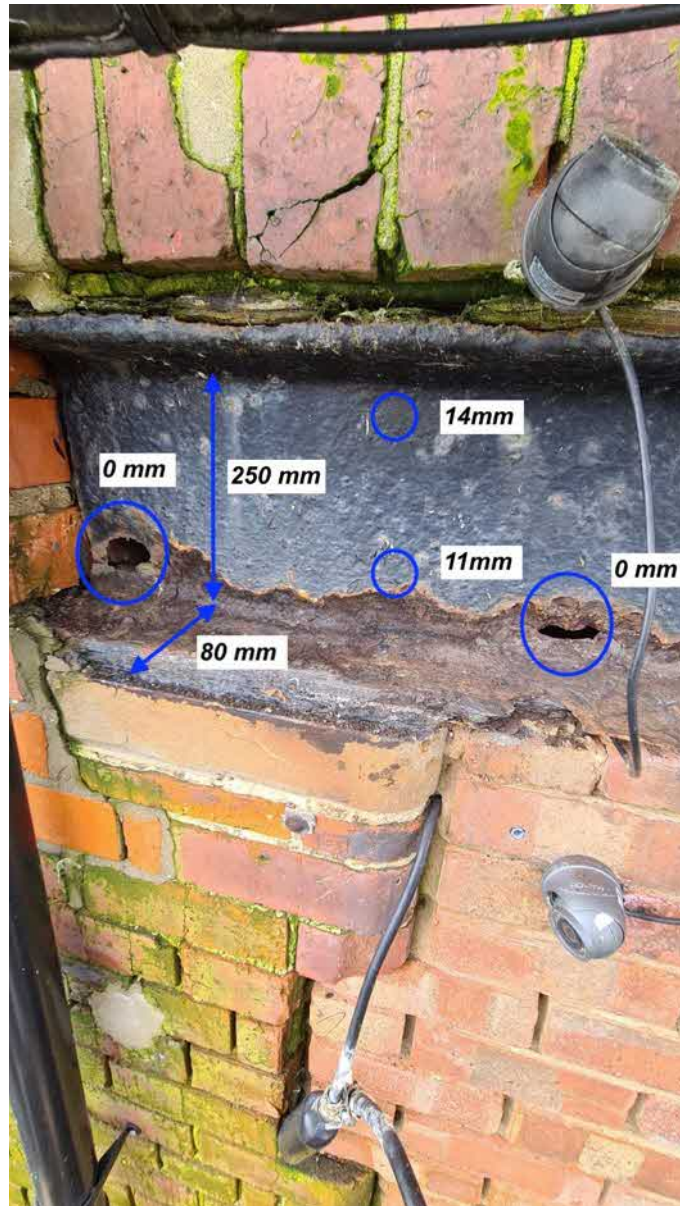
The horizontal I beam Lintel at the rear of the building supports the upper floor; it was inspected at 5 No. Locations along its length at each of these locations the corrosion was hand cleaned from the beam to establish its extent. At each one of these sections, the beam had suffered a 100% loss of section the remainder of the beam tests at between 11mm and 14mm. This beam will have a corrosion allowance within the original design of the building. A 100% loss of section will certainly exceed this corrosion allowance; therefore, this beam should be considered life-expired and be repaired or replaced as soon as possible.

Building No. 2 Rear Horizontal Beam Size and Corrosion, the vertical beam shown below is the same size but in a different orientation.

It may be possible to over plate this beam to restore it to the original design standard. However, the type of plate, thickness and weld procedure would have to be agreed upon with a structural engineer, a specialist paint system should also be sought to protect against further corrosion attack. These factors will also stipulate the future design life of the repaired beam. It is therefore impossible for us to state the expected design life post-repair.

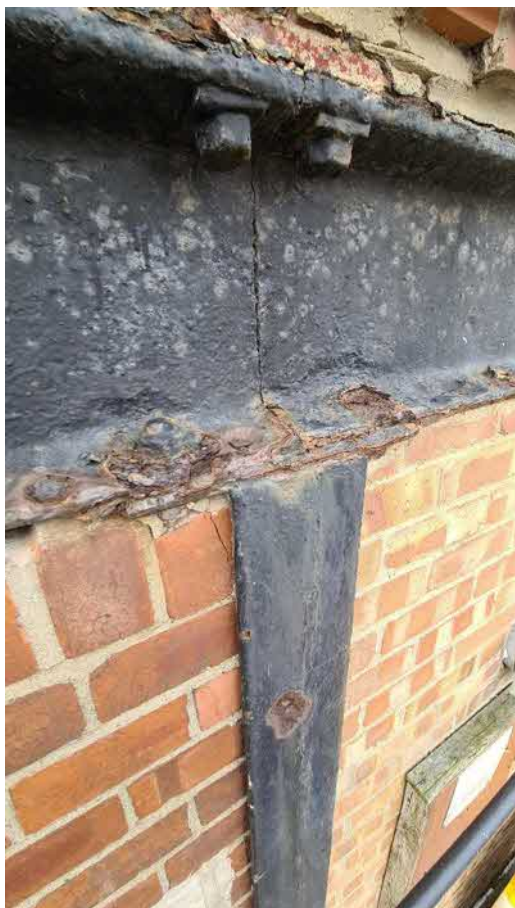
Figure
Location 1

I Beam Severe corrosion / delamination

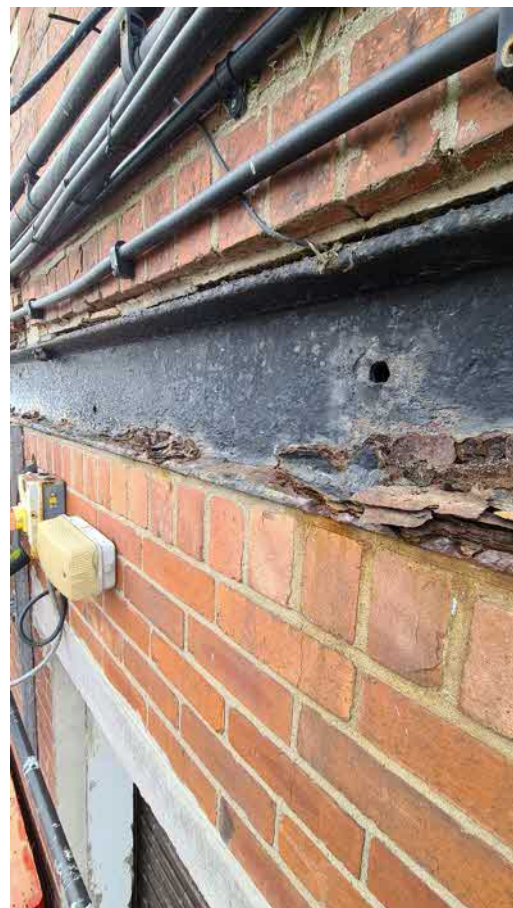
Figure
Location 2

I Beam Severe corrosion / delamination

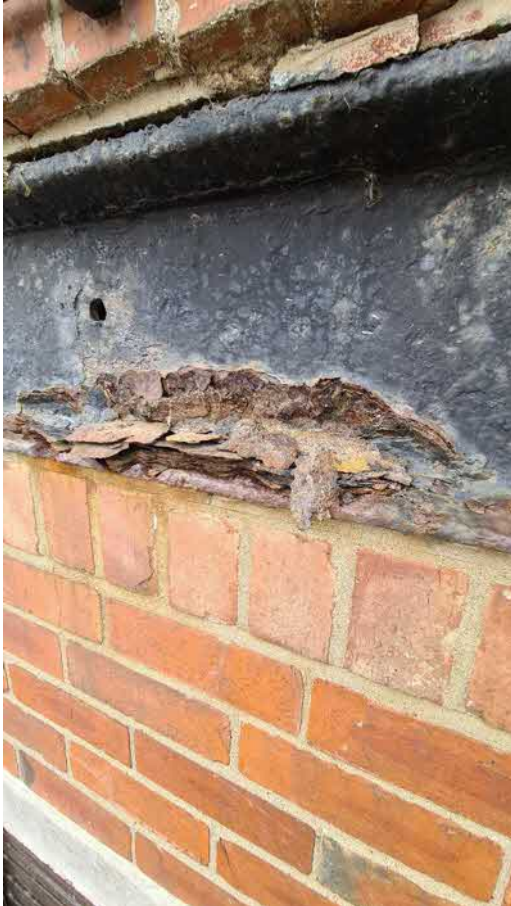
Figure
Location 3

I Beam Severe corrosion / delamination

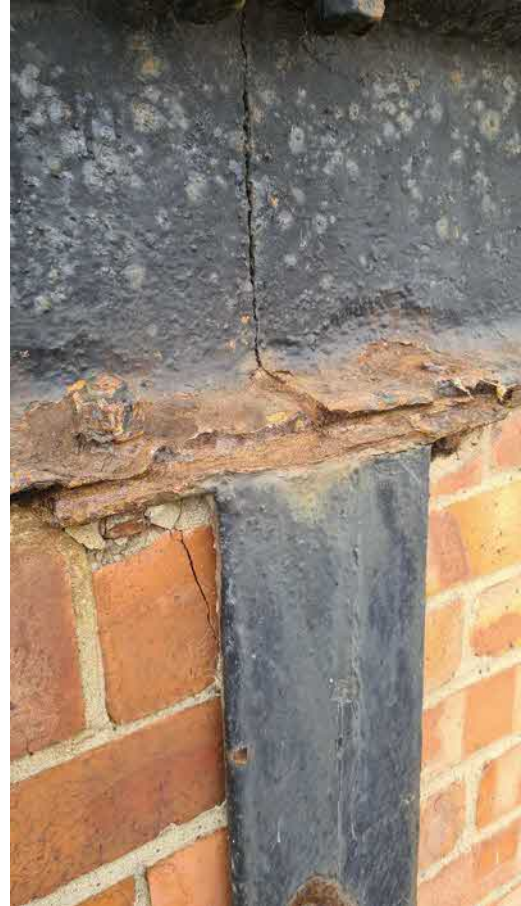
Figure
Location 4

I Beam Severe corrosion / delamination

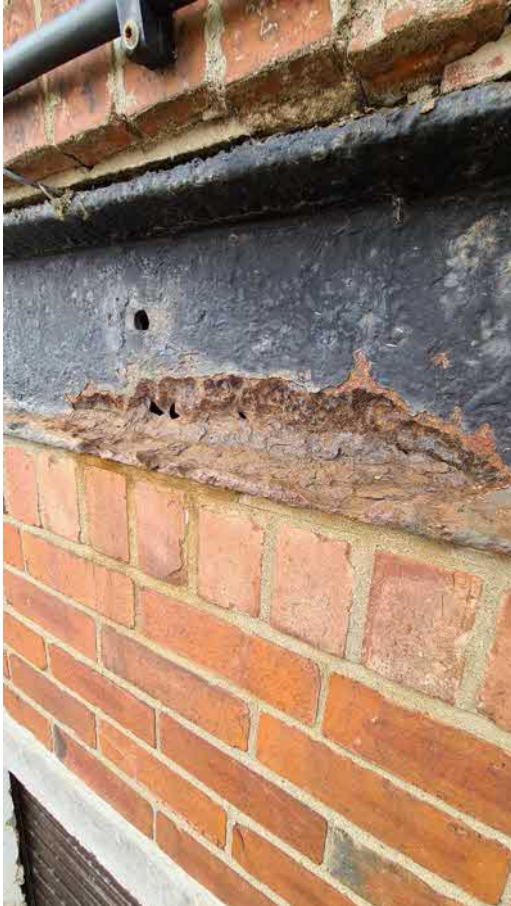
Figure
Location 5

I Beam Severe corrosion / delamination

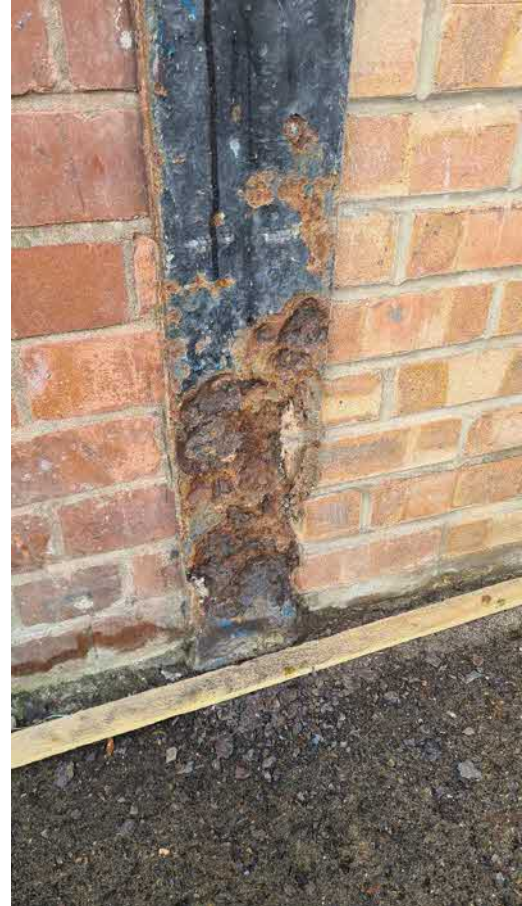
Figure
Location 6

I Beam Severe corrosion / delamination

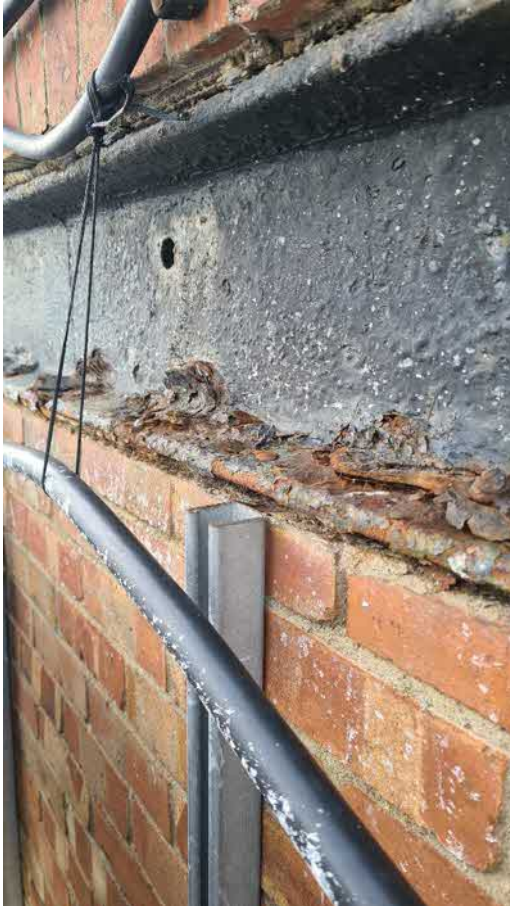
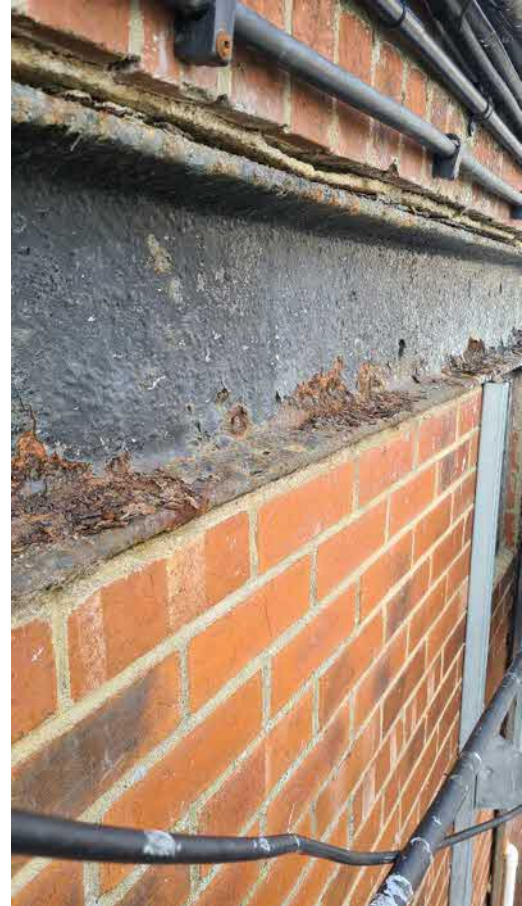
Figure
General Image
I Beam Severe corrosion / delamination

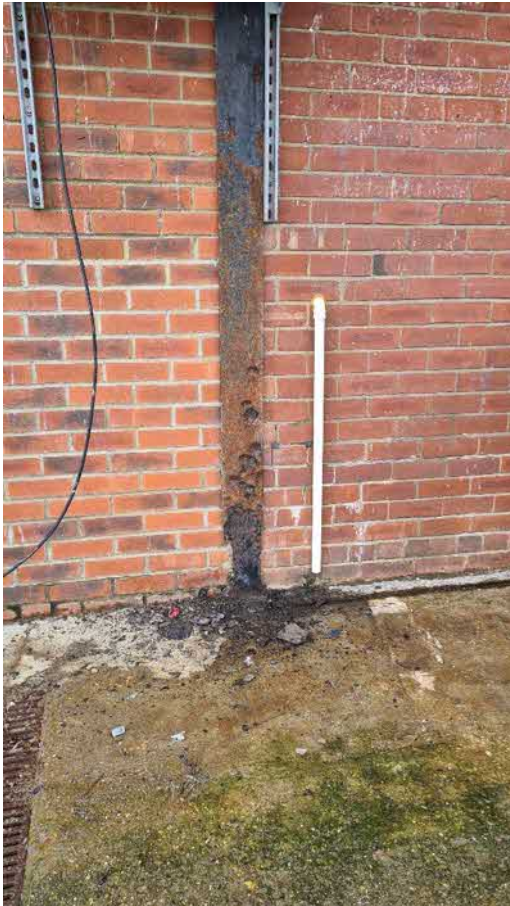
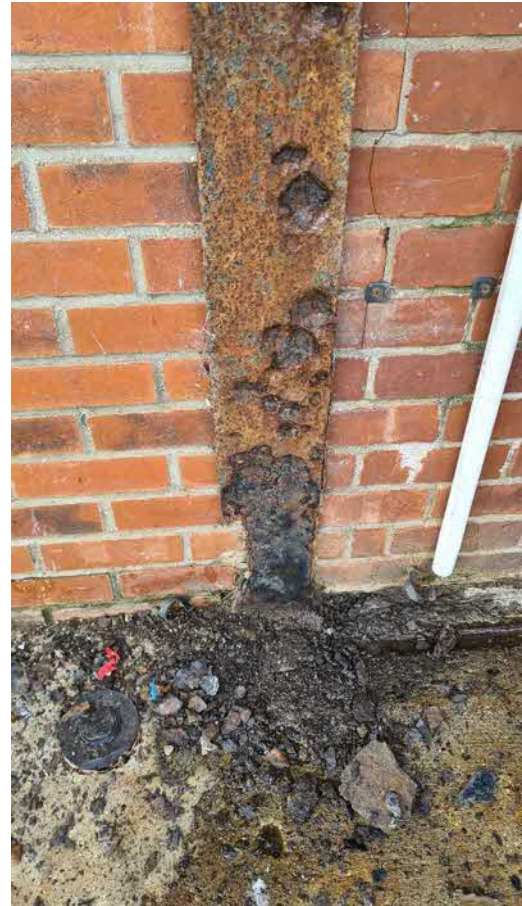
Figure
Location 7

I Beam Severe corrosion / delamination

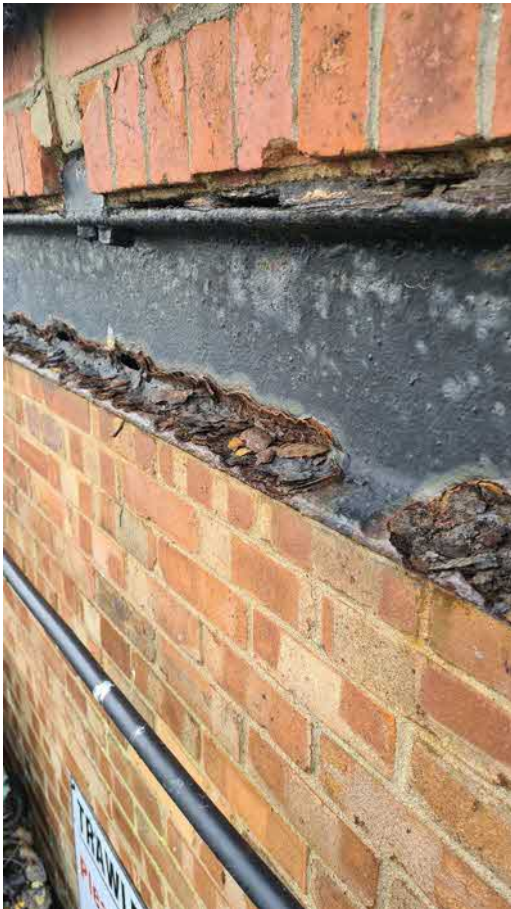
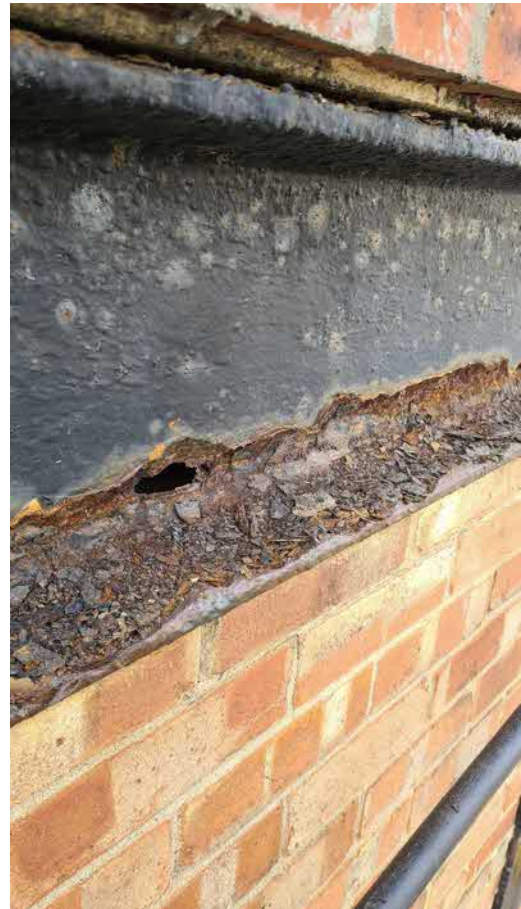
Figure
Location 4
I Beam Severe corrosion / delamination

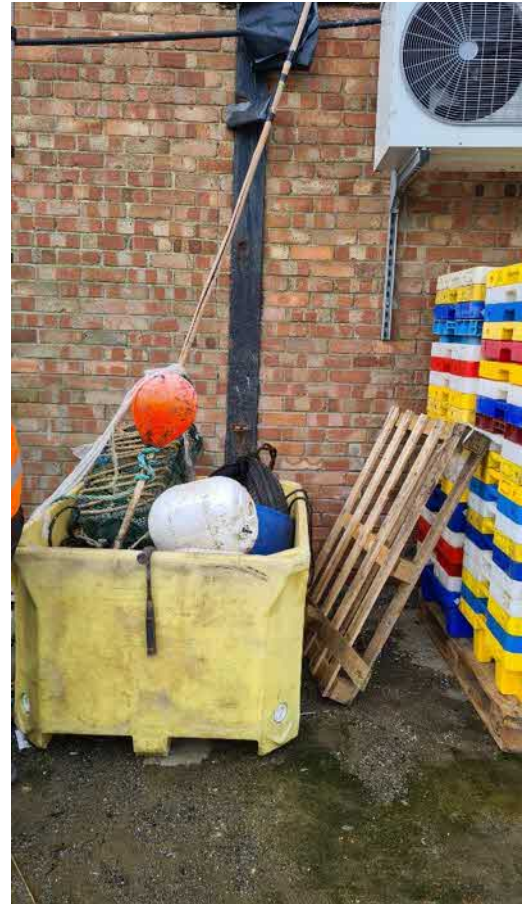
On the harbour side of the building, the horizontal and vertical I beam are exposed directly not only to the saltwater environment of the harbour but also have crab and lobster pots stacked against them causing prolonged exposure to saltwater which our engineer believes has significantly impacted the corrosion present. The Flange of the beam is 80mm the Web of the beam is 250mm. The beams are 4.5(m) long and are jointed using fish plates.

Figure
General Image Showing the Storage of
Materials/Equipment
I Beam Severe corrosion / delamination

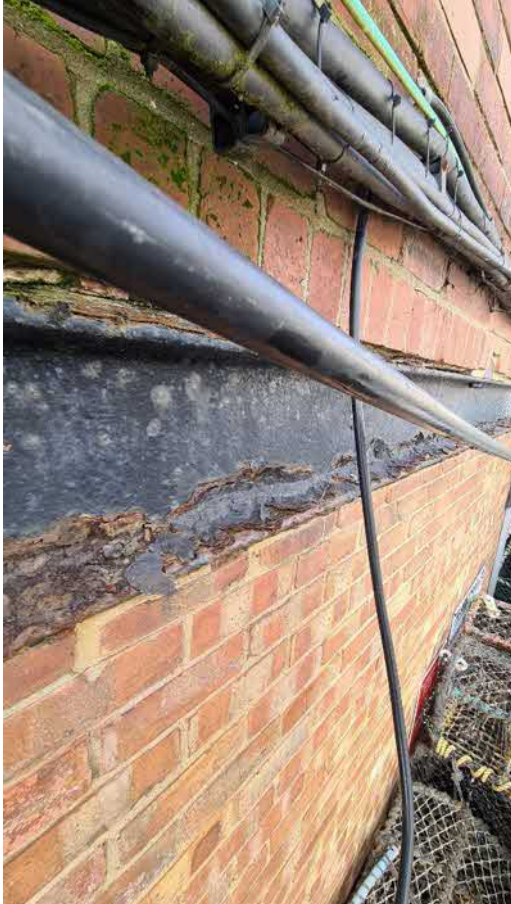
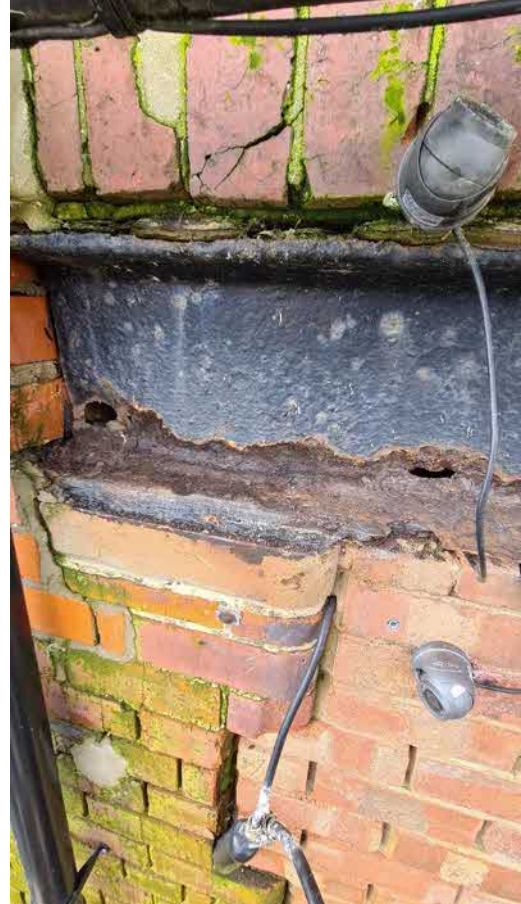
Figure
Location 5
I Beam Severe corrosion / delamination

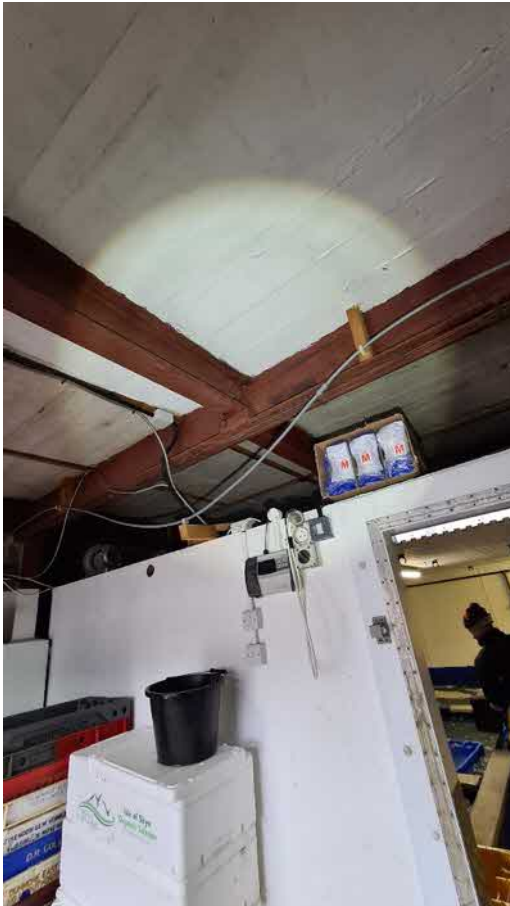
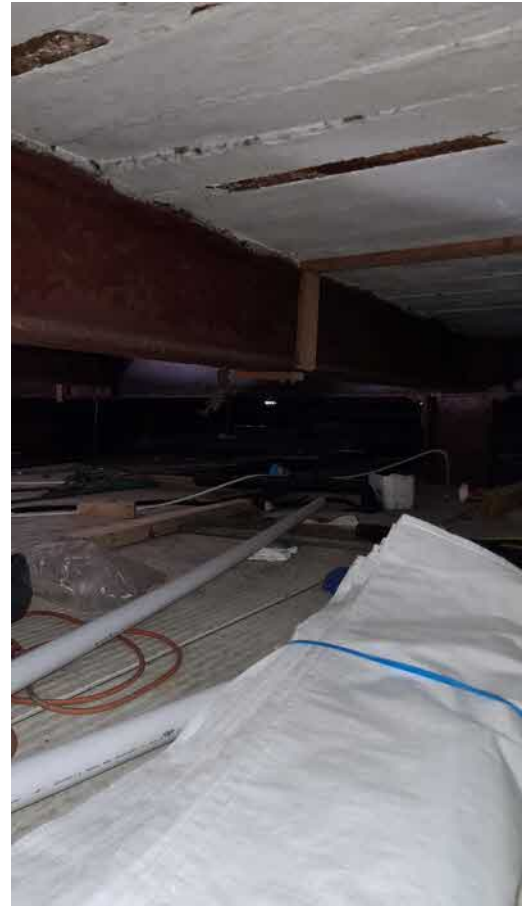
Figure
Jacks Place Internal
Support structure above holding tanks

Surface corrosion requires removal and re-protection.

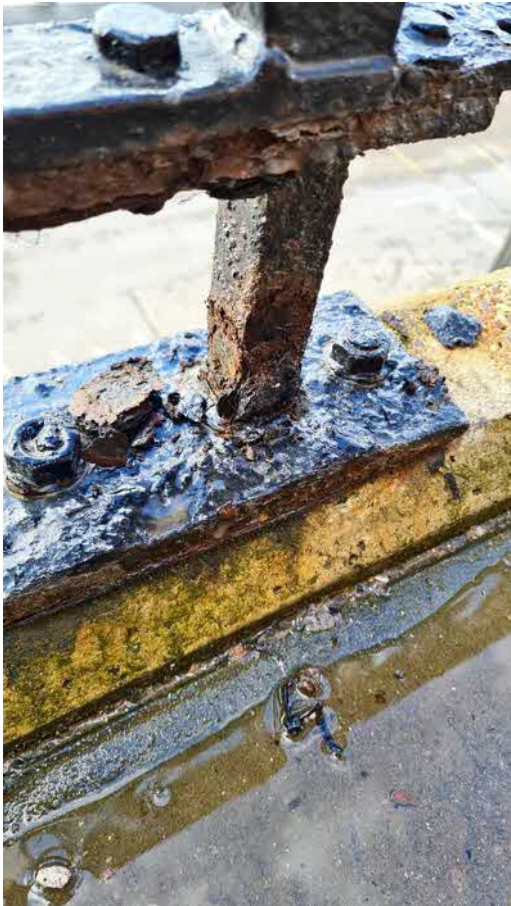
The handrails on the external face of building No1 and No2 are heavily corroded and have been repainted without any evidence of repairs taking place. The engineer's concern was based on the connection point to the concrete substrate, which is spalling and showing signs of cracking and de-lamination.

Figure
Balcony Handrail, severe corrosion

Building 2 Balcony and steps handrail are in poor condition.

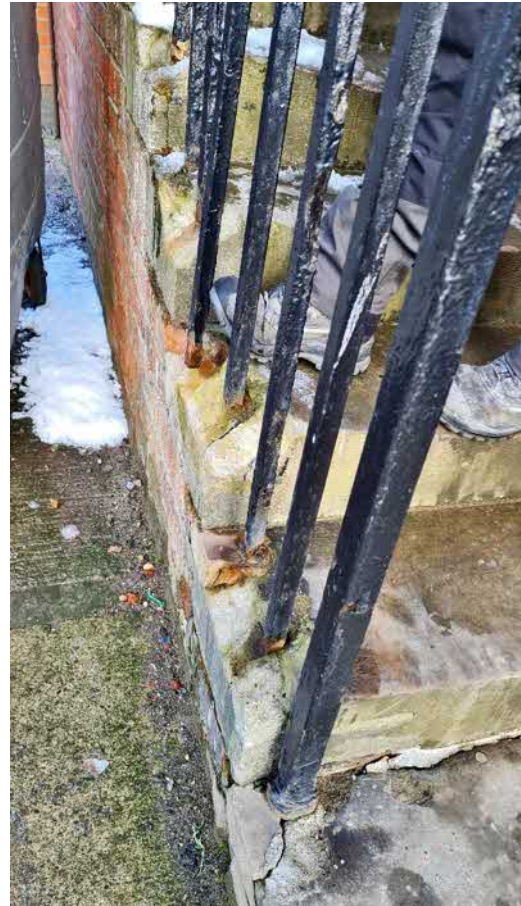
Figure
Failed Stanchions
Handrail severe corrosion. Spalling concrete
