Customer: Proteq Ltd.	Date of test: 6 <sup>th</sup> & 7 <sup>th</sup> March 2023	Report Number: AM-23.186
--------------------------	---	-----------------------------

Site: 18 West Pier, Scarborough

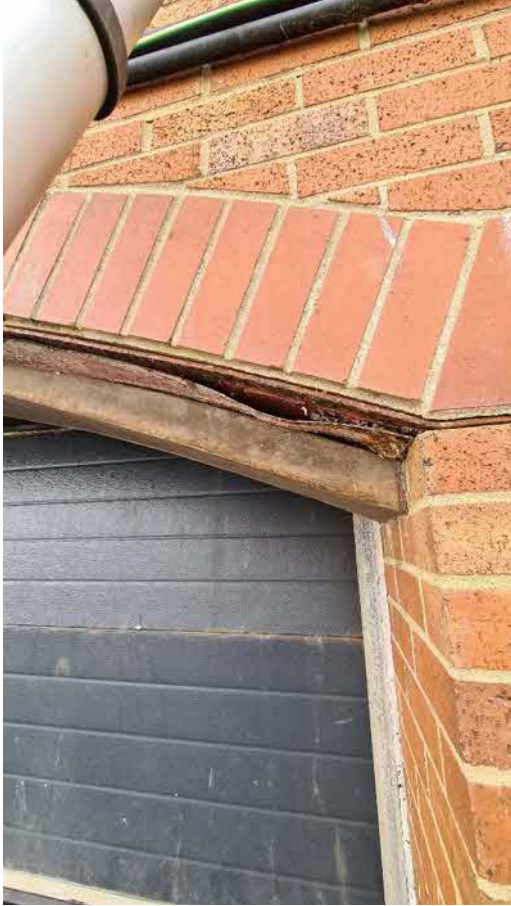
Figure  
Steel Lintel distortion & flashing separation

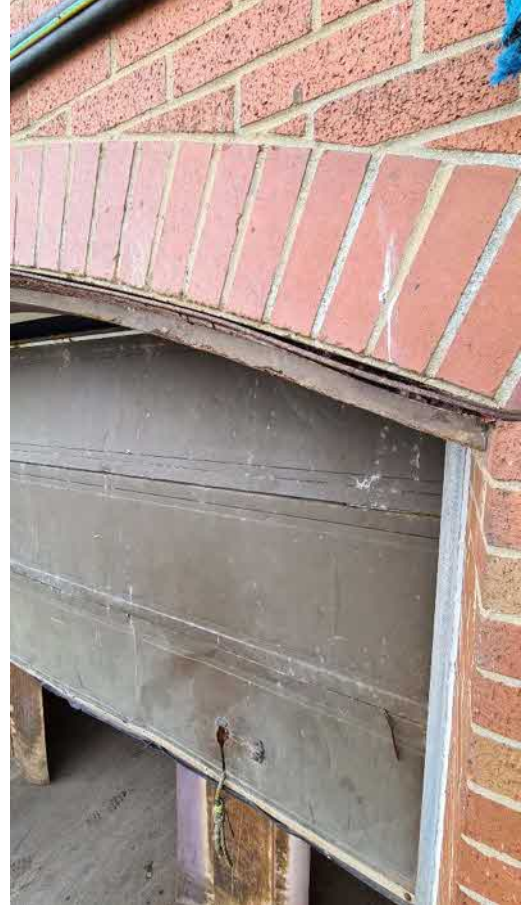
Figure  
Steel Lintel distortion

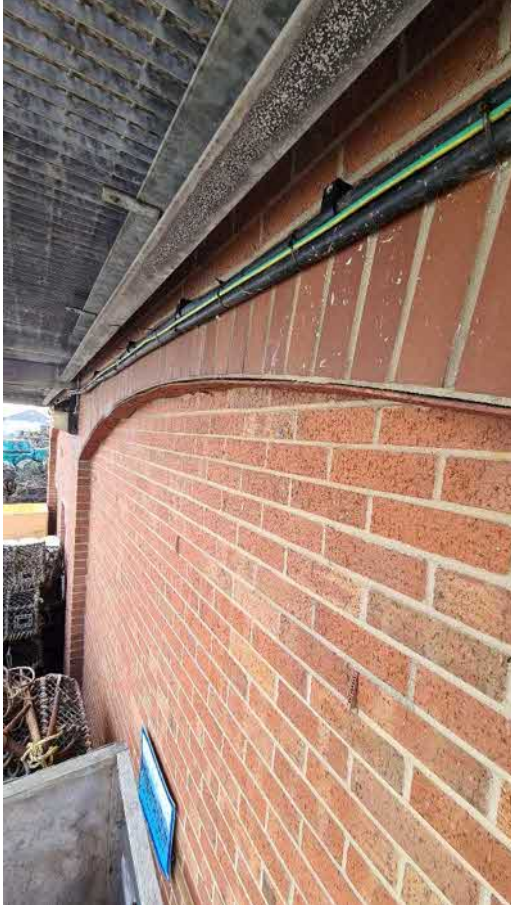
Figure  
Steel Lintel distortion

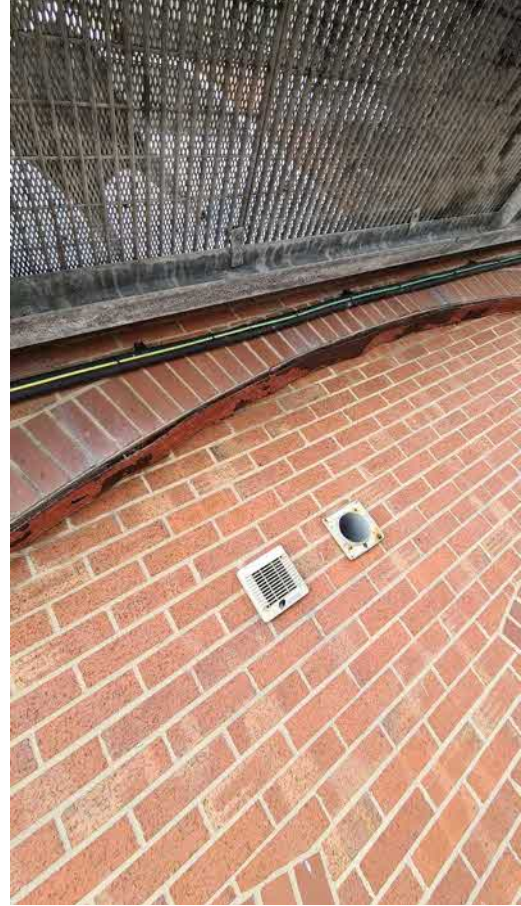
Figure  
Steel Lintel distortion

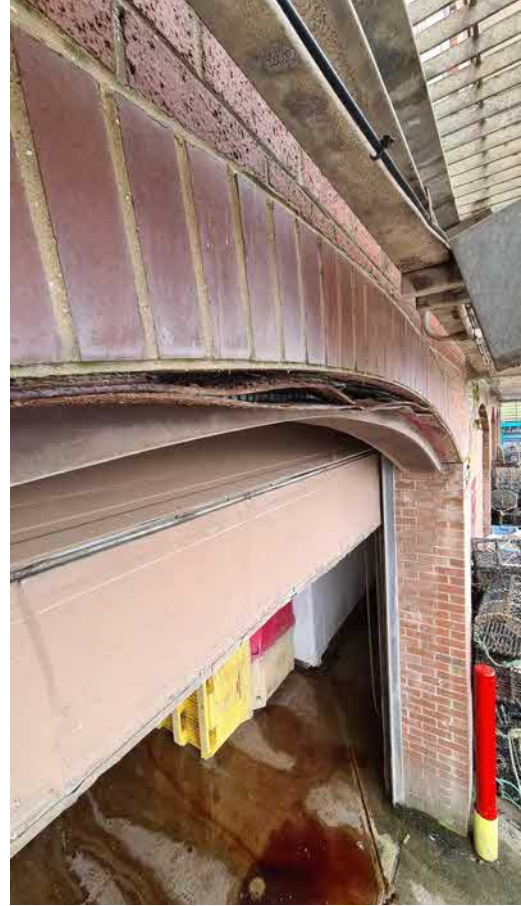
Figure  
Steel Lintel distortion & flashing separation

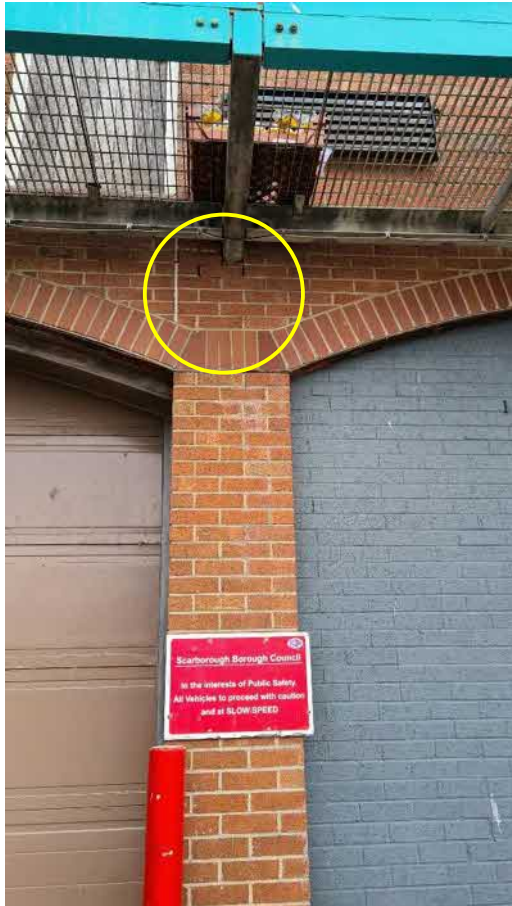
Bricks removed to expose steel support structure

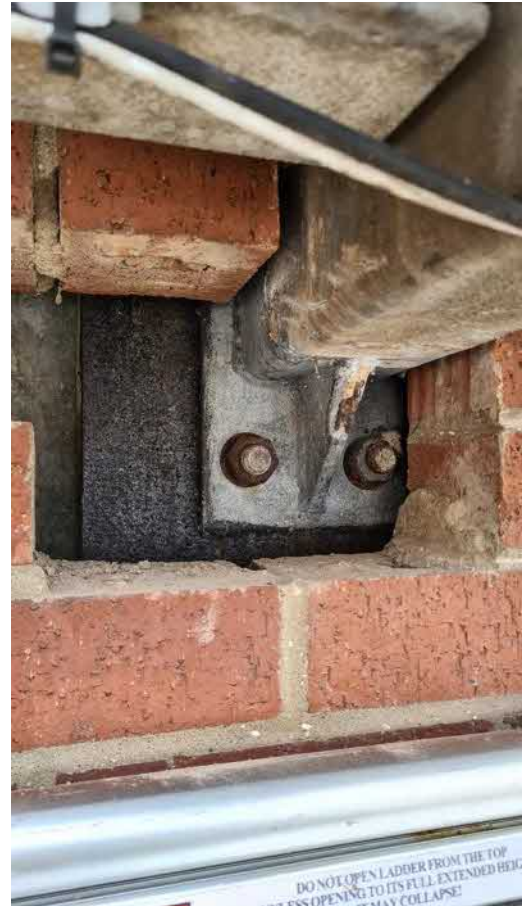
Support structure minor corrosion

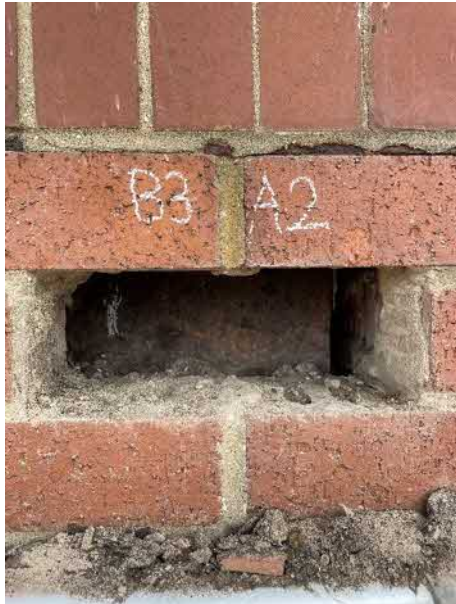
Bricks removed to expose steel support structure

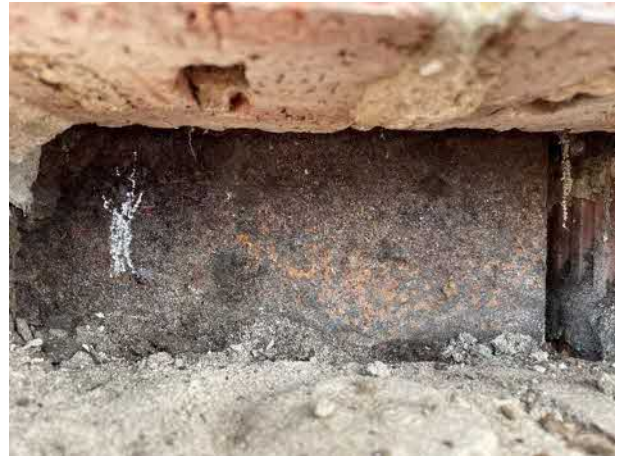
Support structure minor corrosion

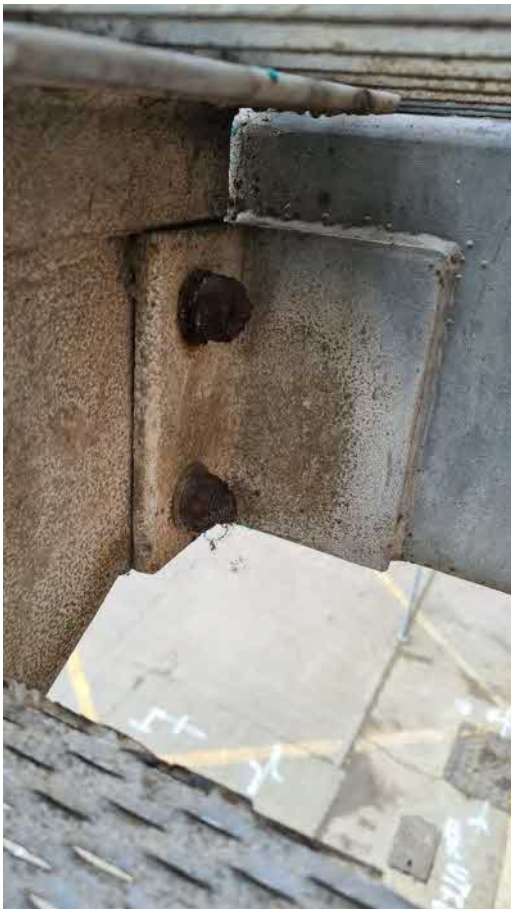
The gantry/balcony to the rear of the café on the harbour side support steelwork is in good condition. However, the bolts are suffering from light corrosion. There are a number of areas where bolts are missing, however, it appears that this was during construction with areas being welded instead of bolted.

Figure  
Front gantry bolts

It is recommended that 20% of these bolts should be removed and replaced with the removed bolts being sent away for microscopic examination and tensile testing, this will highlight if the bolts remain at the required strength and will also show any cracking within the bolts that is not visible to the human eye.

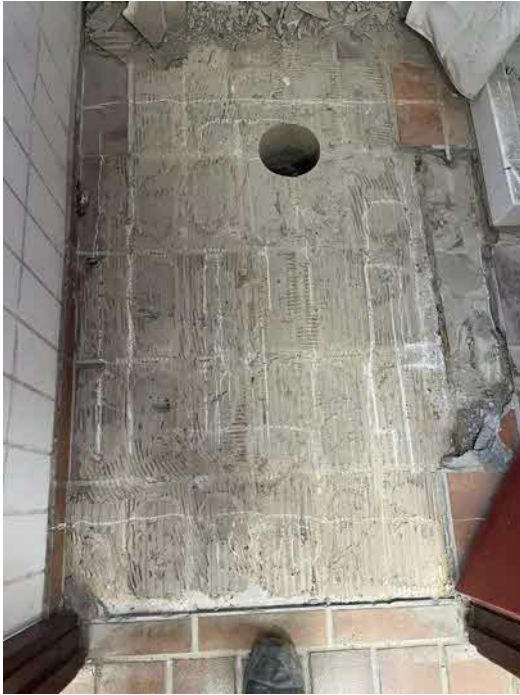
Building 1. Cover metre in the Male Toilet shower. Presence of non-ferrous during the scanning which our engineers suspect is copper pipework feeding the toilets. No Reinforcing bar was detected in the area during the scanning works.

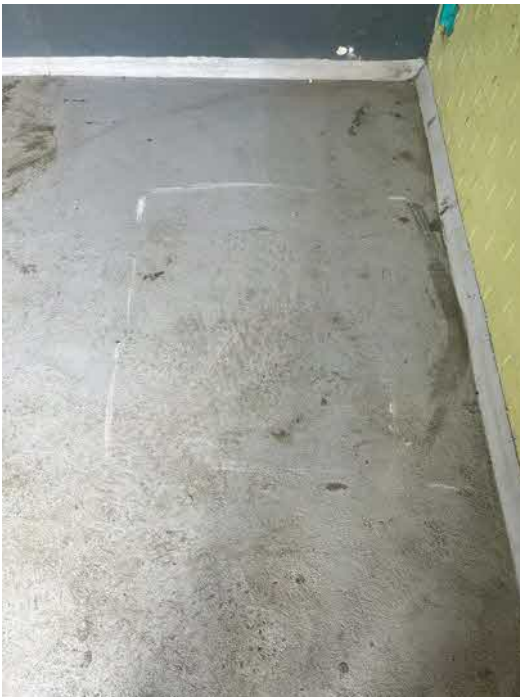
Building No. 2 Upstairs Room, the area was inspected with a cover metre and no reinforcing bar was found during the inspection.
