Project
Scarborough Harbour West Pier Regeneration

Drawing
Building 3 Proposed Interventions - Front Elevation

Scale	As Indicated	Drawn	SJP	Date	05/31/23
Drawing Purpose	PLANNING	Status	S2	Rev.	
Ref	2135-JSA-03-ZZ-DR-A-03035	Rev.	P1

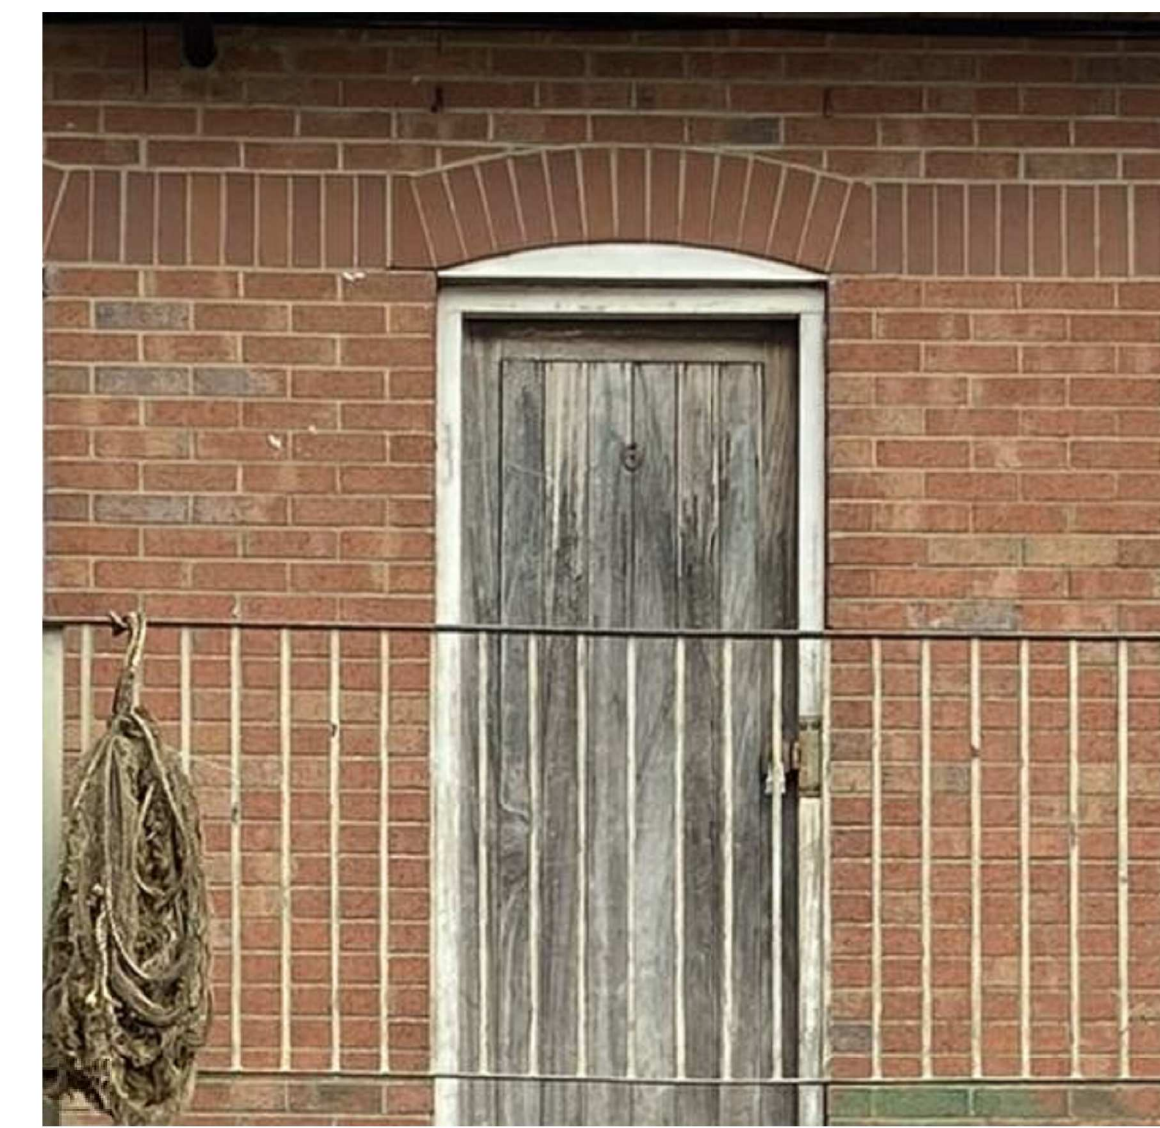
Common appearance / condition of Brickwork to SW Elevation

- Demolition Key**
- Clean / Repair
DOFF clean existing brickwork. Replace any individual damaged bricks with new. Make out all existing pointing and re-point.
 - Removal of Finish
Remove existing black paint using chemical stripper with TORC cleaning system.
 - Assess Area of Brickwork for Replacement
 - Remove and Replace
Remove existing (Brick/ Stone/ Door/ Window/ Gutter) and Replace with new.

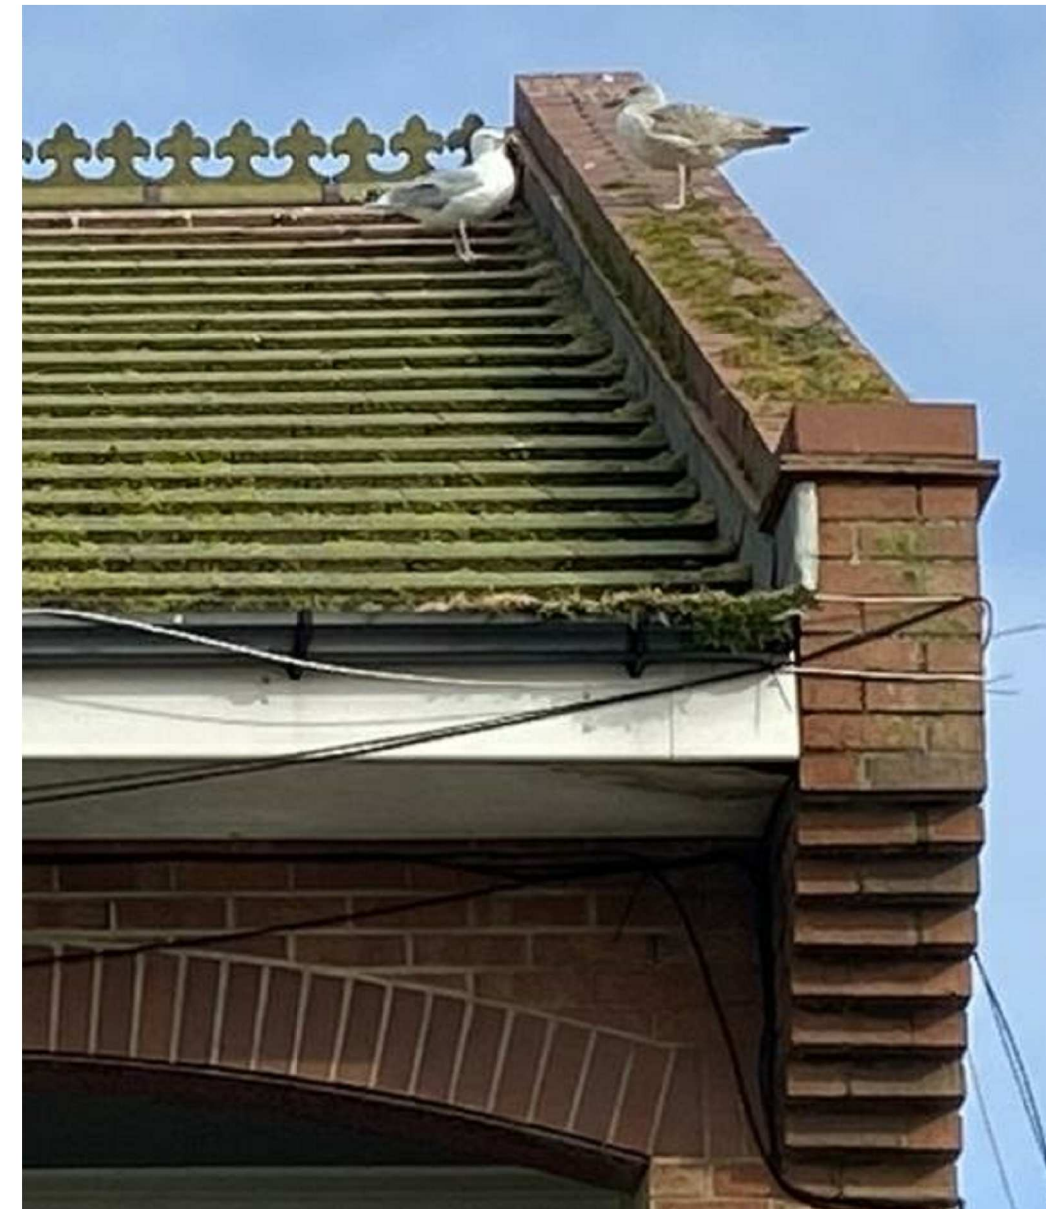
Common appearance / condition of Gable Copings

Gable Tiles & Brick Copings
Inspect tiles and copings for damage. Damaged tiles / copings to be carefully stripped and removed from site. To be replaced with new to match existing material, style and colour.

Clean and clear all dirt and detritus including organic growth from existing copings using DOFF cleaning system.

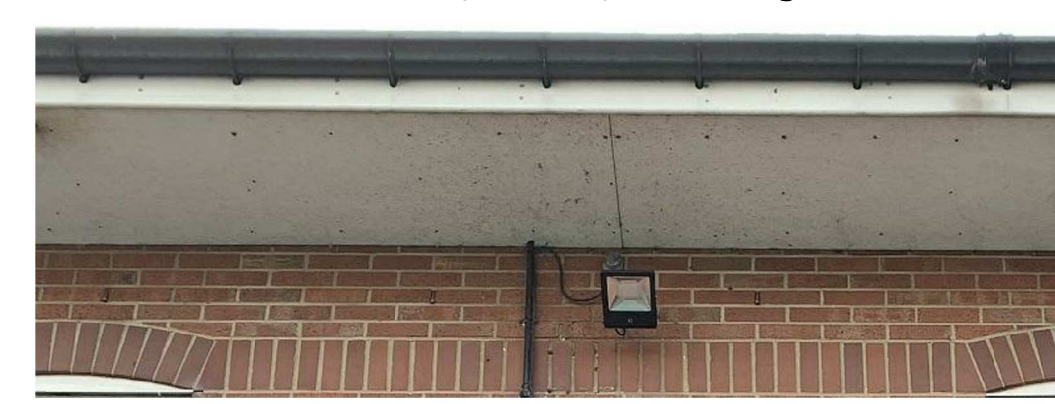
Common appearance / condition of Fascias, Soffits, Guttering

Fascias and Soffits
Existing soffit and fascia boards to be carefully demounted and removed from site. To be replaced with new to match existing material, style and colour. Replace any damaged framing.

Rainwater Goods
Existing guttering and rainwater pipes to be carefully stripped and dismantled - including all fixtures and fittings - and removed from site. To be replaced with new to match existing material, style and colour.

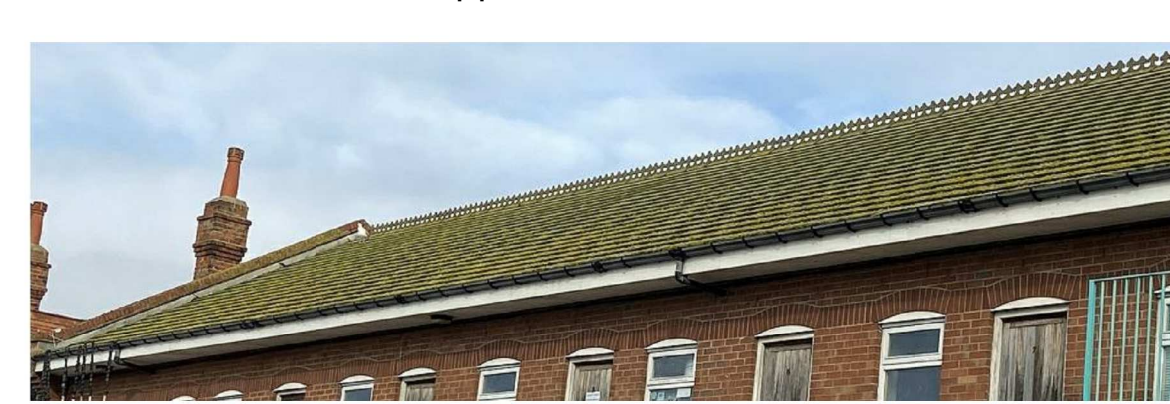
Common appearance / condition of Roof

Main Roof
Inspect existing roof tiles and ridge fleur-de-lis for damage. Damaged roof / ridge tiles to be carefully stripped and removed from site. To be replaced with new to match existing material, style and colour.

Clean and clear all dirt and detritus including organic growth from existing roof tiles and ridge fleur-de-lis using DOFF cleaning system.

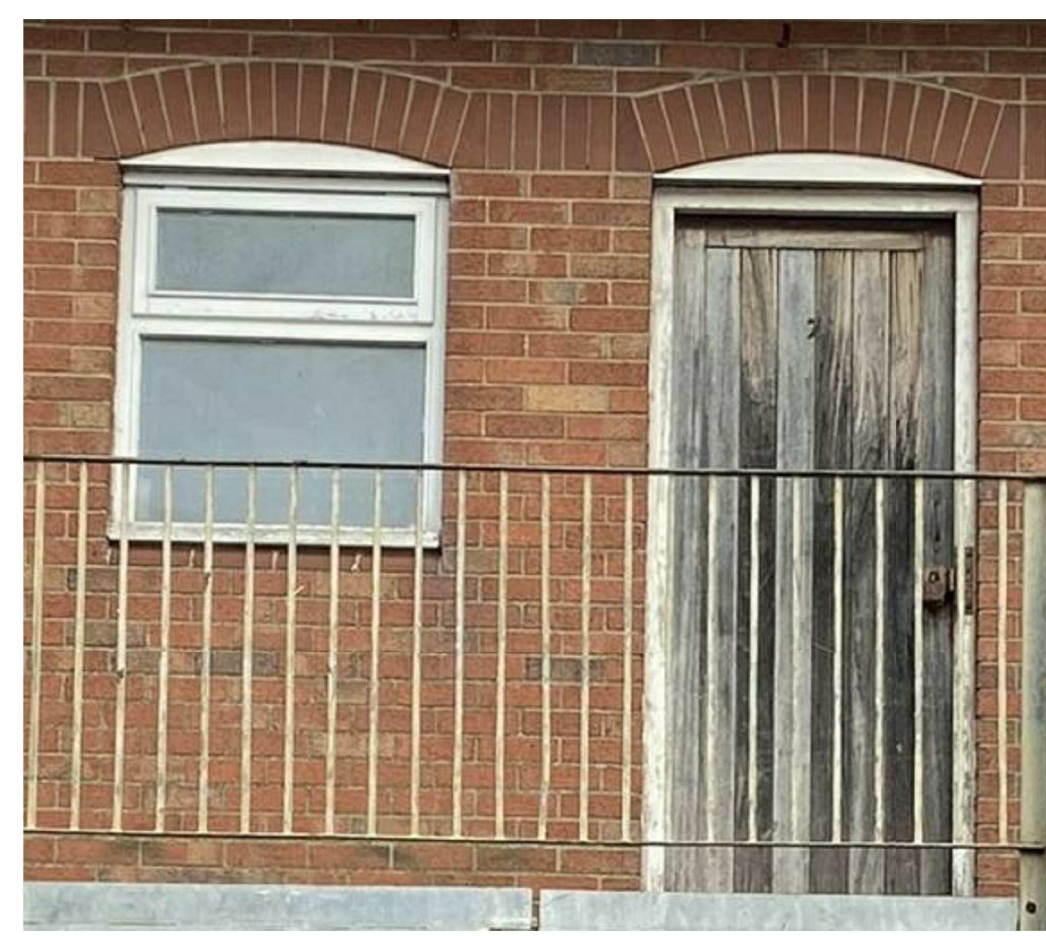
Common appearance / condition of Doors & Windows to SW Elevation

External Doors and Windows - First Floor
Existing doors and windows to be carefully stripped out (including frames) where indicated and removed from site. Make good to surrounding areas as necessary in readiness for new where appropriate.
