Structural RIBA Stage 3 Report
for
Scarborough West Pier Regeneration Scheme
Foreshore Road
Scarborough
YO11 1PD

Commissioned by WBS Ltd.

Report 21037-H-RP-001-R0
27th April 2023

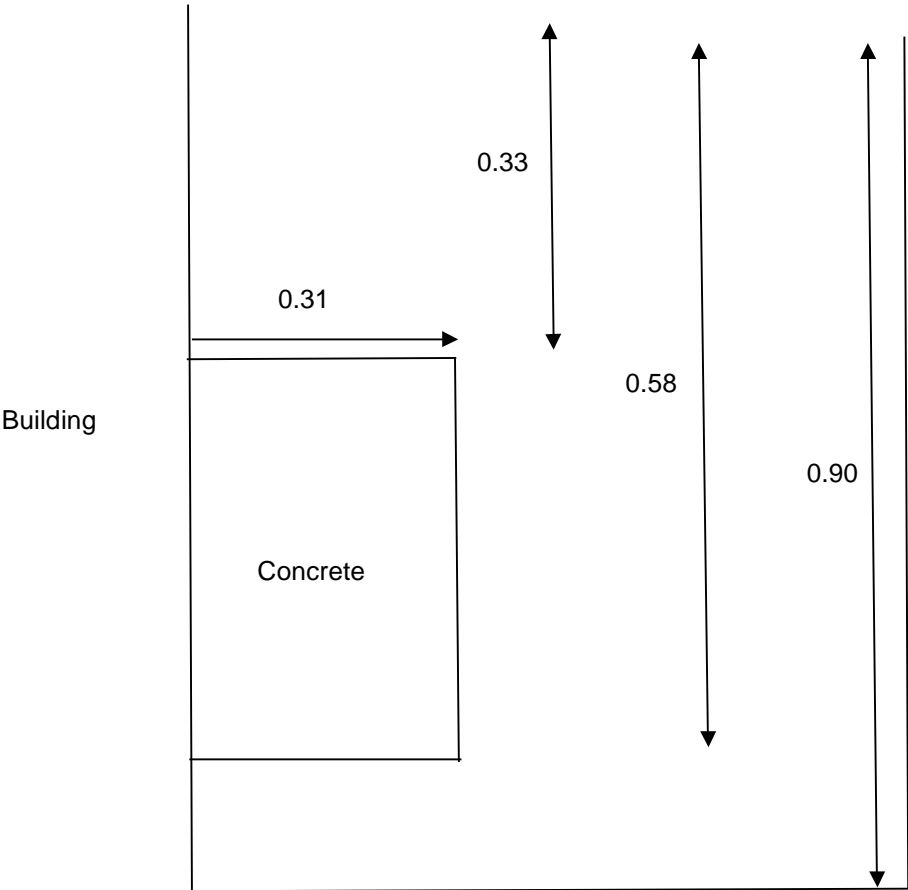
S230227
Scarborough West Pier
TP02

1.5.3 The trial pit TP 02 sketch was not completed at the junction between Building 3 and 4. This will need to be uncovered and recorded to first demolish Building 4 without causing instability to Building 3, and secondly allow the validation of MCA's foundation layout.

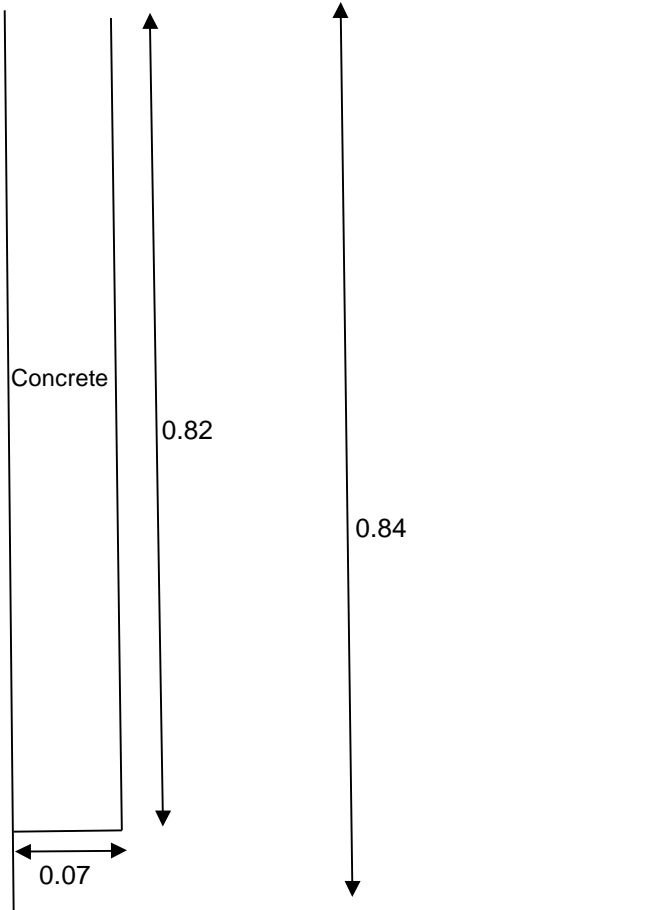
TP03

- 1.4.6 The initial trial pit 03 sketch from Solmek has shown that the existing concrete foundation is 0.82m from EGL. This has allowed design checks of changes to load directly above walls possible.

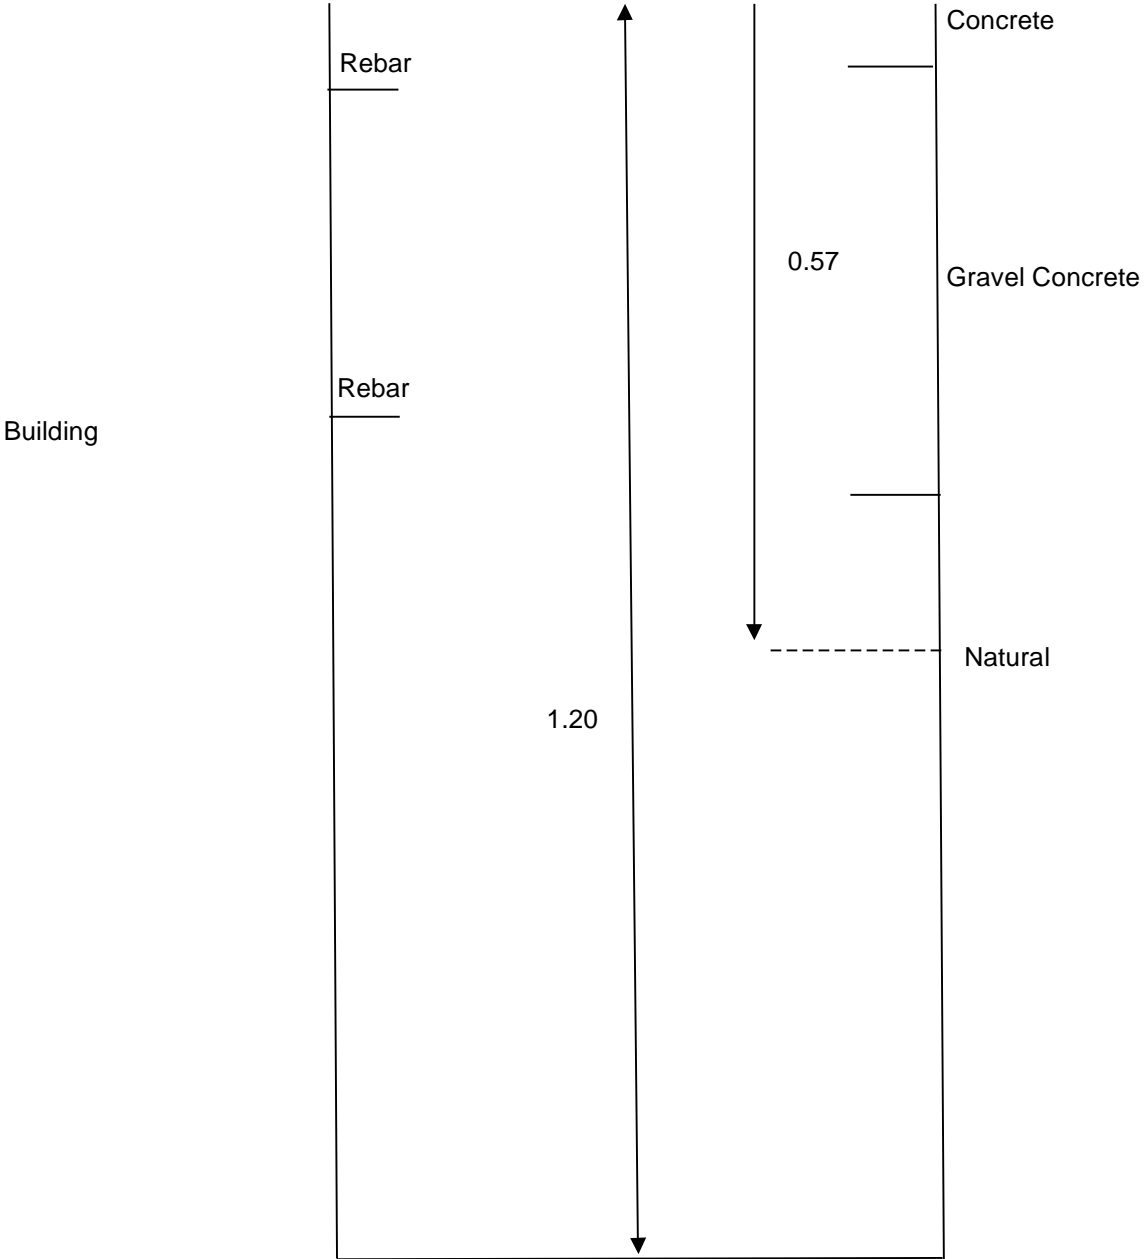
S230227
Scarborough West Pier
TP04

1.3.7 The initial trial pit 04 sketch from Solmek has shown that the existing walls extend at least 1.2m from existing ground level (EGL). No foundation was discovered at the base of the trial pit. This is a good indication the walls are

found on stronger made ground, which is evident from the preliminary borehole records. However, to determine the exact capacity of the foundations, the bottom of wall and any associated foundation is required to be uncovered, along with local plate bearing tests conducted.

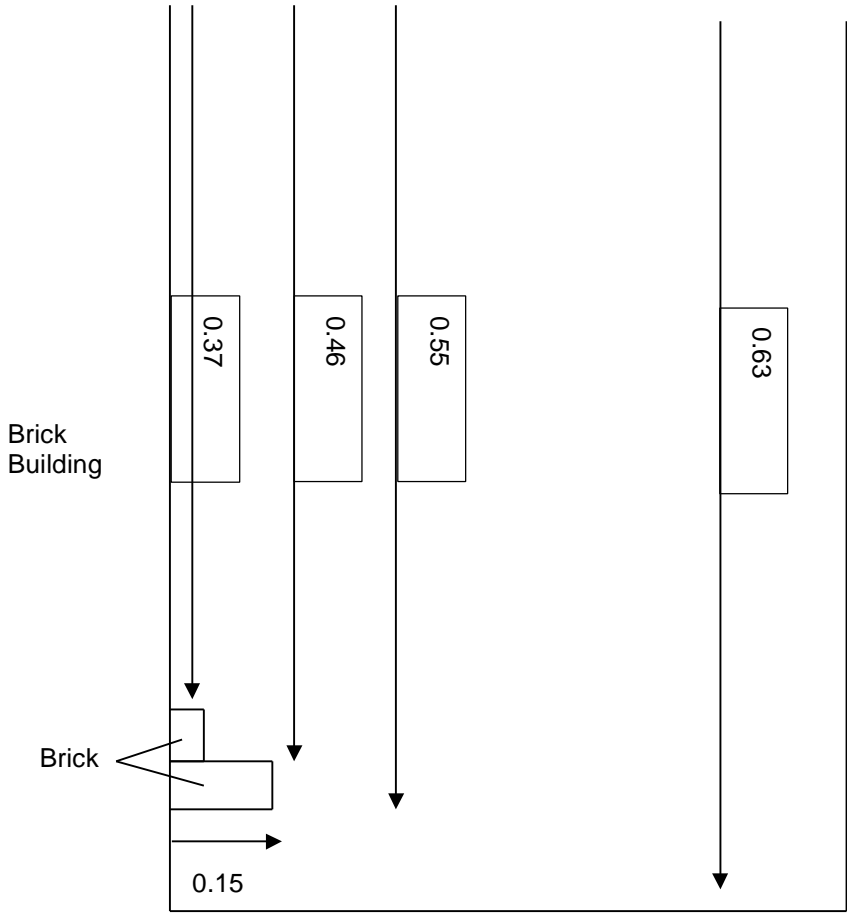
S230227
Scarborough West Pier
TP05

- 1.2.6 Although archive drawings show the extension constructed with brick spreader and concrete strip foundations, TP05 sketch by Solmek, shows only the brick spreader foundation. This in tandem with CBRs showing very weak made ground, requires the proposed foundations supporting the glazed external space and internal steel box frames to be piled. It is noted that Solmek could not complete a trial pit on the main building, which will likely differ in it's foundation geometry and type compared with the extension. This needs to be determined as a priority before construction begins to give MCA a sufficient window to validate or redesign the foundations. It is requested that Solmek, in their final report advise on the safe bearing pressure (SBP), internally, allowing the above to be validated. MCA have designed new foundations to have compressible material / movement joints under proposed foundations to prevent damage to the existing building foundations.
