STRUCTURAL DEMOLITION REPORT  
FOR  
SCARBOROUGH HARBOUR WEST PIER REDEVELOPMENT  
WEST PIER  
SCARBOROUGH  
YO11 1PD

Commissioned by  
WILLIAM BIRCH & SONS LTD.

Report 21037-H-RP-001  
01<sup>st</sup> DECEMBER 2022

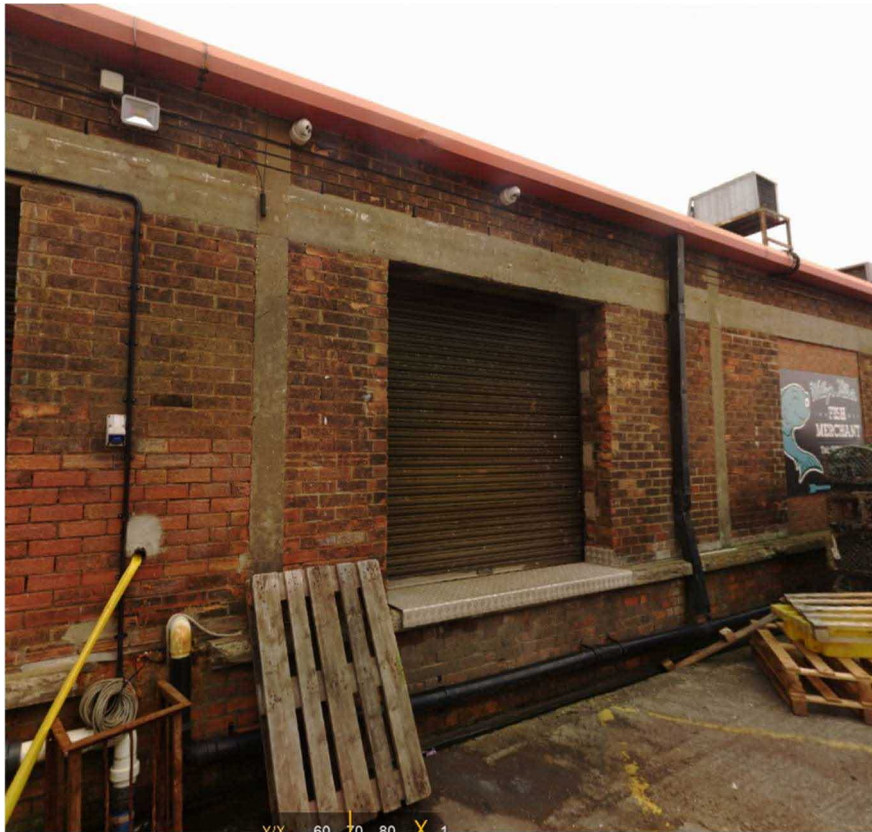
Photo 1 – South-west elevation of Building 4a

Ref.	Element /Location	Sub Element	Grade	Condition	Photo Ref.	Recommended Action	Backlog Maint	Volume	Unit	Rate	Budget Estimate
1.00	Roofs										
1.01	Roofs	Building 4a	C. Fair	Fair condition but gutters blocked and leaking.	1 to 5	Clean out and repair gutters. MEWP or other access equipment needed.	Yes	1	Item	£ 2,000.00	£ 2,000.00

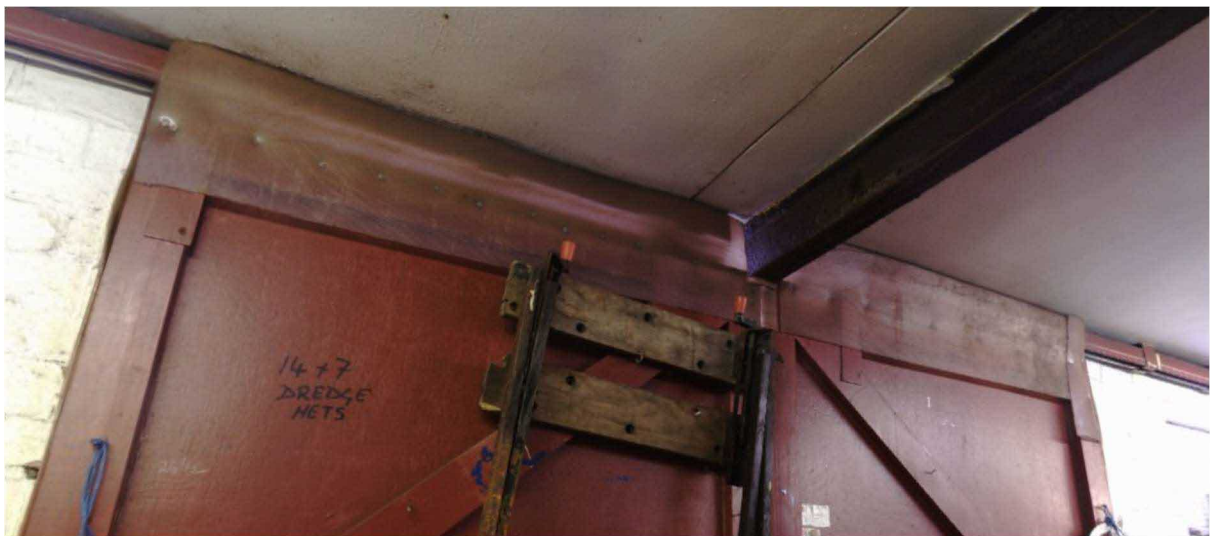
*Photo 8 - Lifting Beam taken from inside Building 4b*

- 3.2.20. There is a 1-ton capacity lifting beam located above an external opening on the second floor. The condition of this lifting beam is heavily corroded, and likely not in commission. It is recommended this is not utilised for demolition methods.

3.04	Lifting beam above loading bay door	Building 4b	D. Poor /Life Expired	Heavily corroded and not safe to use	10, 11, 15	Remove	Yes	1	No.	£ 750.00	£ 750.00

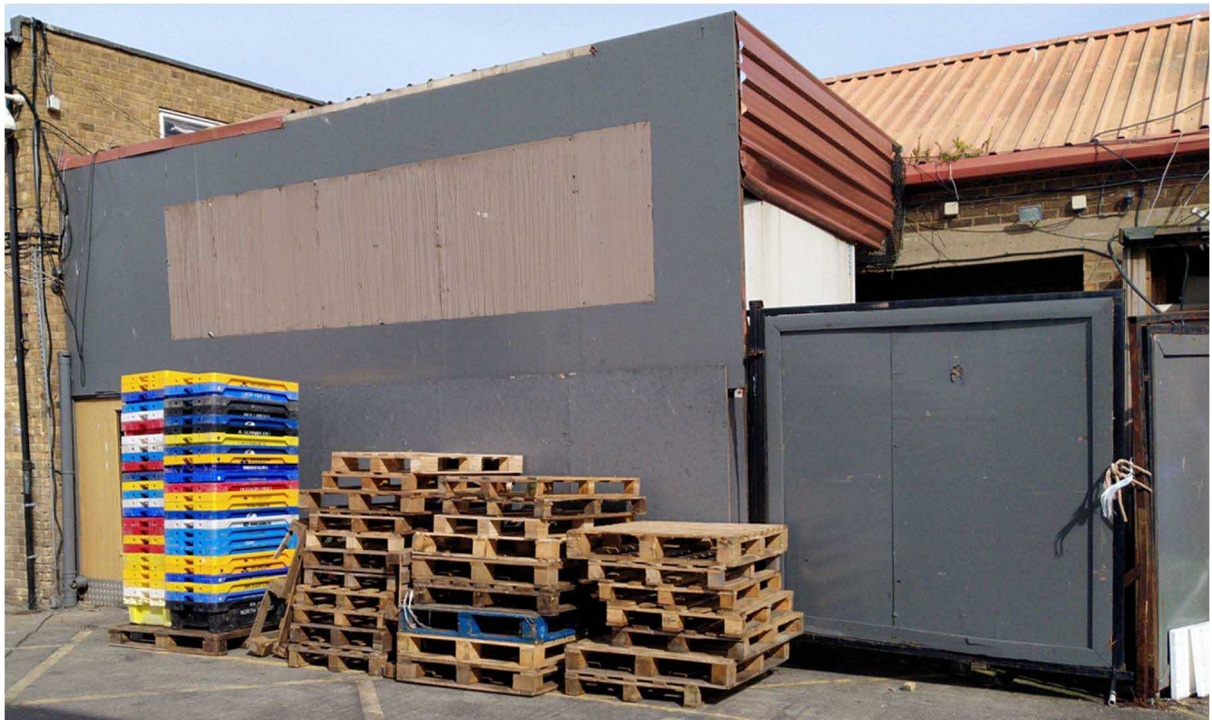
*Photo 11 - South-west elevation of Building 4c*

- 3.2.25. It was noted that this structure has surface corrosion to TEK screw connections between the cladding and frame, leading to loss of cladding fixity back to the structure.

- 3.2.26. The frame itself is generally surface corroded on each member which was visible.
- 3.2.27. The foundations of Building 4c are unknown and require further investigation to provide comment on form, significant risks, or their conditions.

Building 4c is poorly constructed and in a dilapidated condition and we recommend it be taken down and the adjoining parts of 4a and 4b made good after that.

- 4.4.6. A longitudinal sectional 'clamp and cut' procedure is recommended for the removal of the SHS steel frame. This will be done by clamping the column head, and preferably cold cutting the top beams. This will allow the plant to then bend the column over towards the protection mat. The column can then be cold cut at it's base.
