## Details of investigation into proposed new door between the larder / glasshouse

This information has been supplied to discharge condition 12 of listed building consent DC/22/05516.

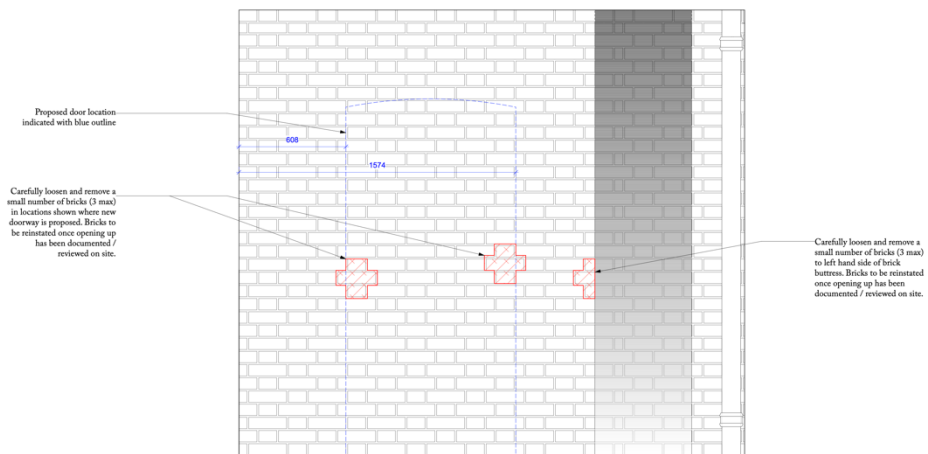
Elevation excerpt (S-107.3) highlighting areas of investigation externally to determine the historic fabric.

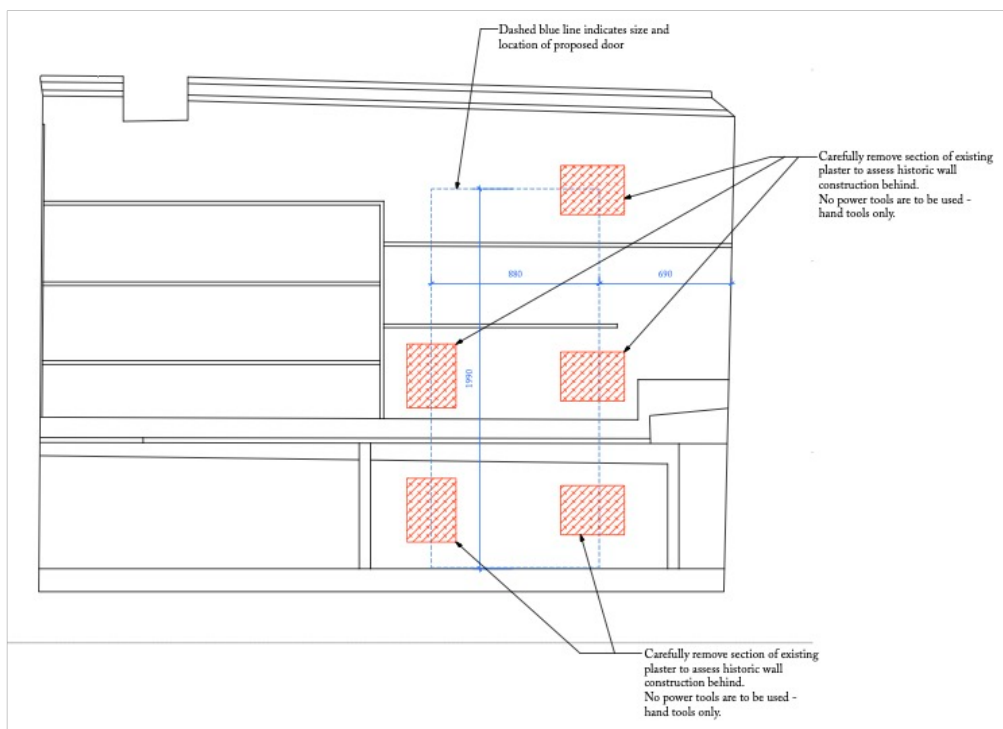
Elevation excerpt (S-102.3) highlighting areas of investigation to determine the existing historic fabric.

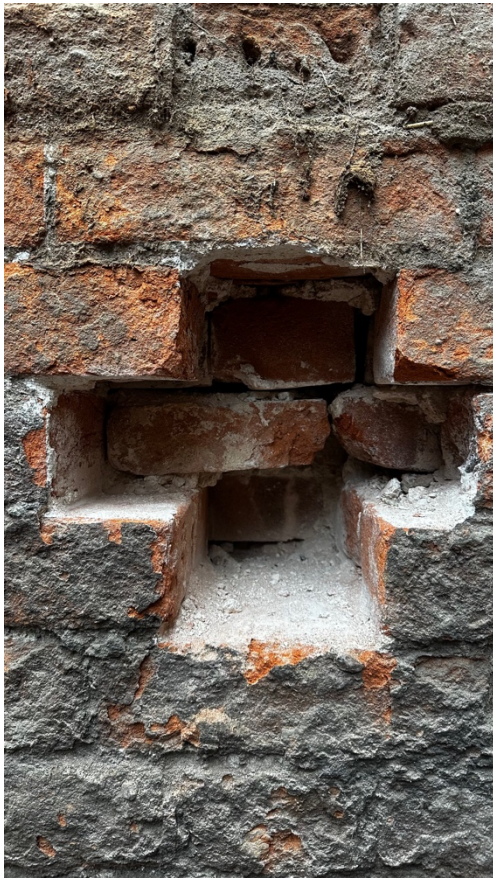
The investigation confirmed that the existing brickwork externally was of a double skin construction.

Image 1: Showing findings of investigation following removal of brickwork.

The external brickwork is to be carefully removed using hand tools only, in the location of the proposed doorway. Great care is to be taken when removing the brickwork, with support being applied to the historic brickwork over the proposed opening. Once the material has been removed, the revealed historic fabric is to be documented, condition checked, and repaired where required using traditional methods and materials to match. Lime based mortars will be tested for colour and consistency to ensure a close match to the existing, in areas where repointing is required. If any bricks are damaged beyond repair, a suitable reclaimed brick shall be sourced to match as closely as possible to the existing. Brick replacements will be kept to an absolute minimum and where possible, existing bricks will be reused.

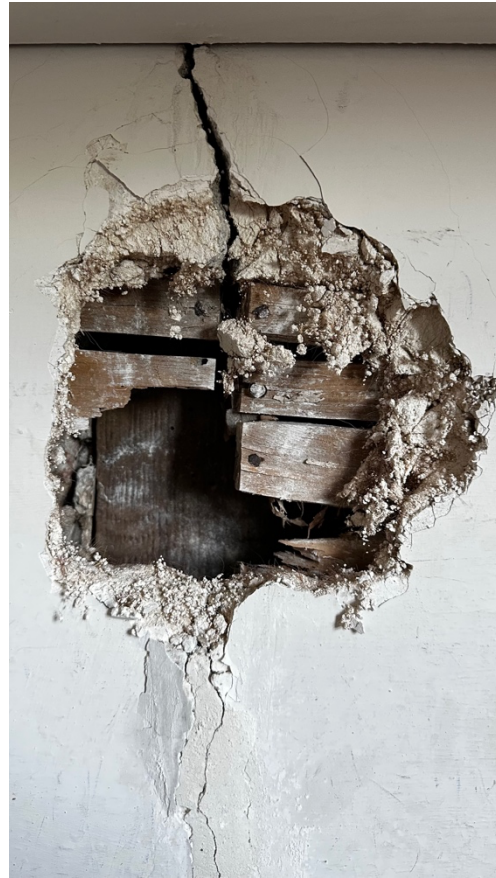
Internally the wall was found to be of a differing construction, with lime plaster on lathes fixed upon timber studs. Additionally, a clear void was found to be present between the external face of the timber stud and internal face of the brickwork found externally.

Image 2: Showing findings of investigation following removal of lime plaster and associated build-up.

Internally, the existing lime plaster and associated build-up will only be removed to the minimum extent required to form the new opening. Once the material has been carefully removed, the revealed historic fabric is to be documented, checked for damages, and repaired where required using traditional materials to match in materiality and thickness.
