## Details of investigation into proposed reopening of blocked fireplace chamber

This information has been supplied to discharge condition 13 of listed building consent DC/22/05516.

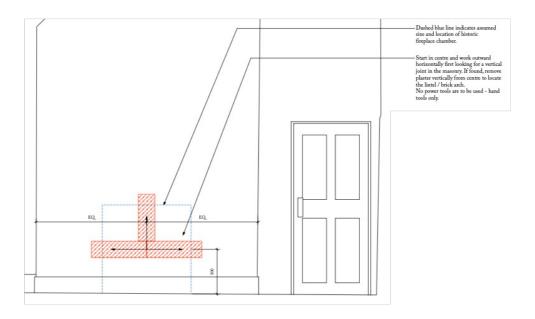
Elevation excerpt (S-101.3) highlighting areas of investigation to locate existing fireplace chamber.

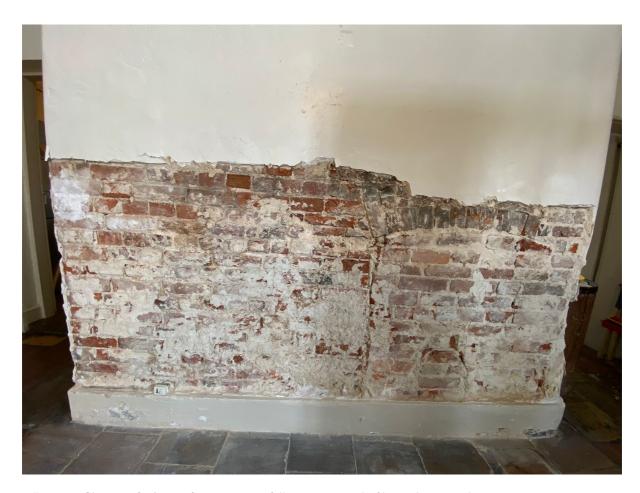
The investigation confirmed the presence of a historic fireplace chamber, with clear distinction between the original fireplace perimeter and later brickwork infill. The below images showing our findings:

Image 1: Showing findings of investigation following removal of lime plaster, with existing fireplace shown to the right-hand side of the chimney breast

The brickwork infill to the historic chamber is to be carefully removed using hand tools only. Great care is to be taken when removing the infill material abutting the sides, rear, arch and floor of the historic chamber. Once the infill material has been removed, the revealed historic brickwork is to be documented, checked for damaged and repaired where required using traditional materials to match. Lime based mortars will be tested for colour and consistency to ensure a close match to the existing, in areas where repointing is required. If any bricks are damaged beyond repair, a suitable reclaimed brick shall be sourced to match as closely as possible to the existing. Brick replacements will be kept to an absolute minimum.
