Arboricultural Report

Subsidence Damage Investigation

Summary of site visit to assess completed vegetation management

83 Yew Tree Cottages
Midgley, Luddendenfoot
Halifax
West Yorkshire
HX2 6UG

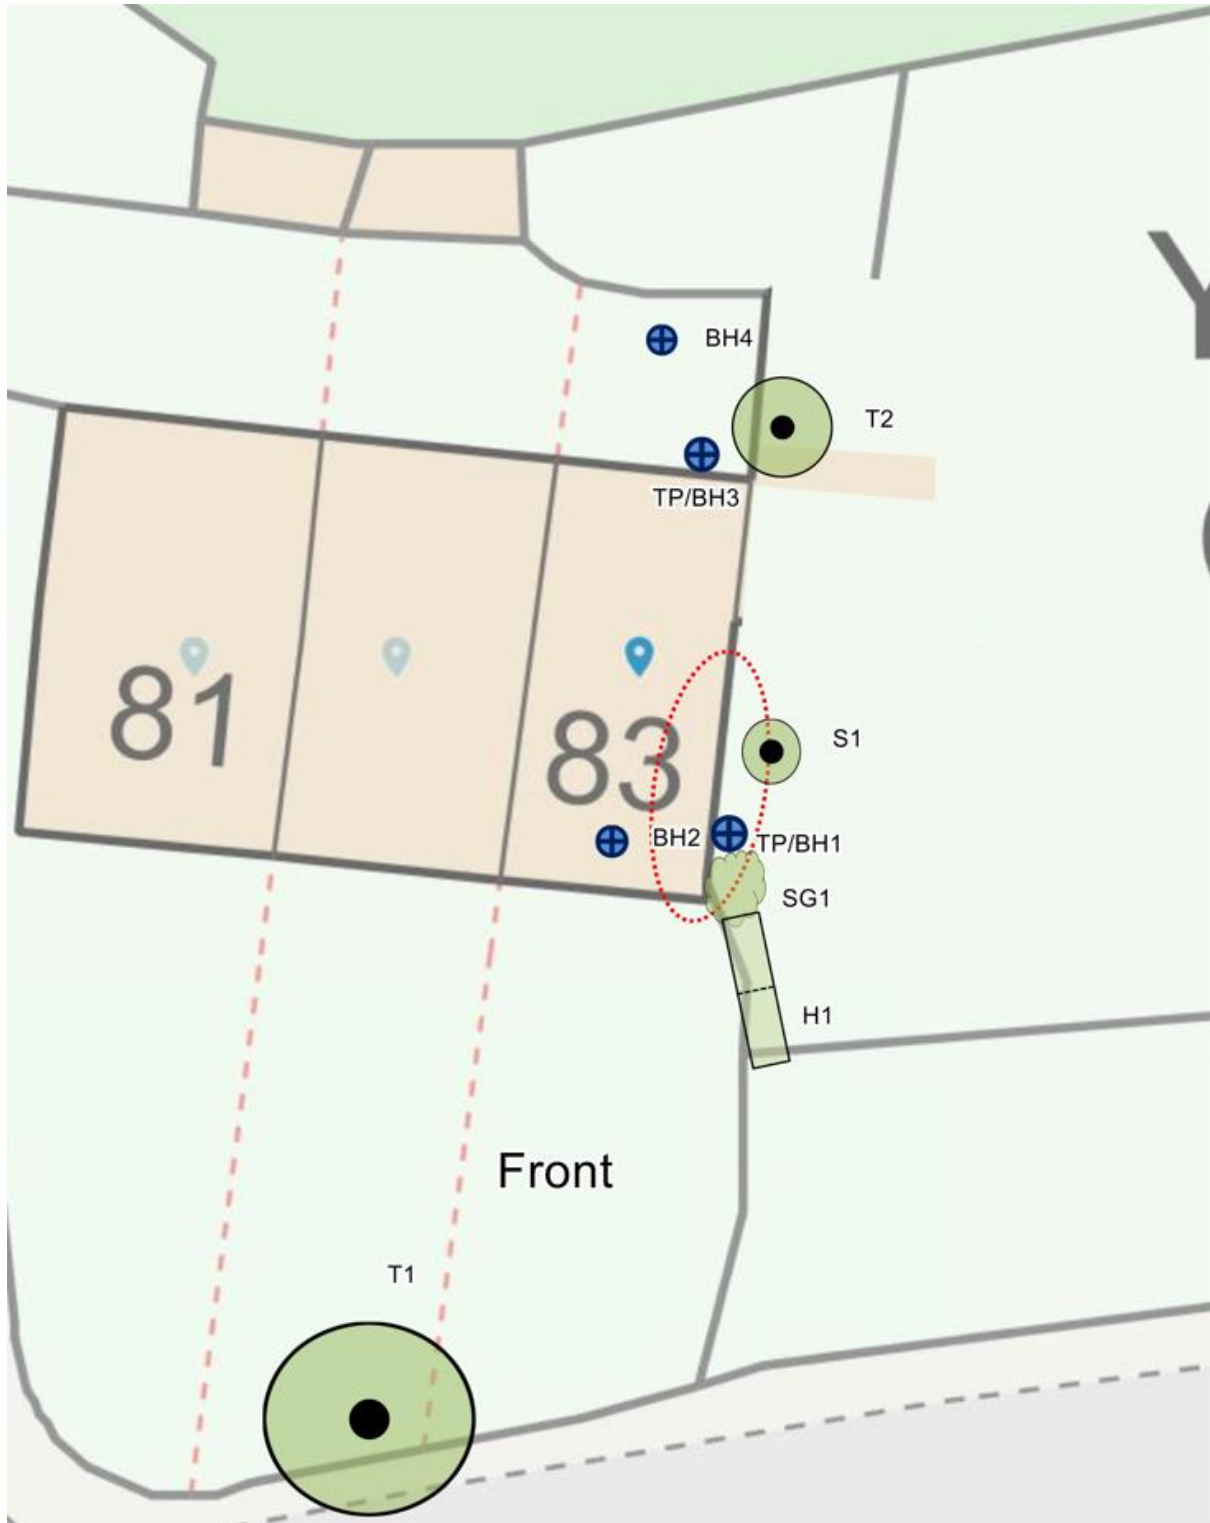
Site Plan

Approximate areas of damage
