Arboricultural Appraisal Report

Subsidence Damage Investigation at:

83 Yew Tree Cottages
 Midgley, Luddendenfoot
 Halifax
 West Yorkshire
 HX2 6UG

CLIENT:	Claims Consortium Group
CLIENT REF:	620917
MWA REF:	SUB210408-8758
MWA CONSULTANT:	John Graham B.Sc. Hons PhD
REPORT DATE:	21/04/2021

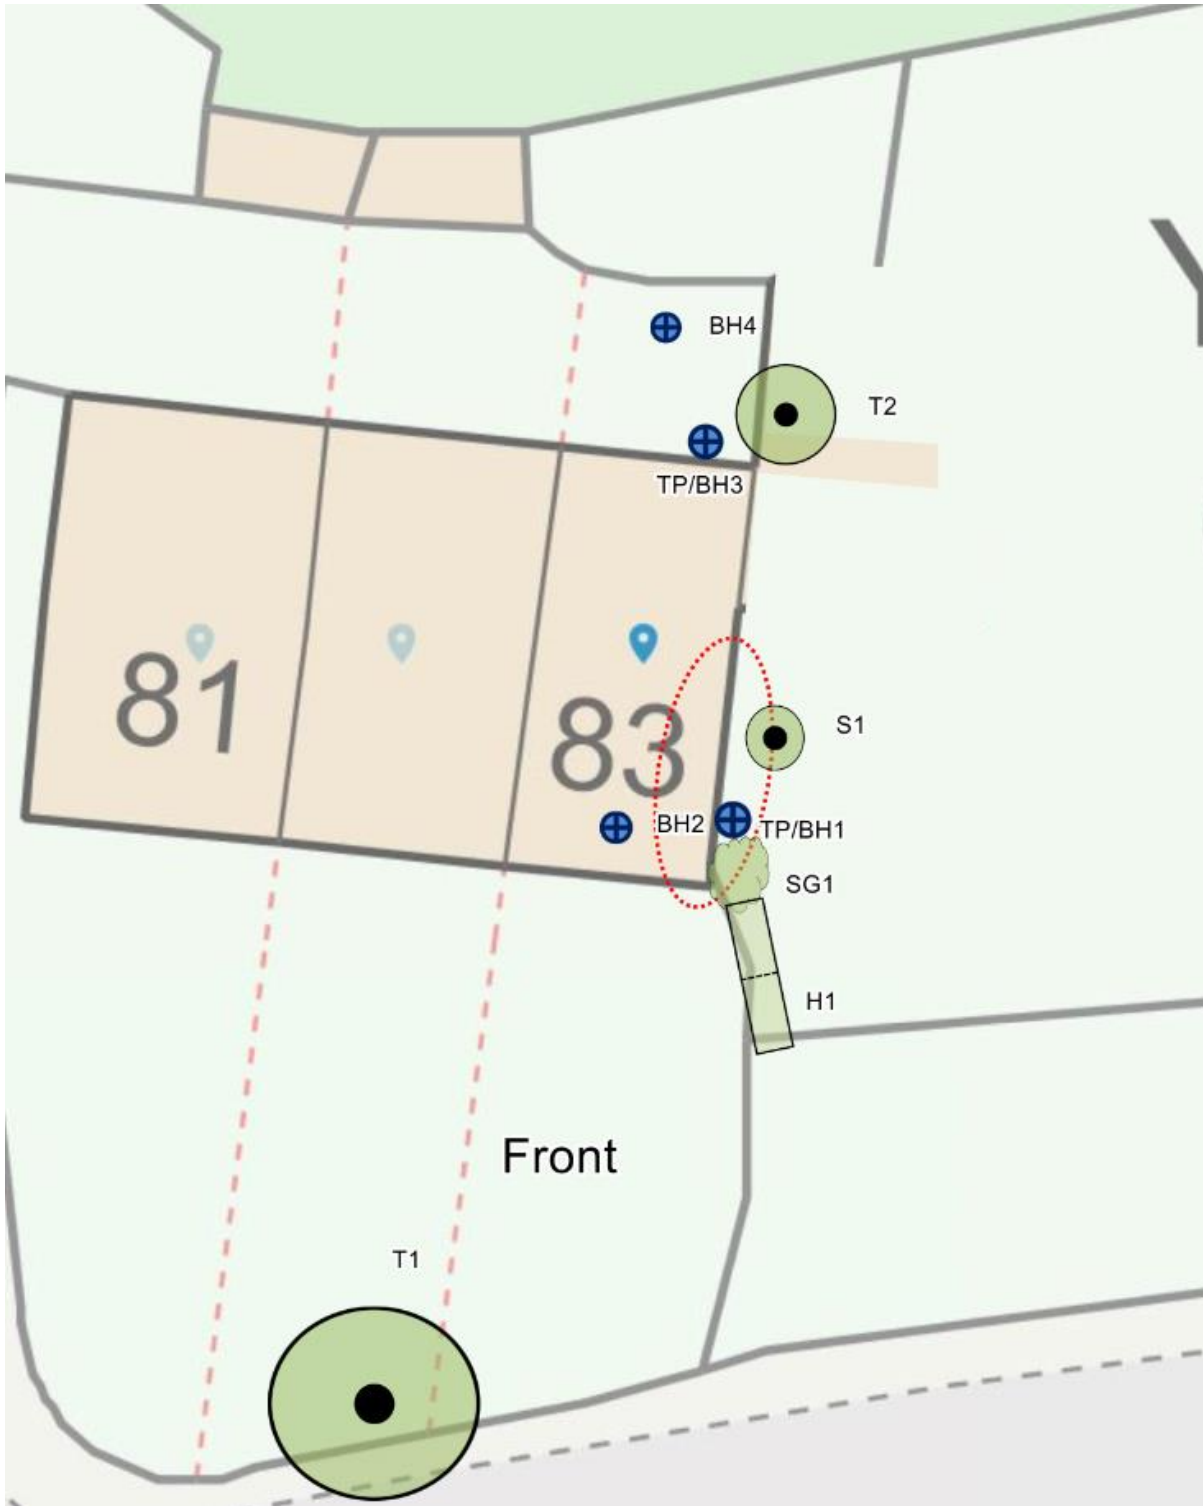
Site Plan

Approximate areas of damage

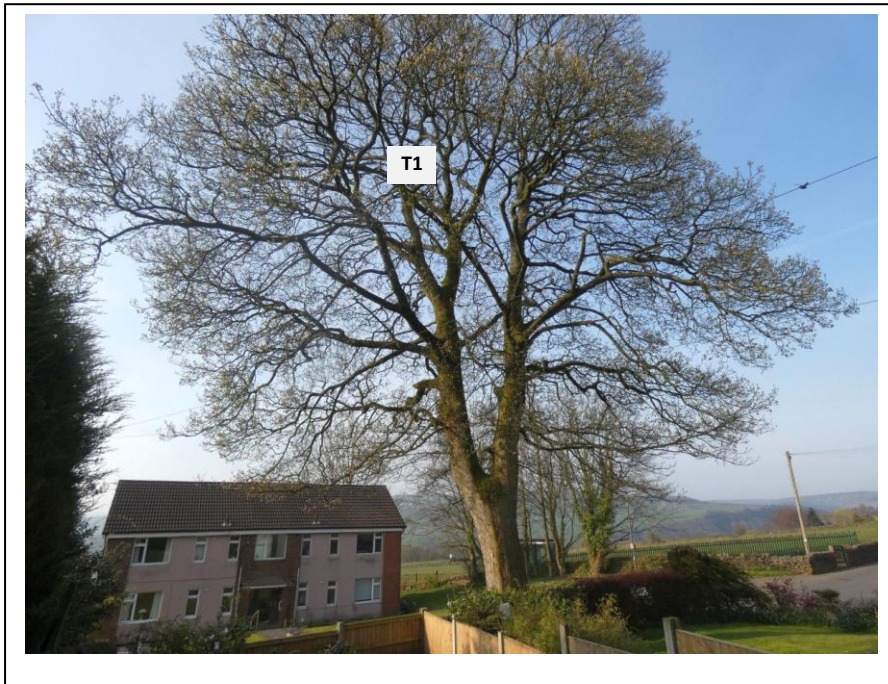
Based on the technical reports currently available, engineering opinion and our own site assessment we conclude the damage appears consistent with shrinkage of the clay subsoil related to moisture abstraction by vegetation. Having considered the information currently available, it is our opinion that the collective influence of the vegetation to the right of the house is the principal cause of the damage with a contribution from T1.

View of T1

Tree No.	Species	Ht (m)	Dia (mm)	Crown Spread (m)	Dist. to building (m)	Age Classification	Ownership
T1	Sycamore	20	750 *	20 *	14	Similar Age to Property	Third Party 82 Yew Tree Cottages HX2 6UG
Management history		No significant recent management noted.					
Recommendation		Crown reduce by 2.0m (linear reduction) all round and prune on a triennial cycle to maintain broadly at reduced dimensions.					
S1	Photinia	2.5 *	20 Ms *	2 *	1 *	Younger than Property	Third Party 86 Towngate HX2 6UE
Management history		Subject to past management/pruning.					
Recommendation		Remove (fell) to near ground level and treat stump to inhibit regrowth.					
SG1	Mixed species including laurel, sycamore, and holly	2 *	20 Ms *	1.5 *	0.5 *	Younger than Property	Third Party 86 Towngate HX2 6UE
Management history		Subject to past management/pruning.					
Recommendation		Remove (fell) to near ground level and treat stump to inhibit regrowth.

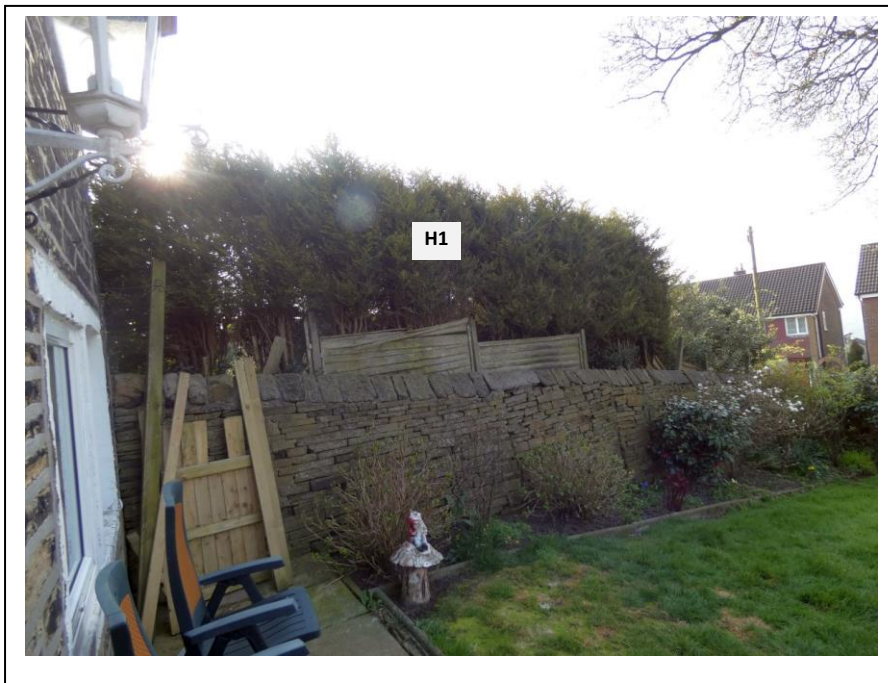
Roots were observed below foundation level in TP/BH1 and recovered samples have been positively identified (using anatomical analysis) as *Prunus*, the origin of which will be SG1 – laurel. Irrespective of the identification of recovered root samples, the roots of S1, H1 and T1 are also likely to be present below foundation level in proximity to the area of movement/damage and influencing soil moisture and volumes.

View of H1

H1	Cypress	2.5 *	50 Ms *	1 *	1 *	Younger than Property	Third Party 86 Towngate HX2 6UE
Management history		Subject to past management/pruning.					
Recommendation		Remove (fell) all stems within 4.0m of the building. Maintain retained elements at no more than current dimensions.
