Claim Information

Client Ageas (All Accounts) Claim Number 6516549G
Claim Type Subsidence Policy Number 8848688X
Policyholder Name [REDACTED]
Risk Address 83 YEW TREE COTTAGES, MIDGLEY, LUDDENDENFOOT, HALIFAX, WEST YORKSHIRE, HX2 6UG

Summary

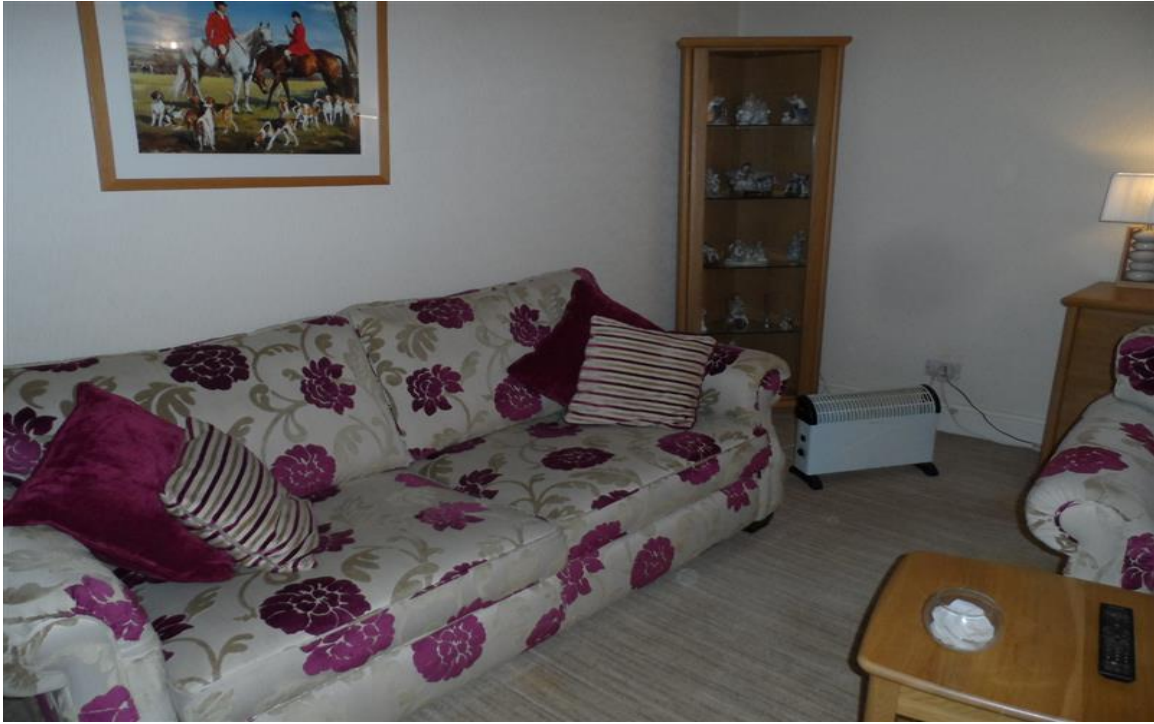
Living room 1

Damage to Main Dwelling	Yes
Internal Rooms	Front Living room - 4.5 x 5.0 x 2.3 The centre of the floor has a substantial rise in its surface although this is covered with carpet.
External Areas	Gable end - 8.7 wide x 4.8 high There is a vertical crack running down from roof level and takes in the side of the blocked up window.

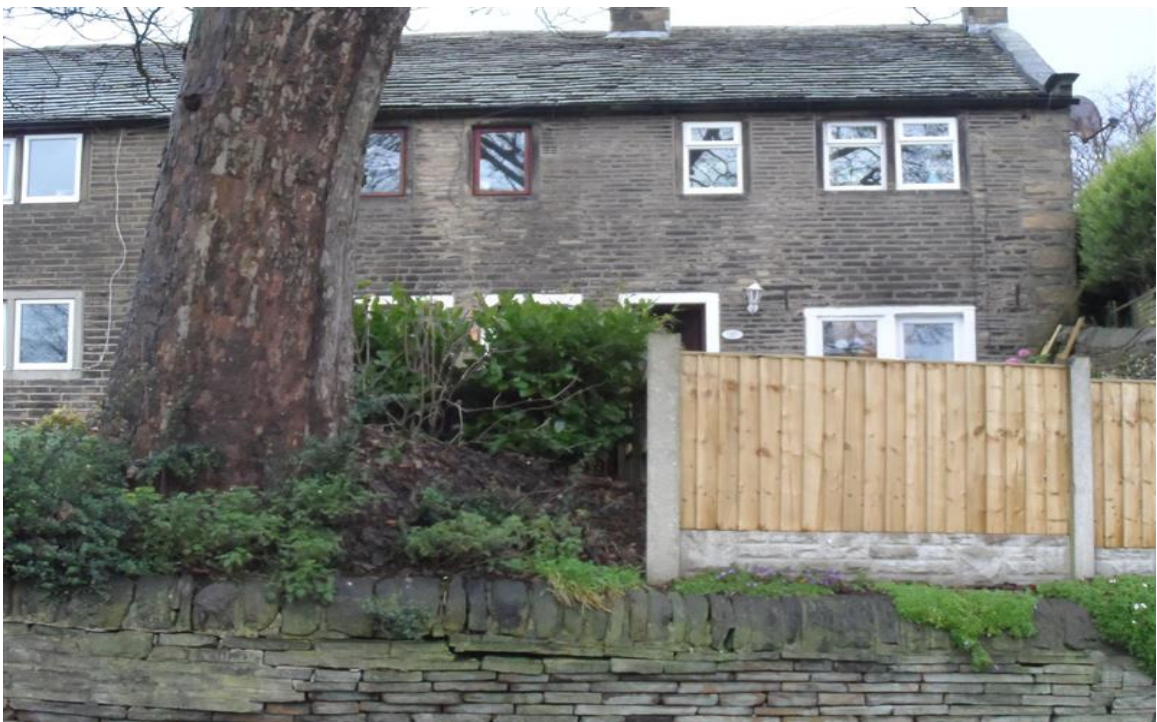
Tree at boundary wall

Damage Cause Description	In our opinion, taking into consideration the cracking to the gable wall and the rising of the asphalt floor to the living room, we believe that the tree to the front boundary may be an influence as to the external damage. We are advised that the Local Authority have had issues with roots in the road from the tree.
Peril	Subsidence
Damage Cause Type	Tree Roots
Recovery Opportunity	No
Claim Outcome	Valid
Validity Reason	We believe that the tree roots, the tree which is owned by the neighbour has damaged the foundation.
Party Structure Damage	No
BRE Damage Category	3- Crack widths of 5 to 15mm (or several of e.g. 3mm). Cracks that require some opening up.
Damage Details	The cracks runs down the stone work from the roof at the front of the side gable but is not mirrored internally. There is a large rise in the centre of the living room floor.

Vegetation Present	Yes
Vegetation Type	Tree
Approx. Height	3
Approx. Distance from Property	4
Vegetation Owner	The neighbour
Vegetation Inside Conservation Area	No
Vegetation Subject to Tree Preservation Order	Yes
Object of Primary Influence	Yes
Arborist Recommended	Yes
Leaking Drains Influencing Damage	No
