Geotechnical Survey Report

FSI Ref: 21735

Risk Address: 83 Yew Tree Cottages

Claim Ref: 6516549G

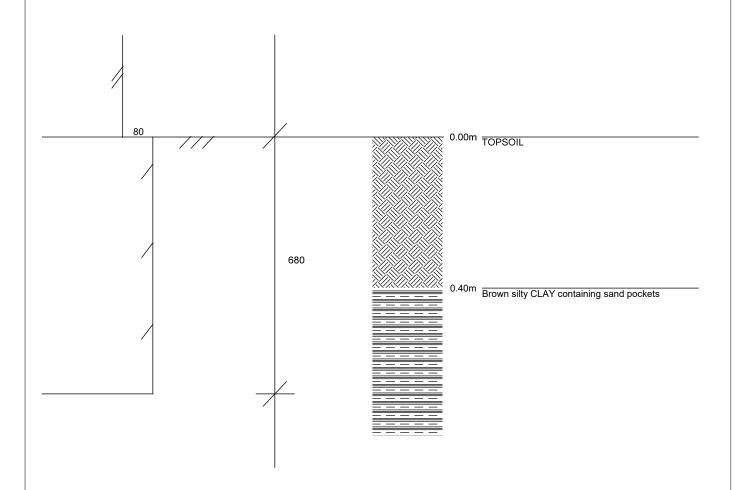
TRIAL PIT 1

D1 @ F.L. (0.68m) V =140kPa Founding strata:Brown silty CLAY containing sand pockets Trial Pit Location:

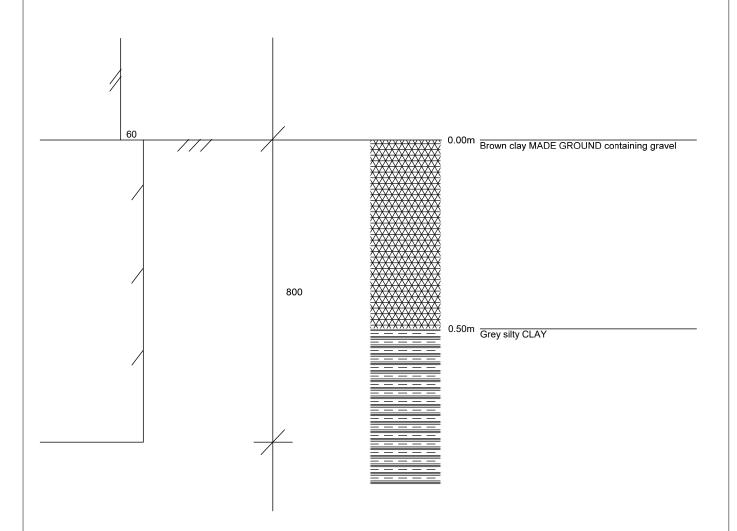
TRIAL PIT 3

D1 @ F.L. (0.80m) V =140kPa Founding strata:Grey silty CLAY Trial Pit Location:
