## Roof Condition Survey Final Report

Stardens, Tewkesbury Road, Newent, Gloucestershire, GL18 1LG

7<sup>th</sup> May 2021

### **Alpine Property Group Ltd**

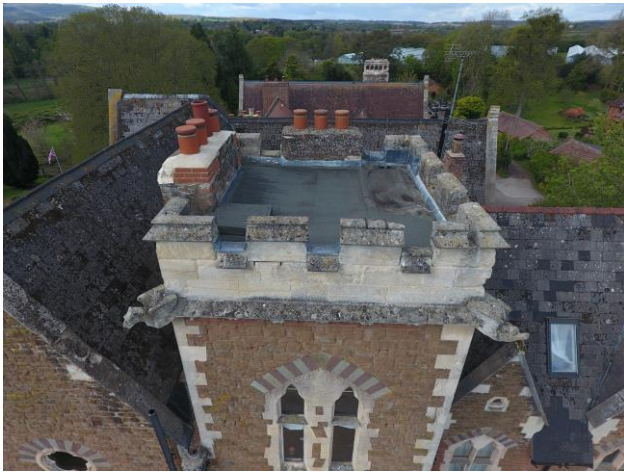
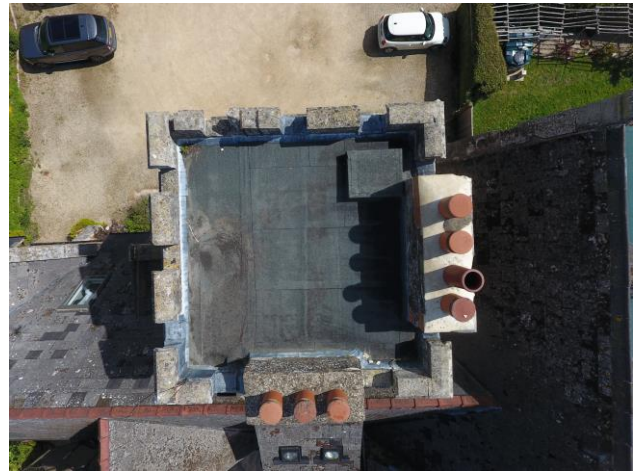
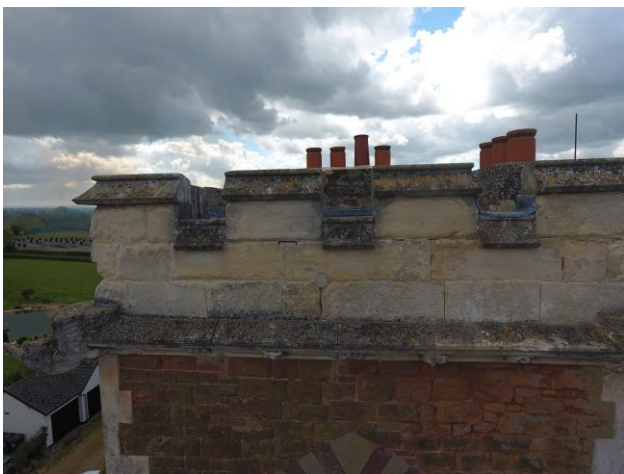
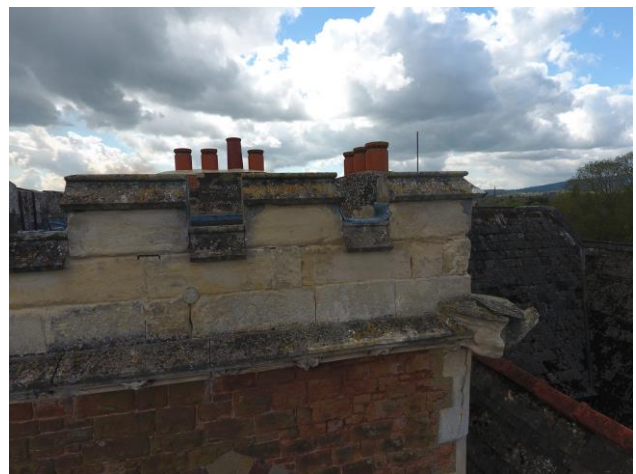
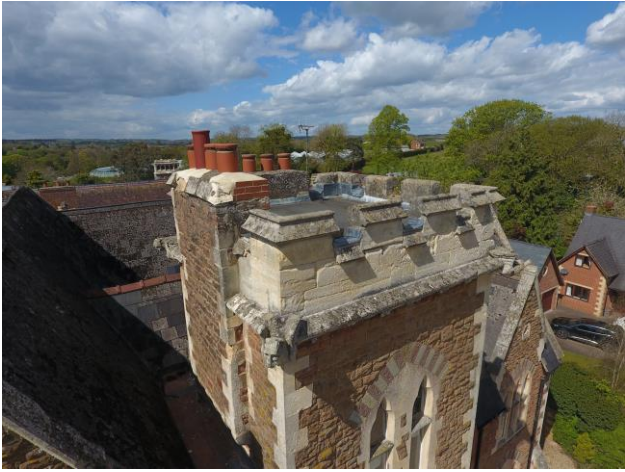
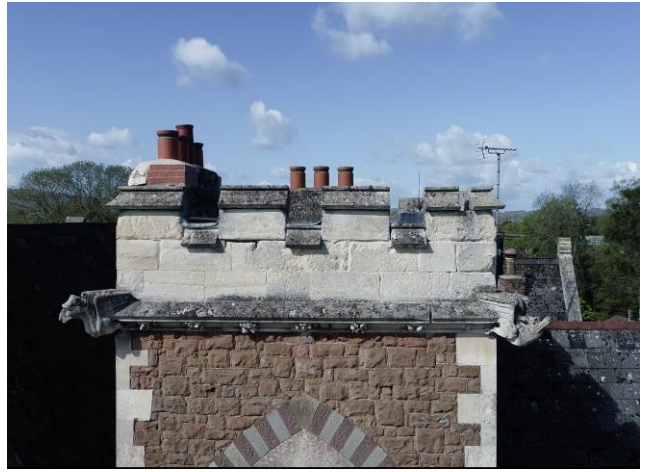
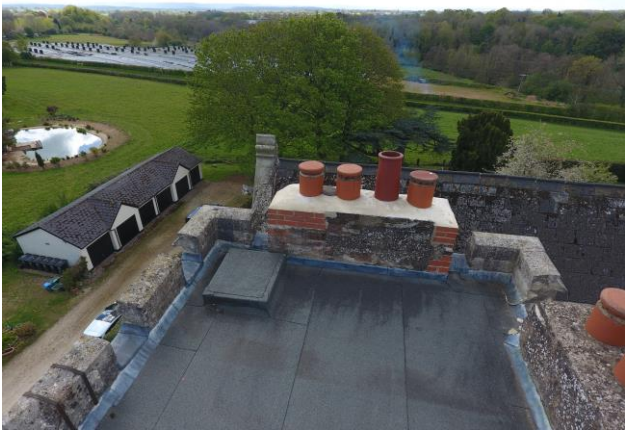
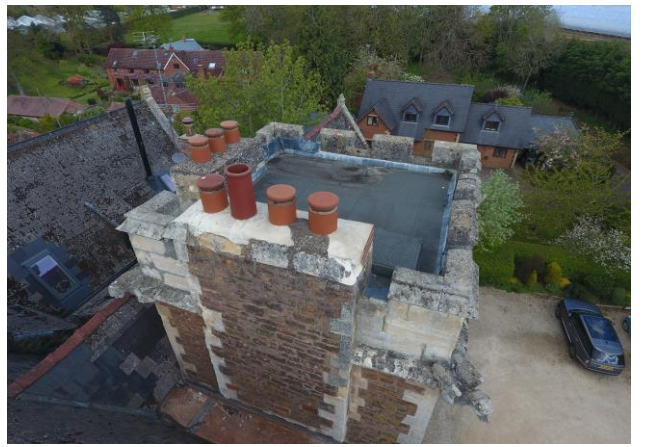
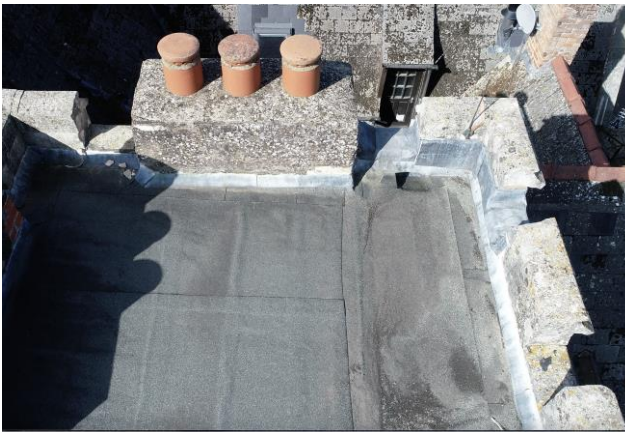
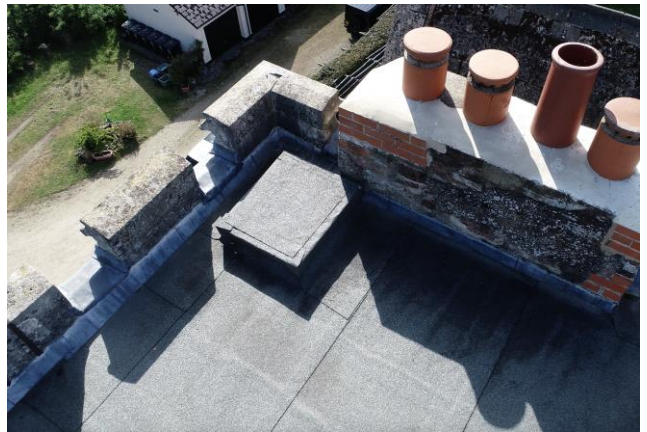
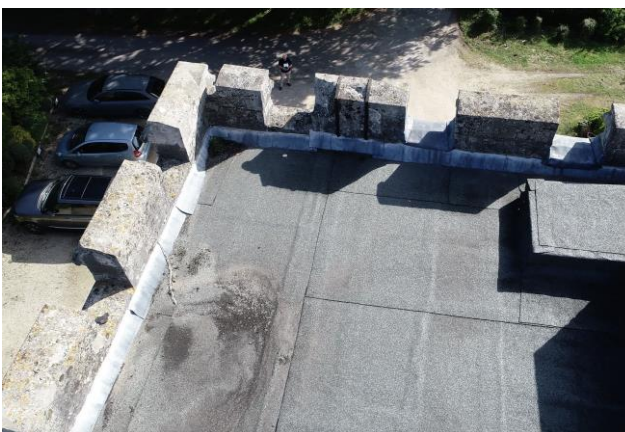
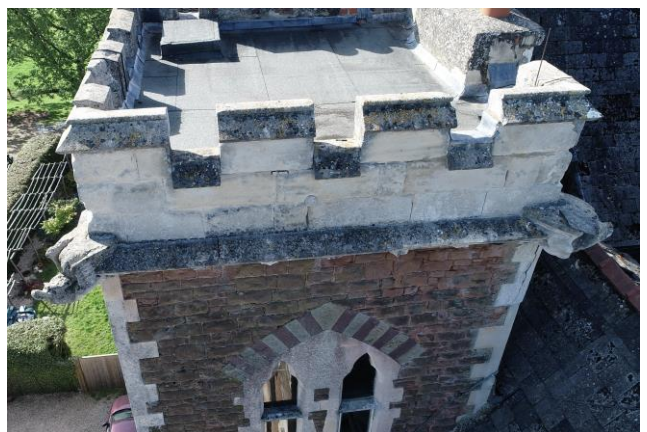
**The Tower:**

The stone-built tower was found to be in a poorly maintained and deteriorated state. The chimney stacks will be detailed later in the report. Constructed of local stone and limestone, we found that the limestone was very much weathered, damaged and eroded, with open joints that will increase the level of moisture and water penetration into the structure, and loose pieces that were broken away adjacent to the chimney stack. This moisture will migrate down through the structure as experienced internally. We also noted damage to the parapet capping stone, although we do not see this to be an issue.

We found that although the lead flashing within the crown was acceptable, the lead liners were missing in five of the Embasures (cut outs in the parapet walls), therefore exposing the stone, and increasing the risk of moisture absorption. As far as was visible, we found that the felt roof coating was in an acceptable condition, although the pointing of the lead flashing over was deteriorated in places.

The corner decorative head stones were found to be eroded, but currently acceptable with regard to moisture ingress.

1. We recommend that an experienced stonemason is engaged to rectify the deteriorated stonework as detailed. We recommend that where fractured or damaged the stone is replaced. We also recommend that where deteriorated or weathered by more than 20%, the stones are also replaced.

2. We recommend that the deteriorated pointing is raked out of the relevant stone and repointed using a lime-based mortar. The deteriorated pointing of the lead flashing within the crown of the tower should be raked out and replaced using a lime mortar.

3. We recommend that where no applied, lead is installed to protect the Embrasures where missing.
4. Although we understand that the renovation of the chimney stacks is planned, we recommend the following.

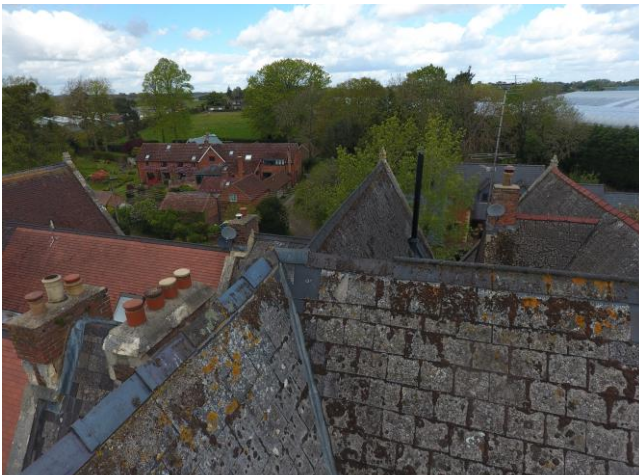
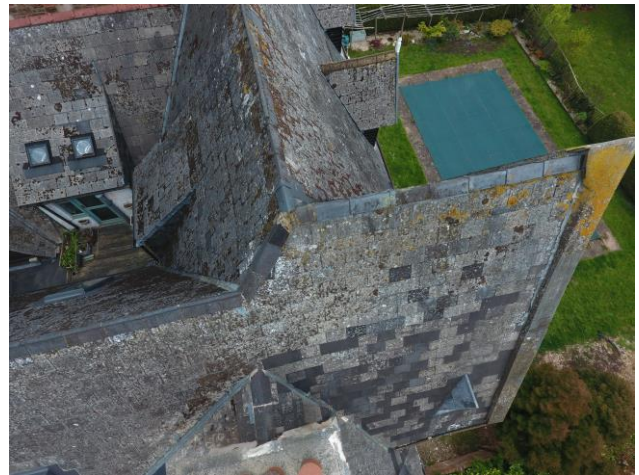
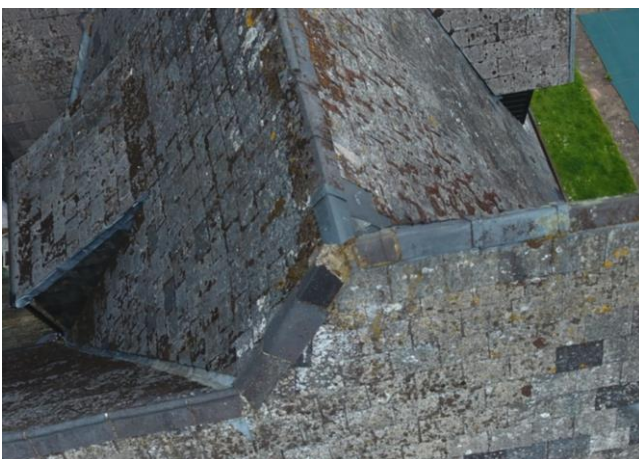
## Ridge & Hip Tiles

We found that to the rear of the property where the two ridges meet the sloping hip, the tiles were defective, and the joining point has been filled with cement mortar, as opposed to the correct tiles being used. The ridge tiles at this point have been replaced. When the mortar between the tiles, or the bedding beneath the tiles becomes deteriorated, there is an increased risk of movement in the tiles, resulting in a hazard, and an increased risk of moisture penetration into the structure.

We also noted that the pointing of the ridge tiles was deteriorated, and in places missing, and we suspect that there will be points where the ridge tile bedding will be deteriorated, and in turn the tiles loose. This could obviously not be confirmed by an aerial survey.

5. The defective ridge tiles and mortar should be replaced to the rear of the property where detailed. The tiles should be bedded on a suitable lime mortar. The deteriorated pointing between the ridge or hip tiles should be replaced using a lime mortar. Any ridge or hip tiles with existing deteriorated mortar bedding should be bedded on replacement lime mortar.

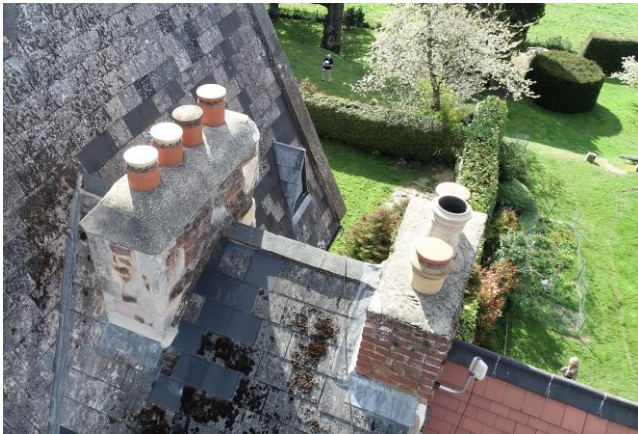
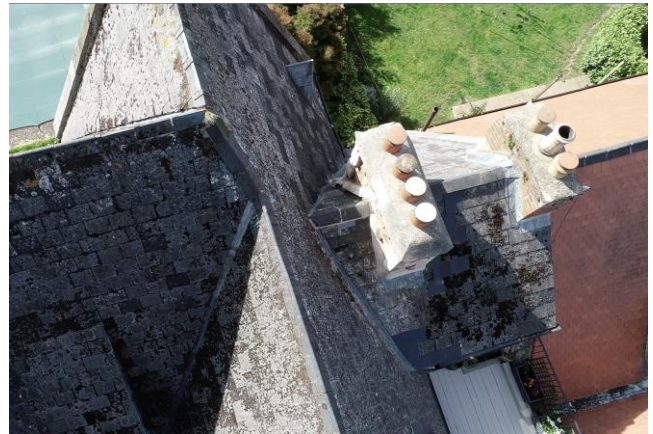
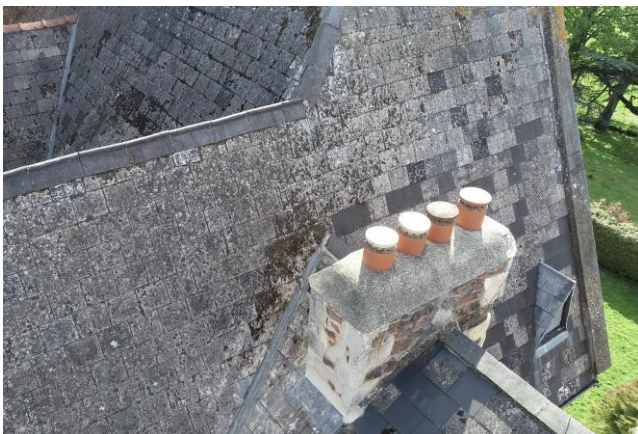
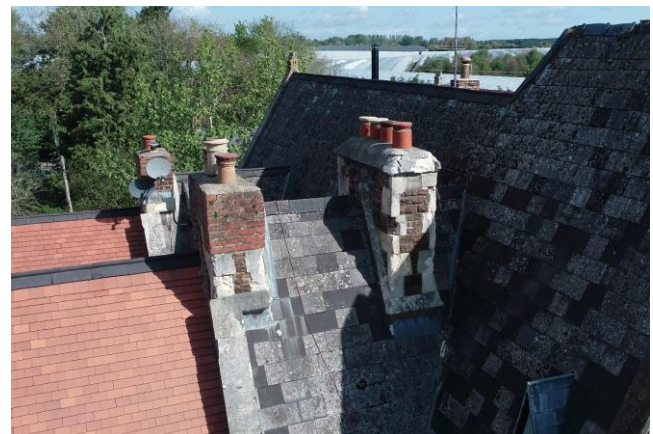
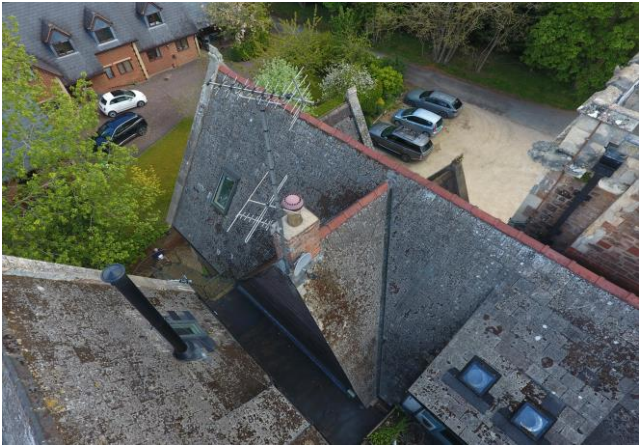
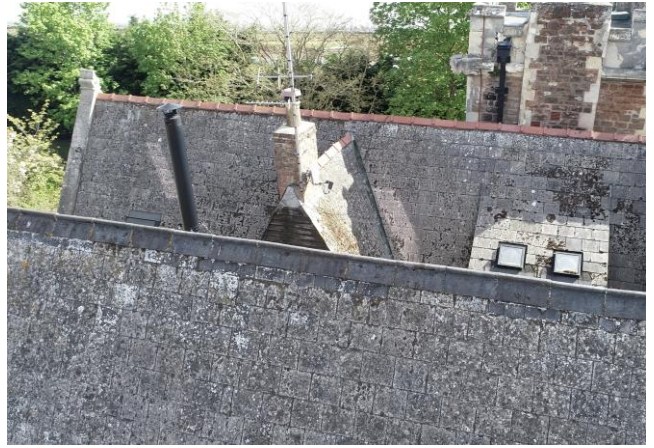
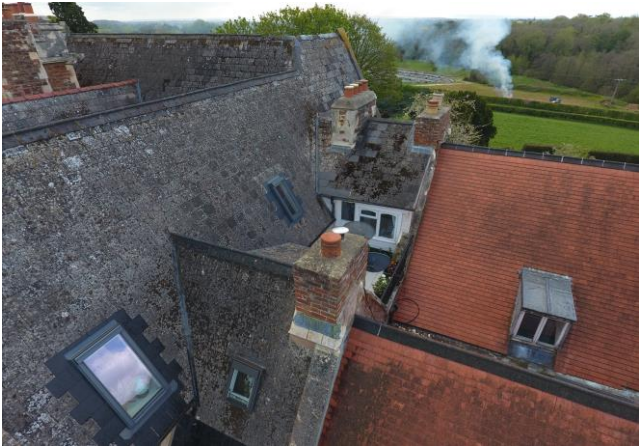
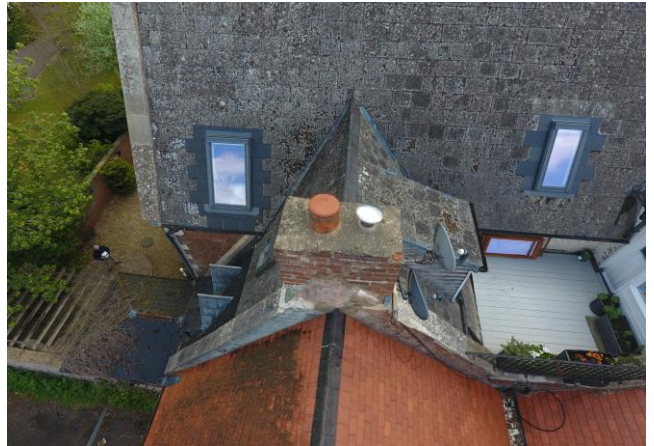
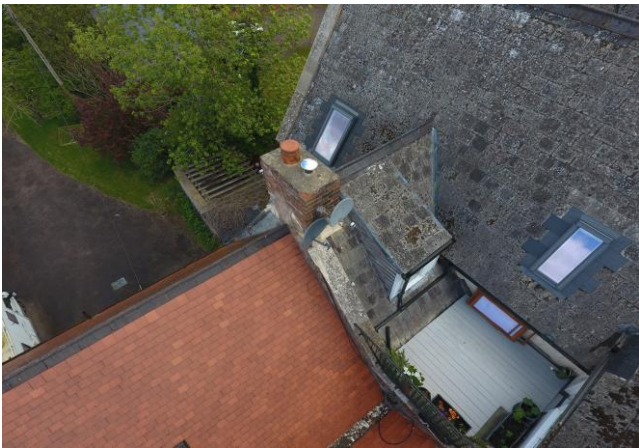
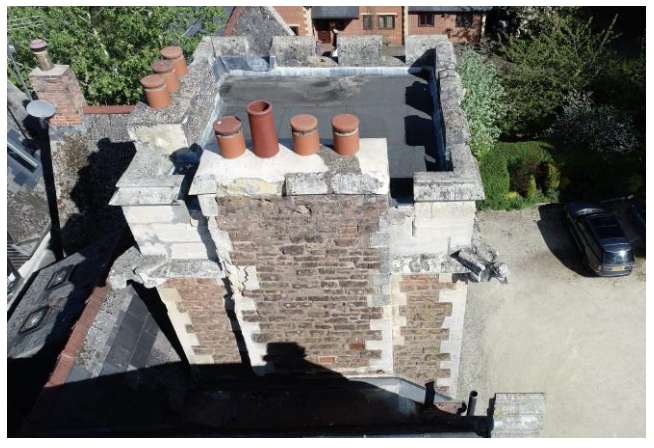
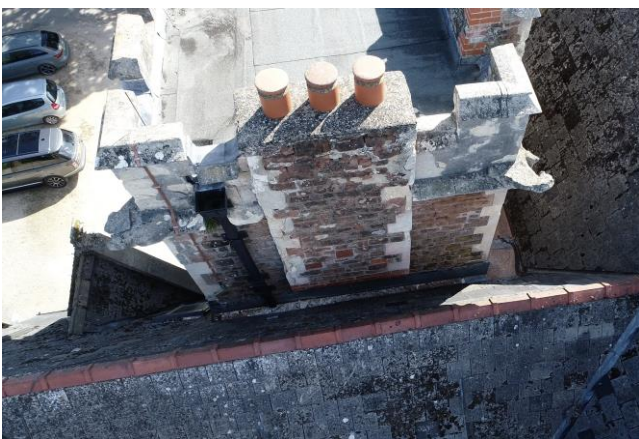
## Chimney Stacks

We found that all of the chimney stacks were deteriorated, and we understand that they are planned to be renovated in due course.

We noted that they have all received cement flashing across the crown of the structure. The cement was found to be cracked and deteriorated. The cracks will increase the risk of moisture penetration into the crown of the stacks, which in turn will migrate down through the structures. We noted that there were cracks in a few of the pots, which will also increase the risk of moisture penetration.

The brick and stonework were found to be deteriorated across all of the structures, to the extent that in places the brickwork was spalled and deteriorated, the pointing was missing, and that there was vegetation growing out of the structures. This level of deterioration will also increase the risk of moisture penetration into the structures, which as previously stated will migrate down through the structures.

- The deteriorated, defective or cement-based flaunching should be replaced across the crown of the stacks using a cement / lime mortar. The cement adds water resistance, and the lime flexibility. At this time, we recommend that any damaged or cracked chimney pots are replaced.

- Any bricks found to be spalled, eroded by more than 20%, damaged or cracked should be replaced.
  - Any deteriorated or hard cement-based pointing should be raked out with care and replaced using a lime-based mortar.

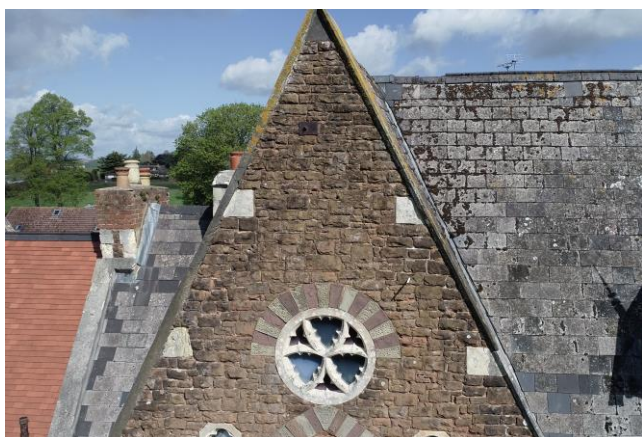
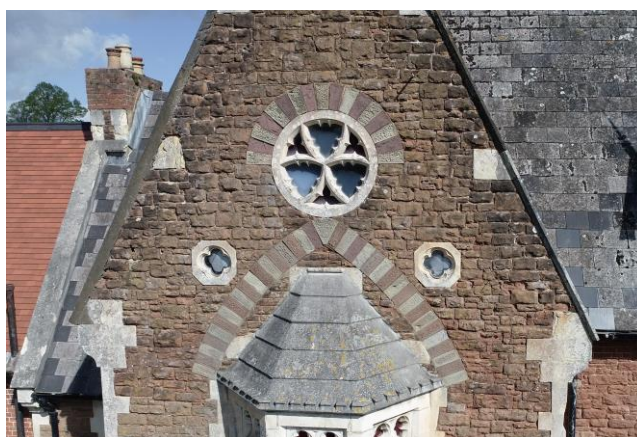
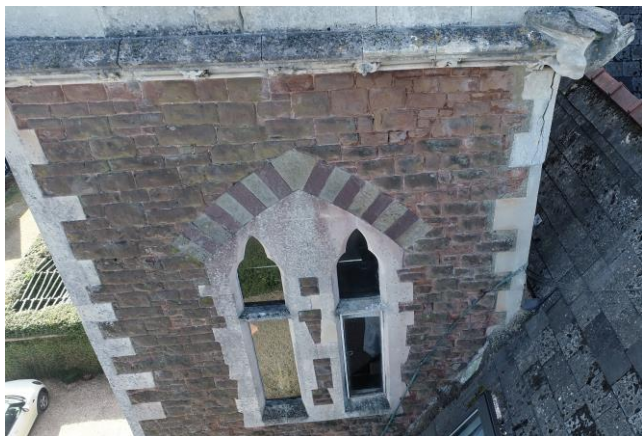
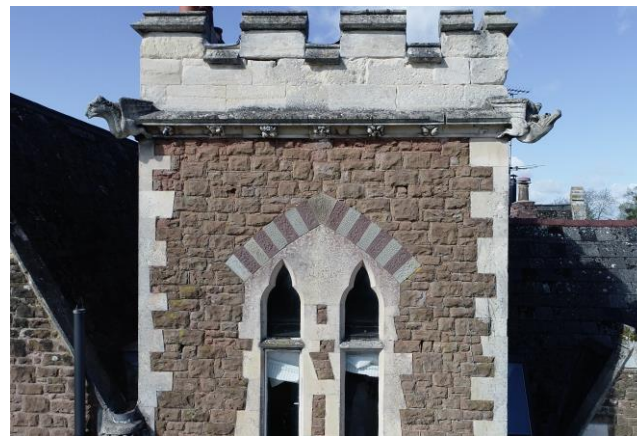
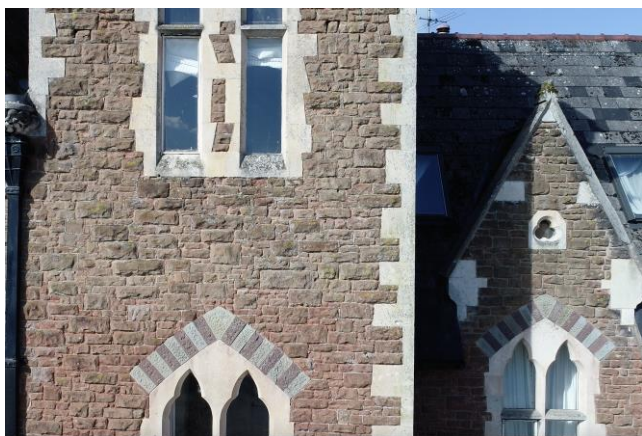
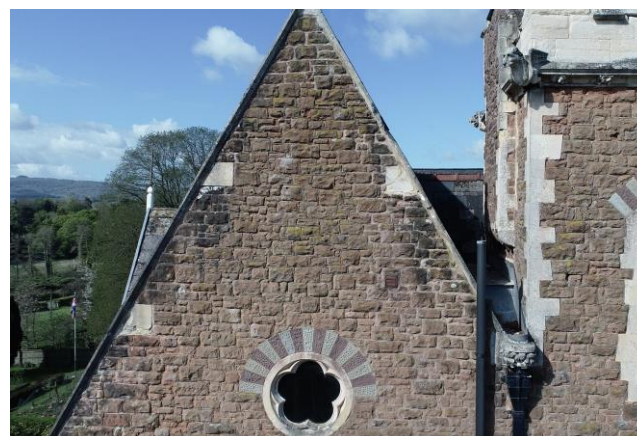
## Elevations

We found that across the elevations the pointing was very much deteriorated, to the extent that in places it was missing. We also noted that multiple stones were spalled, which is the result of moisture absorption, and possible freezing and expansion during cold periods.

There were evident open joints within the stonework, especially around the crown of the tower, where we also noted a vertical fracture in the rear corner stone.

This level of deterioration will much increase the level of moisture penetration into the structure, in turn increasing the risk of internal damp issues

6. We recommend that any deteriorated pointing across the elevations is raked out with care and repointed using a lime-based mortar. Any bricks or stone found to be spalled, eroded by more than 20%, damaged or cracked should be replaced.

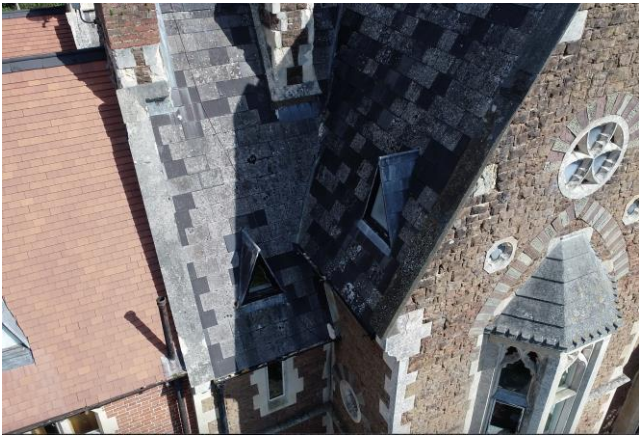
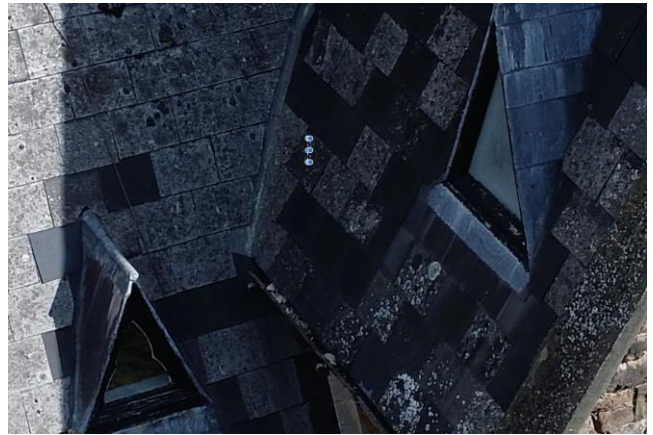
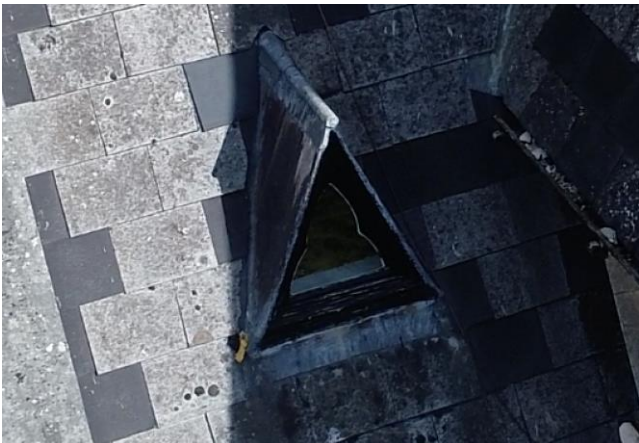
## Windows

To the rear of the property, we noted that the frames of the triangular windows were poorly maintained and deteriorated. They appeared to be rotten, however we were unable to safely assess the full extent of the deterioration.

7. The triangular window frames to the rear should be assessed and if deteriorated as detailed, they should be replaced using suitable and approved frames.
