Chartered Building Surveyors and Architectural Consultants

High Gables, Daglingworth, Cirencester, Gloucestershire, GL7 7AE

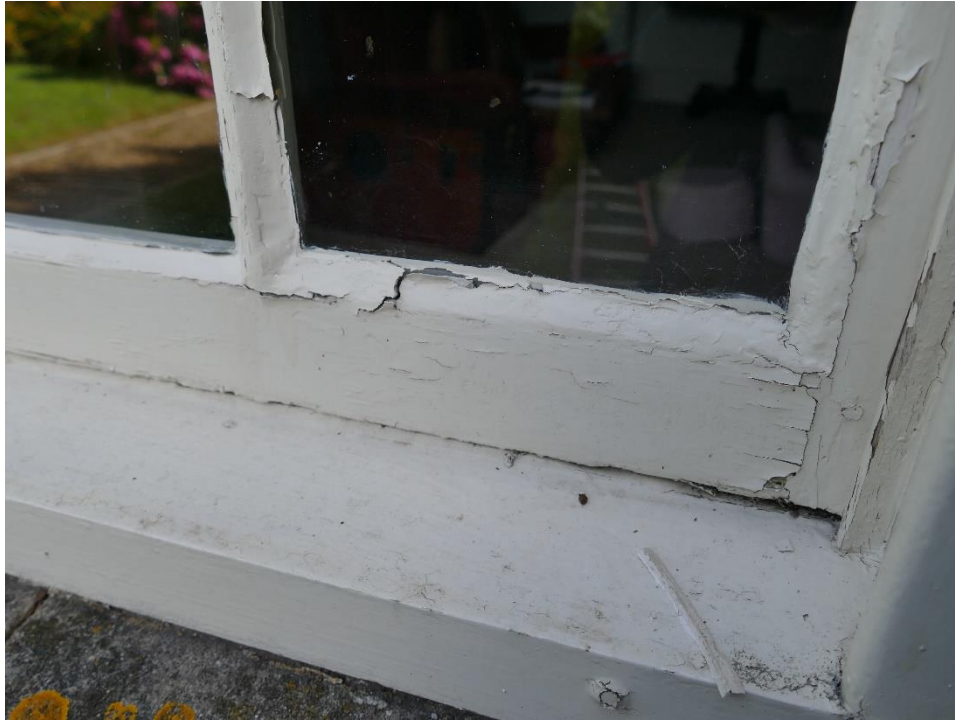
Photograph 1 – Softening and on-set of rot to right-hand side bottom rail to lower sliding sash at abutment with stile (*Ground Floor Front Elevation Window (WG2)*)

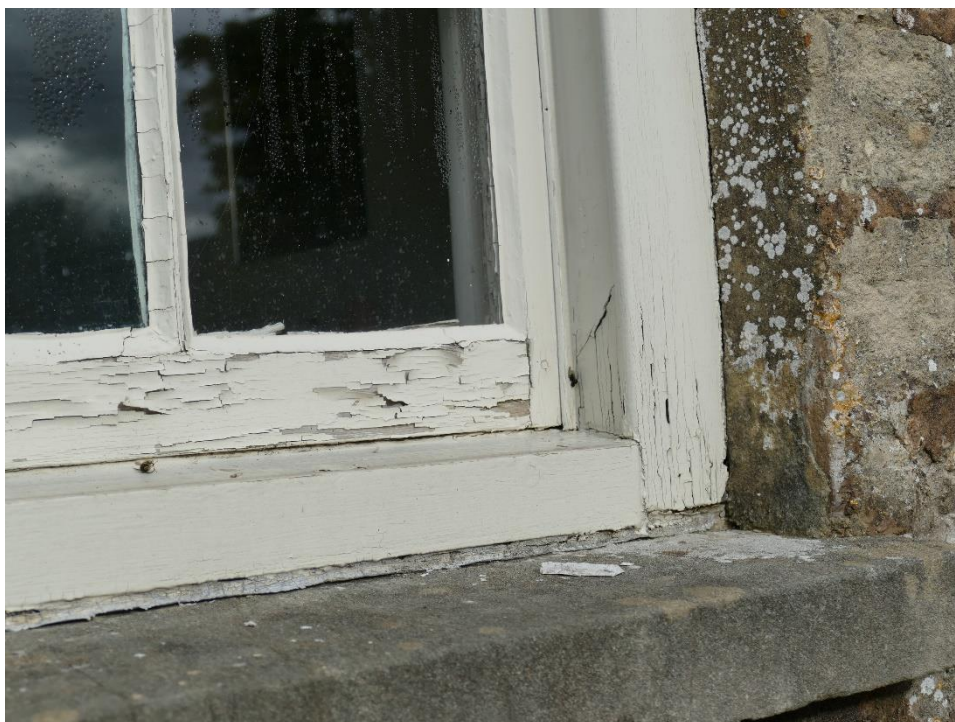
Photograph 2 – Defective peeling/flaking paint, softening and on-set of rot to bottom rail, outer lining, parting beads and pulley stile – despite splice repairs (*First Floor Front Elevation Window (WF2)*)

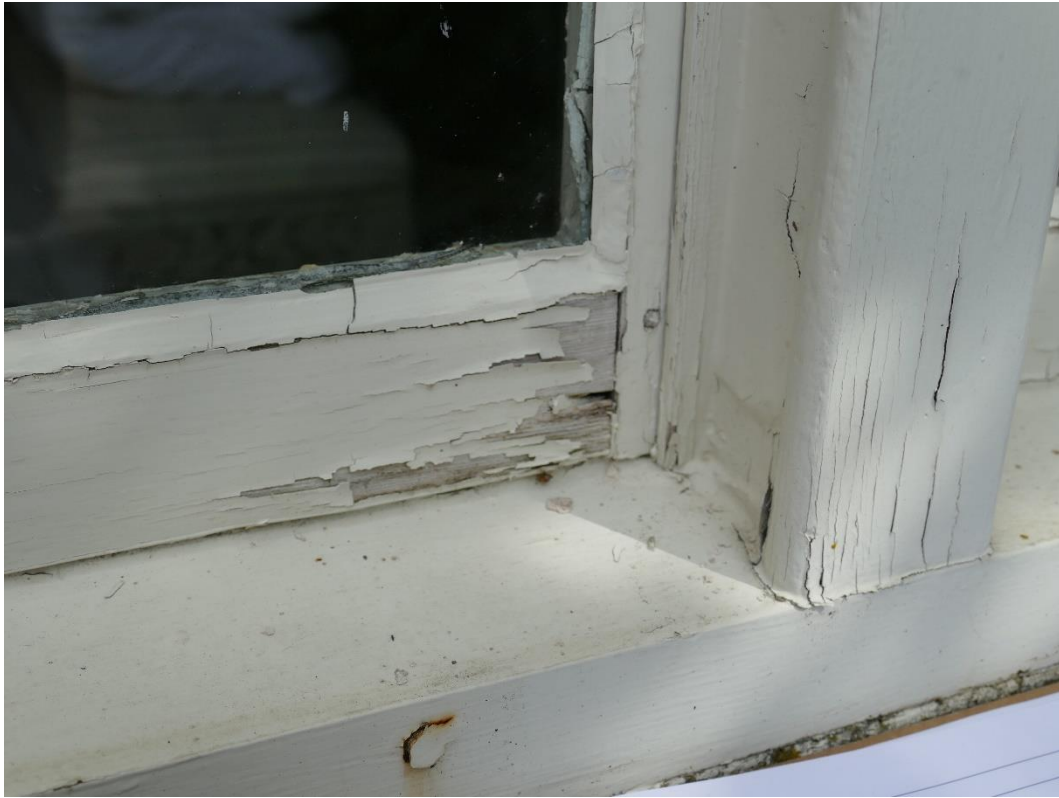
Photograph 3 – Defective peeling/flaking paint, rot to bottom rail, outer lining, parting beads and pulley stile (*First Floor Front Elevation Window (WF3)*)

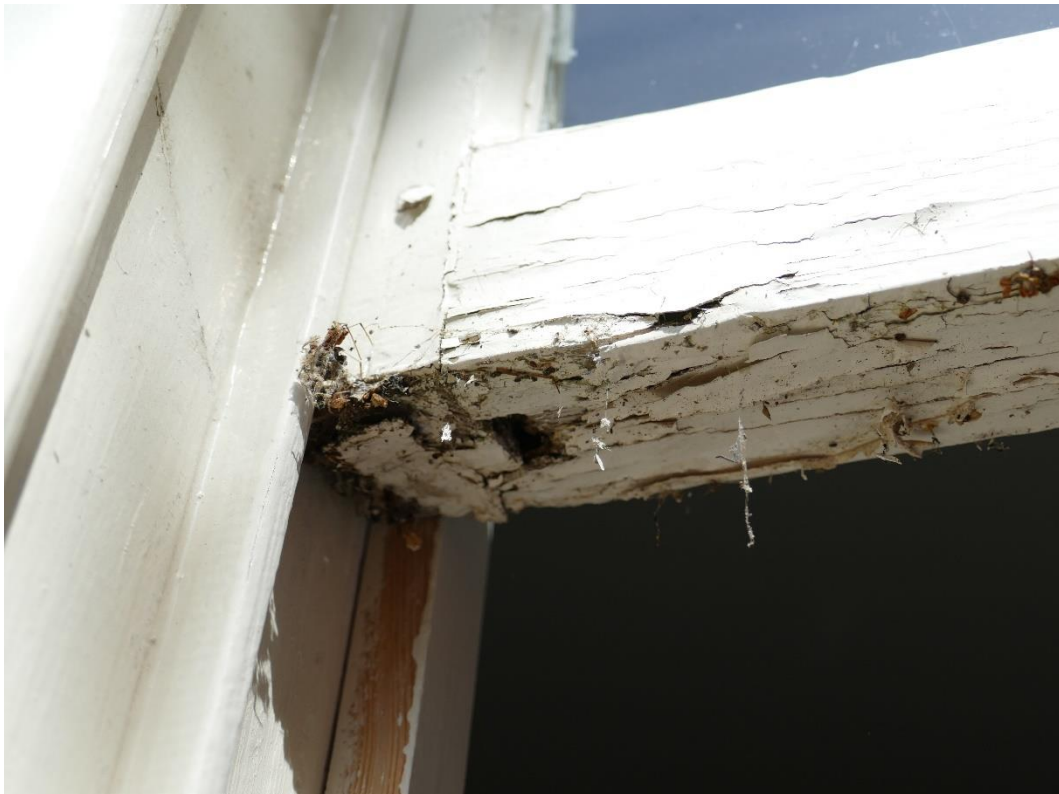
Photograph 4 – Rot to face and soffit of bottom rail to lower sash externally at intersection with stiles on carpentry joint (*First Floor Front Elevation Window (WF3)*)

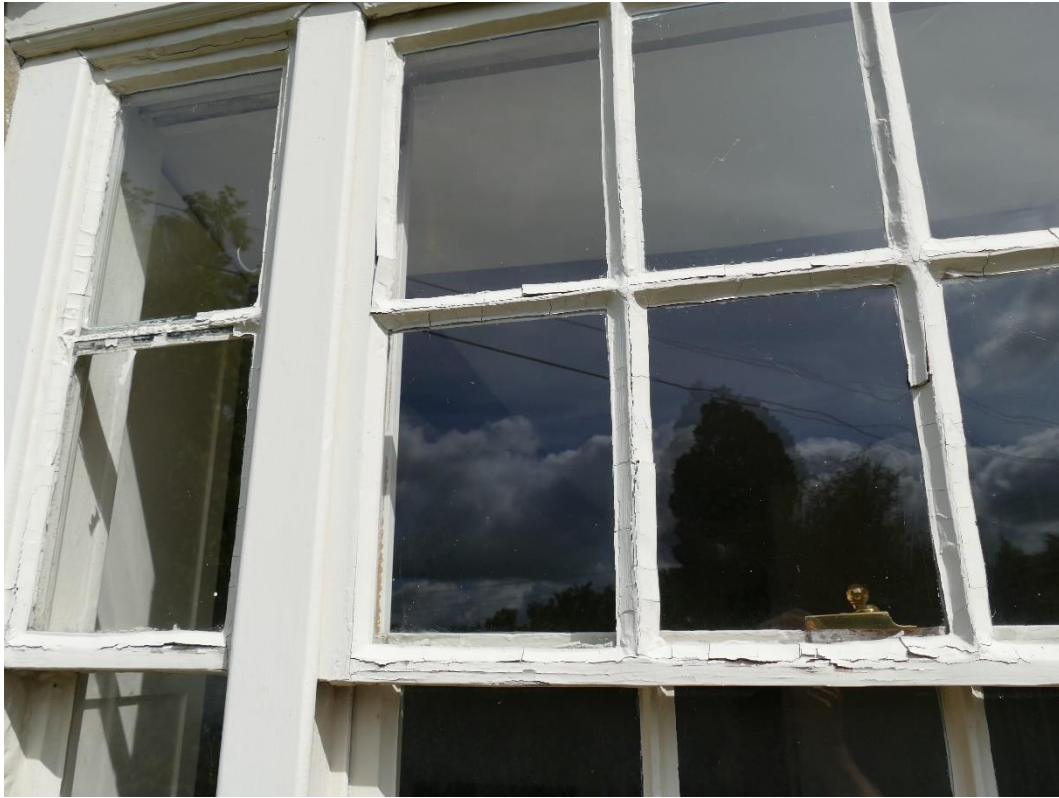
Photograph 5 – Defective rotten and missing glazing bar, with missing and cracking window putty (*First Floor Front Elevation Window (WF1)*)

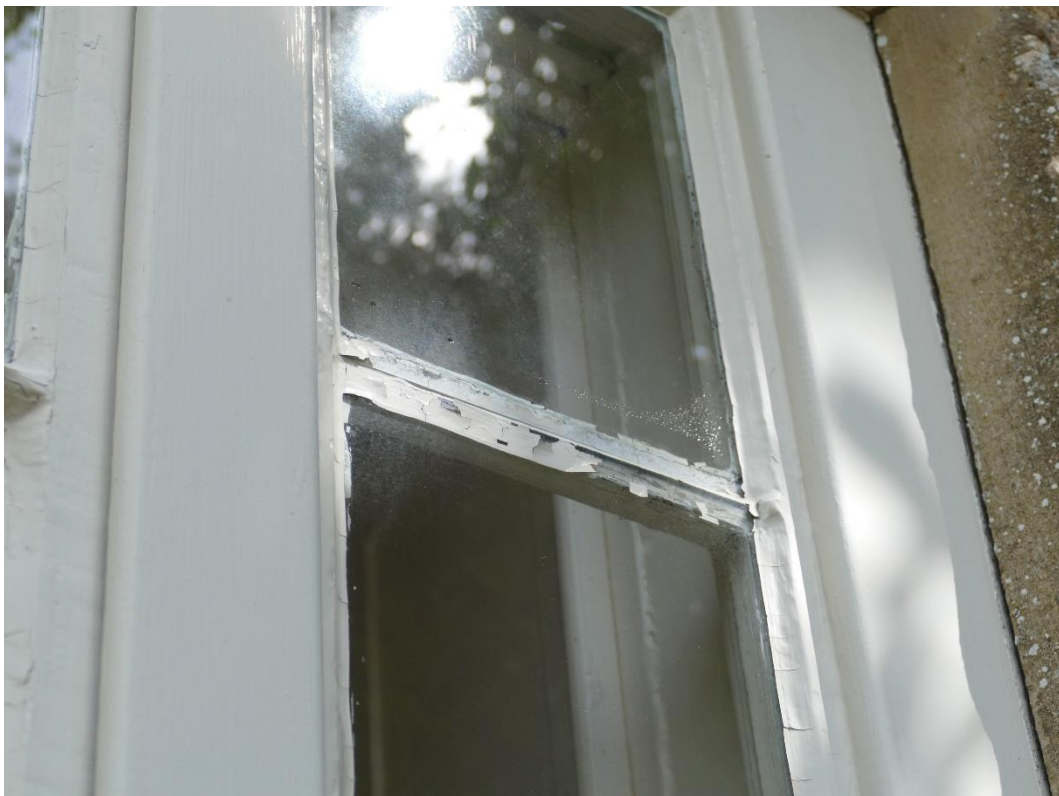
Photograph 6 – Further evidence of completely missing glazing bar to fixed sash casement
First Floor Front Elevation Window (WF3)

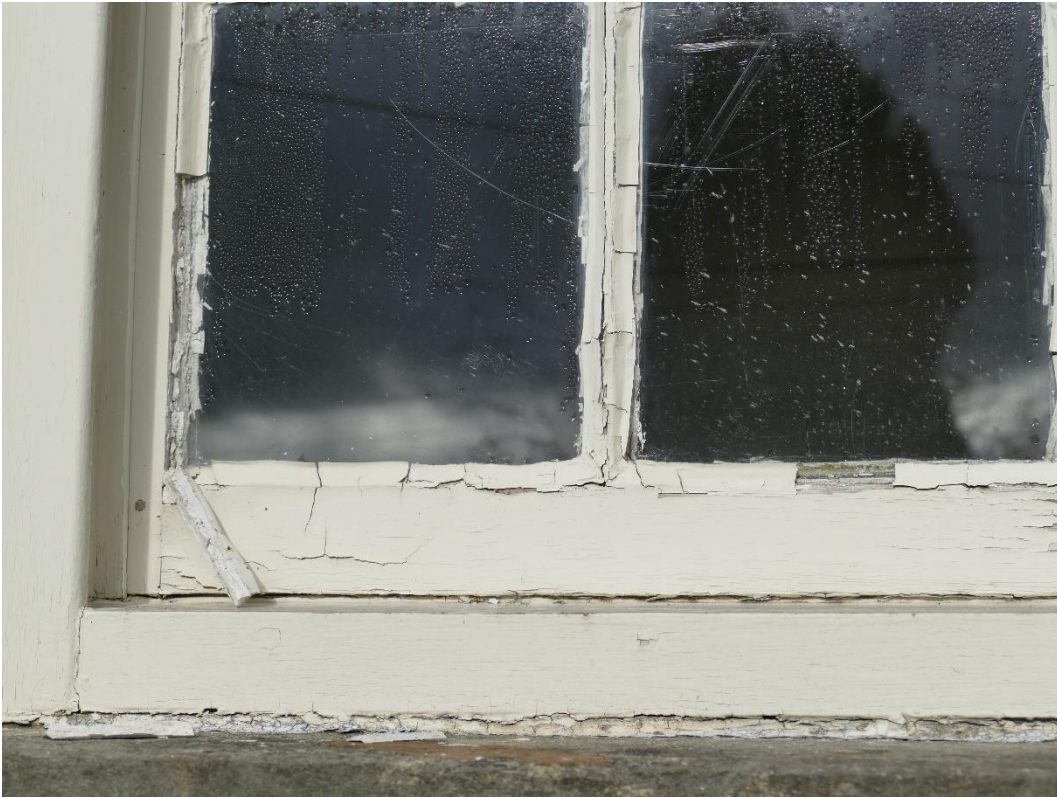
Photograph 7 – Further evidence of defective missing and cracking window putty
First Floor Front Elevation Window (WF2)

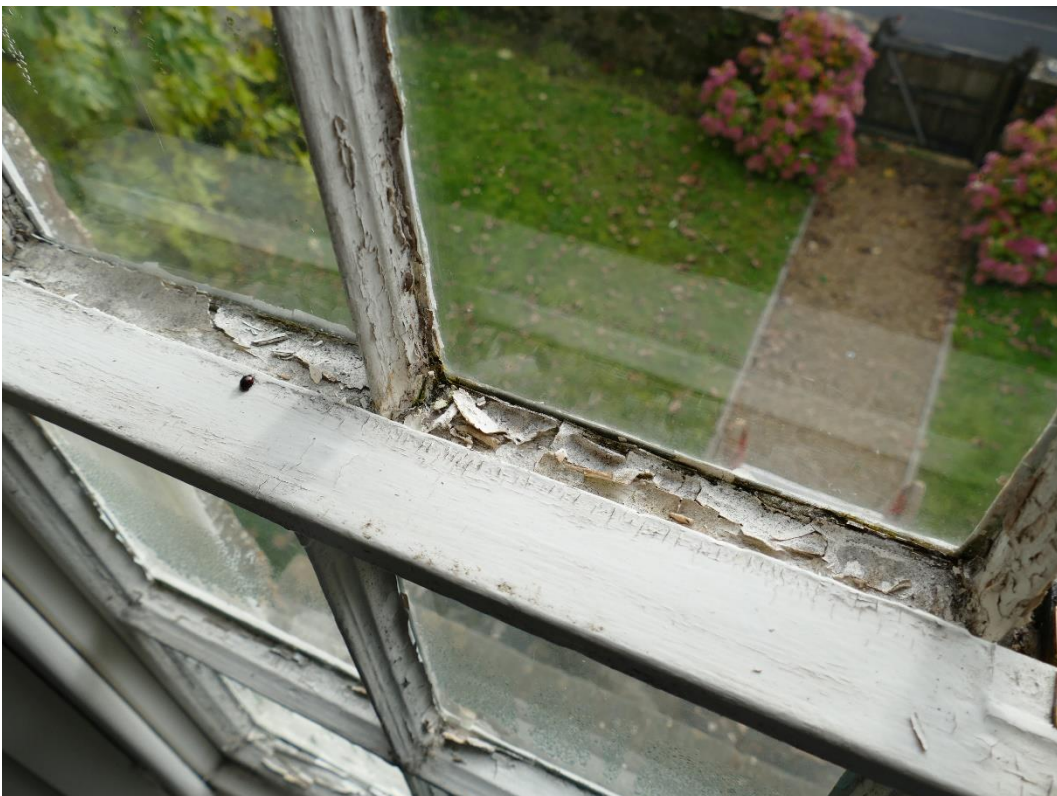
Photograph 8 – Defective peeling/flaking paint to on-set of rot to glazing bars to a sliding sash window as visible internally (*First Floor Front Elevation Window (WF2)*)

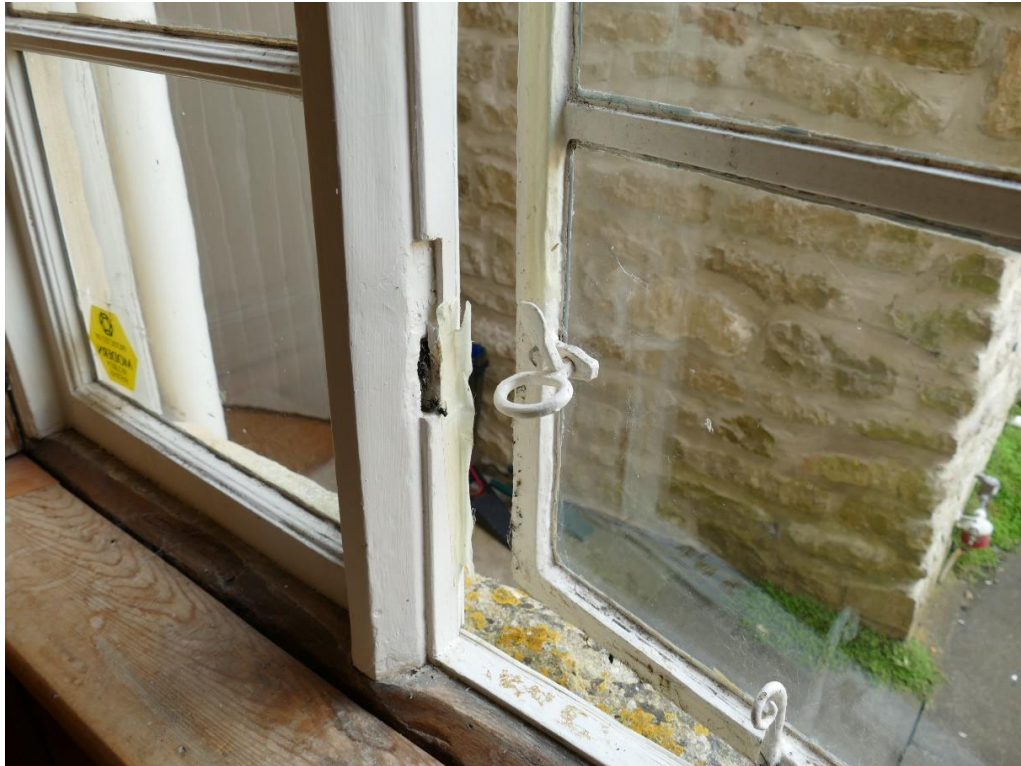
Photograph 9 – Metal casement twisted and poorly fitting to timber frame, resulting in clear daylight visible between frame and casement. Twisted nature of metal casement equally results in difficulty adequately operating and securing window. Tenants resorting to attempting to tape gaps evident between frame and casement due to draughts
(*Ground Floor Rear Elevation Window (WG7)*)

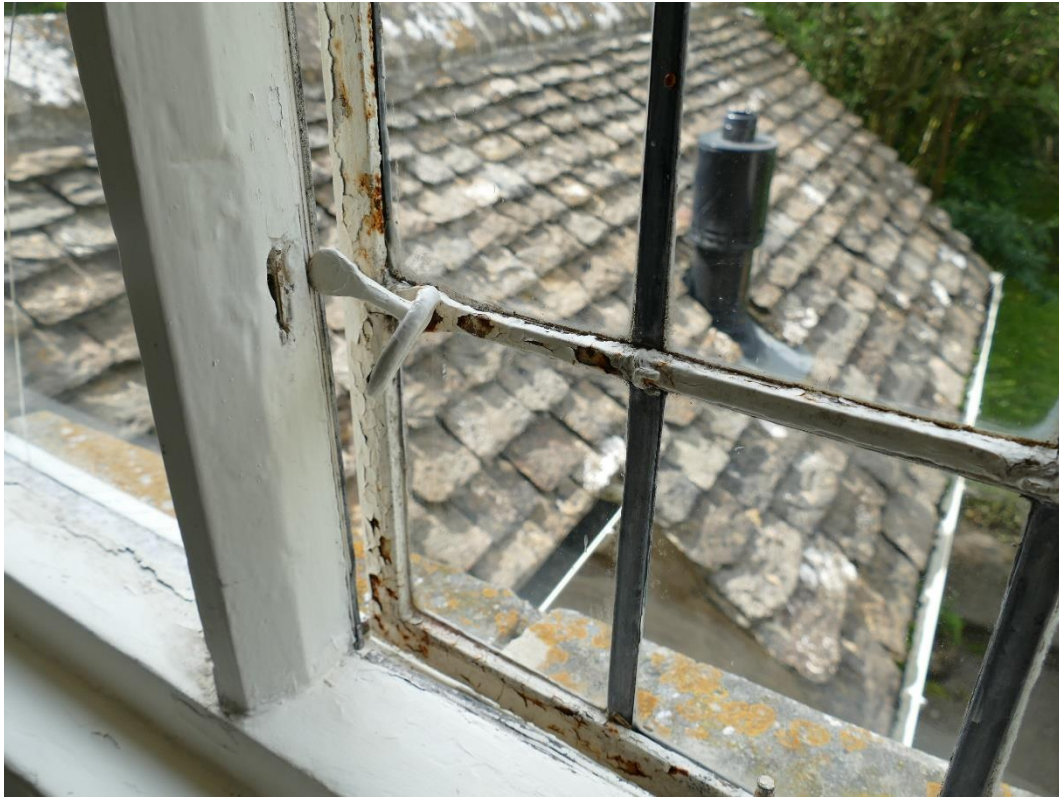
Photograph 11 – Further evidence of poor condition of metal casement, with rust, defective sash fastener and inability to close window (*First Floor Rear Elevation Window (WF6)*)

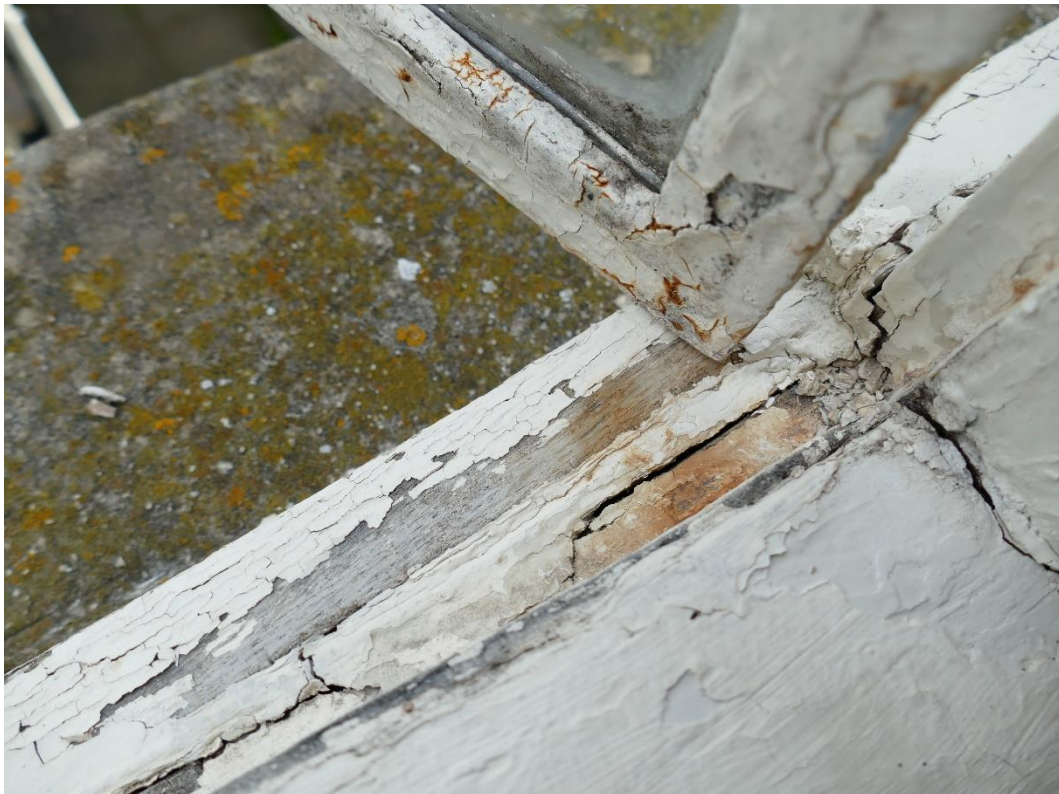
Photograph 12 – Cracking and rot to timber cill, with this particularly evident to opening casement due to rainwater penetration (*First Floor Rear Elevation Window (WF6)*)

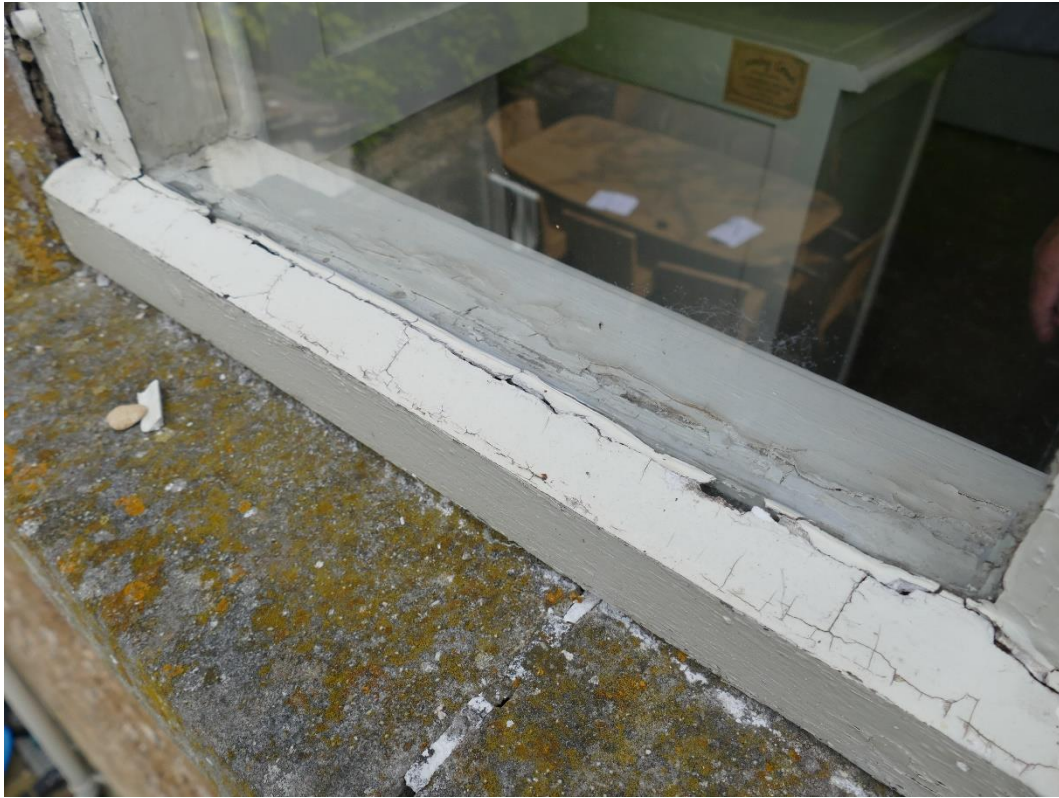
Photograph 13 – Further evidence of cracking and rot to timber cill
First Floor Rear Elevation Window (WF6)

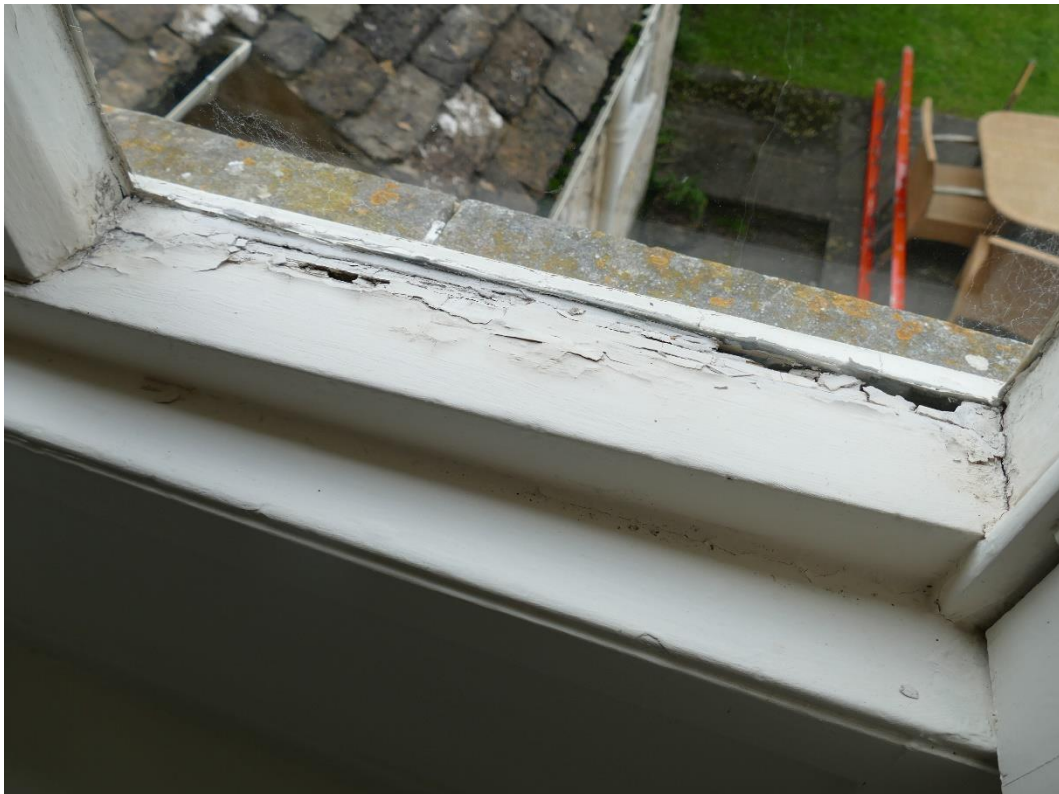
Photograph 14 – Further evidence of cracking and rot to timber cill internally
First Floor Rear Elevation Window (WF6)

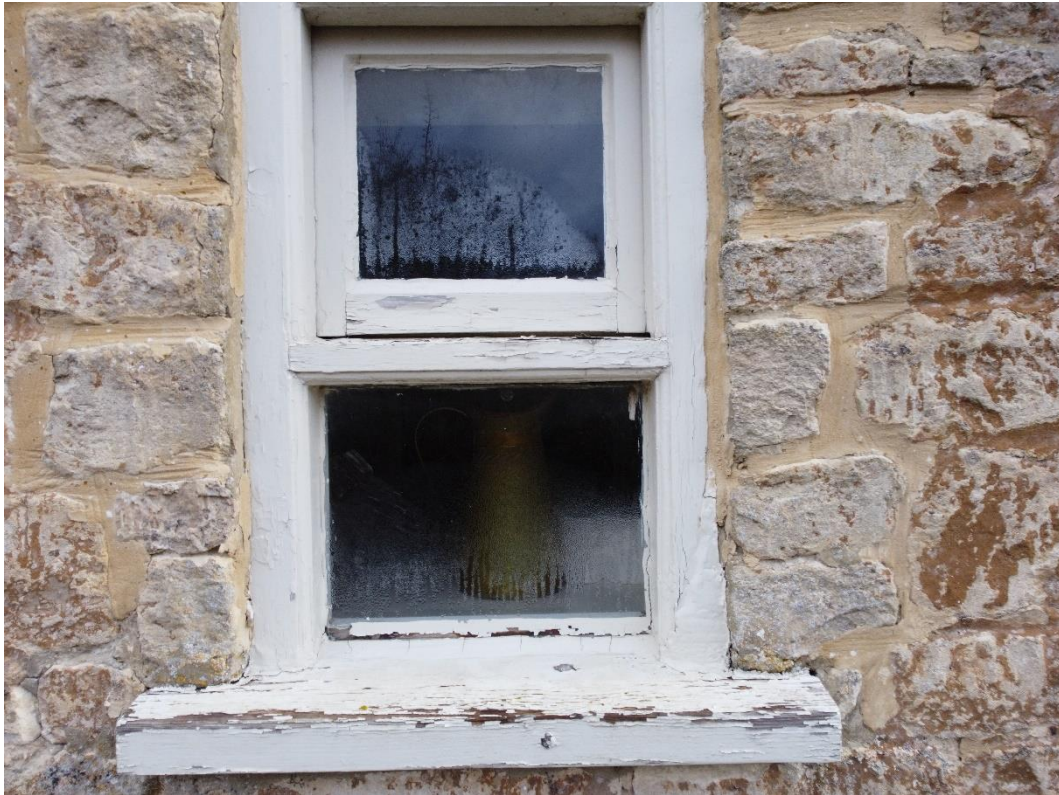
Photograph 15 – Severe poor condition of top-hung fanlight, with severe rot throughout including to: transom, cill, head of frame, bottom rail to fanlight
First Floor Rear Elevation Window (WF7)

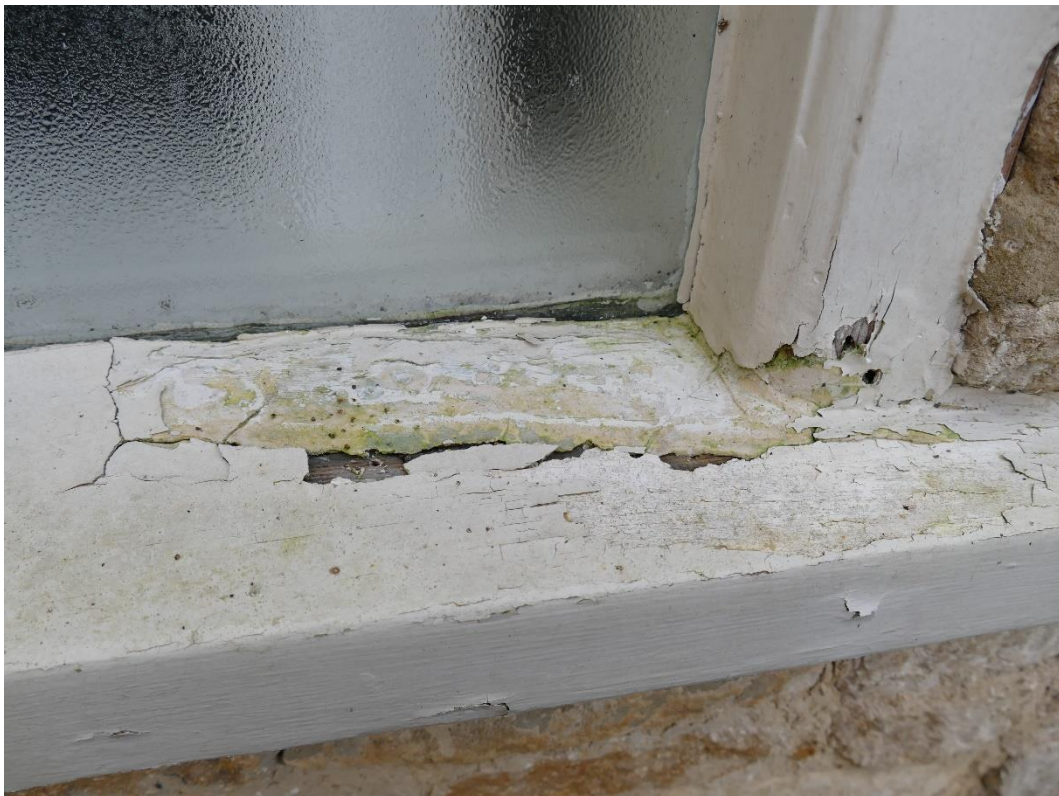
Photograph 16 – Rot and deterioration to cill and jamb to top-hung fanlight
Ground Floor Rear Elevation Window (WG8)

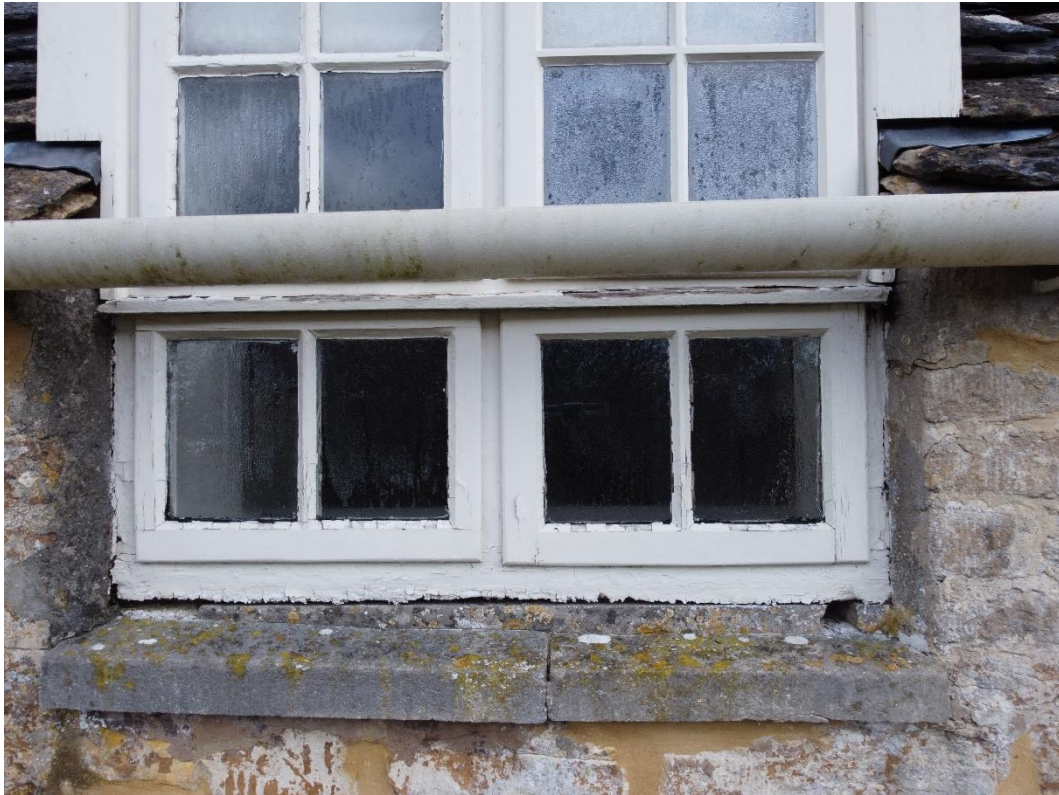
Photograph 17 – General poor condition of dormer window, with defective peeling/flaking paint, rot and cracking/defective window putty (*Second Floor Rear Elevation Dormer Window (WS4)*)

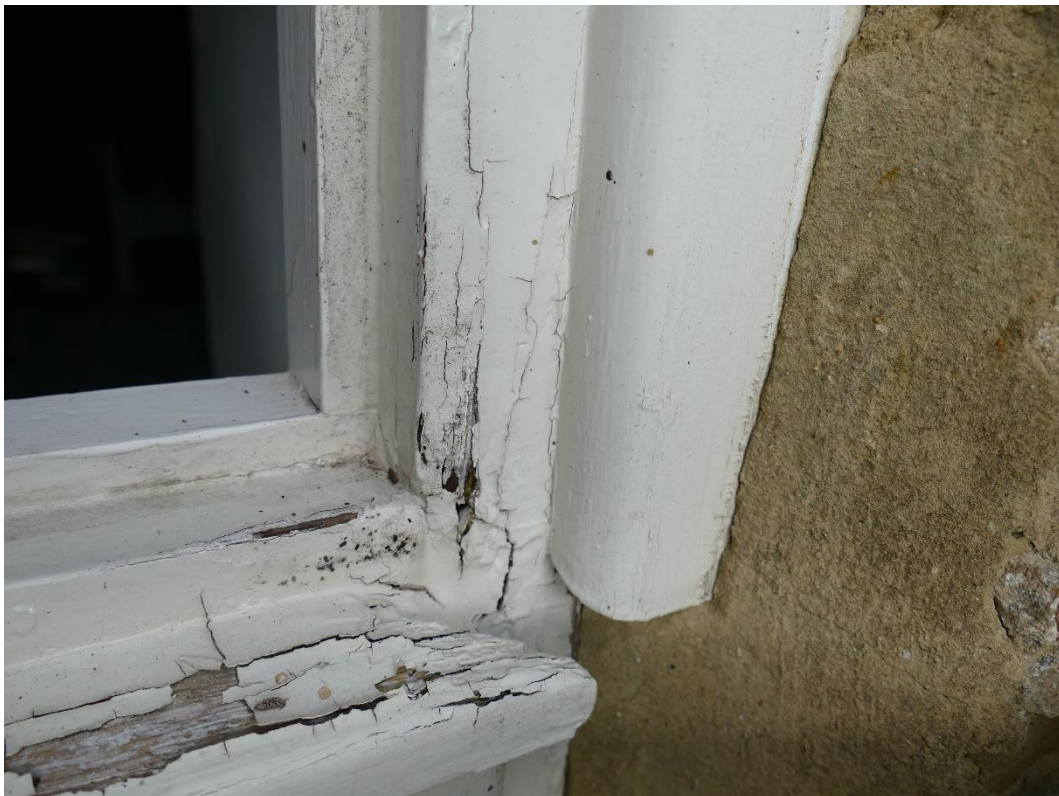
Photograph 18 – Severe rot to right-hand jamb and transom (with equal severe rot to mullion and cill not shown) (*Second Floor Front Elevation Dormer Window (WS3)*)

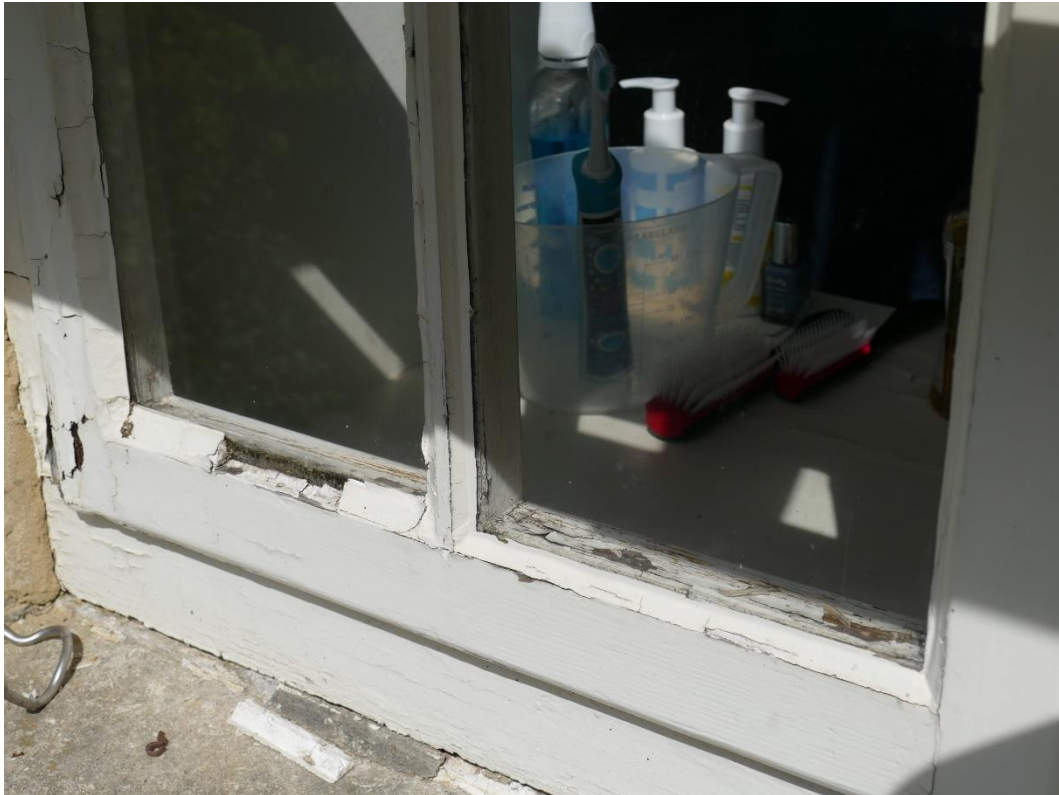
Photograph 19 – Defective missing and cracking window putty
Second Floor Front Elevation Dormer Window (WS2)

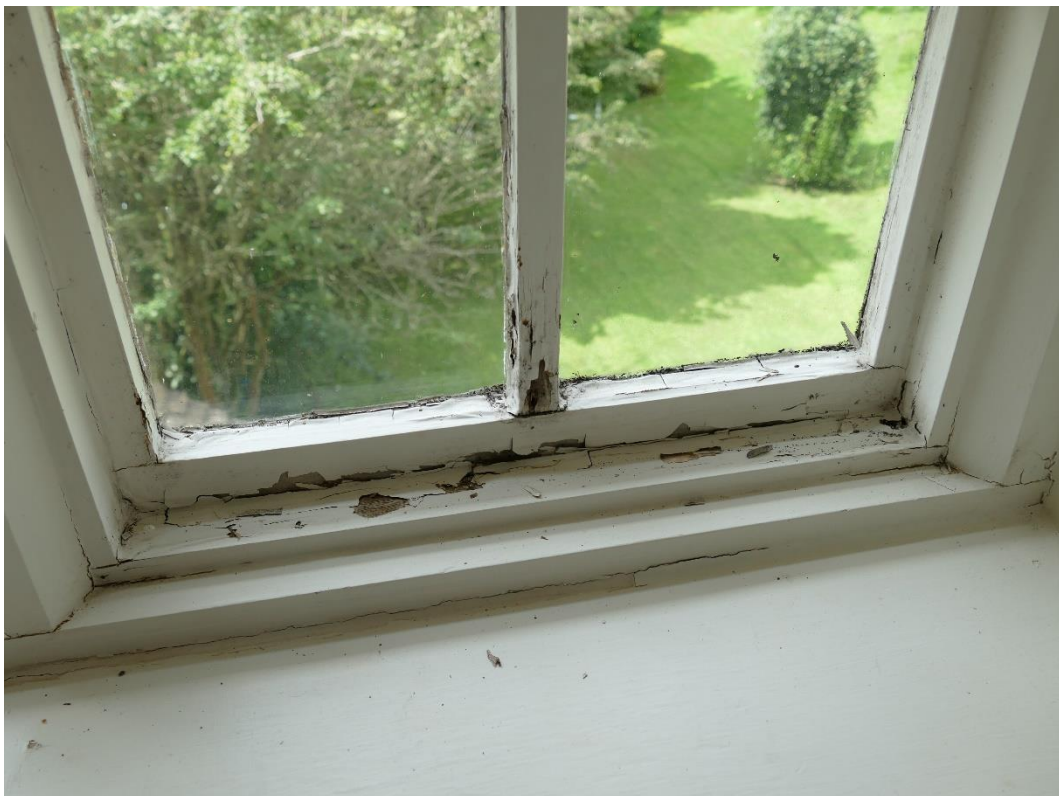
Photograph 20 – Severe softening and rot to top side of bottom rail and glazing bars internally
Second Floor Rear Elevation Dormer Window (WS4)

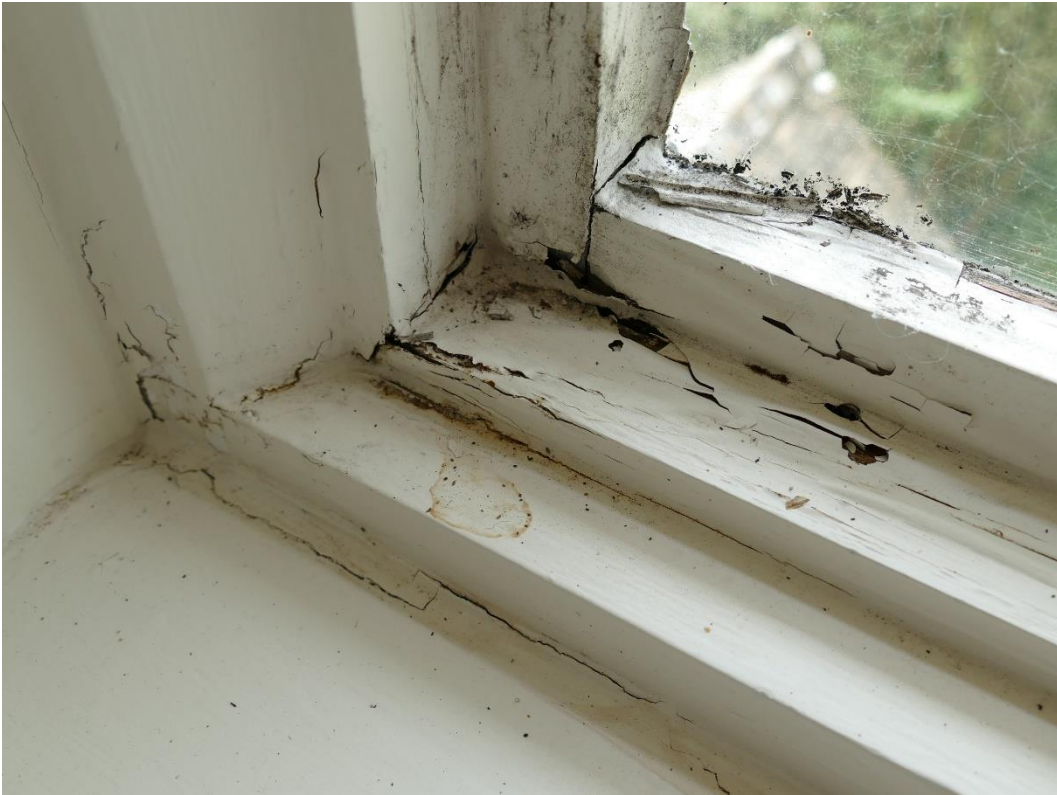
Photograph 21 – Further evidence of severe softening and rot to top side of bottom rail and glazing bars internally (Second Floor Rear Elevation Dormer Window (WS4))

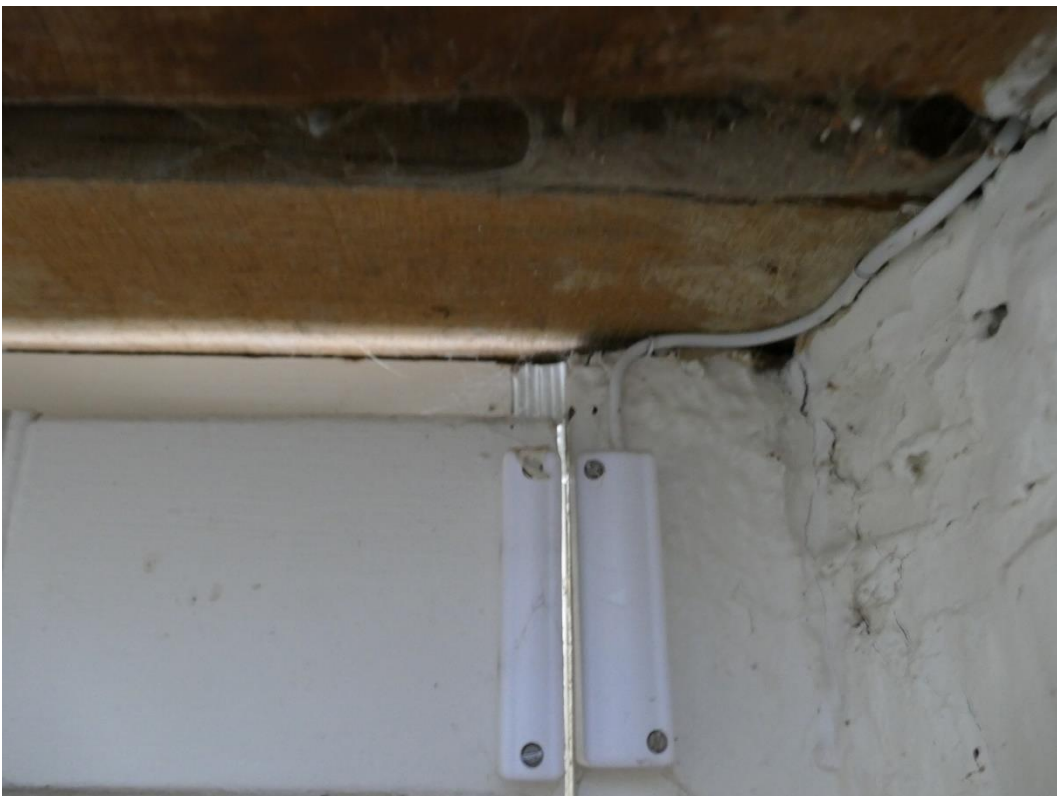
Photograph 22 – Clear daylight visible between the door and frame to the kitchen (DG2), despite the presence of draught stripping, as a result of the twisting of the door
