## PLOTS B, WINDRUSH INDUSTRIAL ESTATE

TREE SURVEY TO BS 5837:2012

**our ref:** 2343 / EH / TR001 **date:** 17<sup>th</sup> May 2023

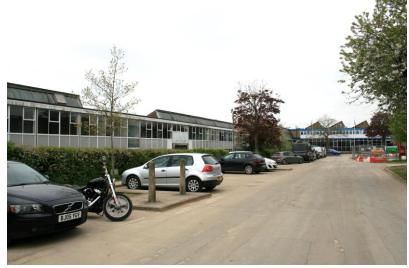
Figure 3. View Southwest towards T01-T05

- 3.1 The majority of the trees surveyed can be associated with the development of the Windrush Industrial Estate from 1960's and are generally considered to be of low to moderate quality and value.
- Trees T01 to T06 are a number of predominantly low quality and value Purple leaved maple, False acacia and Apple trees growing within the hard and soft landscaped areas to the front of the existing buildings (refer to Figure 3 below). Trees T01, T04 and T06 are growing within raised brick planters with the estimated root protection areas shown as a radius as the size of tree indicates a greater root spread than the size of the planters would indicate.

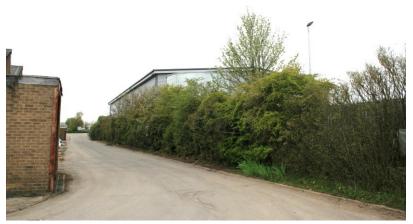
Figure 4. View North towards T07-T13

- 3.3 To the East of the survey area is a slope down from the adjacent site planted with ornamental shrubs and a number of young trees including Whitebeam, Rowan, Apple and Hawthorn of varying value and condition (refer to Figure 4 above).
- 3.4 To the rear of the site are a number of young trees including Hawthorn, Alder buckthorn and Apple adjacent to the yard and Ash adjacent to the rear site access including T19 a mature offsite tree of moderate quality and value (refer to Figures 5 & 6 above).
