ASBESTOS SURVEY REPORT

MANAGEMENT SURVEY

**HARLECH COURT
BUTE TERRACE
CARDIFF
CF10 2FE**

Survey reference:	Report Issue		Lead surveyor	Authorised signatory
A397	01	10/04/18

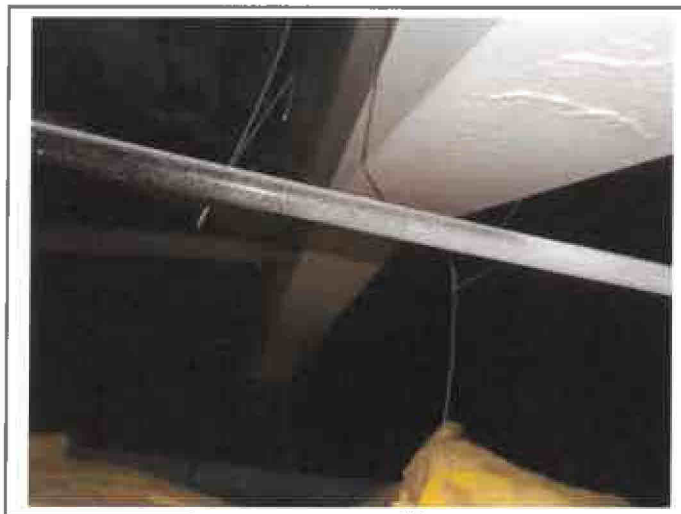
Composite sample from several locations

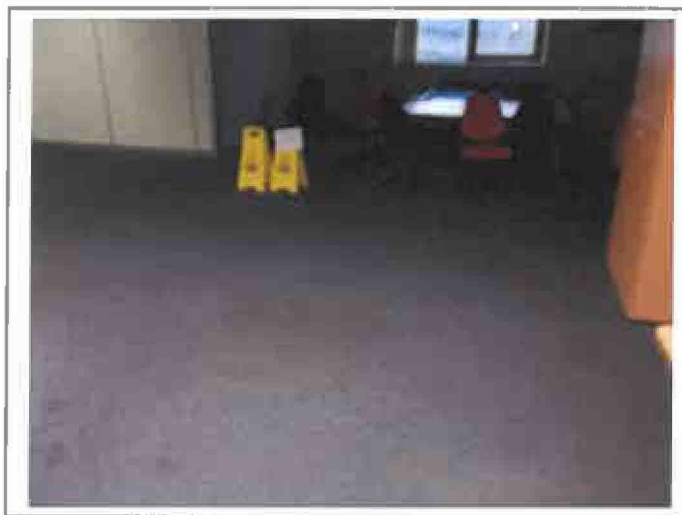
Comments:
Under carpet tiles

Recommendations:
No further action required

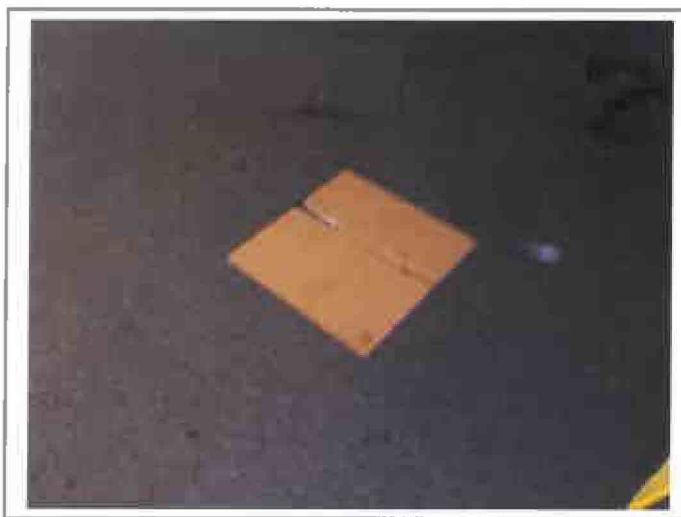
Comments:
Under carpet tiles

Recommendations:
No further action required

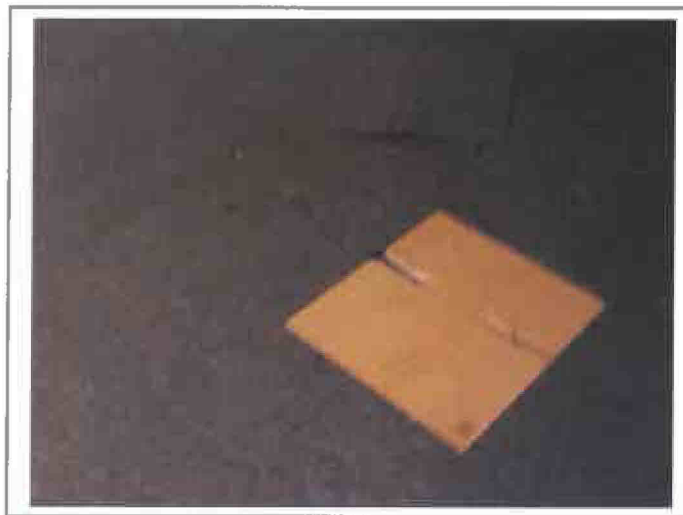
Comments:
Under carpet tiles

Recommendations:
No further action required

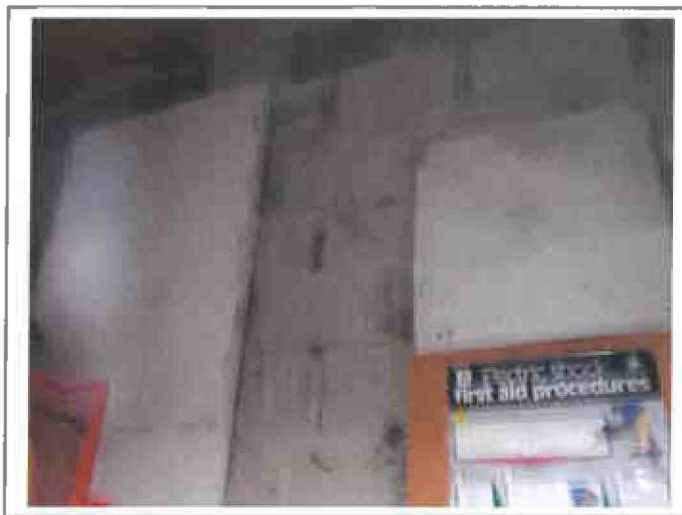
Comments:
Mica board

Recommendations:
No further action required

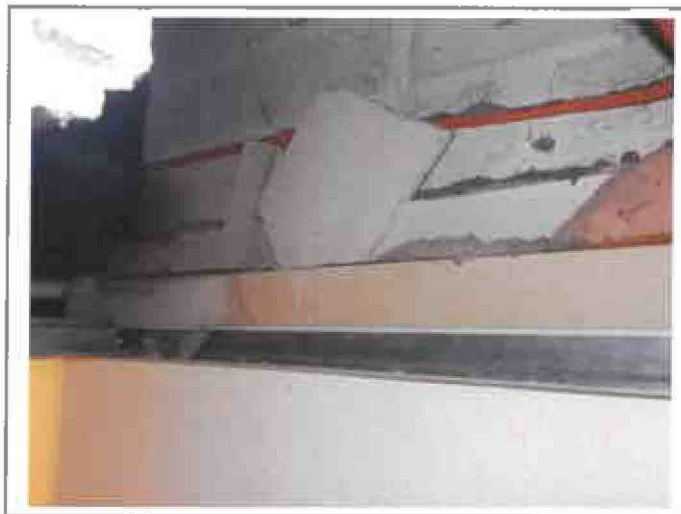
Comments:
Mica board

Recommendations:
No further action required

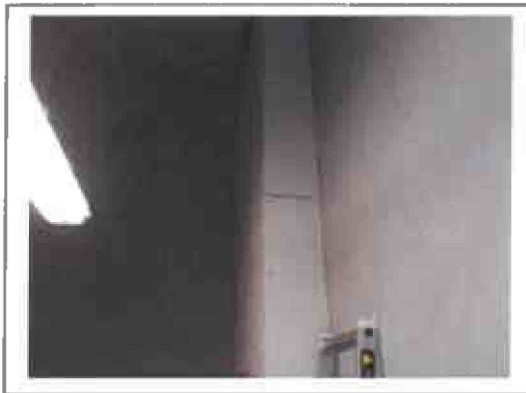
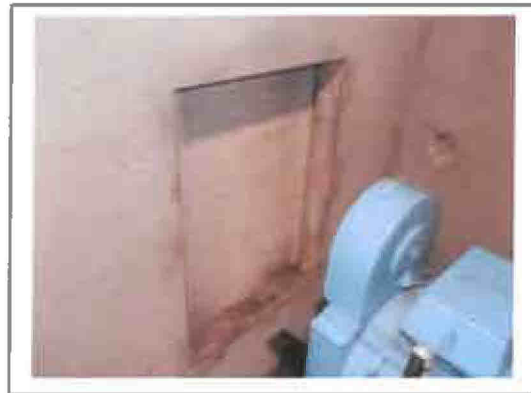
Comments:
 Mica board boxing and panel between boiler & lift motor rooms

Recommendations:
 No further action required

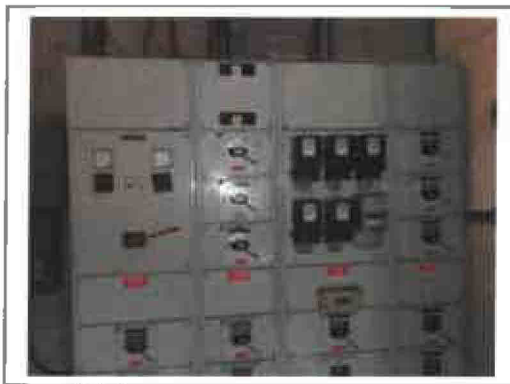
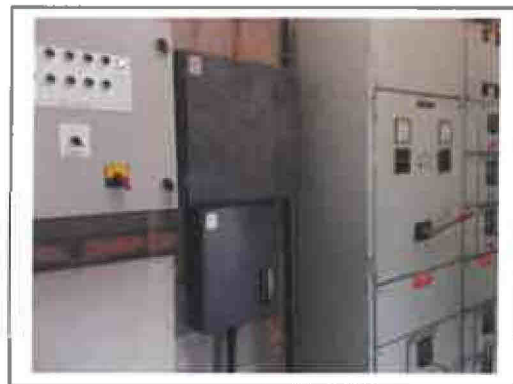
Comments:
 Presumed within live switchgear
 May also contain textiles

Material assessment		
Parameter	Score	Description
Product type:	2	Board
Damage/deterioration:	0	None
Surface treatment:	1	Enclosed
Asbestos type:	2	Chrysotile
Total:	5

Hazard rating
VERY LOW

Recommendations:
 Inform & manage
 Inspect with electrician during planned maintenance

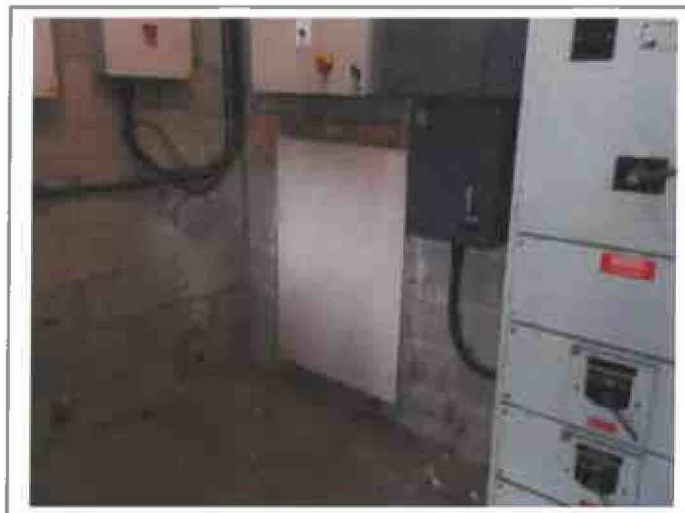
Comments:
Mica panel between boiler & lift motor rooms

Recommendations:
No further action required

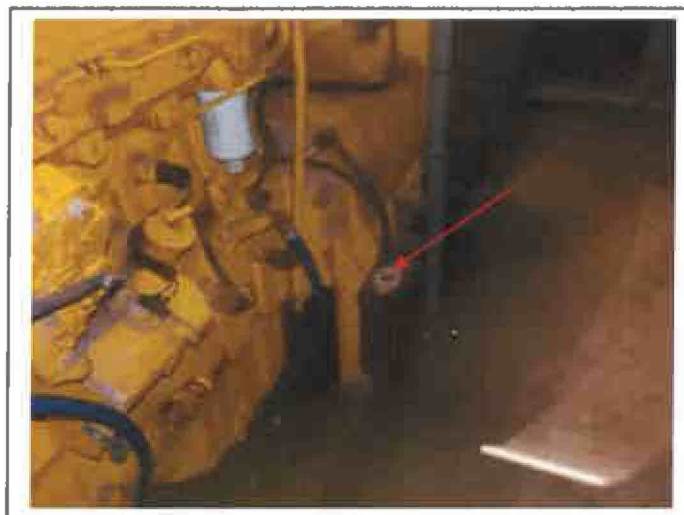
Comments:
Two loose gaskets removed as sample Potentially more within flange joints

Material assessment		
Parameter	Score	Description
Product type:	2	Gasket
Damage/deterioration:	0	None
Surface treatment:	1	Enclosed
Asbestos type:	1	Chrysotile
Total:	4

Hazard rating
VERY LOW

The electrical switchgear & plant room flange joints should be inspected when access is possible, ie. during planned maintenance.

Recommendations:
Inform & manage Inspect during planned maintenance

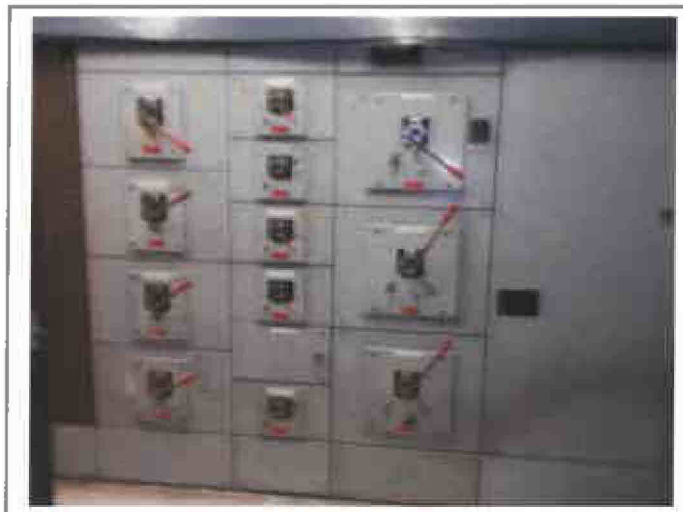
Comments:
 Presumed within live switchgear
 May also contain textiles

Material assessment		
Parameter	Score	Description
Product type:	2	Board
Damage/deterioration:	0	None
Surface treatment:	1	Enclosed
Asbestos type:	2	Amosite
Total:	5

Hazard rating
VERY LOW

Recommendations:
 Inform & manage
 Inspect with electrician during planned maintenance
