**HSG 264
DEMOLITION ASBESTOS SURVEY REPORT**

CLIENT
*Network Rail
Waterloo General Office
London
SE1 8SW*

SURVEY SITE
*Lynn Road Gatehouse
Ely
Cambs
DN39 6TX*

Project No. ABP/14062/P-22338/03/23/ELY025AA
Report 1 (Revision 0)
Report Issue Date: 05/04/2023

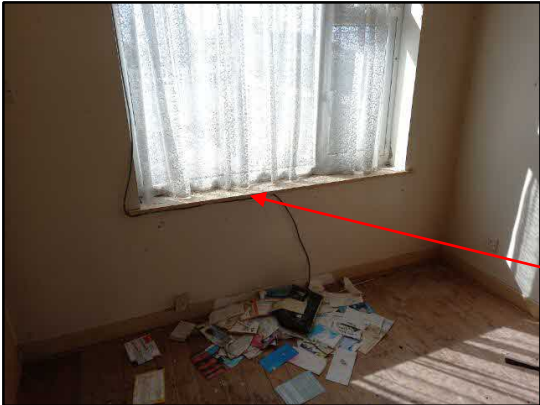
ID level & Sample No.	SP as 001
	Location:	G001 Lounge
	Item Description:	Damp Proof Course under windowsill - Bitumen
	Asbestos Type:	Chrysotile

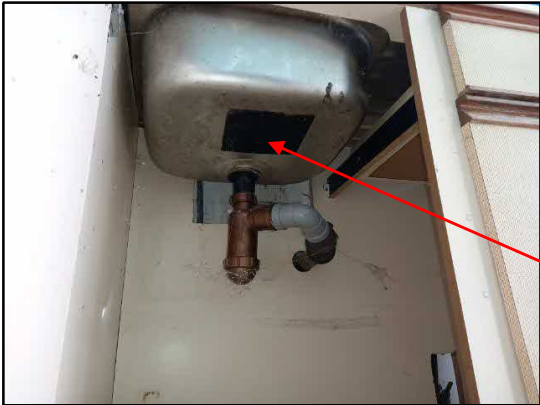
ID level & Sample No.	ID003
	Location:	G002 Kitchen
	Item Description:	Sink pad - Bitumen
	Asbestos Type:	Chrysotile

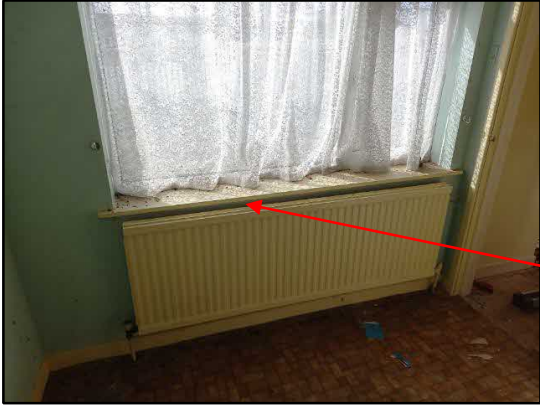
ID level & Sample No.	SP as 001
	Location:	G002 Kitchen
	Item Description:	Damp Proof Course under windowsill - Bitumen
	Asbestos Type:	Chrysotile

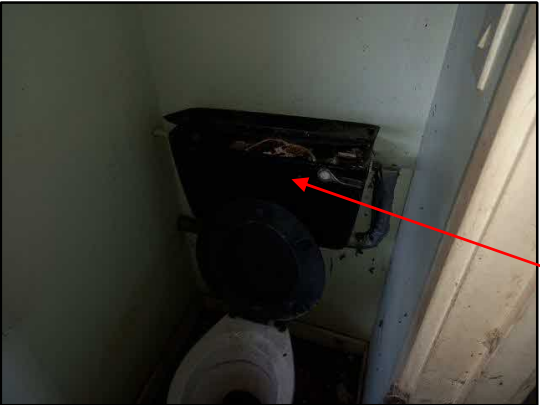
ID level & Sample No.	SP as 002
	Location:	G006 WC
	Item Description:	Cistern - Resin
	Asbestos Type:	Amosite

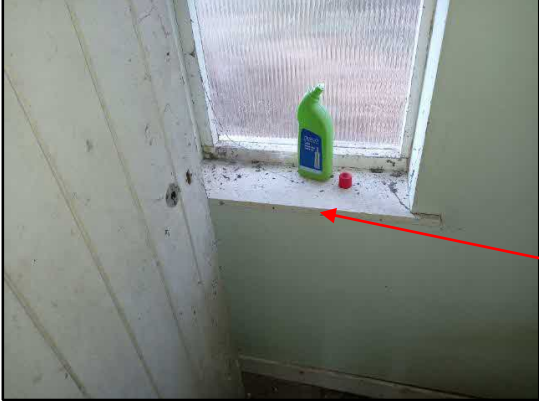
ID level & Sample No.	SP as 001
	Location:	G006 WC
	Item Description:	Damp Proof Course under windowsill - Bitumen
	Asbestos Type:	Chrysotile

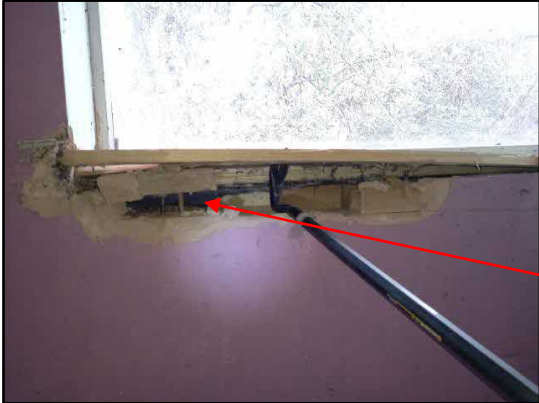
ID level & Sample No.	SP as 001
	Location:	G007 Storeroom
	Item Description:	Damp Proof Course under windowsill - Bitumen
	Asbestos Type:	Chrysotile

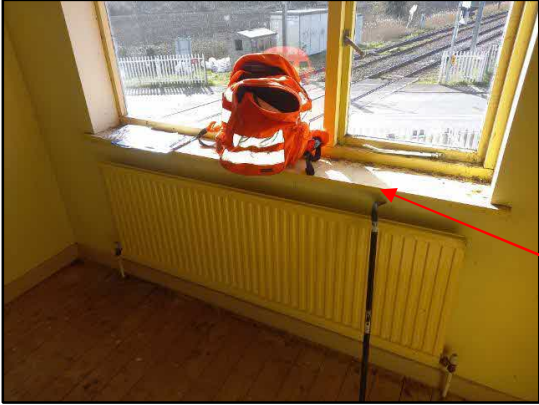
ID level & Sample No.	SP as 001
	Location:	1001 Bedroom 1
	Item Description:	Damp Proof Course under windowsill - Bitumen
	Asbestos Type:	Chrysotile

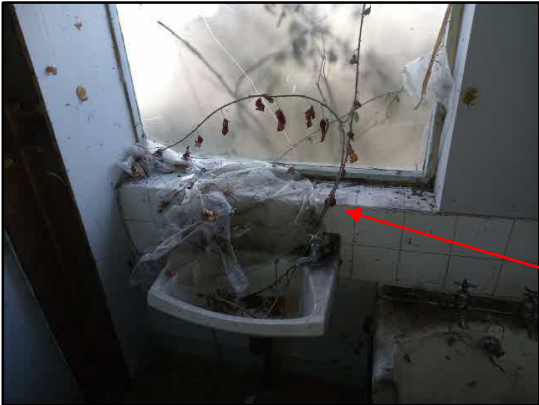
ID level & Sample No.	SP as 001
	Location:	1002 Bathroom
	Item Description:	Damp Proof Course under windowsill - Bitumen
	Asbestos Type:	Chrysotile

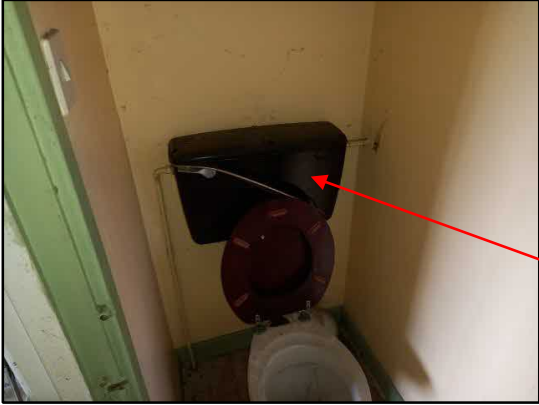
ID level & Sample No.	ID002
	Location:	1004 WC
	Item Description:	Cistern - Resin
	Asbestos Type:	Amosite

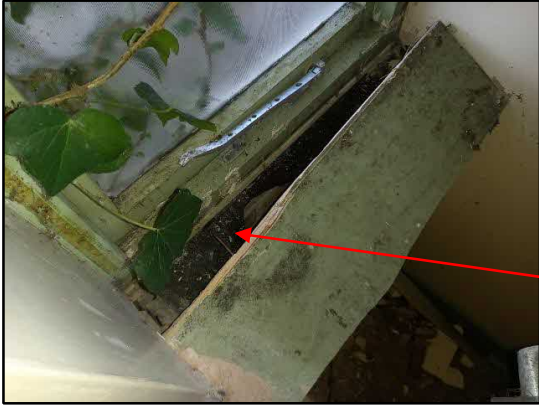
ID level & Sample No.	ID001
	Location:	1004 WC
	Item Description:	Damp Proof Course under windowsill - Bitumen
	Asbestos Type:	Chrysotile

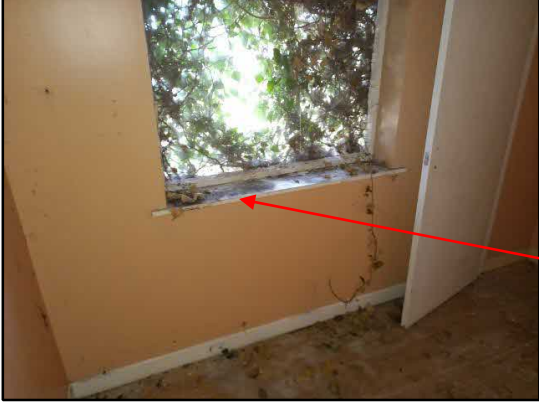
ID level & Sample No.	SP as 001
	Location:	1006 Bedroom 3
	Item Description:	Damp Proof Course under windowsill - Bitumen
	Asbestos Type:	Chrysotile

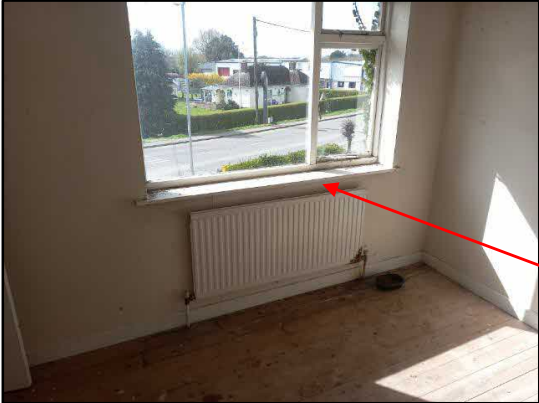
ID level & Sample No.	SP as 001
	Location:	1008 Bedroom 3
	Item Description:	Damp Proof Course under windowsill - Bitumen
	Asbestos Type:	Chrysotile

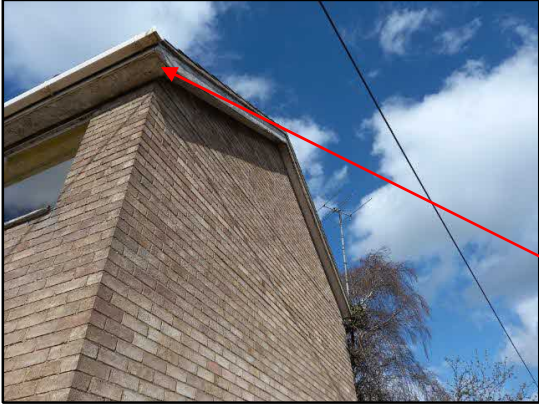
ID level & Sample No.	SP Vis ID
	Location:	EX001 External
	Item Description:	Undercloak - Asbestos Cement
	Asbestos Type:	Crocidolite

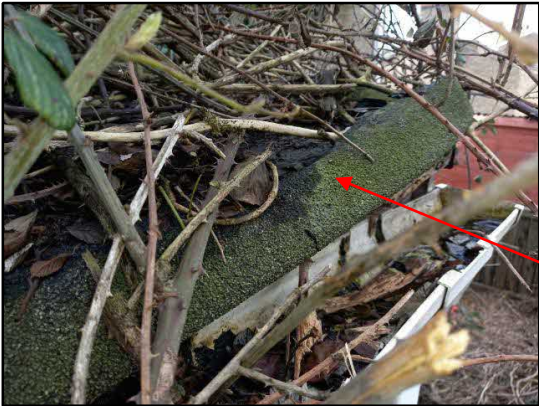
ID level & Sample No.	ID006
	Location:	EX001 External
	Item Description:	Flat Roof - Bitumen
	Asbestos Type:	Chrysotile

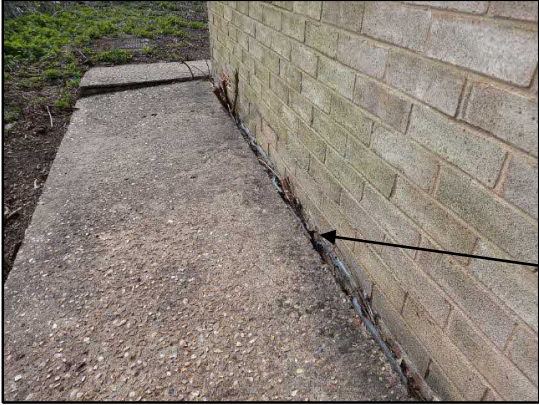
ID level & Sample No.	ID005
	Location:	EX001 External
	Item Description:	Expansion Joints to floor slab - Putty
	Asbestos Type:	No asbestos detected

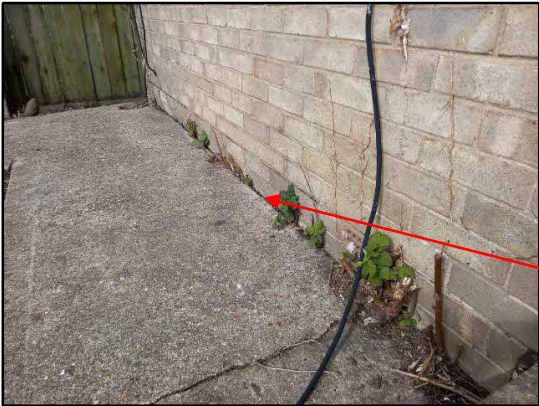
ID level & Sample No.	ID004
	Location:	EX001 External
	Item Description:	Damp Proof Course - Bitumen
	Asbestos Type:	Chrysotile

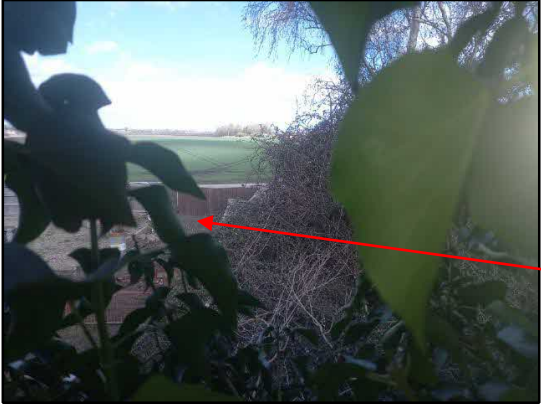
ID level & Sample No.	SP Vis ID
	Location:	EX002 External Shed
	Item Description:	Roof - Asbestos Cement
	Asbestos Type:	Chrysotile
