Ely Road Gatehouse,
Cambridgeshire Condition
Survey Abandoned Building
Structural Condition Survey Report

3809-VED-XX-XX-REP-ST-001001

Date: 19/10/2023

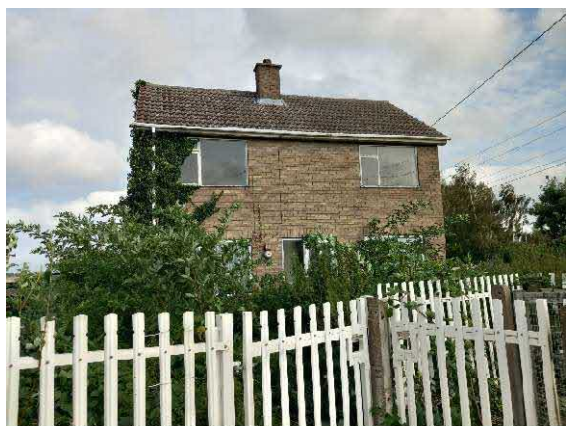
- 2.1.1 The existing detached residential property was observed to be of traditional masonry brick construction. The property has been derelict for some time. The existing building was constructed adjacent to the existing railway tracks. See photos 1, 2 and 3.

- 2.1.2 The existing roof tiles appeared in good condition with no visible deterioration or missing tiles. However, heavy vegetation growth was observed to the roof and 3 No. sides of the building. See photos 1, 2 and 3

Photograph 1: Front View of Building (1)

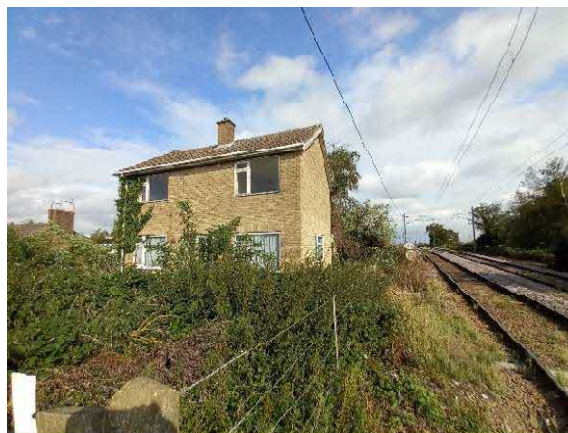
Photograph 2: Front and side View of Building (2)

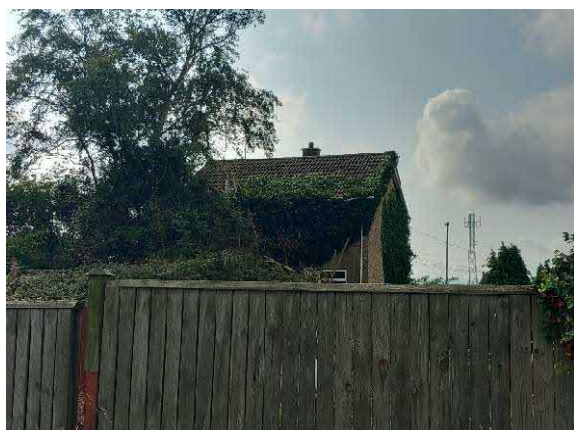
Photograph 3: Rear View of Building

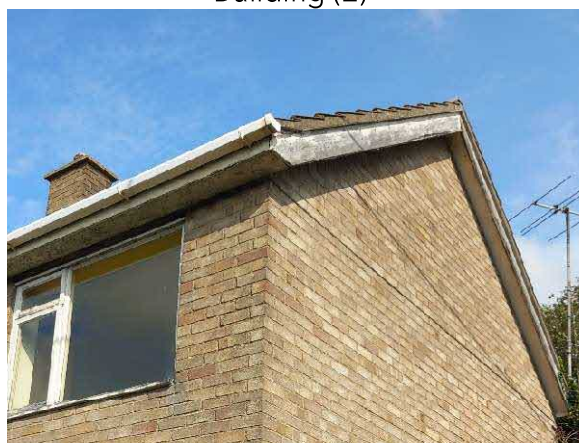
- 2.1.3 The fascia boards to the edge of the roof were observed to have multiple areas of section loss and signs of decay. See photos 4 & 5
- 2.1.4 The existing gutters were observed to be in poor condition and to be disconnected at areas of heavy vegetation growth. See photos 5 and 6.

- 2.1.6 The existing masonry external walls were observed to have minor frost damage. See photo 4.
- 2.1.7 Access to the outhouse to the rear of the property was not possible, due to heavy vegetation surrounding the outhouse. See photo 8.

Photograph 4: View of exterior roof timbers

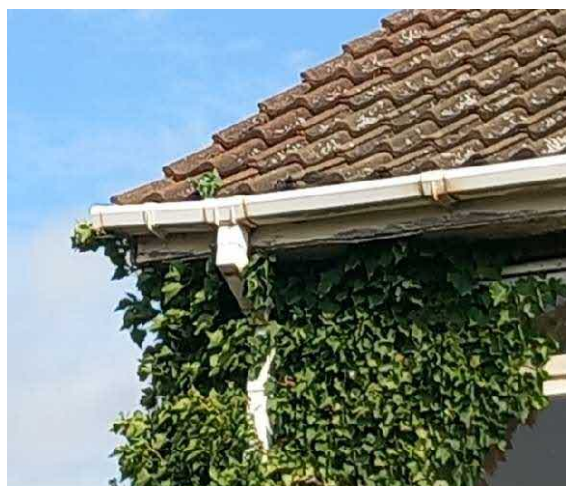
Photograph 5: View of front gutter and Exterior roof timbers

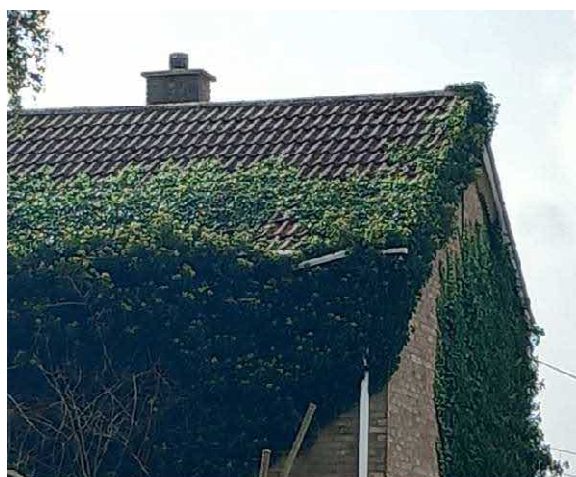
Photograph 6: View of rear gutter

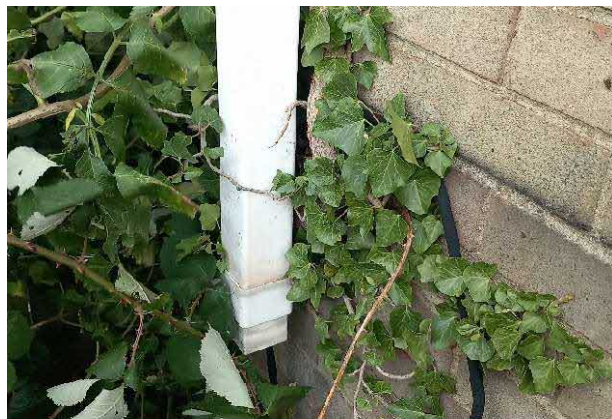
- 2.1.5 The existing downpipes were observed to be in poor condition. 1No. downpipe at the front of the property was observed to be disconnected at the base. See photo 7.

Photograph 7: View of disconnected front downpipe

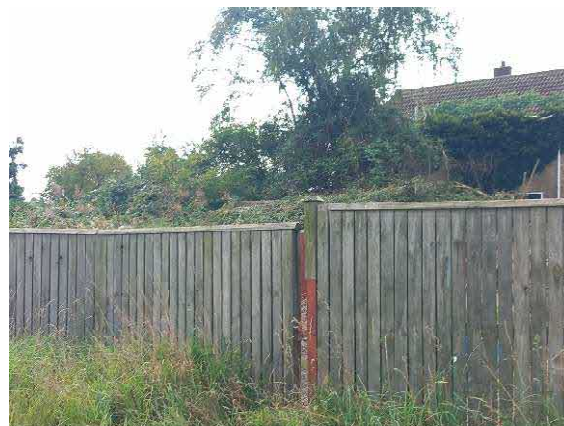
Photograph 8: View of the rear of the building and outhouse.

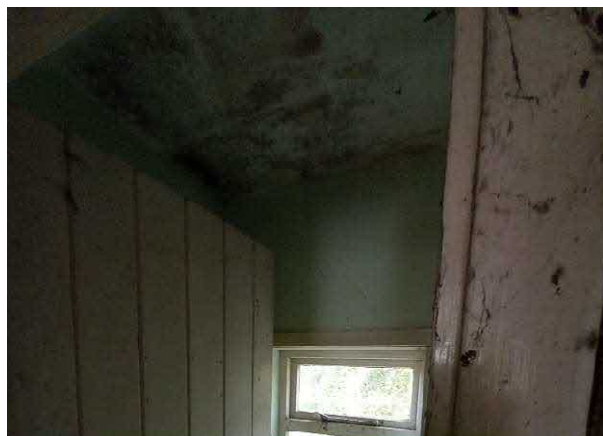
- 2.1.8 Damp and mould growth was observed to the internal ceilings and walls. See photos 9 and 10.
- 2.1.9 External vegetation growth was observed to have penetrated into the property through the gaps in the windows. See photos 11 and 12.
- 2.1.10 The timber roof construction was observed through an opening in the first floor ceiling. The roof timbers were observed to be in generally good condition with no signs of visible decay. See photos 13 & 14.
- 2.1.11 The internal floor construction was observed through an opening in the first floor. The floor construction was observed to comprise of timber floor boards supported by timber joists that are supported on the internal and external walls. See photos 15 and 16.
- 2.1.12 The existing internal ceiling and wall plasterboarding was observed to have large areas of cracking. See photos 17 and 18.

Photograph 9: View of mould growth in a small room of the building

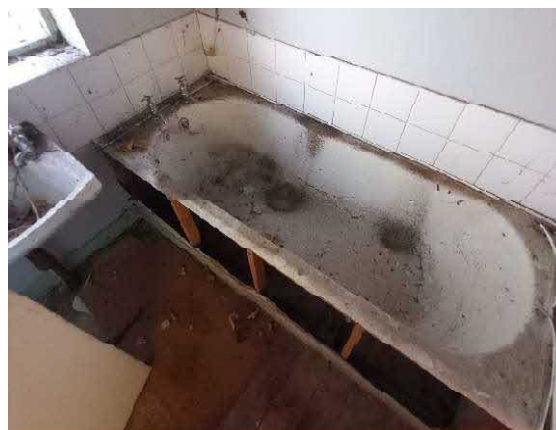
Photograph 10: View of mould growth in bathroom of the building

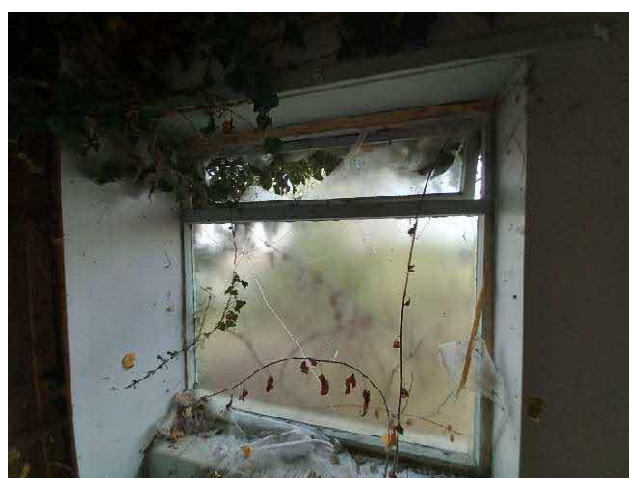
Photograph 11: View of vegetation inside the building (1)

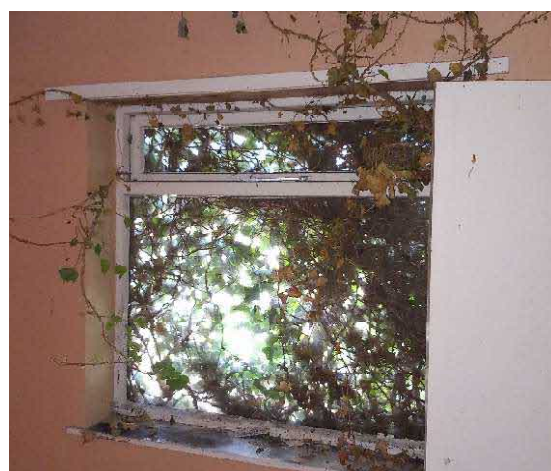
Photograph 12: View of vegetation inside the building (2)

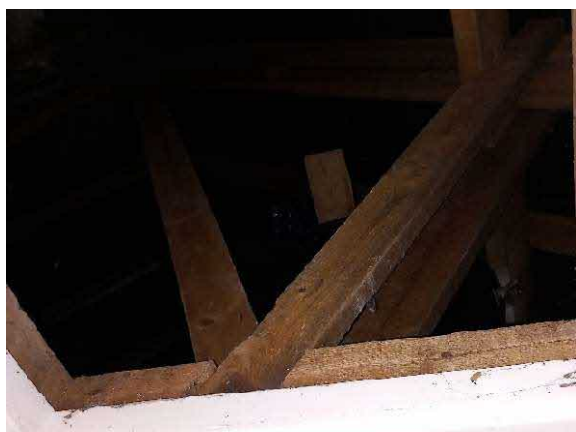
Photograph 13: View of the roof timbers (1)

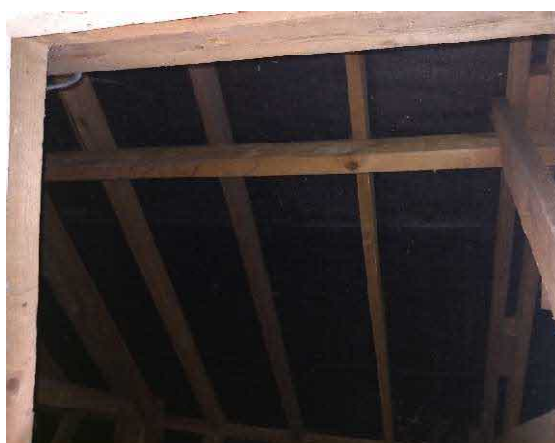
Photograph 14: View of the roof timbers (2)

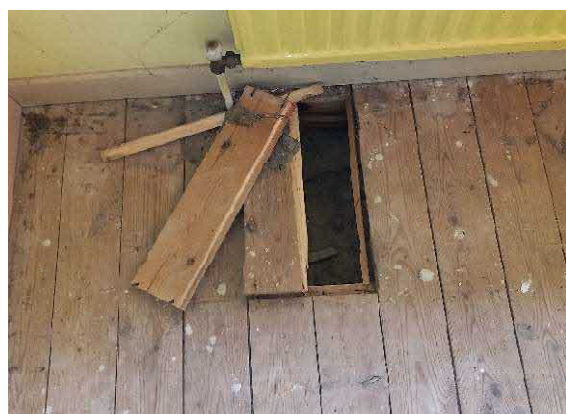
Photograph 15: View of timber flooring with broken floorboards

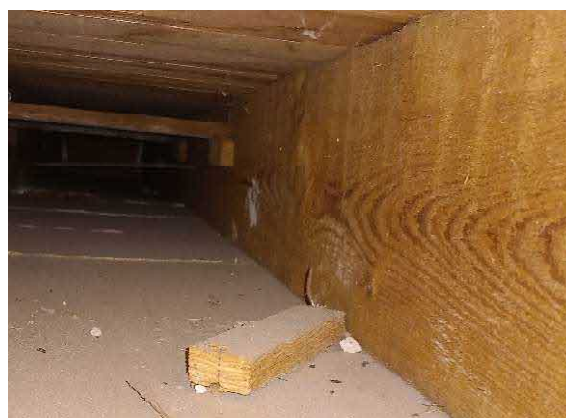
Photograph 16: View of timber joists supporting floorboards

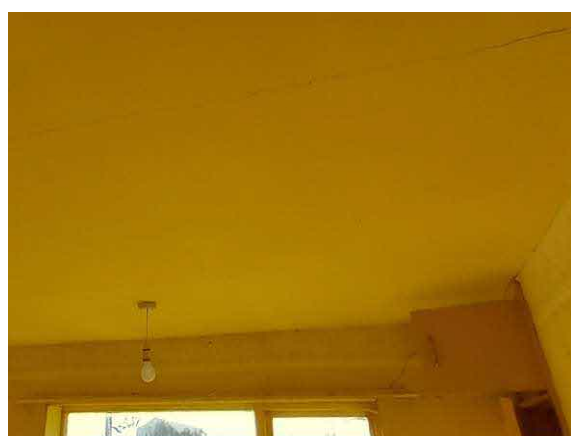
Photograph 17: View of cracking in the plasterboard (1)

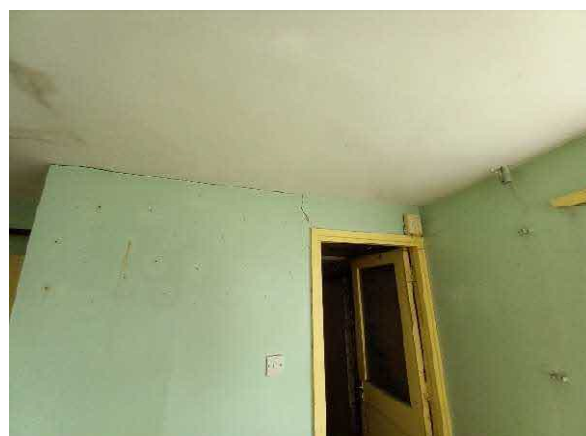
Photograph 18: View of cracking in the plasterboard (2)
