Tree survey report for proposed new house at Newlands Farm, Errogie, Inverness

Grid Ref. NH 56568, 22813

24 October 2023. (Amended 8 January 2024)

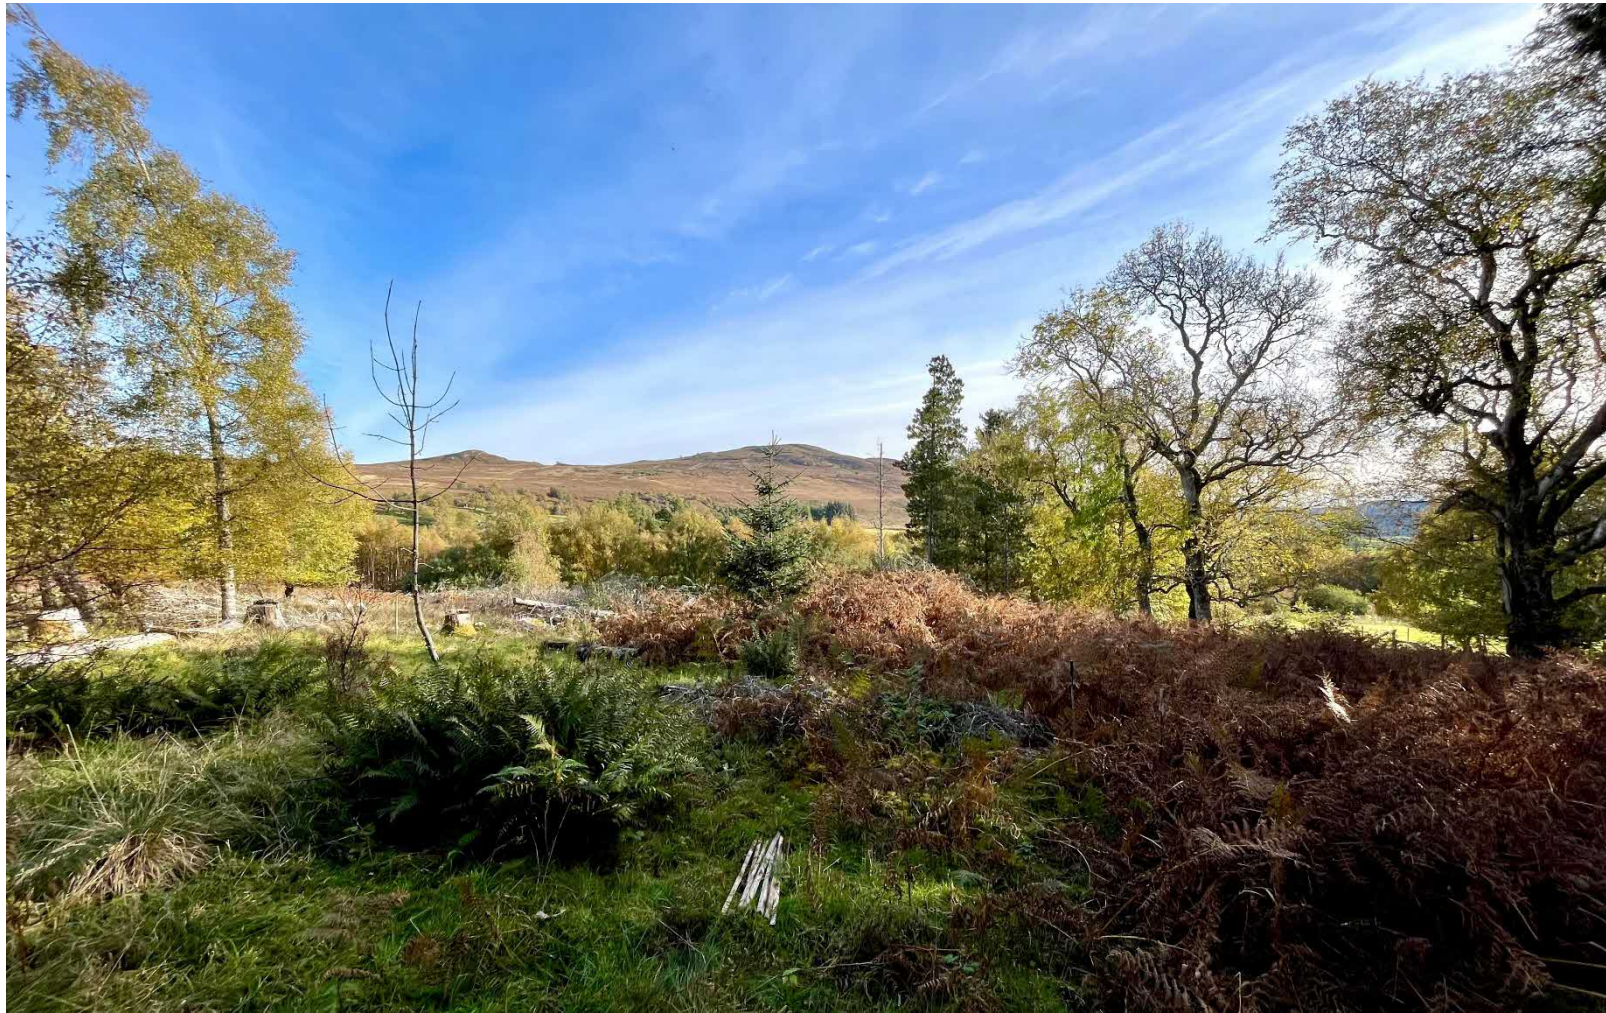
Proposed house site looking south-east with shelterbelt trees on right of photograph

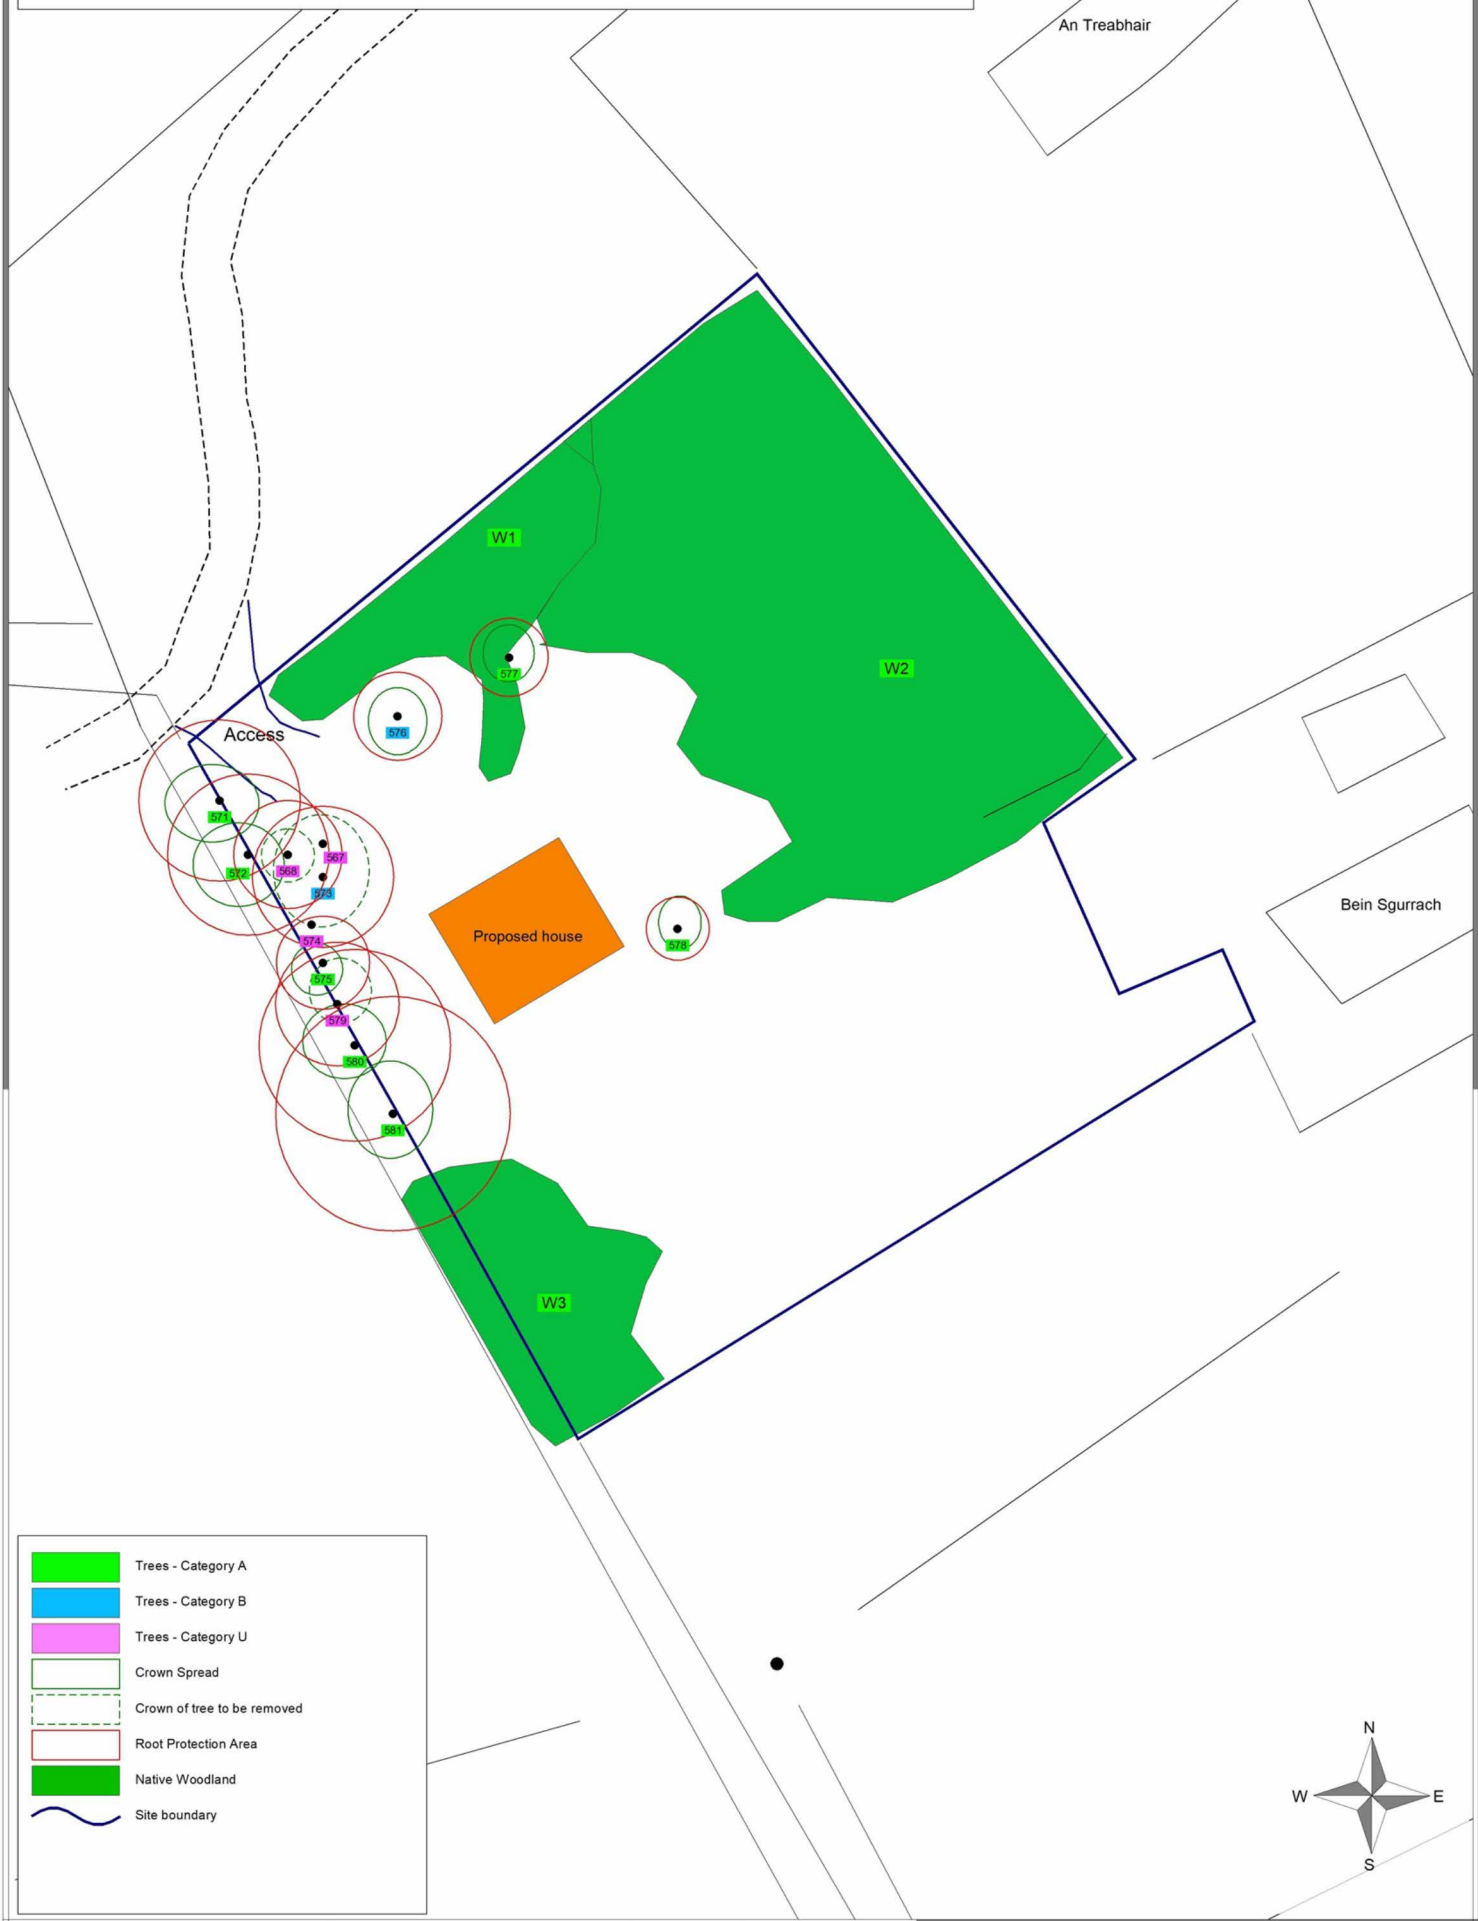
MAP 1 Tree Survey for Proposed New House at Newlands Farm, Errogie

The root protection areas around some of the measured trees (571, 572, 579, 580 & 581) on Map 1 are likely to be exaggerated on the east side because of the proximity of a ditch adjacent to the old dyke on which these trees are growing. The dyke forms the south-west boundary of the site and the ditch runs parallel to it along the north-east side. It is unlikely that tree roots will extend much beyond this ditch. Consequently, root protection barriers will probably not be required for these trees as the ditch itself will form a useful protective feature.

A total of 13 trees were measured of which five are recommended for removal. One of the latter trees has subsequently fallen during the storm. Two trees should be felled for safety reasons due to disease and/or risk of windthrow (568 & 579) and one felled to facilitate access to the site (573). A fourth tree (578) might also have to be removed if it is likely to interfere with construction works. The removal of the three (or four) trees will not impact on the landscape quality of either the shelterbelt or the broadleaved woodland areas. The owners have indicated that they would be planting hedges and native tree species elsewhere on the site and this would more than mitigate any losses due to the development. All other trees and woodland on the site are to be retained. The owners of the plot also own the land to the north, west and south and a large part of this land is upland birch and wet woodland planted under a Forestry Grant Scheme over twenty years ago. The house site is therefore largely screened on all sides by mature or regenerating native woodland.

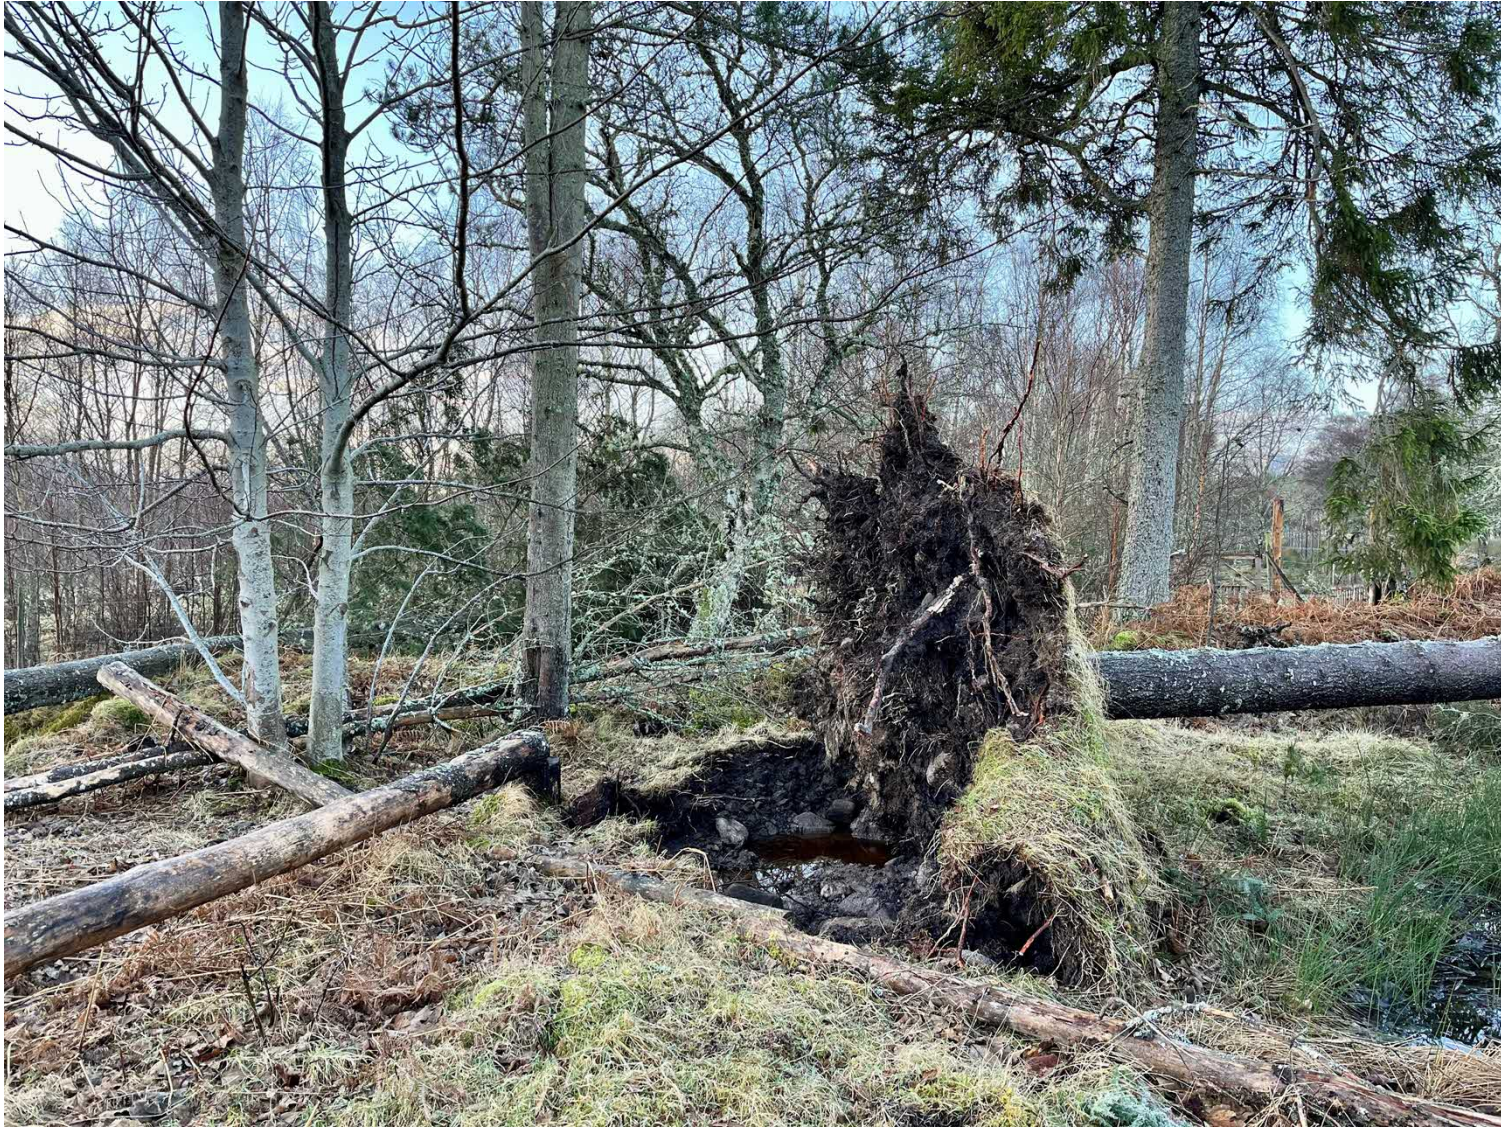
An assessment of the trees and woodland on a proposed new house plot was undertaken on 11th October 2023. The map and data table were subsequently amended following the loss by windthrow of two trees during storm Gerrit on 27th December 2023.

Rootplate of windblown Scots pine No. 567.
