REPAIR OF WOOD WINDOWS AND EXTERNAL DOOR

The Mill Cottages, Mill Lane, Empingham

Project reference ; JDA/2020/400

This document is part and parcel of a Condition Discharge application to Rutland County Council - Condition 3.

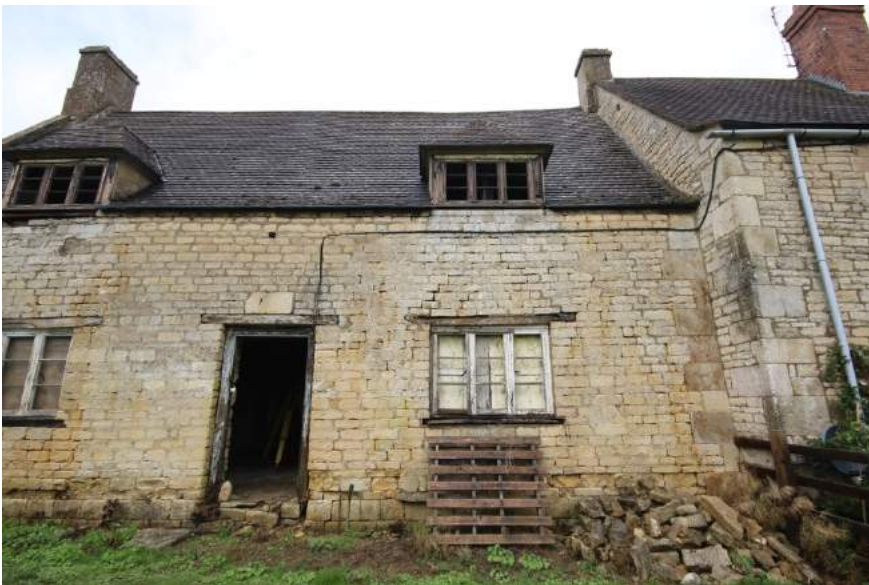
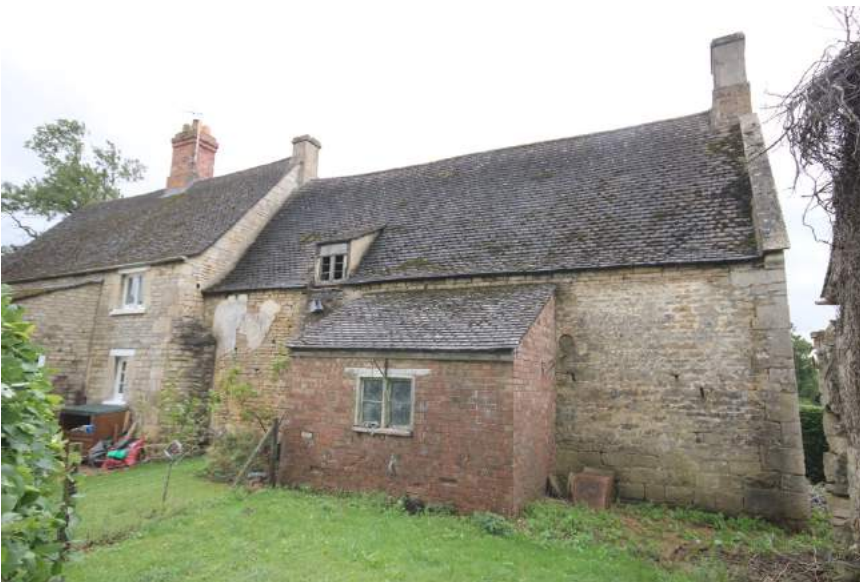
All of the windows and the plank front door serving the property were found to be in a poor condition and it is the purpose of this document to set out how said identified windows are to be restored.

* All windows are considered capable of repair and restoration (none or the original glass remains)
The front plank door is also considered capable of repair and restoration.

All restorative works to existing timber mullion/casement windows to be carried out in full accordance with the guidance set out in SPAB Technical Advice Note - Repair of Wood Windows.

***The same approach to the restoration of the front door in relation to timber entrance door will apply.**
