TREE SAFETY SURVEY

The Shire, St Ronan's Way, Innerleithen

March 2024

Prepared by Liam Dawson BSC (Hons)

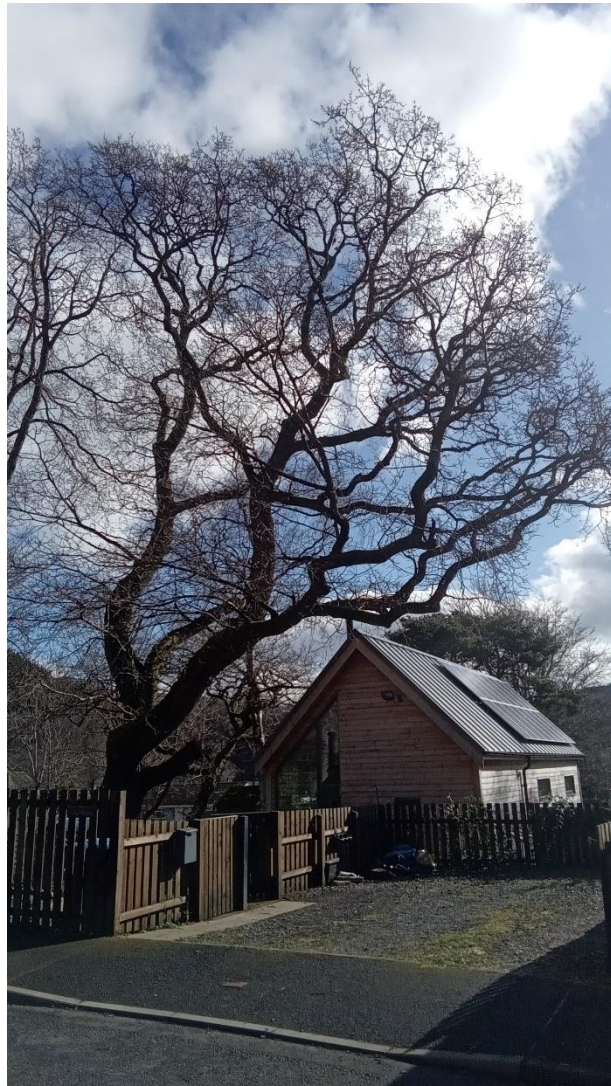
OAK (3712) IN SITU

Tag	Species	Height	DBH (cm)	Crown Spread (N)	Crown Spread (E)	Crown Spread (S)	Crown Spread (W)	Life Stage	Vigour	Targets	Condition	Survey Notes	Recommendations	Timescale	Life expectancy (years)	Inspect Period
3712	Pedunculate oak <i>(Quercus robur)</i>	23	82	3	6	10	4	Mature	Normal	Building Dwelling Road	Fair	Single stem tree growing in garden, adjacent to house, overhanging; fungal fruiting bodies from the Lycoperdaceae family found at base of stem; wire embedded in stem at 1.5m; major union at 3m where 2 co-dominant stems originate forming u-shaped union; pruning wound at base of stem to the south, 200mm in diameter with good reaction wood and limited decay of heartwood; limbs over house to east have been pruned back at 3, 7 & 10m, not to pruning points, leaving approximately 250-300mm diameter wounds, wounds not fully observable from ground level; limbs exhibit erratic epicormic growth on them; further pruning wounds at 11m on limb to south; relatively minor dead wood in upper canopy over decking and driveway	Aerial inspection of pruning wounds at 3, 7, 10, 11m; prune dead wood over targets	Moderate (6 Months)	5+	2 Years

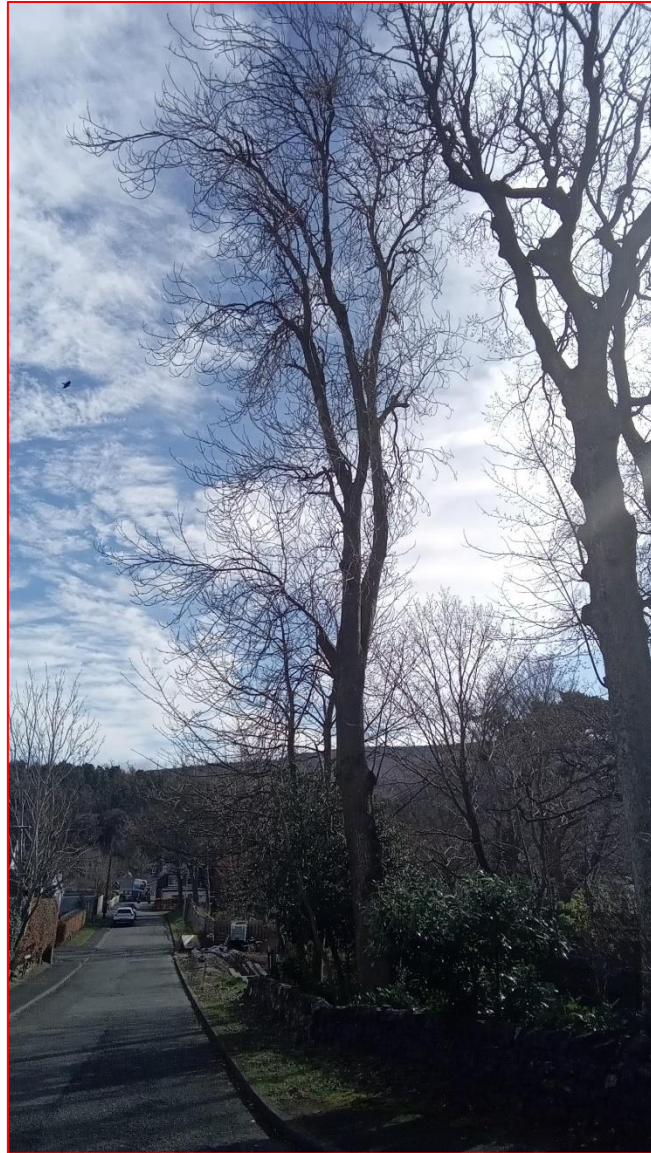
ASH (3715) IN SITU

An ash (3715) on your property boundary requires removal due to the presence of ash dieback and very significant structural defects.

Tag	Species	Height	DBH (cm)	Crown Spread (N)	Crown Spread (E)	Crown Spread (S)	Crown Spread (W)	Life Stage	Vigour	Targets	Condition	Survey Notes	Recommendations	Timescale	Life expectancy (years)	Inspect Period
3715	Common ash <i>(Fraxinus excelsior)</i>	25	66	5	7	4	6	Mature	Low	Dwelling Footpath Road Street lights Garden pod	Poor	Single stem tree growing on property boundary, adjacent to road, overhanging; wire embedded in stem at 1m; major union at 8m where 2 co-dominant stems originate forming u-shaped union; decaying pruning wound at 8m to north over road with regrowth exerting leverage; stem to south exhibits open cavity of approximately 400x120mm with associated hollowing of stem and dark exudate staining bark suggesting severe hollowing; moderately severe dieback symptoms in canopy with lesions on primary limbs and increased proportion of dead wood, erratic epicormic growth on scaffold limbs, many decaying broken stubs in canopy	Remove; remove broken, hanging limbs from adjacent sycamore 3m to east	High (3 months)	<2	Not Recorded

Tag	Species	Recommendation	Timescale
3715	Common ash (<i>Fraxinus excelsior</i>)	Remove; also remove broken, hanging limbs from adjacent sycamore 3m to east	High (3 months)
3721	Pedunculate oak (<i>Quercus robur</i>)	Use of decay detection equipment to determine structural integrity; prune dead wood in canopy; reduce limb over garden pod with decaying cavity to remove damage; monitor for decline	High (3 months)
3722	Silver birch (<i>Betula pendula</i>)	Remove	High (3 months)
3712	Pedunculate oak (<i>Quercus robur</i>)	Use of decay detection equipment to determine extent of dysfunction at base of stem; aerial inspection of pruning wounds at 3, 7, 10, 11m; prune dead wood over targets	Moderate (6 Months)
3713	English elm (<i>Ulmus procera</i>)	Prune dead wood in canopy	Moderate (6 Months)
3714	Sycamore (<i>Acer pseudoplatanus</i>)	Prune dead wood from canopy; aerial inspection of squirrel damage	Moderate (6 Months)

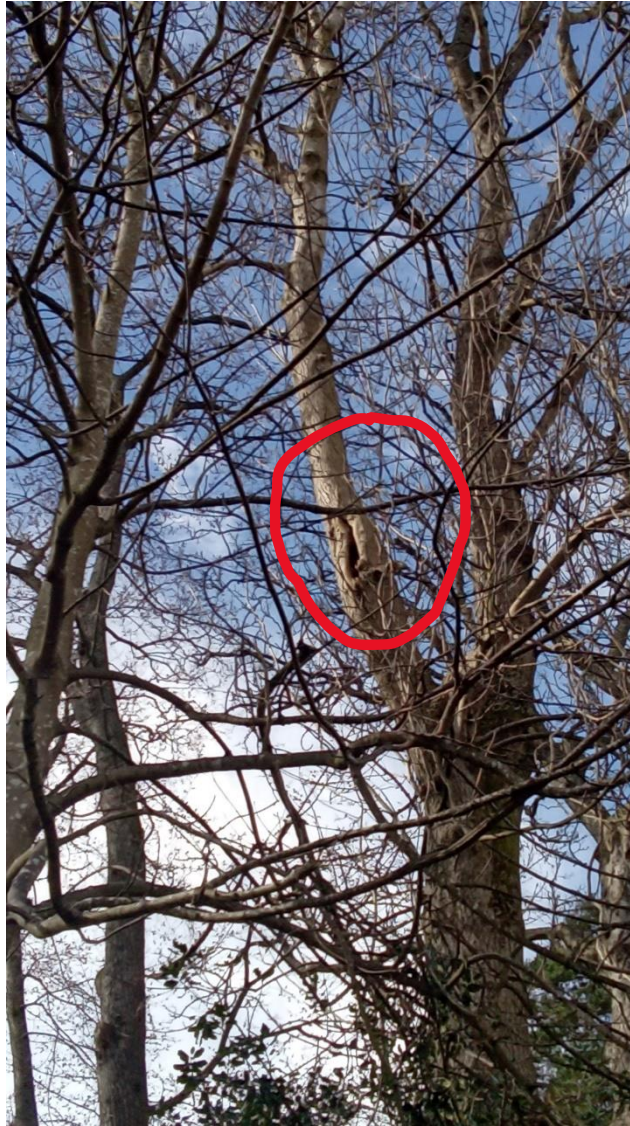
ASH (3715) DETAIL OF LARGE CAVITY IN CO-DOMINANT STEM

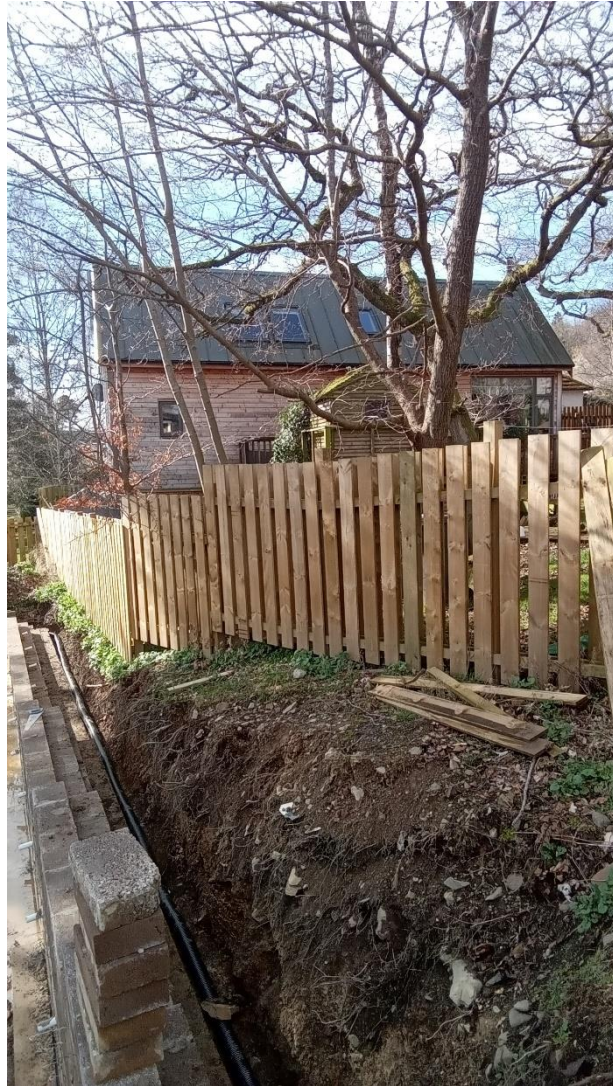
Several surveyed trees (3716, 3717, 3720) appear to have been affected by excavation for on-going development of the neighbouring property, with root protection areas being apparently disregarded and significant roots having been severed. This will necessitate the removal of the small sycamore and beech closest (3717, 3720) to the property line and will likely affect the elm (3716) in the longer term.

Tag	Species	Height	DBH (cm)	Crown Spread (N)	Crown Spread (E)	Crown Spread (S)	Crown Spread (W)	Life Stage	Vigour	Targets	Condition	Survey Notes	Recommendations	Timescale	Life expectancy (years)	Inspect Period
3716	English elm (<i>Ulmus procera</i>)	14	37	6	7	4	3	Early Mature	Normal	Garden pod Tree house Adjacent property	Poor	Single stem tree growing adjacent to property boundary, overhanging; adjacent property is currently being developed, with foundations dug and laid resulting in damage to rooting by excavation within 3m of stem, tree may not be viable long-term due to severe root zone interruption (root protection area should be 4.4m min.); relatively minor dead wood in canopy	Monitor; prune dead wood	Low (1 Year)	3+	2 Years
3717	Sycamore (<i>Acer pseudoplatanus</i>)	12	15	1	5	4	0	Semi Mature	Normal	Tree house Adjacent property	Poor	Double stem tree growing adjacent to property boundary, overhanging; adjacent property is currently being developed, with foundations dug and laid resulting in damage to rooting by excavation within 2m of stem, tree no longer viable beyond medium term due to severe root zone interruption (root protection area should be 1.7m min.)	Remove	Low (1 Year)	<3	Not Recorded

ELM (3716) DETAIL EXCAVATION IN ROOT ZONE

3716	English elm (<i>Ulmus procera</i>)	Monitor; prune dead wood	Low (1 Year)
3717	Sycamore (<i>Acer pseudoplatanus</i>)	Remove	Low (1 Year)
3720	Common beech (<i>Fagus sylvatica</i>)	Remove	Low (1 Year)

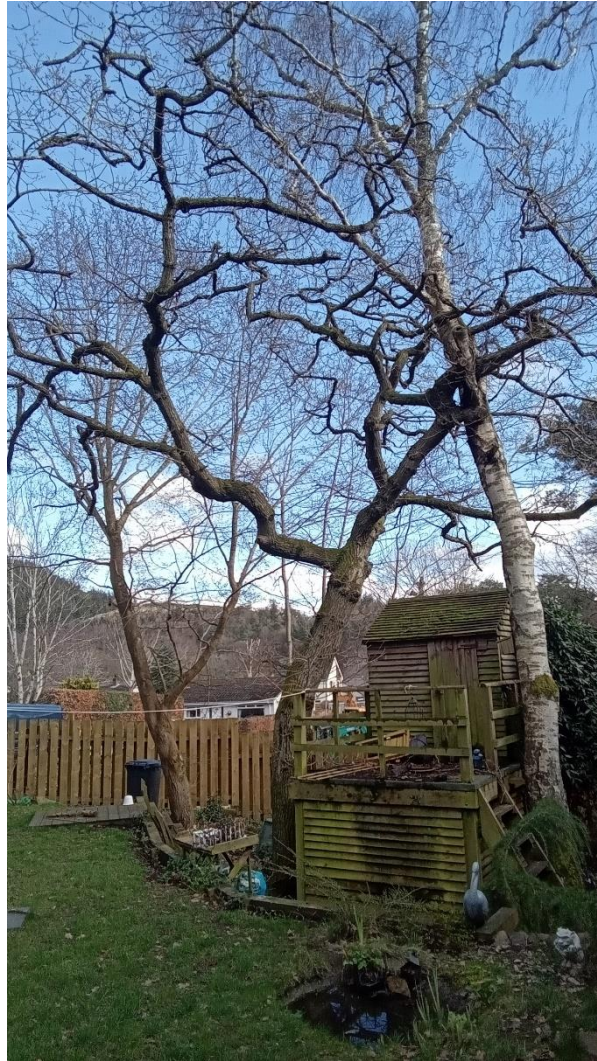
Two trees, an oak and a birch (3721, 3722) grow in some degree of entanglement adjacent to your house, over a tree house. Both are in a poor condition, with the birch apparently quite hollow and potentially partially propped-up by the oak. The birch exhibits low vitality, with poor branch elongation. The oak also exhibits low vitality, with a high proportion of dead wood in the canopy, also with apparent hollowness in the trunk.

**OAK (3721) AND BIRCH (3722) IN SITU, EXHIBITING DEGREE OF ENTANGLEMENT
AND POSSIBLE PROPPING-UP OF BIRCH**

In the case of oak (3721) the use of decay detection equipment to determine structural integrity of the main stem is recommended. There will of course be a cost involved in carrying out this procedure, however without determining the safety of the tree in this way we will struggle to recommend the retention of it.

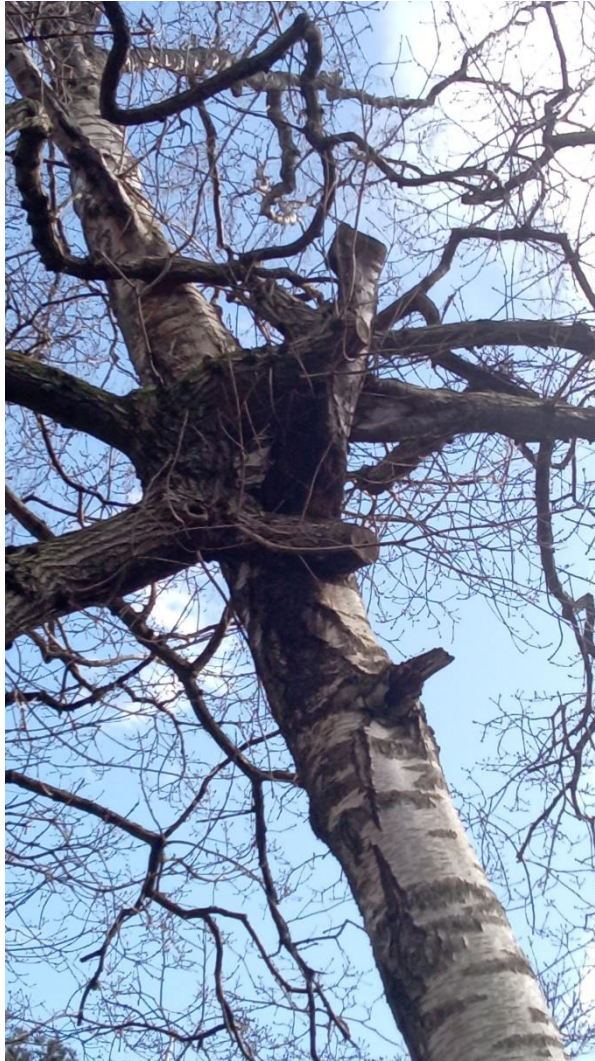
Tag	Species	Height	DBH (cm)	Crown Spread (N)	Crown Spread (E)	Crown Spread (S)	Crown Spread (W)	Life Stage	Vigour	Targets	Condition	Survey Notes	Recommendations	Timescale	Life expectancy (years)	Inspect Period
3722	Silver birch (<i>Betula pendula</i>)	17	40	6	5	3	3	Mature	Low	Building Dwelling Neighbouring property	Poor	Single stem tree growing adjacent to dwelling, leaning away, tree house over root zone; through-and-through rib in stem running east-west, apparent degree of hollowing of stem from ground level to 2m major limb to west at 10m pruned, leaving 600mm stub which supports a limb growing from an adjacent oak tree, severe rubbing and creaking noises in breeze, apparent decay and hollowing of stub with dark staining of stem below; upper canopy appears relatively sparse with reduced branch elongation	Remove	High (3 months)	<2	Not Recorded

BIRCH (3722) DETAIL OF OAK LIMB GROWING THROUGH, AND RUBBING ON DECAYING UNION
