CLIENT
OWNERS OF 74-76 HIGH ST,
DUNBAR

PROJECT
74-76 HIGH ST,
DUNBAR

DRAWING TITLE
EXISTING ELEVATIONS

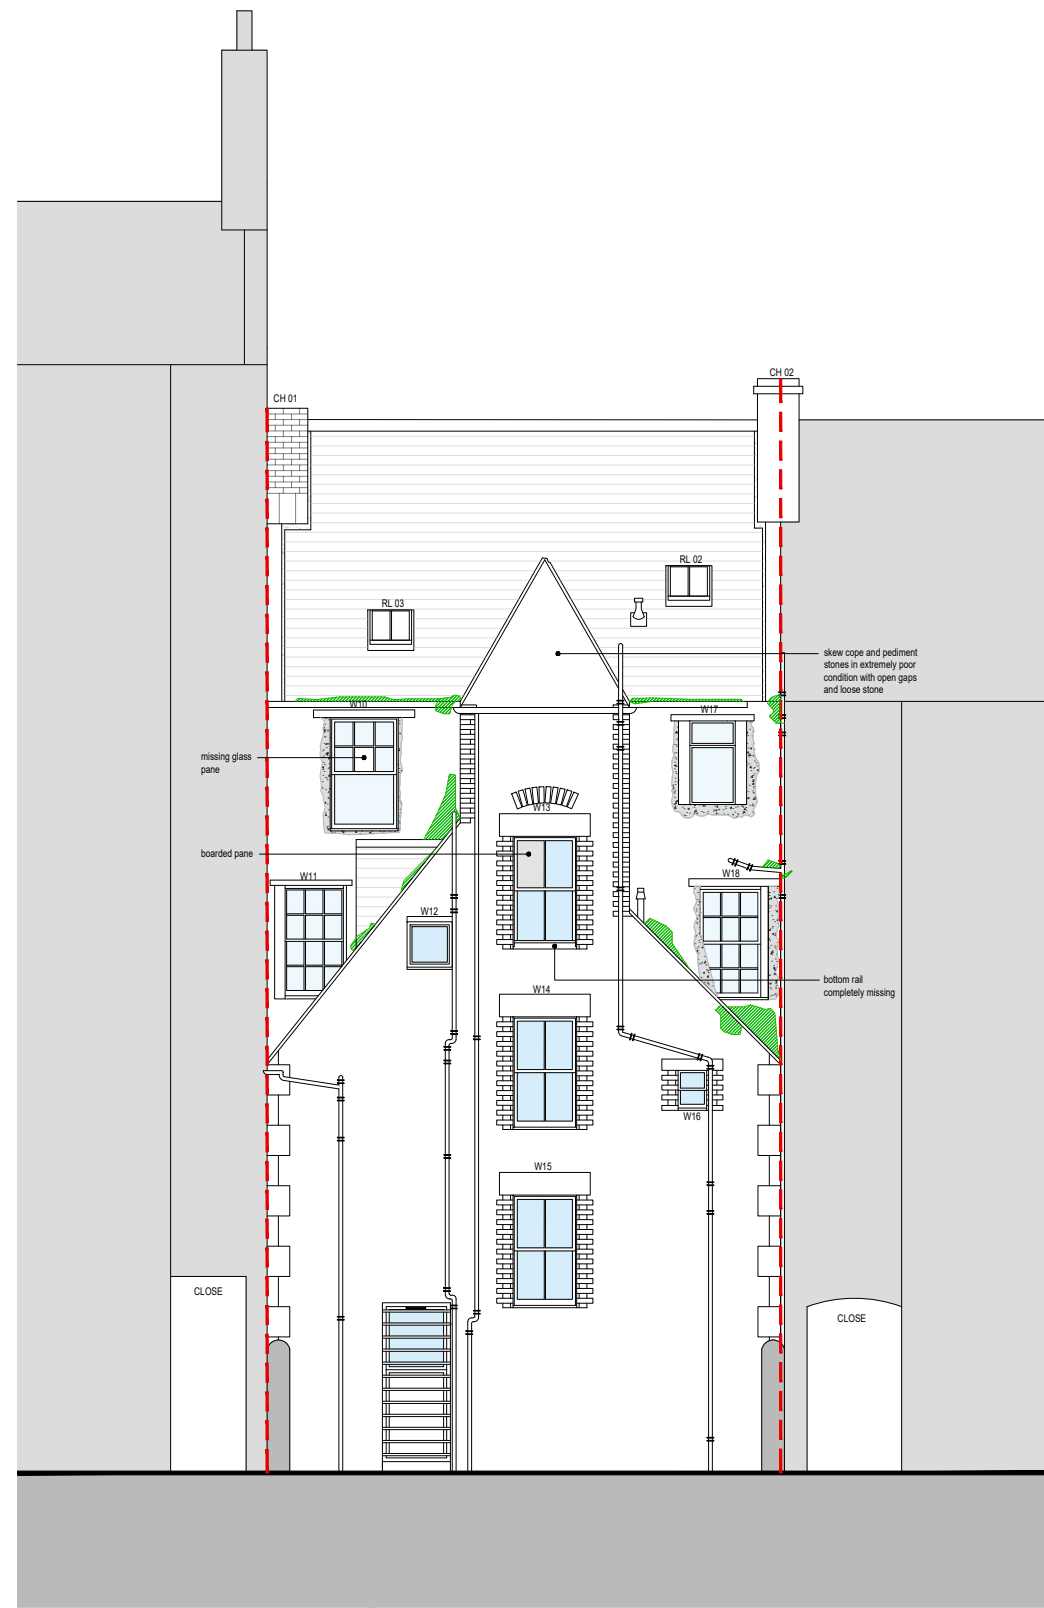
OVERALL REAR ELEVATION IS IN EXTREMELY POOR CONDITION WITH DELAMINATED STONEMWORK, LOOSE COPES, ROTTEN TIMBER WINDOWS AND EXPOSED ROTTEN TIMBER LINTOLS, MISSING AND CRACKED GLAZING, MISSING GUTTER RUNS, VEGETATION GROWTH, SLIPPED SLATES AND INADEQUATE CEMENT MORTAR REPAIRS. REFER TO PHOTO SHEETS FOR DETAILED EXISTING DEFECTS.
