**SUPPORTIVE STATEMENT**

To form part of a Planning & LBC Application

**74-76 High Street, Dunbar**

**APRIL 2024**

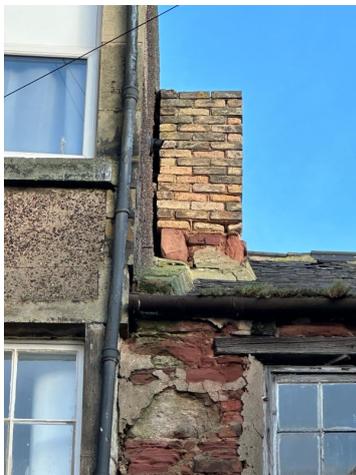
Due to ongoing recent water ingress problems, temporary repairs have been carried out by a roofer, the most recent carried out in December 2023. This was very much a temporary fix and as can be seen from this photograph of the rear there are a number of defects to the roof, chimney, gutter, windows and masonry areas that need immediate attention.

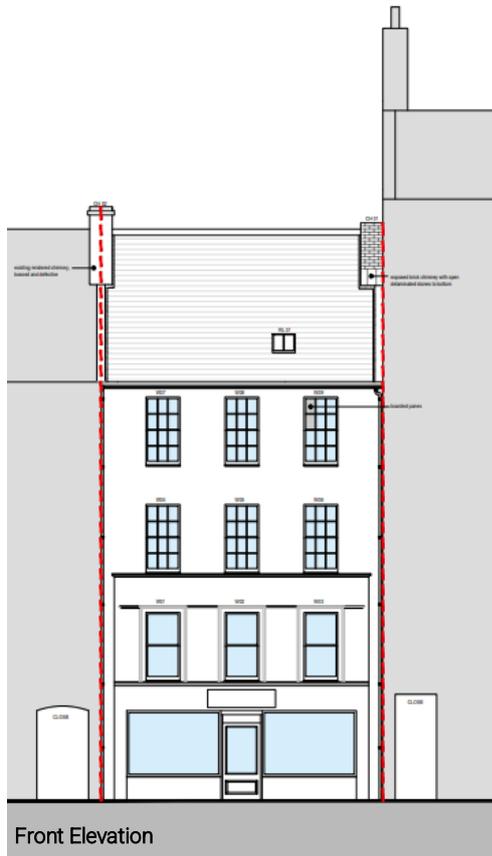
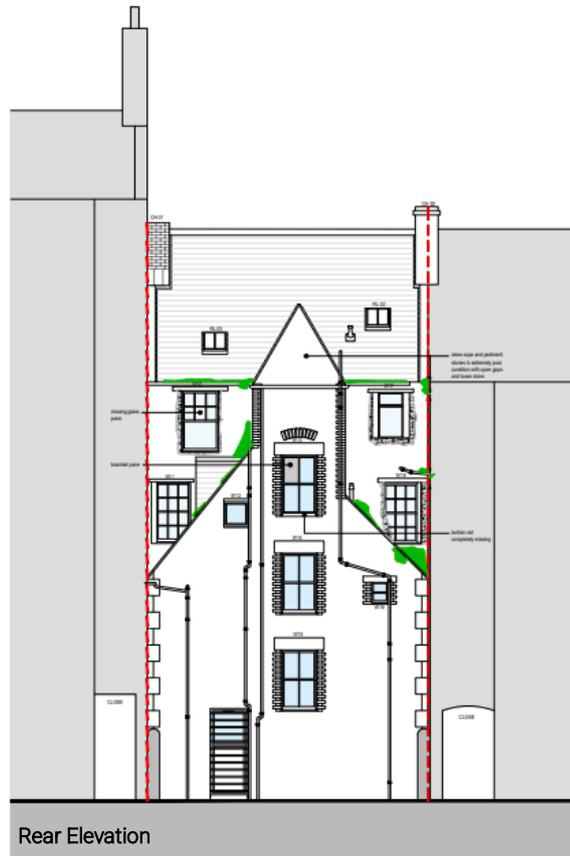
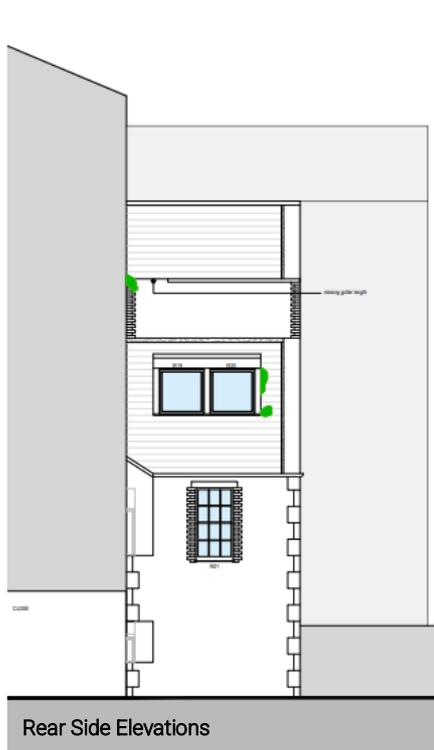
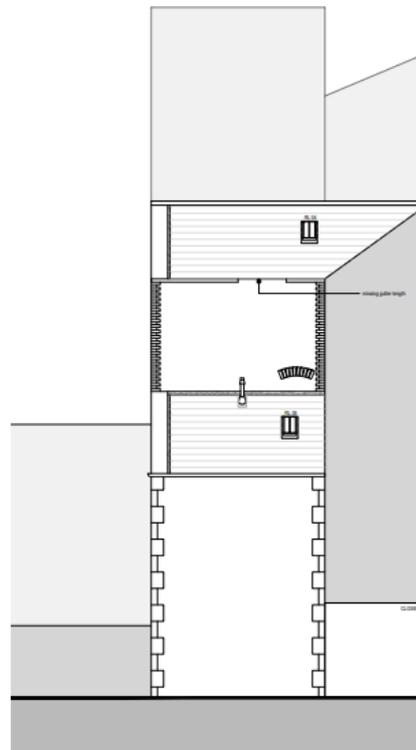
1.4 Existing Drawings (continued):

The elevations, shown above, shows the pediment to the rear elevation with two lower roofs to either side as well as a dormer to one side. The green areas on the drawings highlight the significant vegetation growing on the stone.

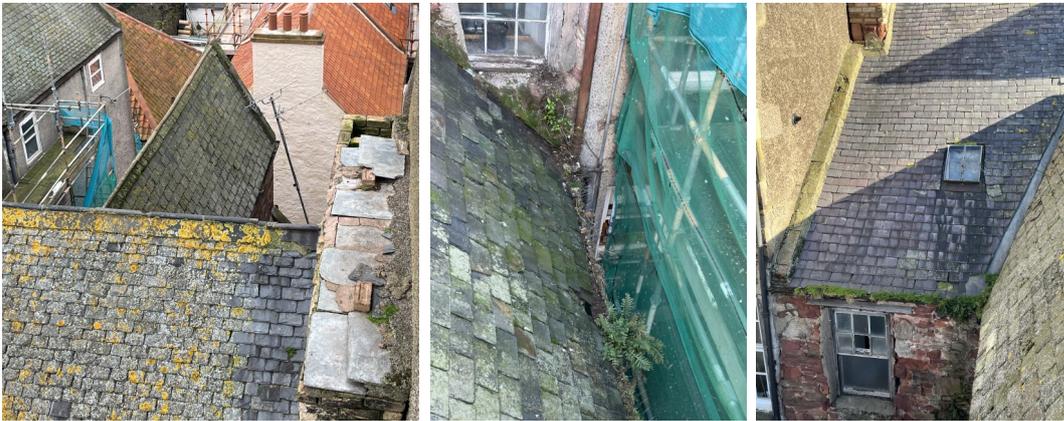
#### 2.1.1 Roof slated slopes & ridge tiles:

The slates to all roof slopes are in poor condition. They are thought to be a mixture of scotch and welsh (where a purple tint can be seen) and noted to be covered in moss, porous and likely nail sick. Due to the condition and size of these slates it is considered unlikely that many of them will be able to be saved and reused as the redressing of them will reduce their size further negating their use.

It should be noted that it is imperative that these slates are addressed. Over the future years more and more slates will fail damaging the integrity of the building and causing a real health and safety concern to passers by along with continued and ongoing water ingress.

- **Roof slated slops & Ridge tiles** to be renewed where possible and replaced on a like for like basis, however it is thought 100% replacement will be required. Ridge tiles to be reused and rebbeded if possible.

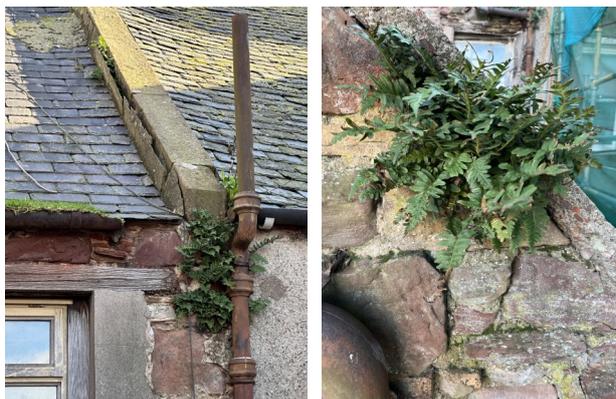
The ridge tiles are showing signs of being uneven due the deterioration of their bedding. During the strip and reslate exercise the tiles should be removed and reinstated with adequate bedding. Any defective tiles to be replaced on a like for like basis.

Skews throughout are noted to be cement and now failing to the point where they are falling away from the building. These are in extremely poor condition with large amounts of material cracked with vegetation growing.

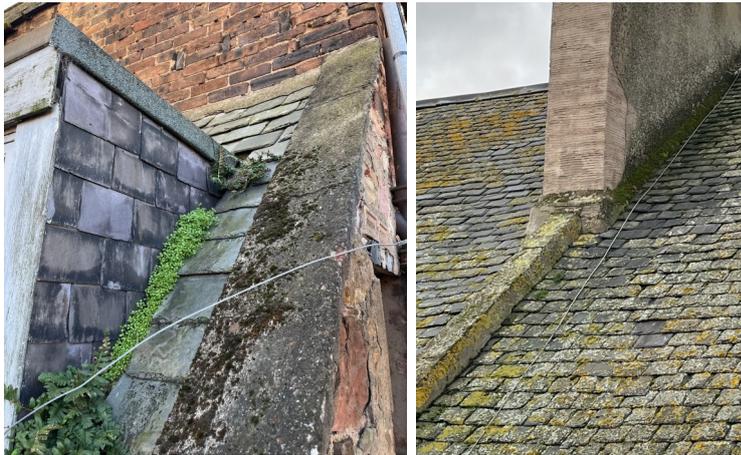
### 2.1.2 Skews & Skew copes (cont):

The stones to the existing skew copes are a mixture of stone to the front and concrete/aggregate to the rear main and lower slopes/pediment. The majority of skew copes to the rear are defective and beyond their life span.

- All **cement skewes & skew copes** to be replaced with replaced with lead soakers/Watergates as appropriate. Skew copes to rear to be replaced in stone, skewes copes to front to be taken back to sound, dowelled and pointed in appropriate lime based mortar.

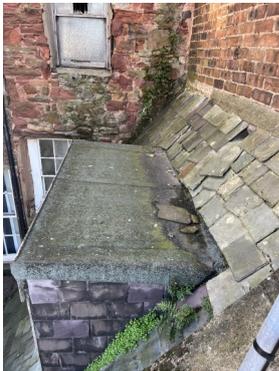
### 2.1.3 Flat roof:

The only area of flat roof is the roof of the dormer to the rear. This is in poor condition and beyond its lifespan.

- As mentioned above the **flat roof** is beyond its lifespans and it is propose to be stripped and renewed.
- It is proposed that area of inappropriate haunching and joints to be removed and replace with more appropriate **lead flashings** and cover flashings. There is minimal leadwork noted on the building however it is proposed this to be replaced with new as it is beyond it's lifespan

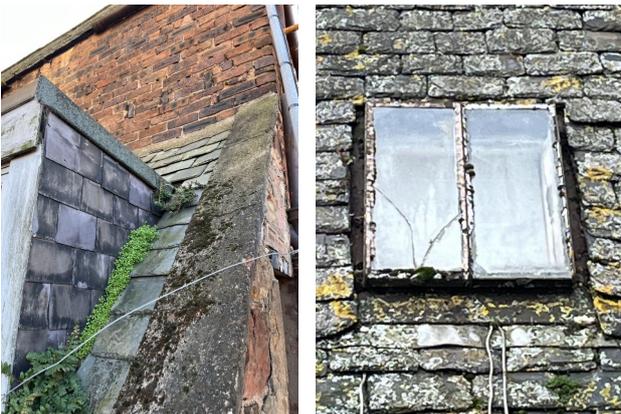
### 2.1.4 Lead flashings/valleys:

For a building of this nature with a number of different junctions it has surprisingly little lead! The only lead flashings are noted around the rooflights and to the watergates of the rear dormer (which as can be seen are covered in vegetation). The roof as noted has significant defective areas that would benefit from the addition of lead such as the replacement of skews with lead soakers/watergates (as discussed above) and the junctions where the lower slopes meet the upper pediment. Here a cement skew has been used and the necessity for a lead cover flashing would negate ongoing water ingress issues along this junction. In essence too much cement and not enough lead has now become detrimental to this building.

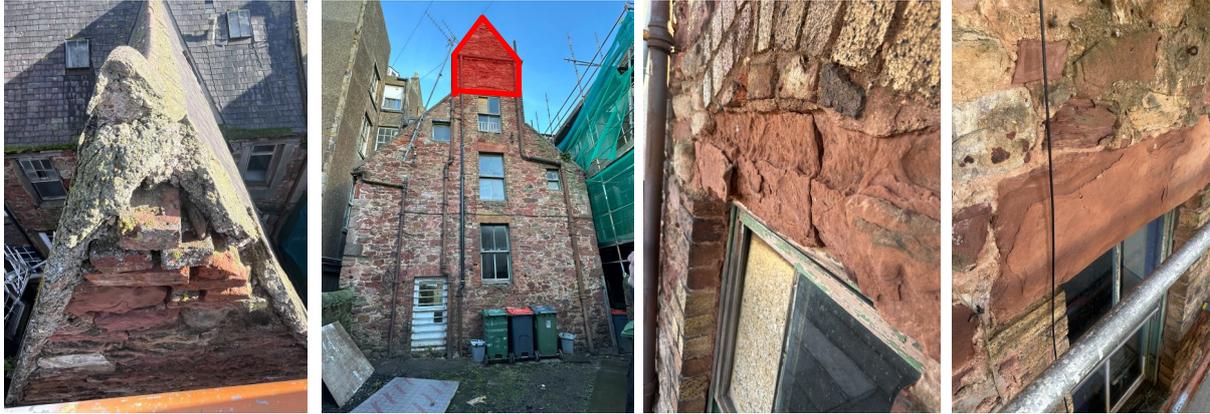
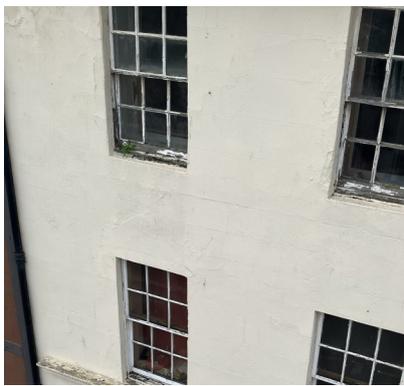
### 2.1.5 Elevations (cont):

The rear elevation is a mixture of exposed brick and red sandstone in general the exposed stonework is in an extremely poor and failing condition. As a Conservation Architect I have rarely seen a rear elevation in such a detrimental condition. The brickwork is also failing and there are notable open areas where the stone has deteriorated so significantly that it no longer exists. Previous cills have now deteriorated and fallen away and a number of inappropriate repairs have been carried out over the years, all of which are now beyond repair.

To the rear sandstone is noted to quoin, lintols and cills (although many have deteriorated away) and the overall elevation is made up with a mixture of rubble and red brick. It has already been highlighted that the top rear pediment (LHS photo) is in a dangerous and failing condition with its brickwork, rubble and skew cope having deteriorated and fallen away in areas. It is recommended that the external face of the rear pediment be taken down to window lintol level and rebuilt/stabilised in brick with new stone skew copes as part of an urgent Health and Safety requirement. Due to the condition of this elevation the possibility of repairing its fabric on a like for like basis has passed due to the severe state of the fabric. However works could be carried out with brick infill and lime based render including exposed cills, lintols, quoins and skew copes.

- The **elevations**, especially the **rear elevation**, are in extremely poor condition. To the rear it is proposed the pediment to be taken down to top window lintol level in its entirety and rebuilt due to the health and safety concern of falling and deteriorating fabric. Window cills and lintols to be replaced in stone. Once rebuilt rear elevation is proposed to be rendered in lime based render, enabling cills, lintols and quoins to be exposed. To the front any repairs to the render should be made good and it is proposed this elevation be repainted.

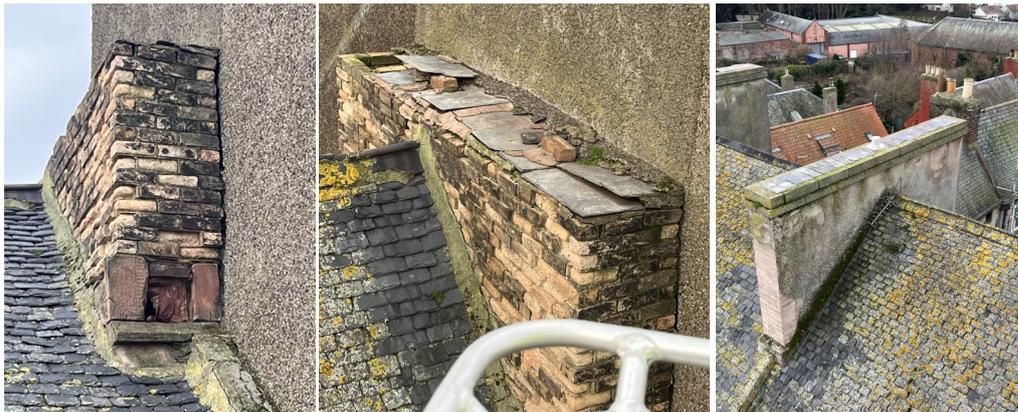
### 2.1.6 Chimneys:

There are 2no chimneys to the property, one is mutual with no. 64 and one is a dwarf chimney sitting within the edge of the roof abutting the neighboring property on the other side. Both chimneys have lost their pots and the dwarf chimney has completely lost its cope, open areas have been patch repaired with slates to stop ongoing water ingress issues.

The mutual chimney has existing render which is falling off in chunks and although there is a cope, there are no longer any pots. The gaps where the pots would have been have been covered with slate to prevent water ingress down the flues. With regards to the dwarf chimney, the brickwork is beyond repair and there is a small area of defective red sandstone with apparent holes and deterioration.

- It is proposed that the mutual **chimneys**, shared between property no 64 & 66, to be re-rendered like for like with existing with new chimney pots and associated haunching. Dwarf chimney is proposed to be taken down due to its deterioration and rebuilt using brick to be same dimensions. There is currently no cope to this chimney and to better the situation it is proposed that a concrete drip edge cope should be instated to the top of this chimney along with associated pots and haunching.

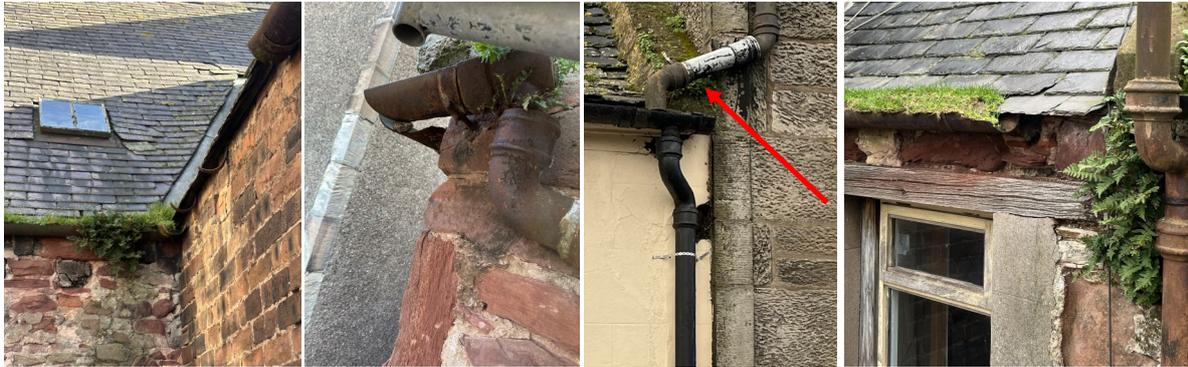
Rainwater goods are noted to be in a deteriorated condition, and missing in many areas causing considerable damage to the surrounding fabric. Guttering that is in place is covered and blocked with foliage and overgrowth.

It is noted that the adjacent buildings rain water is also being taken by no 76 as their downpipe has been routed into the gutter of no. 76 as shown above. In general a full overhaul of the cast iron goods is now required. It is likely there will be damage behind the rhones due to ongoing water saturation. The downpipes are noted to be cast iron and it is recommended they received an overhaul with defective sections replaced as required. All cast iron goods to receive decoration.

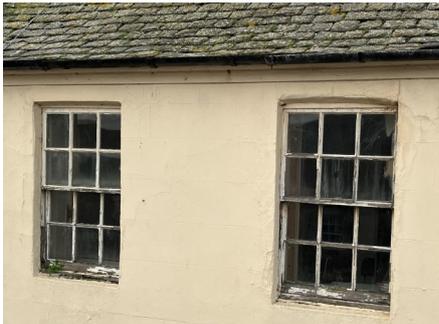
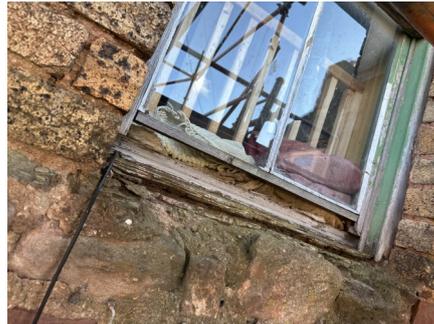
### 2.1.8 Windows:

In lines with the general condition of the block, the windows throughout are in a poor and failing condition. Mostly are noted to be in a poor condition with minimum maintenance carried out to them over the years.

- It is proposed that 6no. of **windows** be replaced on the front elevation with the remaining 3 no. to be overhauled/retained. To the rear elevation it is proposed 12 no. windows to be replaced with new. All window to be replaced like for like.

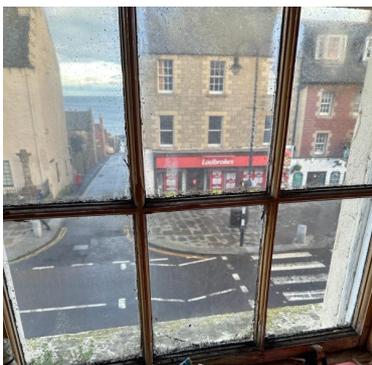
All are single glazed, timbers are noted to be rotten internally and externally. Large sections of timbers have fallen away and paint is peeling away to the majority.

It should be noted that the windows to the rear are in the worst condition and all of these now require to be replaced on a like for like basis. To the front there are 3 windows at first floor level that have been replaced and require a minor overhaul. However the sash and case 6 over 6 windows to the second and third floor are in a poor and failing condition and now need completely replaced.
