W4-W9 - TYPICAL EXISTING EXTERNAL WINDOW ELEVATION  
scale 1:10

**EXISTING WINDOW CONDITION NOTES:**

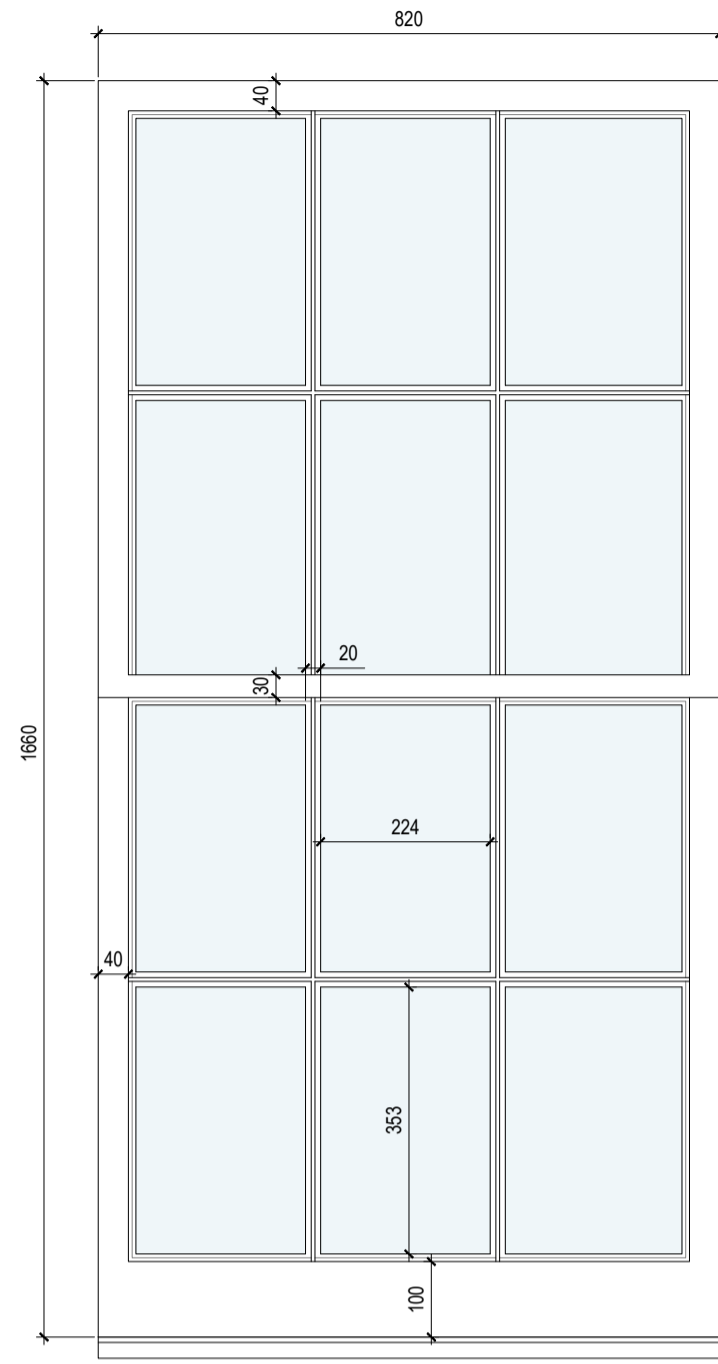
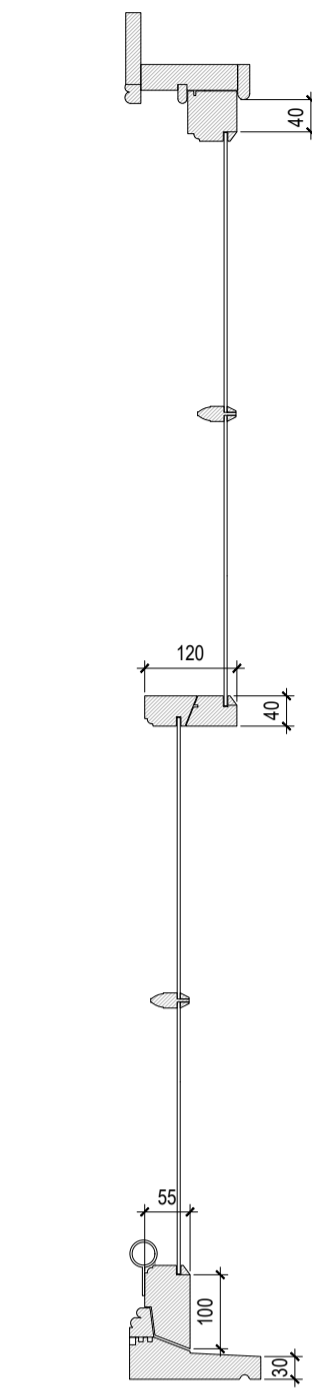
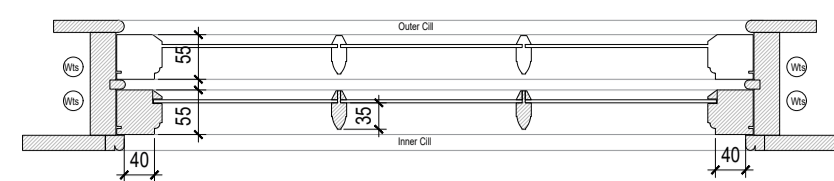
Front windows are in poor condition. Timbers are rotten beyond repair, gaps are evident throughout all windows causing major draught and water ingress problems.

6 over 6 configuration, evidence of crown glazing, as shown, suggests window arrangements are as per the original design, although timber integrity is noted not to withstand repair or refurbishment for re use of glazing. 2no. panes to front elevation W09 are noted to be boarded up.

All front windows are identical in dimension and profile. Astragals appear to be original in profile and dimension.

Front elevation Single Glazed timber framed sash and case windows, W4-W9, to be removed and replaced as follows:

- Existing window timbers are in poor condition. All timber windows have rotten/defective timber sections for all elements of the window as demonstrated in Supporting Statement.
- W4-W9 Single Glazed existing timber sash and case windows to be replaced with new hardwood timber framed sash and case windows on a like for like basis.
- New 6 over 6 window layout, astragals to match existing astragal profiles.
- New single glazed safety glass to be fitted into new windows.
- Windows to be fitted with new waxed cotton ropes and weight distribution to all windows to be checked to ensure ease of opening.
- Schlegel draught seals to be rebated into new window sashes, top/bottom. Polyflex draughts seals rebated into sides of sashes. Draught brush to be rebated into mid transom.
- New sash weights to be balanced along with install of new pulley wheels to allow for ease of opening.

- New windows to be painted in white gloss to match existing. External and internal of window, to be primed with 2no coated of Acrylic water based undercoat and finished with 1no coat of brilliant white gloss paint.
- Window pane putty to be replaced on a like for like basis allowing 28 days to fully cure prior to being painted white to match existing, painting of putty should be carried out soonest after 28 days curing period to minimise the putty becoming brittle.
- Existing, failing exterior sand mastic to be removed and joints re pointed with lime mortar.

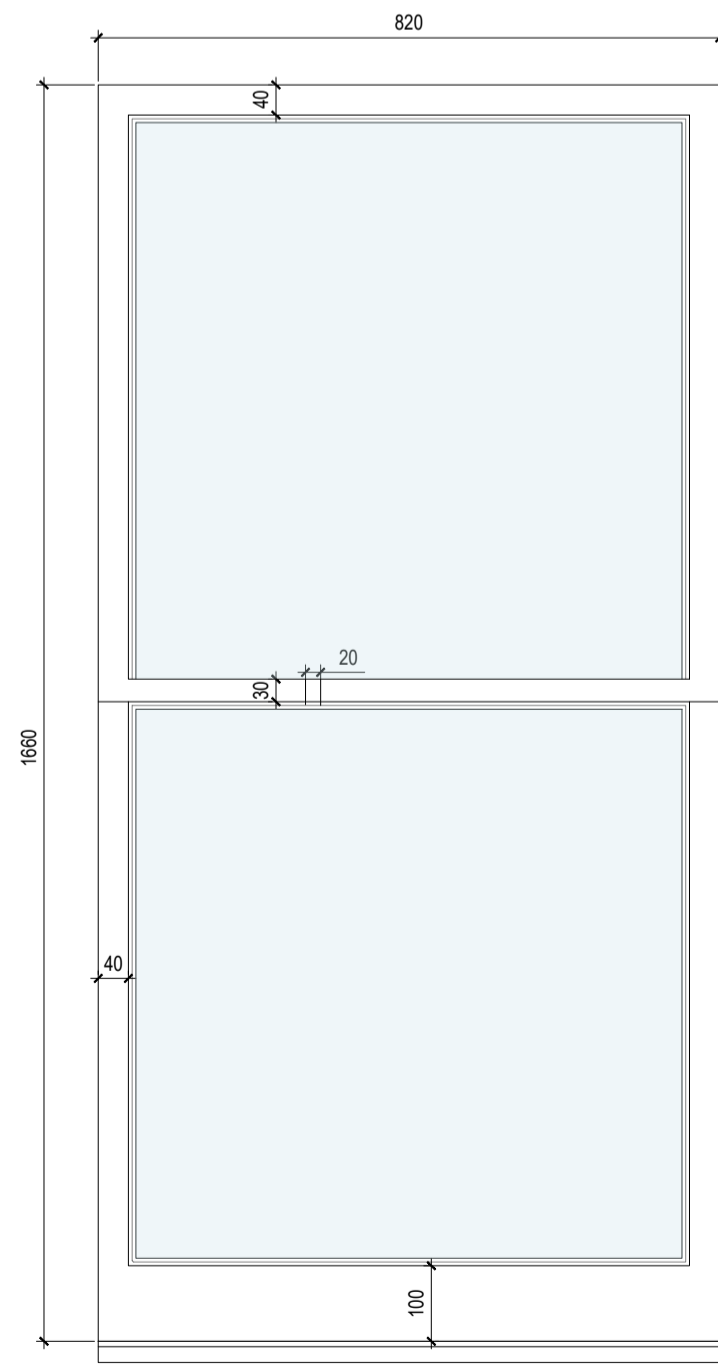
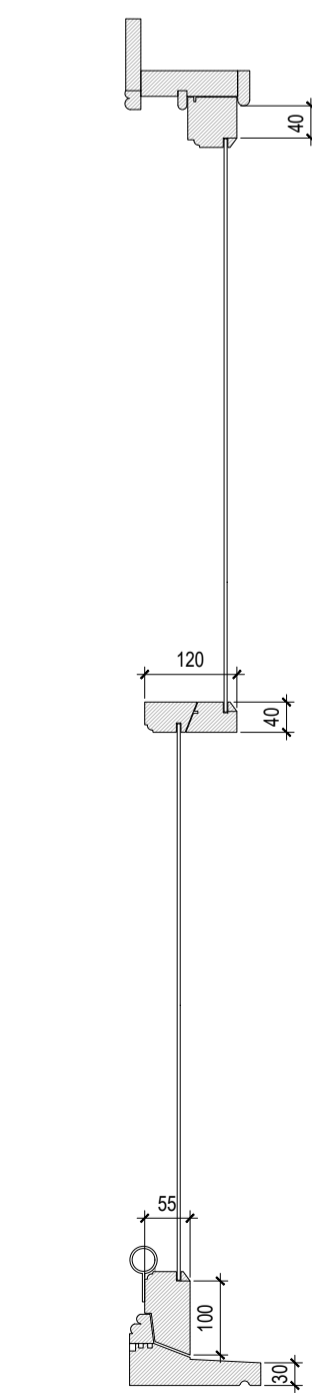
W1-W3 - TYPICAL EXISTING EXTERNAL WINDOW ELEVATION  
scale 1:10

Sashes are not in full working condition and cannot open, pulleys, ropes and weights require immediate replacement to allow ease of opening. No evidence of existing draught brushes installed to face of inner frame, bottom rail and mid transom have gaps and as a result the windows are very draughty.

All front windows are identical in dimension and profile. Astragals appear to be original in profile and dimension.

Front Elevation W1-W3 to undergo full refurbishment as follows:

- Generally all existing window timbers are in good condition. Replace all existing defective ropes with new waxed cotton ropes and check weight distribution to both windows to ensure ease of opening. Existing defective top sash rope pulls to be replaced and reinstated
- Schlegel draught seals to be rebated into existing window sashes, top/bottom. Polyflex draughts seals rebated into sides of sashes. Draught brush to be rebated into mid transom.
- Existing sash weights to be adjusted and re balanced along with install of new pulley wheels to allow for ease of opening.

- Removal of existing defective and heavily coated paint internally and externally with full dip and strip of existing windows.
- Windows to be painted in white gloss to match existing. External and internal of window, to be primed with 2no coated of Acrylic water based undercoat and finished with 1no coat of brilliant white gloss paint.
- Window pane putty to be replaced on a like for like basis allowing 28 days to fully cure prior to being painted white to match existing, painting of putty should be carried out soonest after 28 days curing period to minimise the putty becoming brittle.
- Existing, failing exterior sand mastic to be removed and joints re pointed with lime mortar.
