REAR ELEVATION - TYPICAL EXISTING SASH & CASE EXTERNAL WINDOW ELEVATION  
scale 1:10

**EXISTING WINDOW CONDITION NOTES:**

**PROPOSED WINDOW SCOPE:**

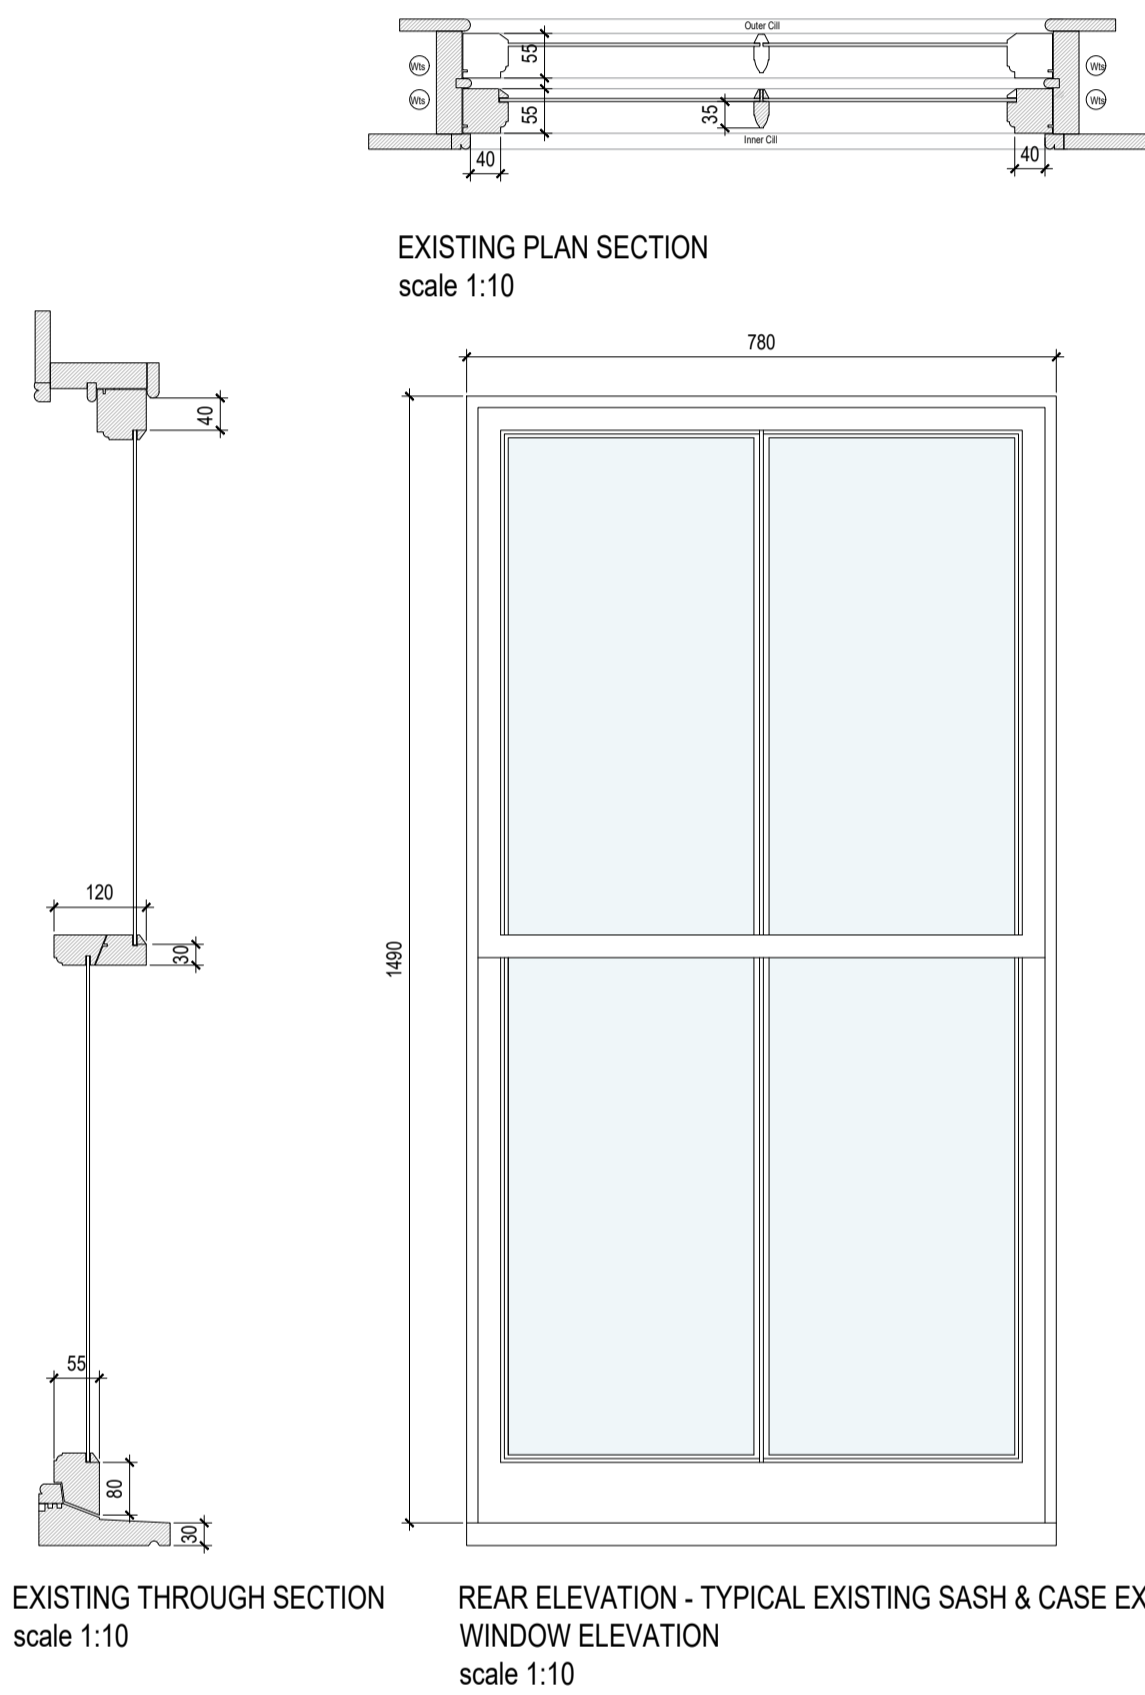
All rear windows are in extremely bad condition. Timbers are rotten beyond repair, cracked glazing, missing glazing and gaps are evident throughout all windows causing major draught and water ingress problems. Windows are so badly deteriorated that some have bottom rails completely missing leaving interior completely open to the elements. Should also be noted that exposed timber lintels to rear window elevations are rotten beyond repair and require to be replaced.

Windows have a varied configuration arrangement; 3no. 2 over 2, 2no. 6 over 6, 1no. 1 over 1, 1no. 6 over 1, 1no. top hopper over fixed pane, 1no. fixed pane.

Majority of windows are assumed to be as per the original design, although timber integrity is noted not to withstand repair or refurbishment for re use of glazing.

W10, W16, W19 & W20 are assumed to be non original and have been previously altered or added (dormer tilt and turn)

Glazing Type: Single Glazing  
GLASS MAKE UP: 6-7mm
