Beech ARCHITECTS
 Church Farm Barn
 The Street
 Thornston
 Suffolk
 IP23 7JR
 www.beecharchitects.com
 enquiries@beecharchitects.com
 t 01379 678442

PROJECT
 Yew Tree Farm
 Ward Green
 Old Newton
 IP14 4EZ

DRAWING
 South end of farmhouse showing repairs

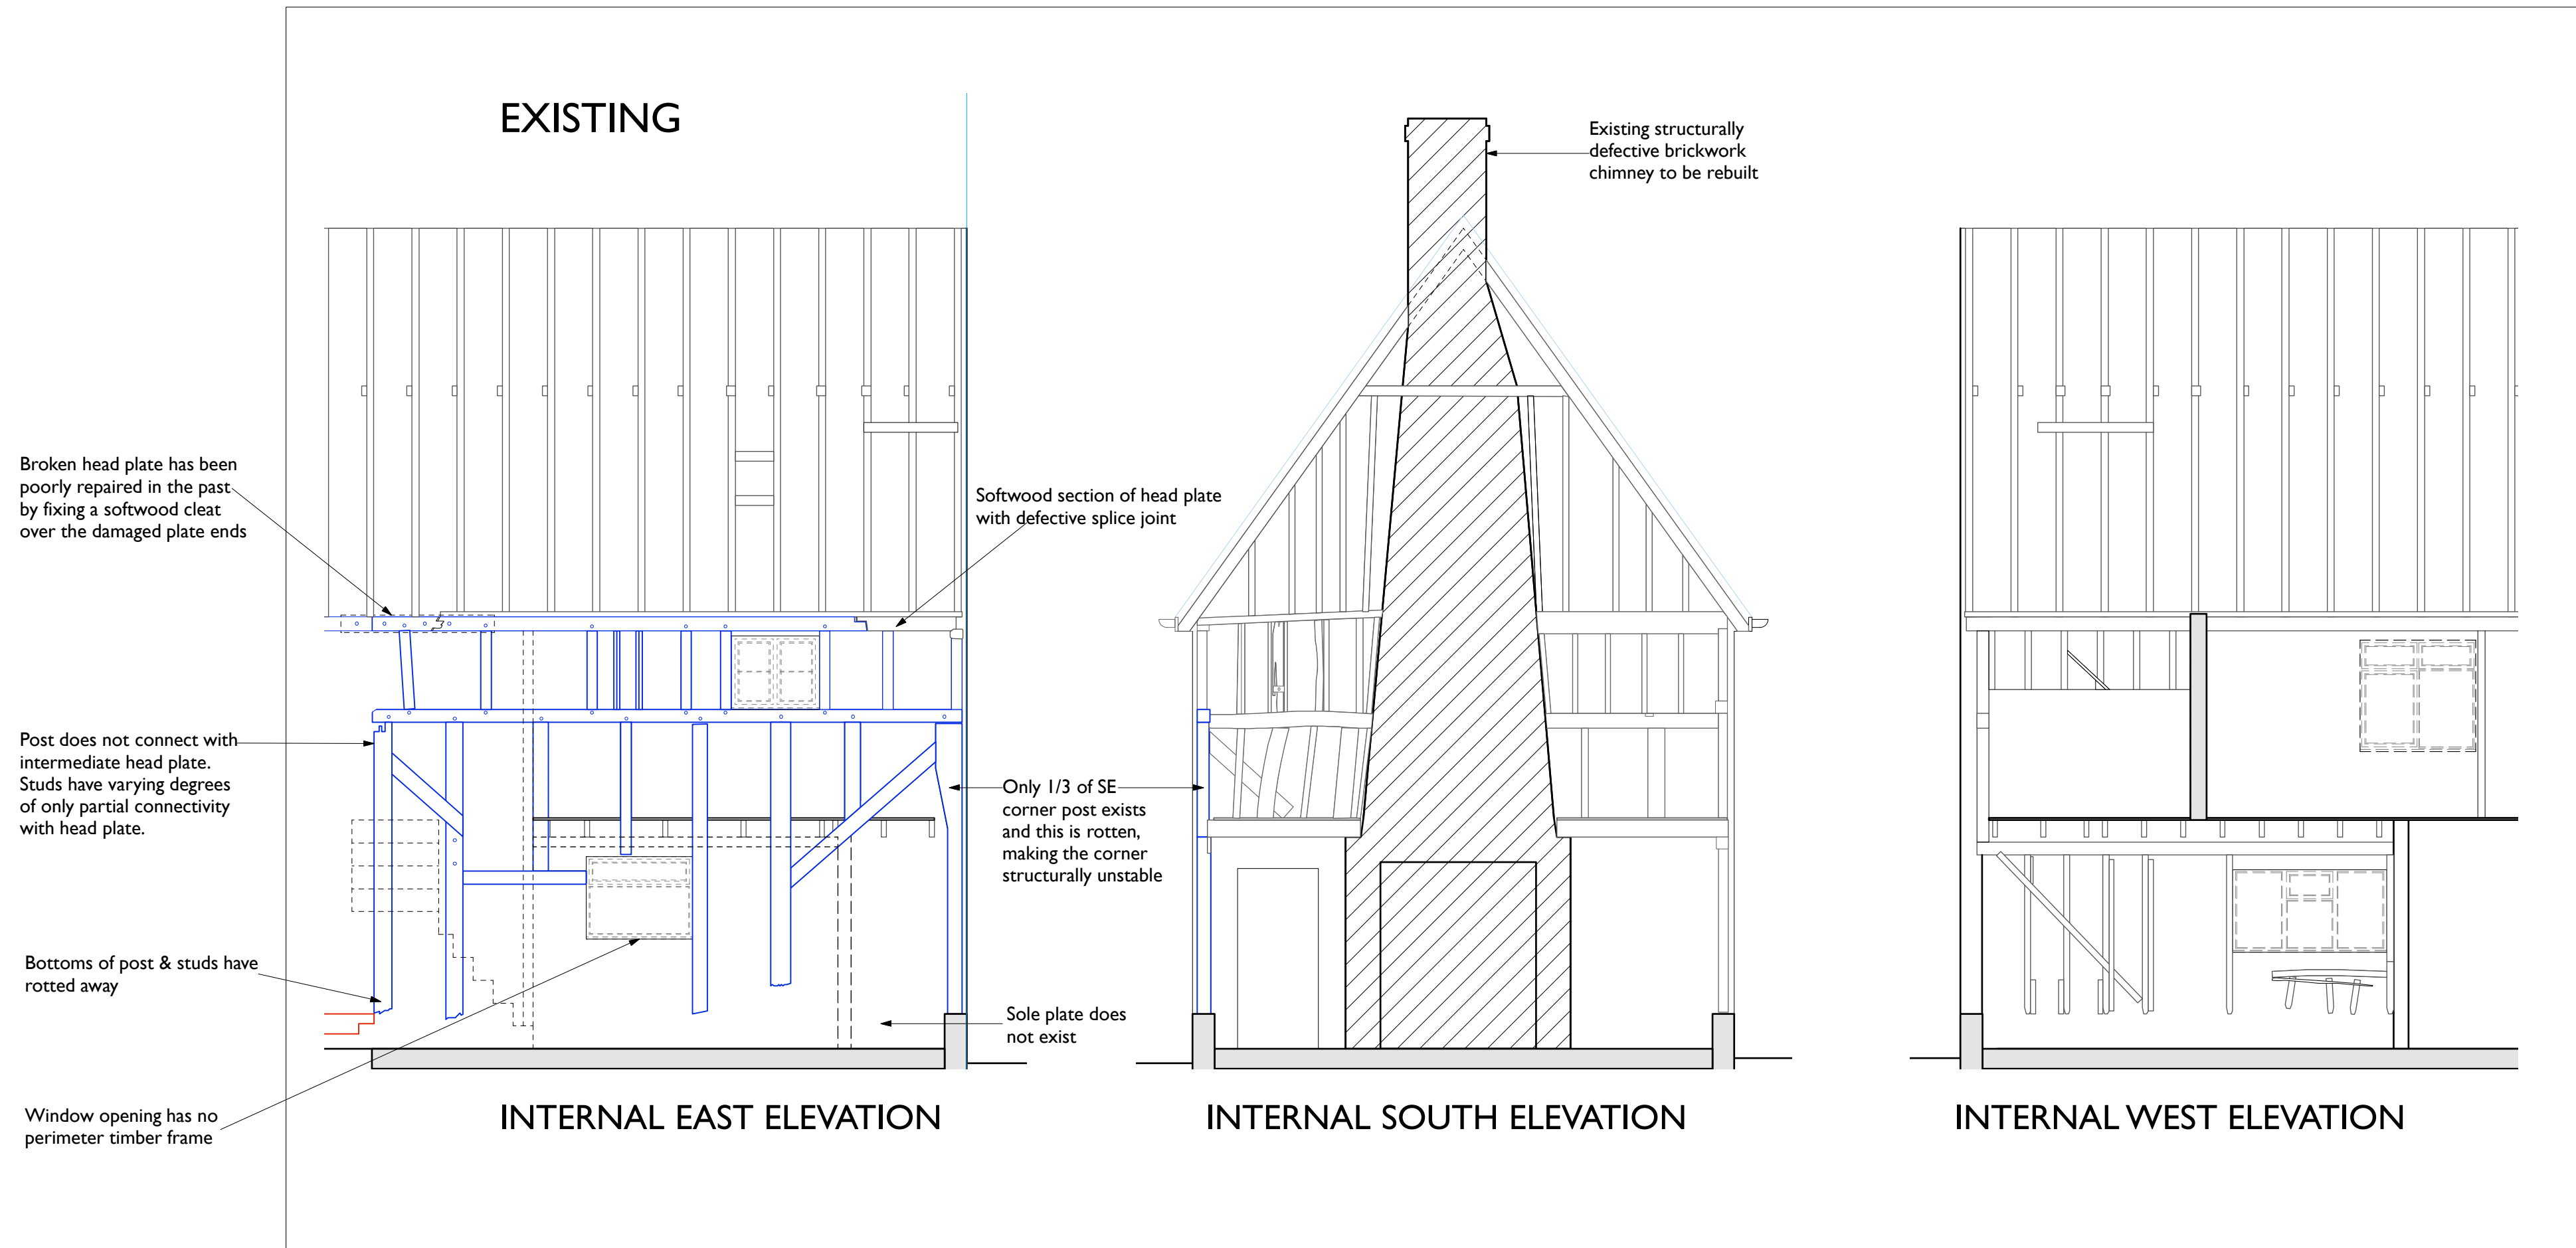
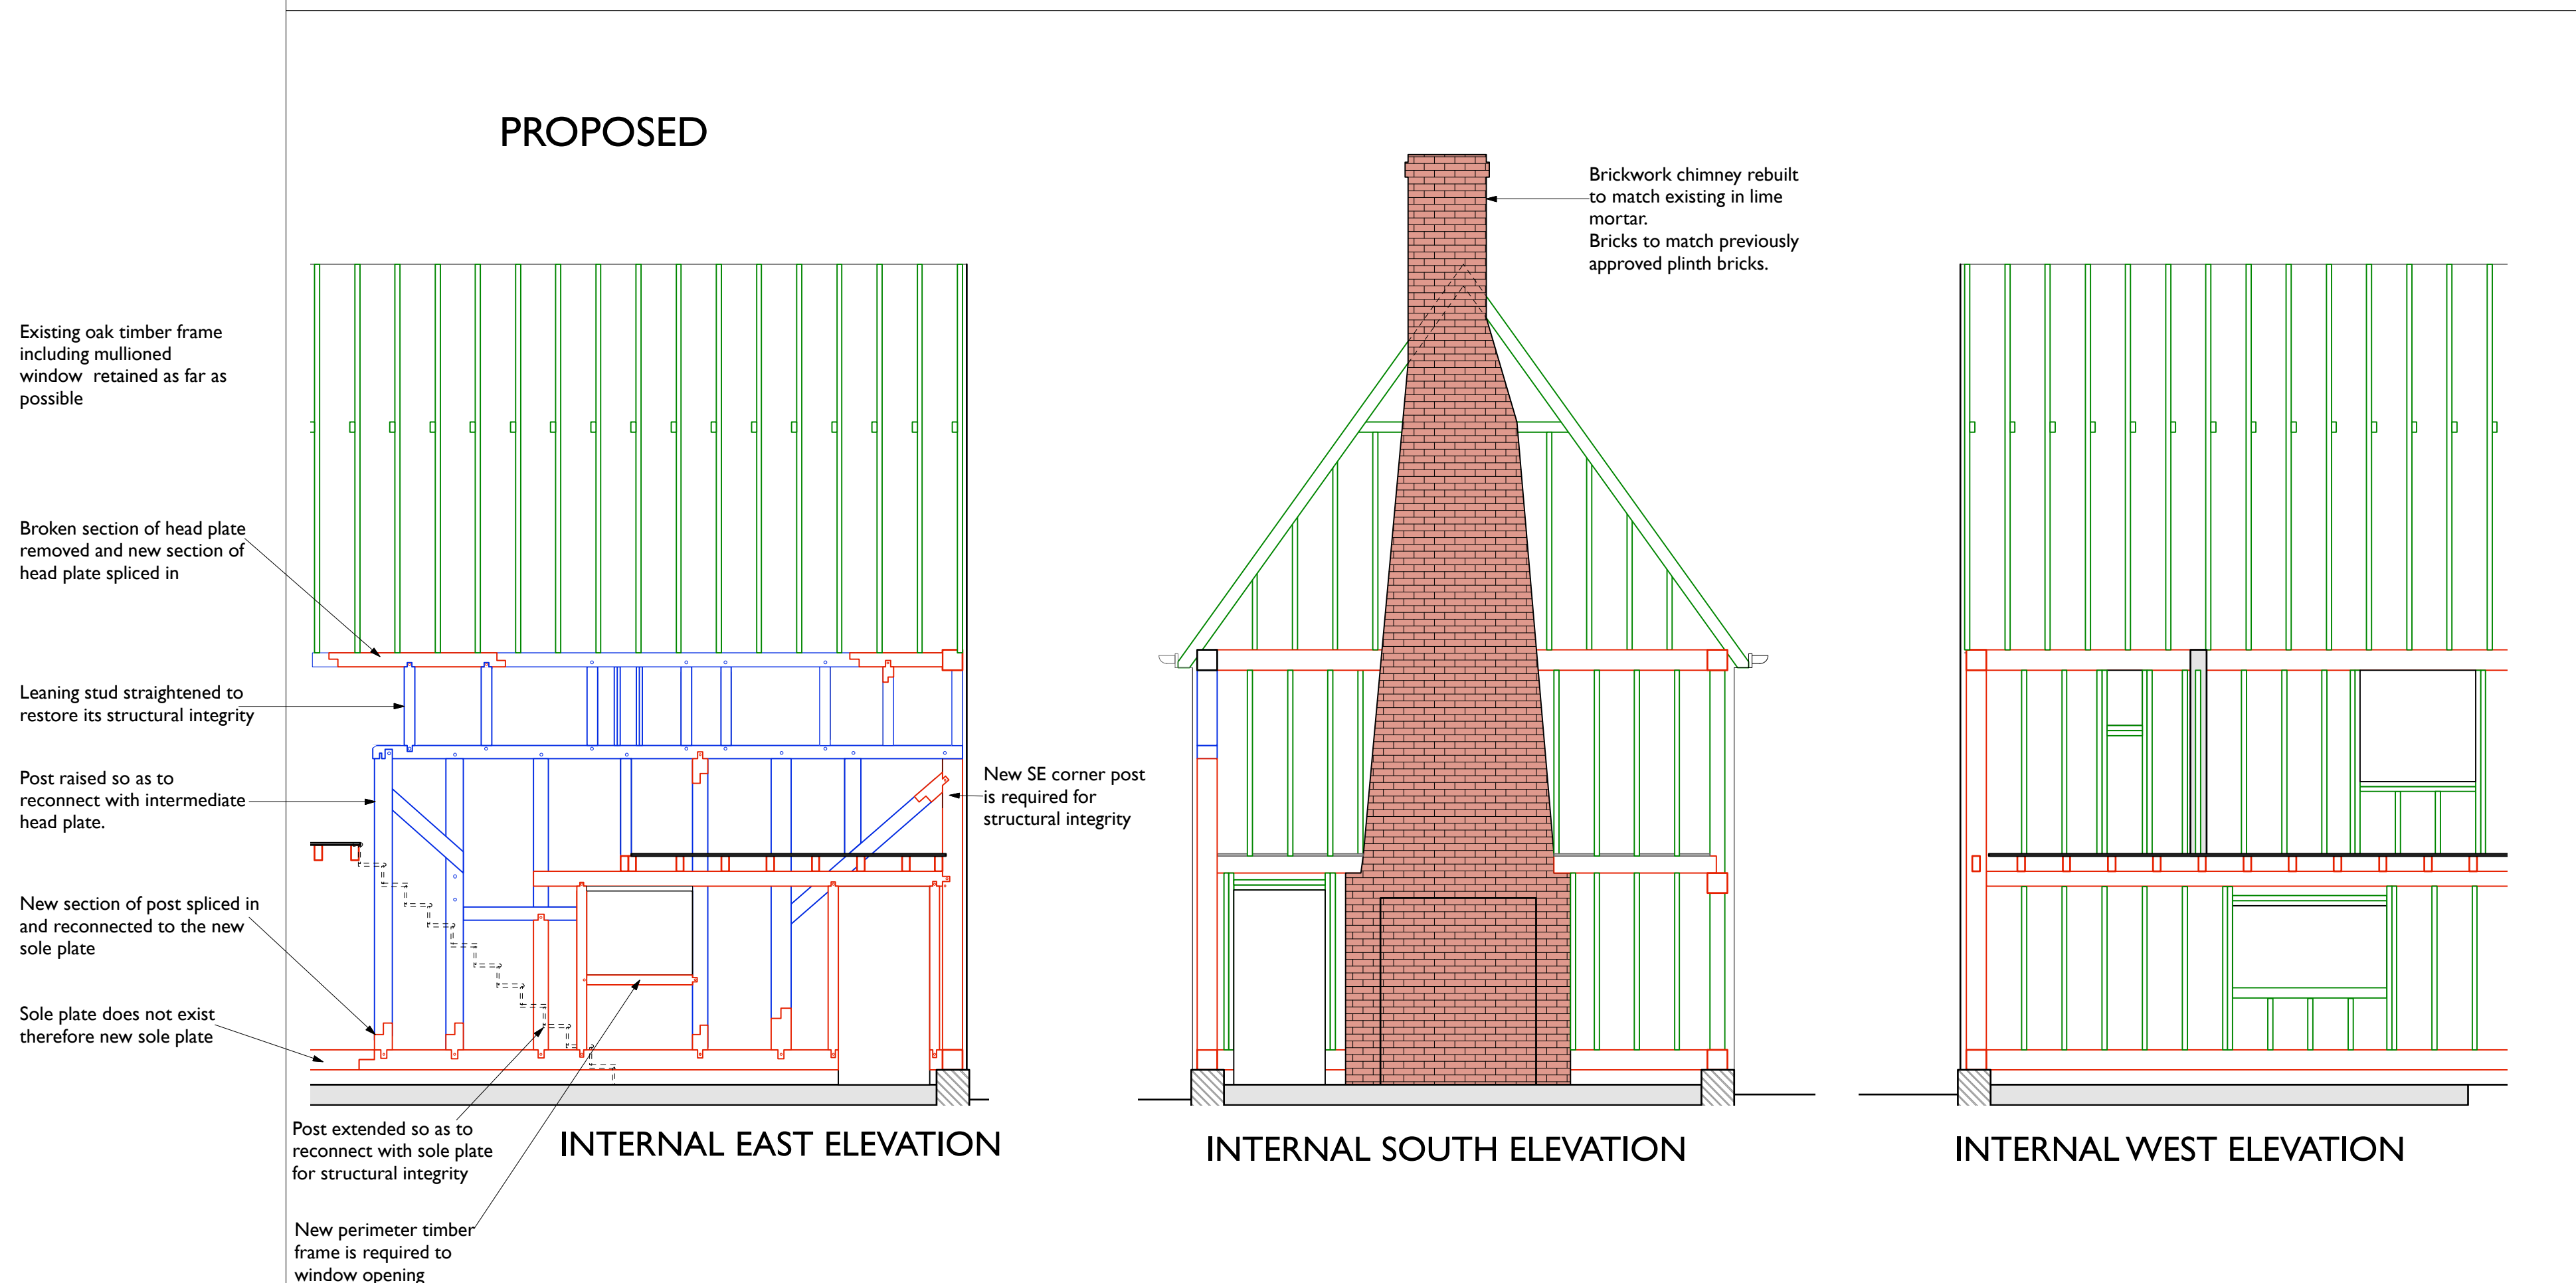
South end of Farmhouse
 The South end of Farmhouse appears to be a later extension to the original house.

Timber frame to the south end of the farmhouse:-
 West and south elevation timber frame is in 1970s softwood. It is structurally defective and in poor condition, with extensive decay. There is no sole plate or dpc.
 Most of the studs to the west elevation were found to have their bottom part missing and had been infilled at the bottom with concrete. These studs were nailed to diagonal bracing and were not load bearing. This wall is therefore structurally unstable and all timber framing needs to be replaced.
 East elevation timber frame will all be retained and repaired (including some older oak timbers and mullioned window). This wall also has no sole plate or dpc.

South chimney: The brickwork chimney was found to be structurally unstable, please refer to Structural Engineer's report 'May 2023 Defects 5002-Report-160523'

East Wall: The exact extent of decay to the east wall timbers cannot be ascertained until the external cement render has been removed, but it has become evident that the timber frame and wall is being held together structurally by the external cement render; and if the render were removed the wall is likely to collapse and set off an uncontrolled demolition of the south end.

It is already obvious that it will be necessary to replace the south east corner post entirely because the outer 2/3 of the existing post has previously rotted away and the remaining inner 1/3 is rotten.

As stated previously, there is no sole plate and the bottom of the lower timber studs have rotted away previously leaving a considerable gap to where the sole plate would have been. If the lower timber studs are found to have an adequate cross sectional area of sound (not decayed) timber remaining it should be possible to splice in new sections of stud and connect to the new sole plate.

The following actions are required to make the building structurally sound and solve the damp ingress:-
 Take down the unstable chimney.
 Remove the defective / decayed timber framing.
 Remove the defective plinth wall.
 Remove the modern softwood first floor joists.

Rebuild brickwork chimney to match existing in lime mortar. Bricks to match previously approved plinth bricks.
 Install a replacement concrete foundation and rebuild the plinth wall in brickwork with lime mortar (to match previously approved). Bricks to match previously approved plinth bricks.

The existing oak timbers to the east elevation are to be propped in place, removed and repaired one at a time and refixed in the original position.
 Timber framing to be replaced as follows:-
 New replacement 200 x 200mm oak sole plate, and 200 x 200mm oak head plate, left exposed.
 New replacement softwood timber studwork and framing to south and west walls, which will be concealed by wall linings.
 New replacement first floor joists and support beams in oak, exposed in room below.

It is therefore proposed to label the existing east wall timbers, carefully dismantle the timber frame in a careful and controlled manner and by the timbers in order on the ground. The cement render will be cleaned off, the timbers will be inspected to ascertain their condition and extent of decay, and proposals for repairs / replacement will be confirmed.
