Structural Survey Report for Barn Outbuilding at The Old Bakehouse, Main Street, Flintham , Newark NG23 5LA

Date	Issued	Revision
24 April 2024	Planning	A

Reference: 82880-01

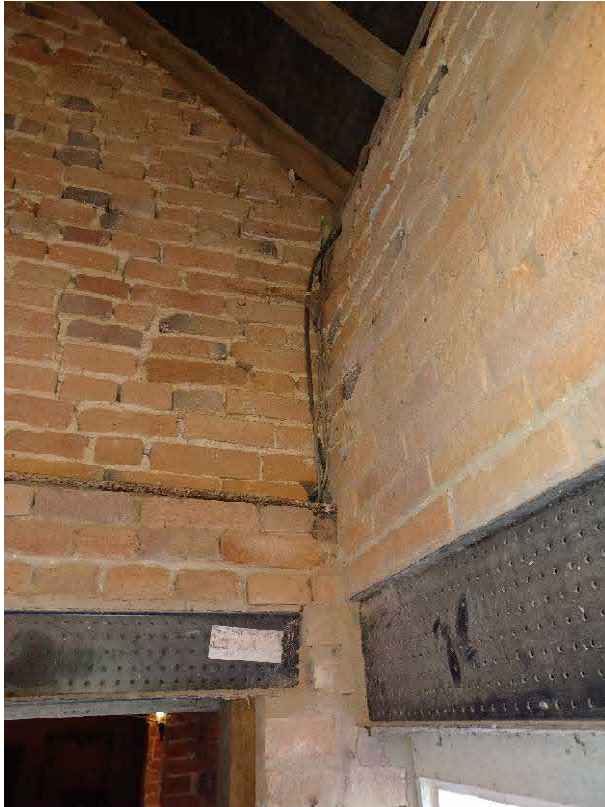
Photograph 1

- 3.1 Some of the original lintels had been replaced by modern pressed steel lintels presumably because of deterioration of the original members. The masonry above these openings appeared sound. The masonry was also arched over the main door and window openings (photograph 1).

- 4.1 Any timber lintels which remain over openings should be taken out and replaced with steel or concrete lintels as a matter of good practice. This is to mitigate deterioration of the timber at a later date.

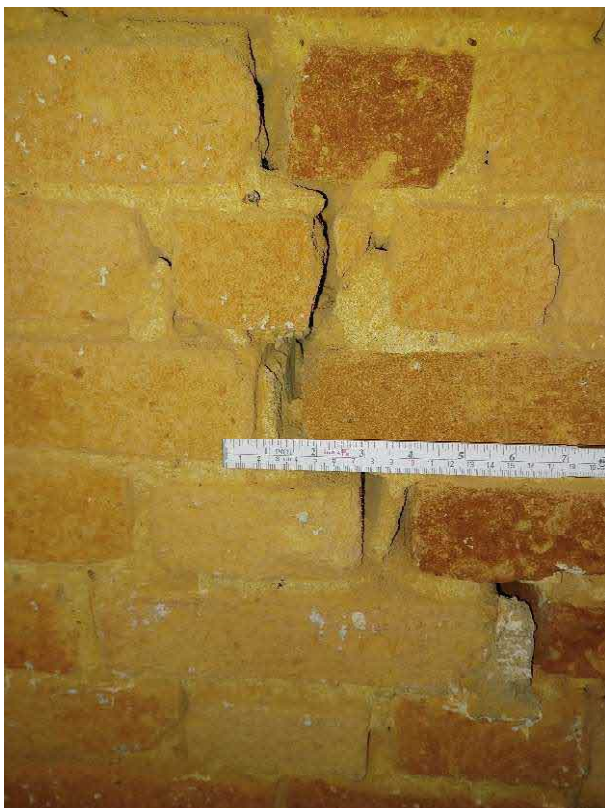
Photograph 2

- 3.2 Diagonal and vertical cracking was noted at the junctions between the front/rear walls and the left hand division wall. The cracks appear to have been repaired previously and have cracked again (photograph 2).

- 4.3 The bond between the front and rear walls and internal division walls needs to be improved. This could be by better brick bonding as part of works undertaken as outlined in 4.2 above or by introducing bed joint reinforcement drilled from the outer face and fixed with resin.

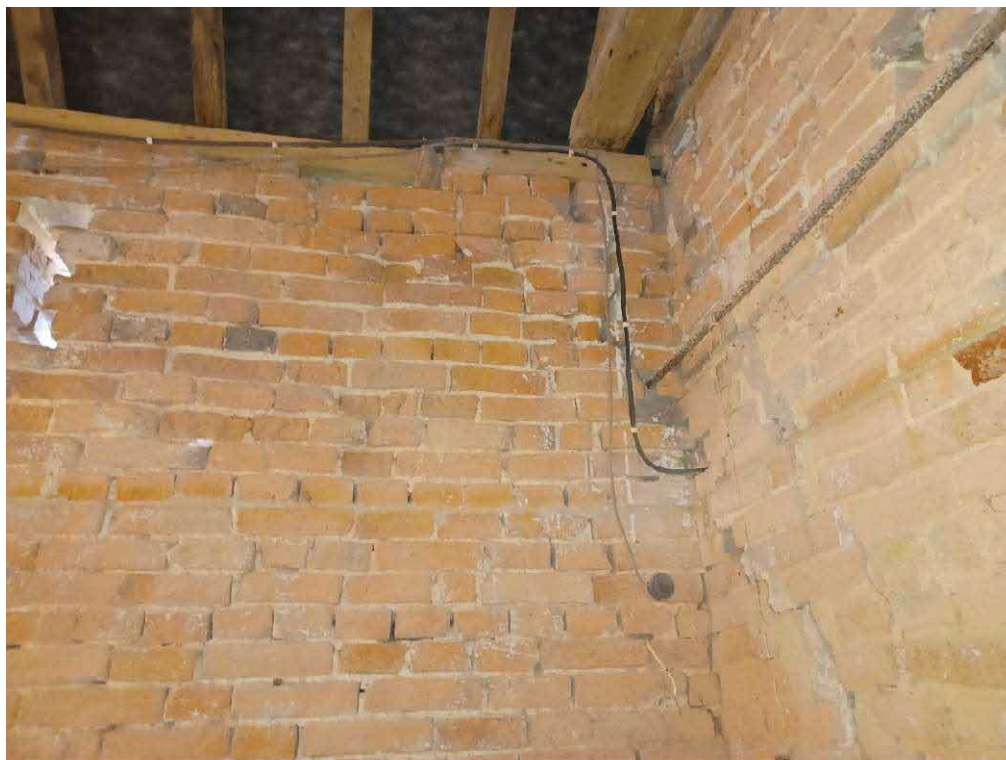
Photograph 3

- 3.3 Steel tie bars had been introduced at approximately $\frac{3}{4}$ height of the front and rear walls in three locations in the main area. These passed through the walls and were finished with a pattress plate to the external wall face. The middle tie coincided with the timber truss position and the steel tie had been bent up to affix to the bottom chord of the truss (photograph 3).

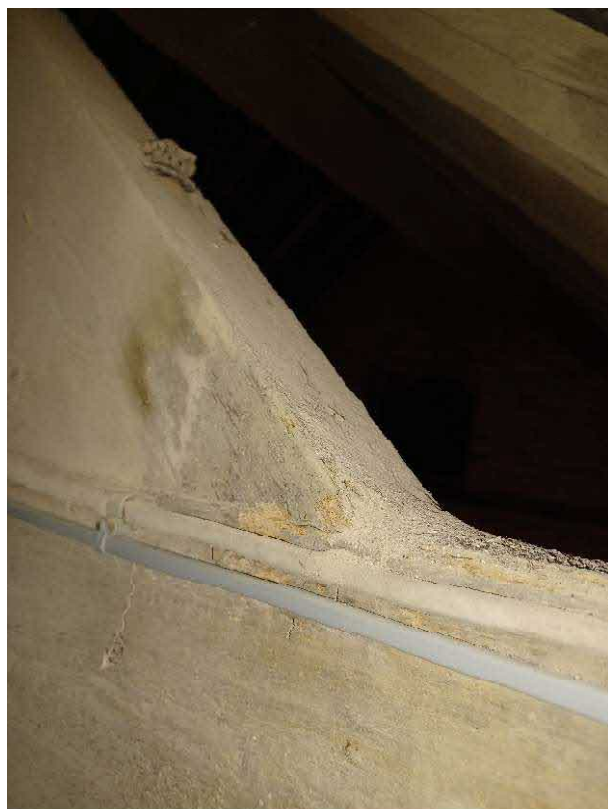
Photograph 4

- 3.4 There was some deterioration of the timber at the junction of the top and bottom chords to the rear of the middle roof truss. The depth of this was nominal and was not considered to be significant (photograph 4),
