Structural Survey Report for Barn Outbuilding at The Old Bakehouse, Main Street, Flintham , Newark NG23 5LA

Date	Issued	Revision
24 April 2024	Planning	A

Reference: 82880-01

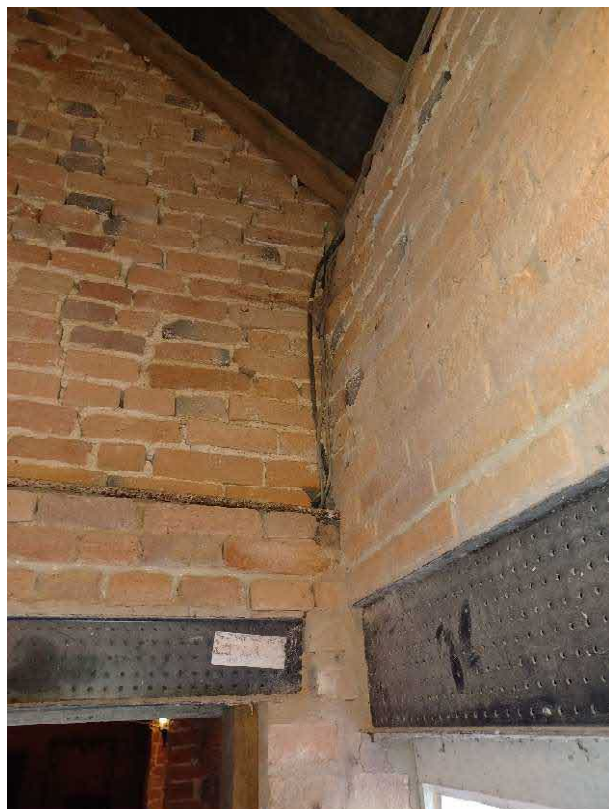
Photograph 1

- 3.1 Some of the original lintels had been replaced by modern pressed steel lintels presumably because of deterioration of the original members. The masonry above these openings appeared sound. The masonry was also arched over the main door and window openings (photograph 1).

- 4.1 Any timber lintels which remain over openings should be taken out and replaced with steel or concrete lintels as a matter of good practice. This is to mitigate deterioration of the timber at a later date.

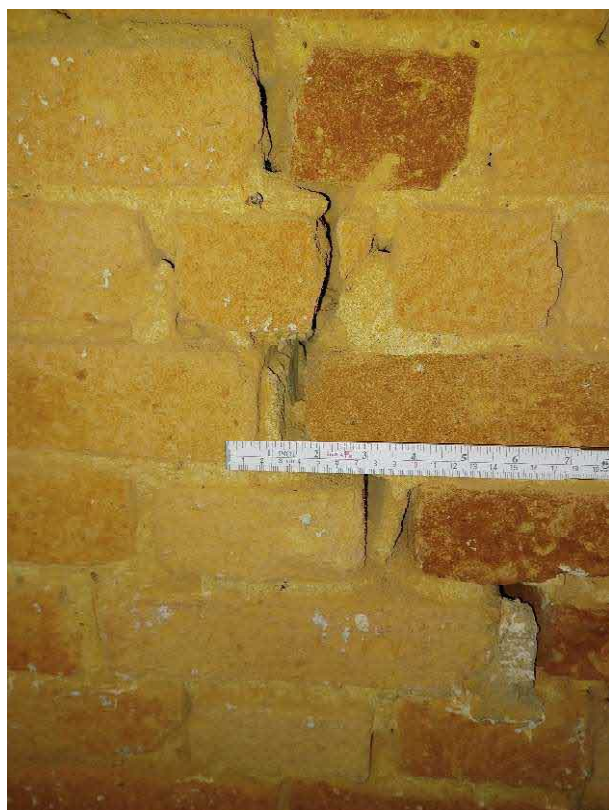
Photograph 2

- 3.2 Diagonal and vertical cracking was noted at the junctions between the front/rear walls and the left hand division wall. The cracks appear to have been repaired previously and have cracked again (photograph 2).

- 4.3 The bond between the front and rear walls and internal division walls needs to be improved. This could be by better brick bonding as part of works undertaken as outlined in 4.2 above or by introducing bed joint reinforcement drilled from the outer face and fixed with resin.

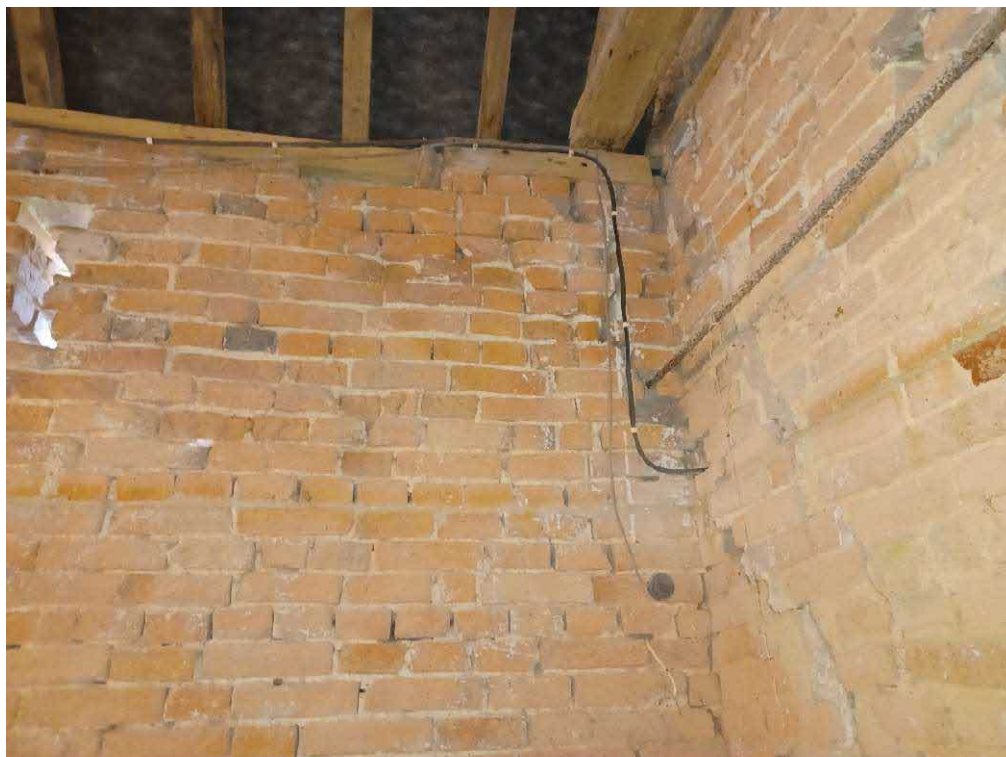
Photograph 3

- 3.3 Steel tie bars had been introduced at approximately $\frac{3}{4}$ height of the front and rear walls in three locations in the main area. These passed through the walls and were finished with a pattress plate to the external wall face. The middle tie coincided with the timber truss position and the steel tie had been bent up to affix to the bottom chord of the truss (photograph 3).

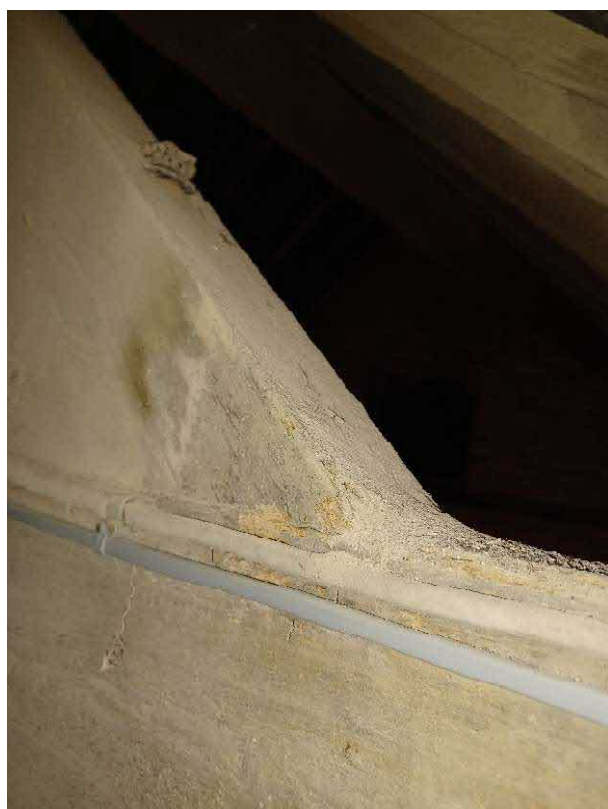
Photograph 4

- 3.4 There was some deterioration of the timber at the junction of the top and bottom chords to the rear of the middle roof truss. The depth of this was nominal and was not considered to be significant (photograph 4),

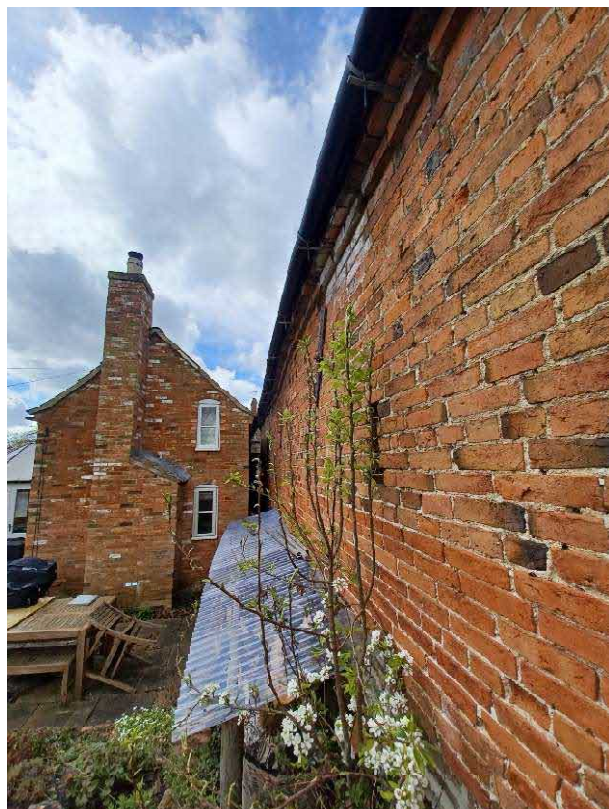
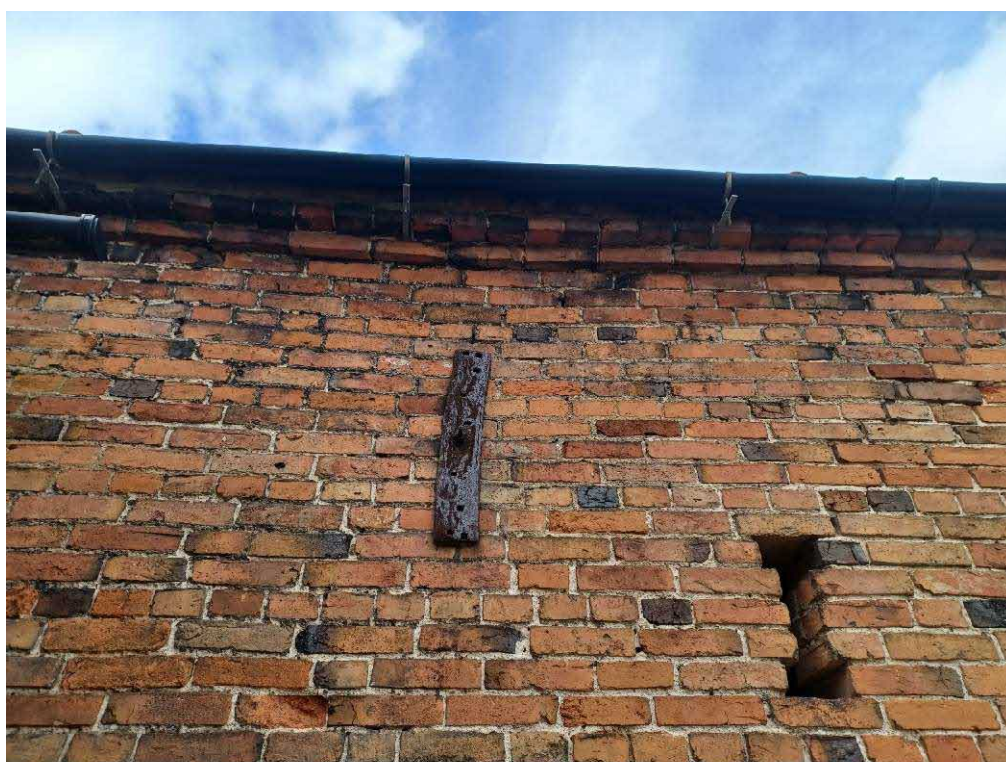
- 3.5 There was a significant bow and lean in the length of the rear wall between the two internal division walls. In the worst case, this was measured as 77mm over the length of a 2.0m straight edge. Pro-rata over the height of the wall, this would equate to the wall being out of plumb by approximately 126mm. The movement resulting in this bow may have occurred some time ago and may have been arrested to some extent by the introduction of the metal tie bars. However, the cracking in the masonry at the junctions with the internal divisions walls had been repaired at some point and has subsequently cracked again since repairs were undertaken and suggests that the movement may be ongoing. The extent to which the wall was out of plumb warrants the wall being rebuilt at least from above ground level on the neighbour's side. However, before preparing a detailed schedule of repairs a full plumb survey of the wall should be undertaken (photographs 5 and 6).

- 4.2 The front and rear walls are out of plumb by a considerable amount. There are indications that movement of these walls has not been fully arrested by the introduction of steel ties. The walls should be monitored at regular intervals for indications of further deterioration. However, any conversion of the building to residential use should include for either full or partial demolition of these walls, the extent of which is subject to further detailed measured survey of both walls.

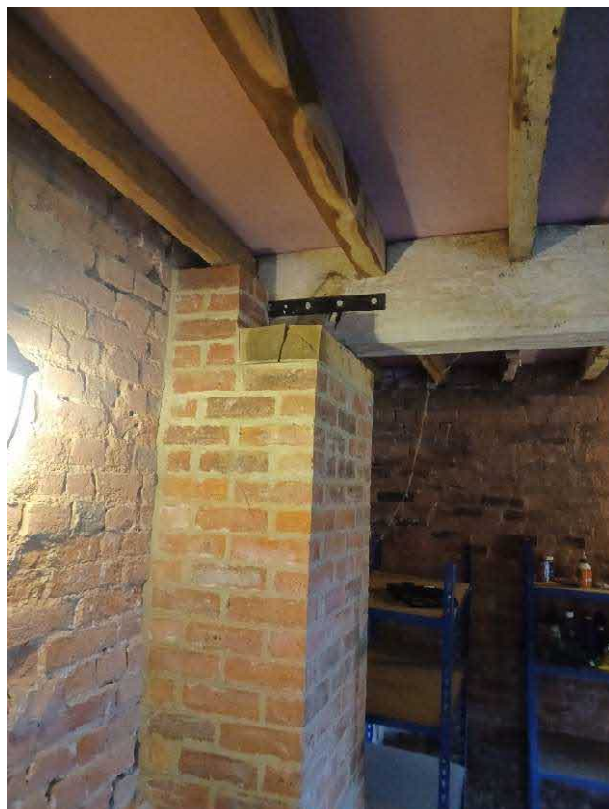
Photograph 7

- 3.7 Some remedial work had previously been undertaken in the area above and below the mezzanine floor. New brick piers had been constructed at ground floor level at the bearings of the timber floor beams and steel ties introduced. The ties were coach bolted to the sides of the timber floor beams, passed through the front and rear walls and finished on the outer face of the masonry with a pattress plate (photograph 7).
