# West Bradley House

## Existing Building Survey

Doc ref    *WBH-HYD-XX-ZZ-RP-S-0001*

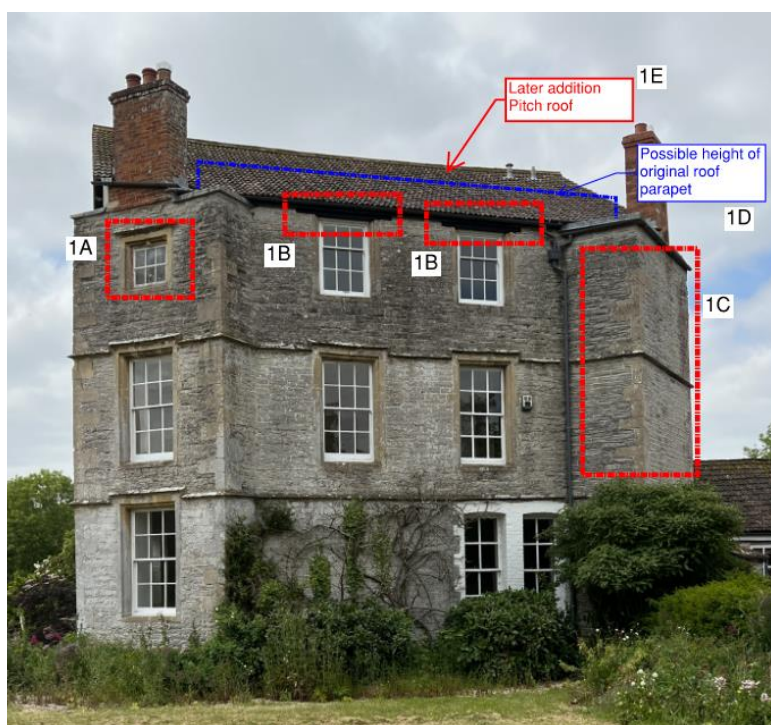
Figure 4: East Elevation

- » Blind/fake windows at the top floor outside the fire place (1A)
- » Original lintels have been replaced with a more modern and shallower lintel (1B)
- » The original stone is repointed in places (1C)
- » There was likely an original roof parapet that was demolished and the overall height of the external wall was reduced (1D)
- » Later added pitched roof (1E)

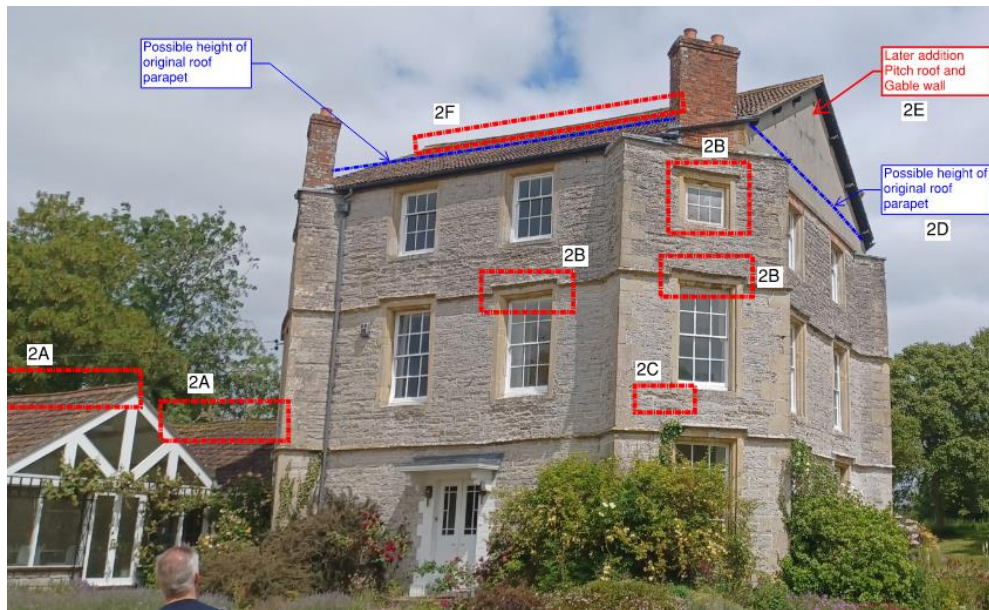
Figure 5: West-South elevation

- » The ridges of the kitchen and access are not straight (2A)
- » The stone lintels have sagged at mid span and some of them are cracked (2B)
- » The façade stone has lost section in places (2C)
- » There was likely an original roof parapet that was demolished in the East and West elevations and built up to form the gable end walls in the South and North elevations (2D), (2E)
- » The ridge of the later added pitched roof is not straight and has deflected over the recommended deflection values for a roof (2F)

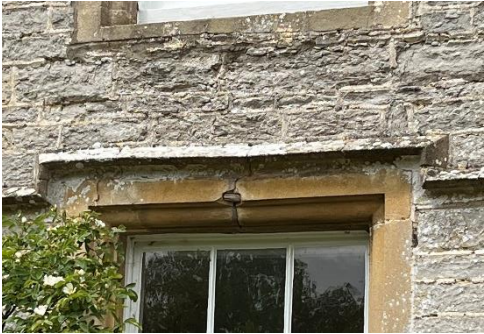
<p>Repointing required</p>
2	<p>Lintel crack</p>

<p>Some external masonry lintels have cracked.</p> <p>As there are no alterations to external openings lintels can remain as they are.</p>
3	<p>Masonry walls in poor condition around historic fire place</p>

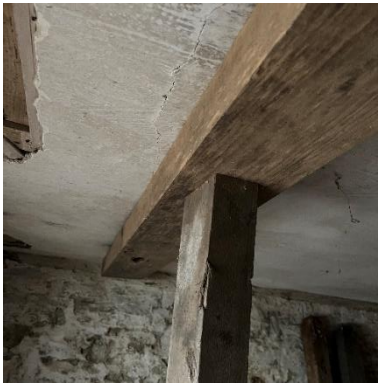
<p>Allow for replacement of deteriorated masonry, particularly where it has become soft and crumbly to touch,</p>
4	<p>Unfixed timber props to Ground Floor</p>

<p>Timber propping to be removed. Once ground floor joists have been strengthened.</p>

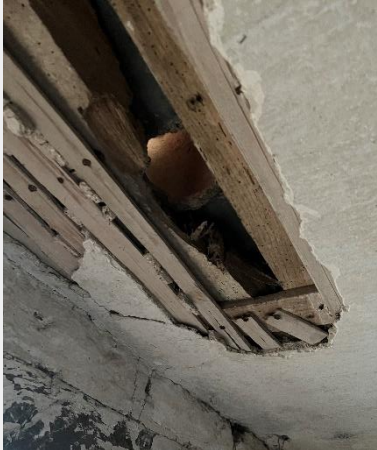
Structural Defect	Proposed Solution
5	<p>Insect infestation/rotten timber</p>

<p>Strengthen existing timber joists at ground floor to make ground floor structurally safe</p>
6	<p>Sagged Timber lintel</p>

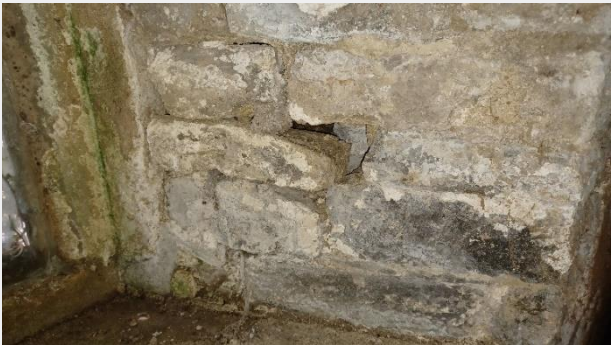
<p>All timber lintels in basement to be replaced.</p>
7	<p>Local loss of mortar and masonry section</p>

<p>Damaged masonry/stone to be replaced and mortar repointed</p>

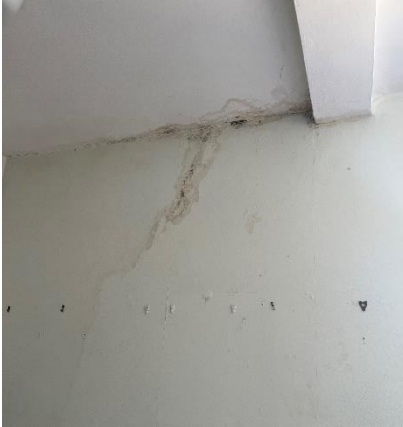
Structural Defect	Proposed Solution
8	Damp patch, horizontal and 45-degree crack

Wall finishes to be removed to expose masonry and beam support. Allow for Helifix stitching of masonry
9	Horizontal crack under lintel

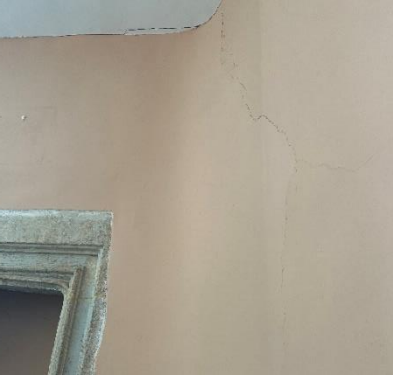
Remove existing finishes to inspect lintel bearing
10	45-degree crack in external wall caused by roof

Remove existing finishes and allow for Helifix masonry stitching
11	Vertical / 45-degree crack from roof

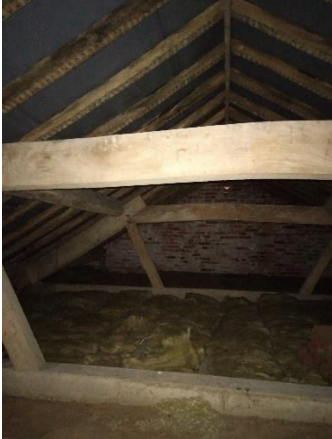
The pitched roof structure is a timber roof with no support to the apex and no continuous ridge beam. The timber rafters have signs of damp. Hairline cracks in the gable end wall suggest that the new masonry gable ends are not properly restrained. Due to the current status of the timber rafters and design of the roof, it is recommended that a new roof is installed for the preservation of the heritage asset.

Structural Defect	Proposed Solution
<p><b>12</b></p>	<p>Pitched roof structure</p>

<p>There is no recommendation for repairing the existing pitched roof.</p> <p>The existing roof should be demolished and a new flat roof should be constructed that is more in keeping with the original building design intent.</p>
<p><b>13</b></p>	<p>Loose Cornice (General maintenance)</p>

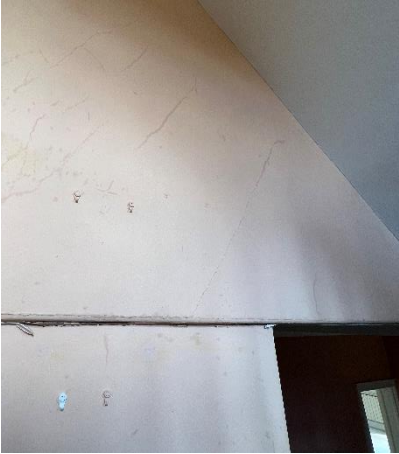
<p>Replace or fix accordingly</p>
<p><b>14</b></p>	<p>45-degree parallel cracks</p>

<p>Provide Gable end lateral restraint ties to roof structure.</p> <p>Remove wall finishes to determine the extent of the cracks and repair masonry wall accordingly.</p> <p>Allow for rebuild of masonry gable end walls.</p>

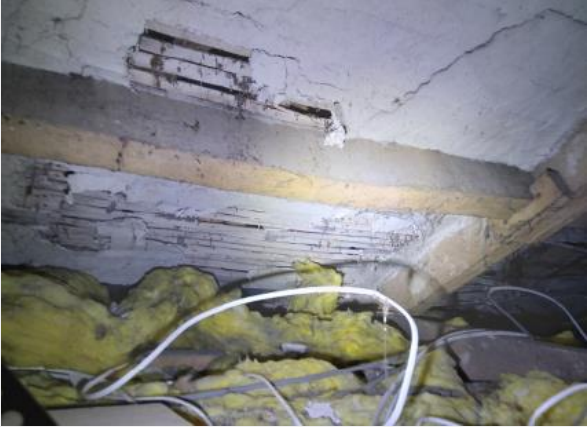
Structural Defect	Proposed Solution
15	<p>Pitched roof above kitchen extension sagging.</p>

<p>No observable structural failures of elements and therefore the roof is able to be retained.</p>

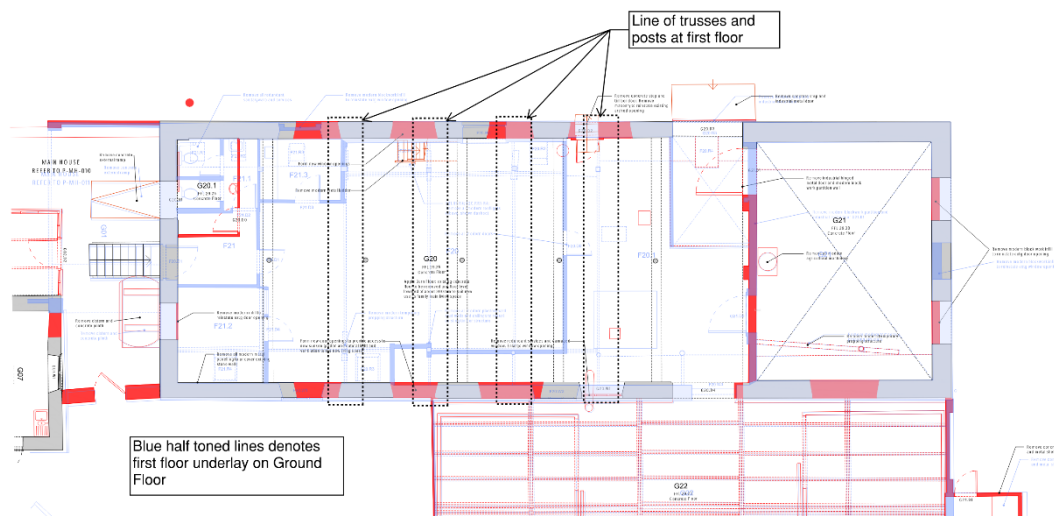
Figure 8: Overlaid first floor and ground floor. Apple Barn

- » The timber trusses are propped to the first-floor slab without fixings. The line of the trusses and props are not on the line of columns as shown in Figure 8 below,
- » One of the trusses is cracked, likely a shear failure at the prop location.
- » There are signs of damp on the external wall next to the Velux window
- » The first floor build-up is 200mm deep timber joists with chipboard.

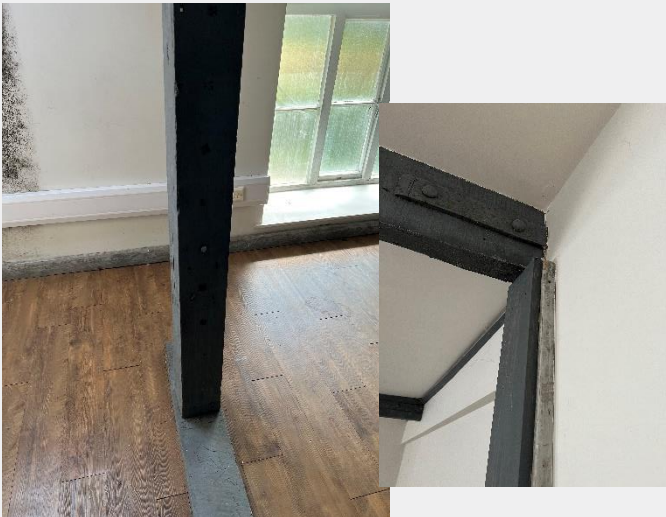
Structural Defect	Proposed Solution
1	<p>Timber props for roof truss unfixed</p>

<p>Roof structure to be removed along with propping. New roof to be installed.</p>

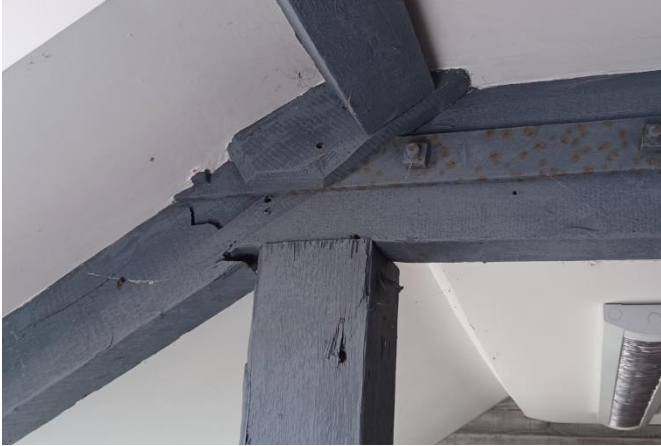
Structural Defect	Proposed Solution
<p>2</p>	<p>Shear failure in one of the main rafters at the prop location</p>

<p>These rafters are proposed to be removed and new roof to be installed.</p>
<p>3</p>	<p>Damp patch under roof window</p>

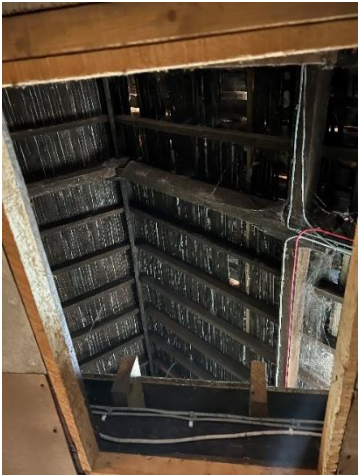
<p>Expose damp to find source and repair accordingly. Allow for timber rafters replacement.</p>
<p>4</p>	<p>No roof ridge beam to main barn roof</p>

<p>Replace roof structure – some of the newer timbers may be able to be reused</p>

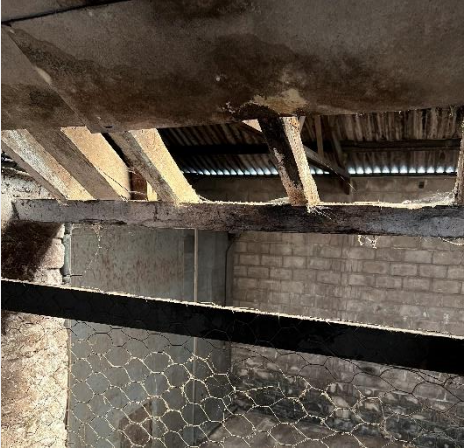
Structural Defect	Proposed Solution
<p>5</p>	<p>Degradation of timber roof structure adjacent to Annex Barn extension</p>

<p>Apple barn roof structure requires replacing in entirety – some of the newer timbers may be able to be reused</p>
<p>6</p>	<p>Partially supported roof</p>

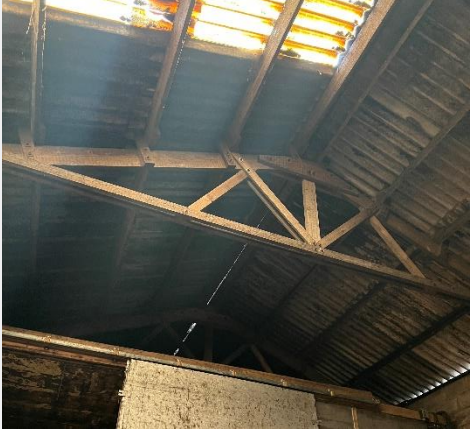
<p>Roof to be replaced in Apple Barn</p>
<p>7</p>	<p>Existing roofing structure and timber sections</p>

<p>The blockwork barn is to be removed.</p>

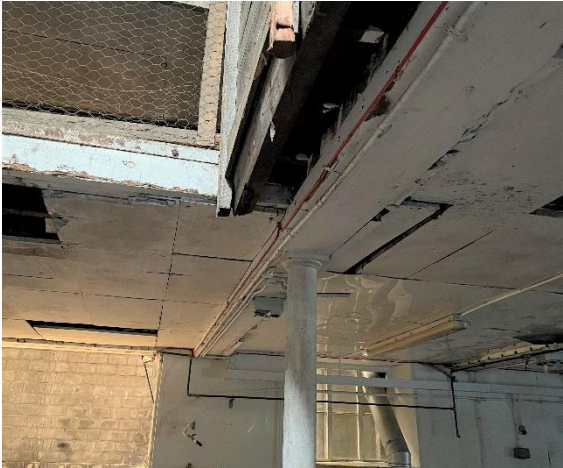
Structural Defect	Proposed Solution
<p>8</p>	<p>Existing first floor beams</p>

<p>Existing beams to be exposed and structurally checked for compliance.</p>
<p>9</p>	<p>Corroded base of steel column</p>

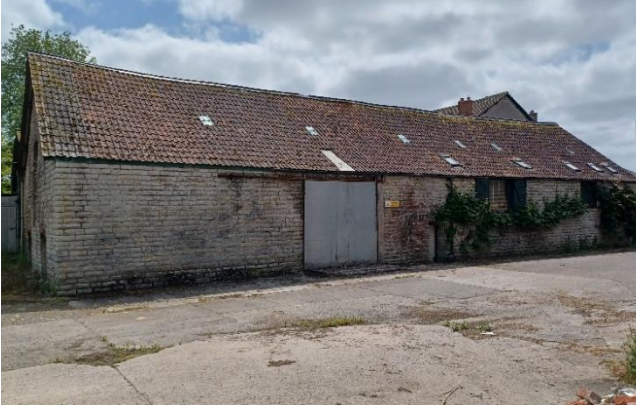
<p>Allow for additional plates at the base of the columns for strengthening.</p>
<p>10</p>	<p>Deflected ridge</p>

<p>Allow for replacement of the roof structure. Some of the newest sections could be reused,</p>

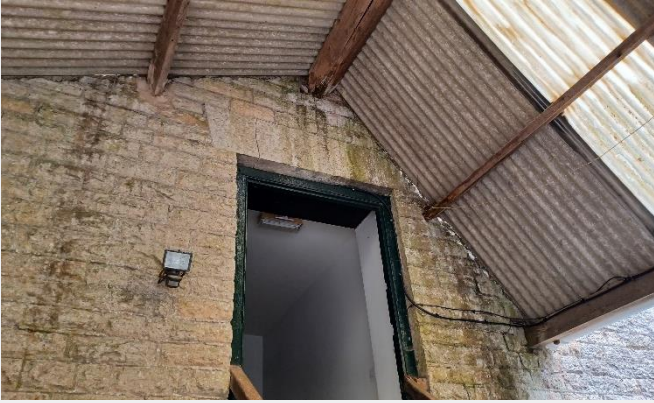
Structural Defect	Proposed Solution
<p><b>11</b></p>	<p>Rotten timber rafters</p>

<p>New roof structure to be proposed as part of the new scheme,</p>
<p><b>12</b></p>	<p>Mortar in poor condition</p>

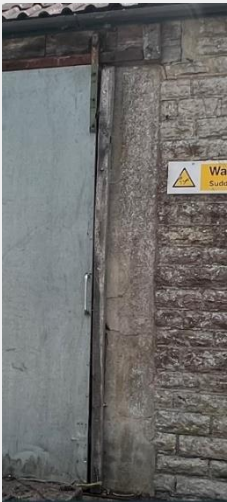
<p>Blockwork barn is not being retained.</p>
<p><b>13</b></p>	<p>Several cracks in the door frame</p>

<p>Allow for structural door framing to be replaced with new timber structure.</p>

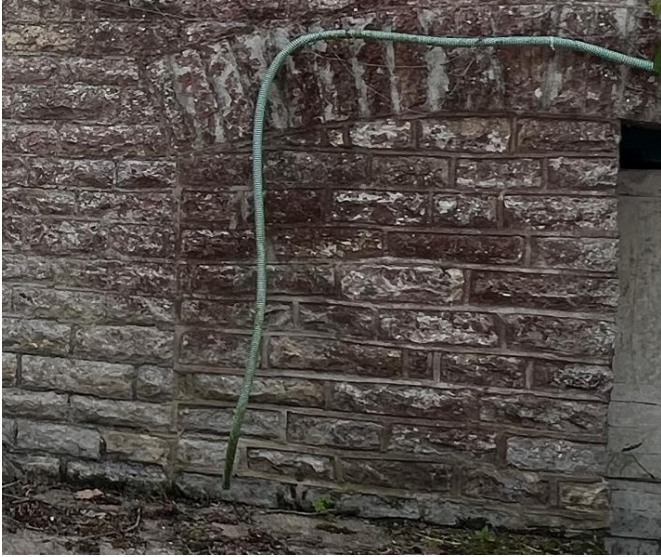
Structural Defect	Proposed Solution
<p><b>14</b></p>	<p>External bed mortar in poor condition</p>

<p>Allow for mortar repointing generally to external structure</p>
<p><b>15</b></p>	<p>5-10 crack in the North-East elevation</p>

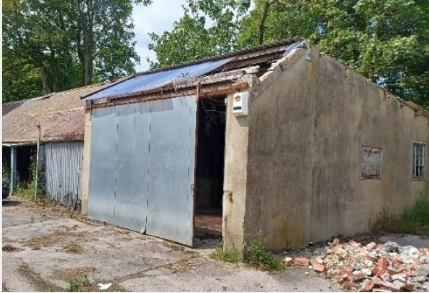
Structural Defect	Proposed Solution
<p>1</p>	<p>Existing external door beams corroded</p>

<p>Existing doors and posts are to be demolished</p> <p>No further solution proposed</p>
<p>2</p>	<p>Existing timber post cracked</p>

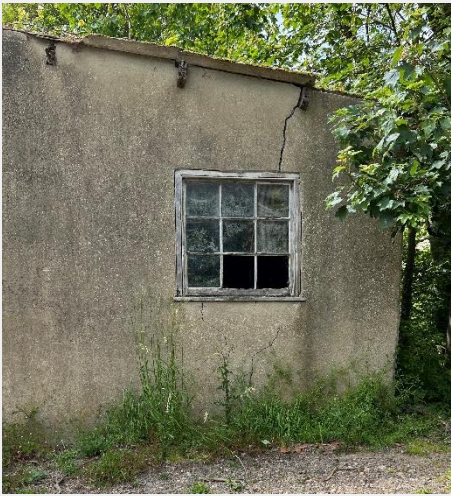
<p>Timber posts to be demolished and new foundations required.</p> <p>New roof structure required existing roof to be demolished</p> <p>No further solution proposed</p>
<p>3</p>	<p>Crack in external masonry</p>

<p>New load bearing masonry walls required as part of the new Architectural proposals.</p> <p>No further solution proposed</p>

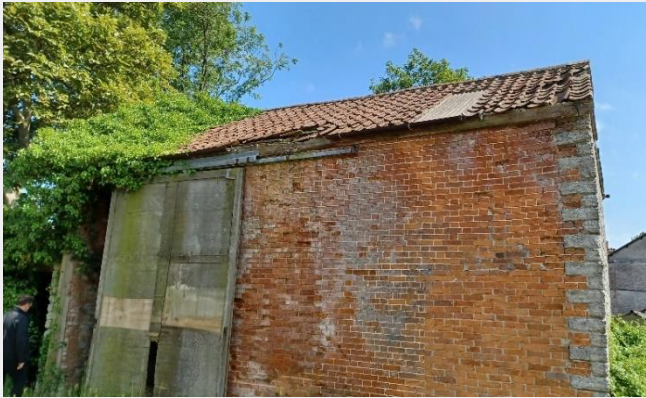
Structural Defect	Proposed Solution
<p>1</p>	<p>General poor mortar condition and poor masonry condition</p>

<p>Repointing required generally and brick/stone replacement locally</p>
<p>2</p>	<p>Significant leaning and bulging of masonry walls. Masonry walls unrestrained at the head.</p>

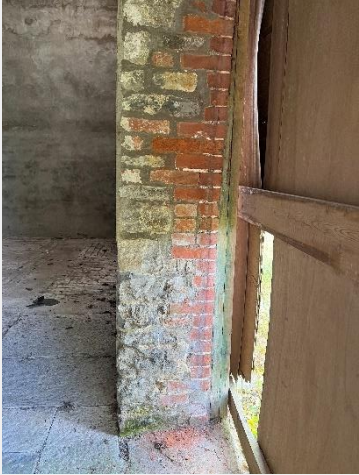
Structural Defect	Proposed Solution
<p>3</p>	<p>Crumbing stone</p>

<p>Damaged bricks and stone needs rebuilding and repointing</p>
<p>4</p>	<p>Poor condition of masonry</p>

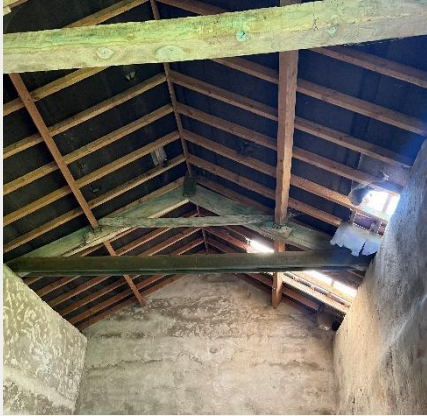
<p>Damaged bricks and stone needs rebuilding and repointing</p>
<p>5</p>	<p>Roof structure in poor condition and not providing restrain to the masonry walls</p>

<p>Replace roof structure.</p>

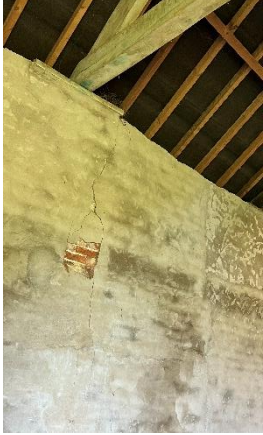
Structural Defect	Proposed Solution
6	<p>Vertical &gt;5mm crack separating wall panel from pier</p>

<p>Allow Helifix crack stitching</p>
7	<p>No ground floor slab visible</p>

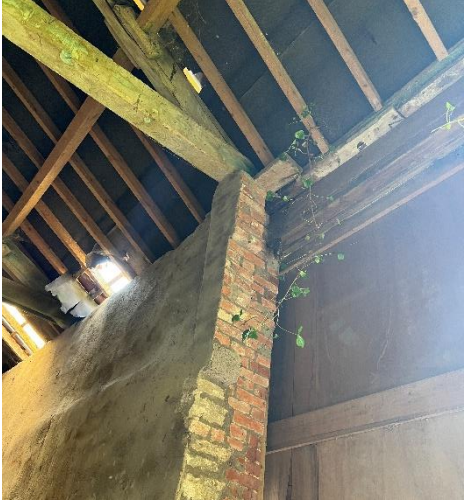
<p>Allow for Ground Bearing slab</p>
8	<p>Unsafe support to Timber truss</p>

<p>New roof structure to sit on steel frame tied into masonry walls</p>

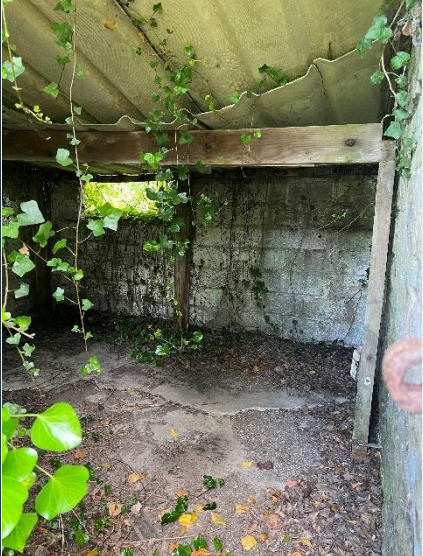
Structural Defect	Proposed Solution
9	<p data-bbox="400 331 858 365">Collapsed roof, unfixed timber props</p>

<p data-bbox="1093 331 1428 398">Blockwork extension to be rebuilt.</p>

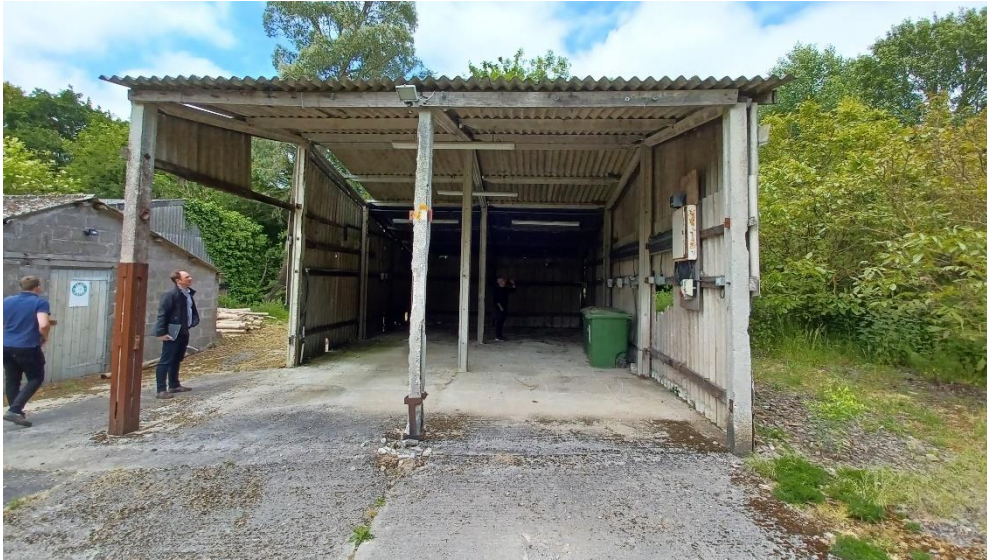
Figure 9: Precast Concrete Shed

Throughout the precast concrete shed, it can be noted that different structural repairs have happened to strengthen the columns where the concrete cover was lost.

- » The structural repairs used steel angles that have corroded during the time.
- » The structural repairs are very localised and not everywhere that is required.
- » The concrete columns have continued to degrade during the time.
- » The roofing sheet looks in reasonably good condition.
- » This shed is proposed to be demolished in the New Architectural Proposal.
- » Some of the external wall panels have fallen.
- » The concrete ground floor slab is in very poor condition with loss of cover.
- » The timber rails supporting the cladding panels show signs of degradation.
- » The precast concrete beams supporting the roof are in reasonably good condition.

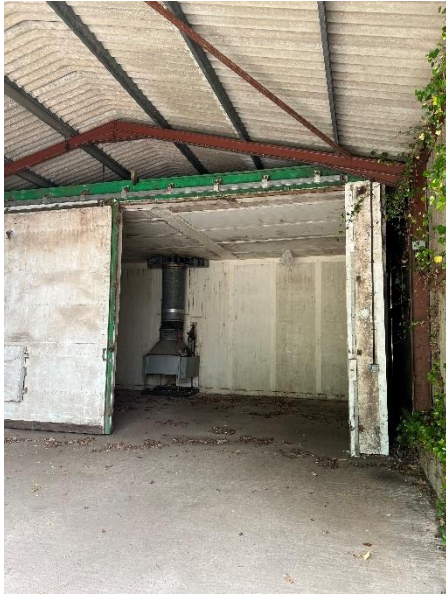
Figure 10: Steel portal frame shed

Throughout the steel frame shed, there are signs of corrosion.

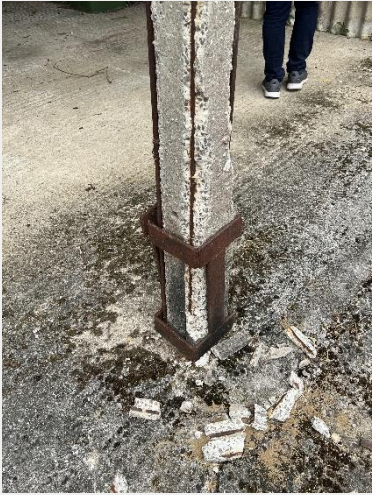
Structural Defect	Proposed Solution
<p>1</p>	<p>Loss of section in existing precast concrete columns</p>

<p>Columns are proposed to be demolished.</p> <p>No further solution proposed.</p>
<p>2</p>	<p>Loss of section in most of precast concrete columns</p>
