P10335/23/10

STRUCTURAL INSPECTION

**THE GRANARY, CHESTERTON MILL
FOR
BENCHMARK LIMITED.**

Document Reference	P10335/23/Structural Inspection Report
Version	01
Date released	03 November 2023
Originator	Kieron Hounslow BEng (Hons) CEng MIStructE

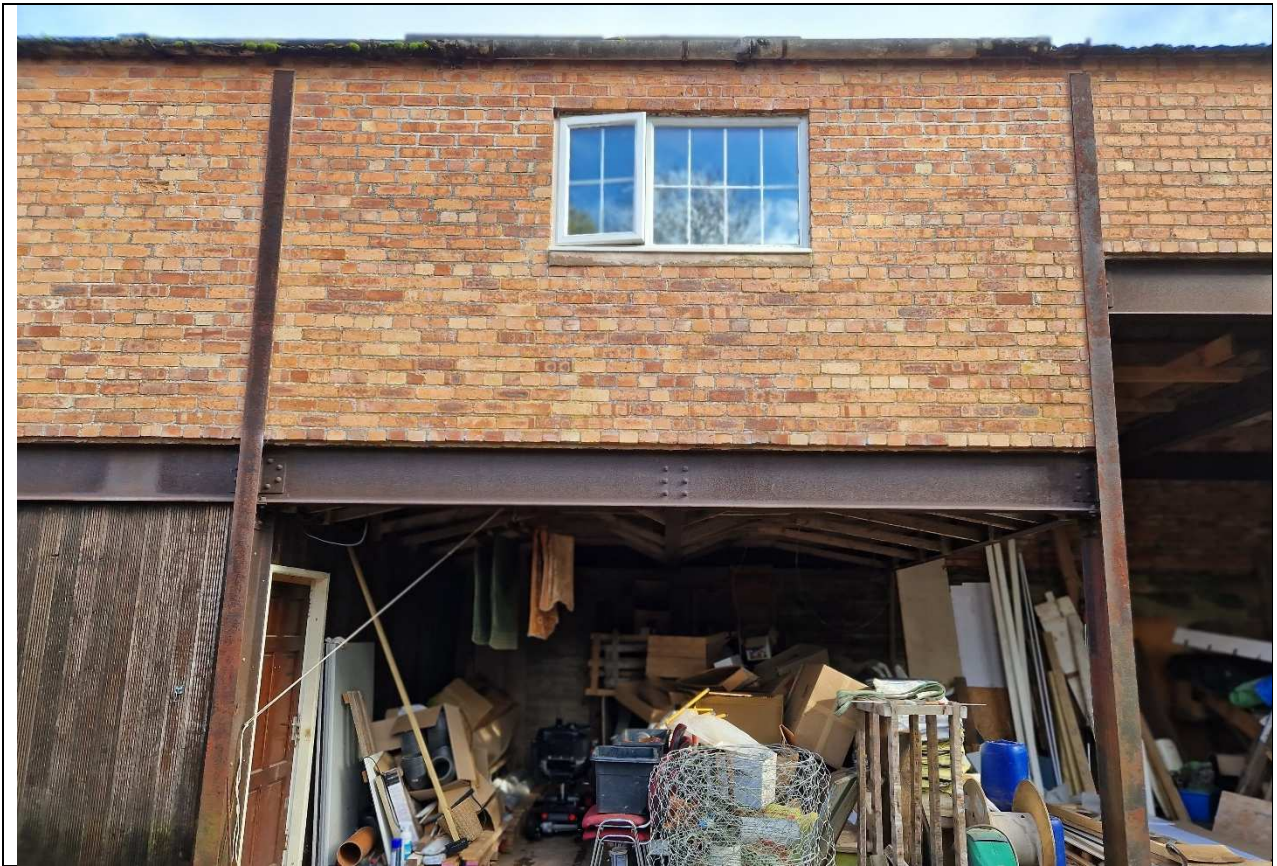
- Brickwork generally vertical.
- No significant structural cracking observed.
- Steel framing has surface corrosion generally. Frame was found to be reasonably vertical.
- There is some loss of section to webs of steel columns at the base.

Typical Steel Frame to Front of Building

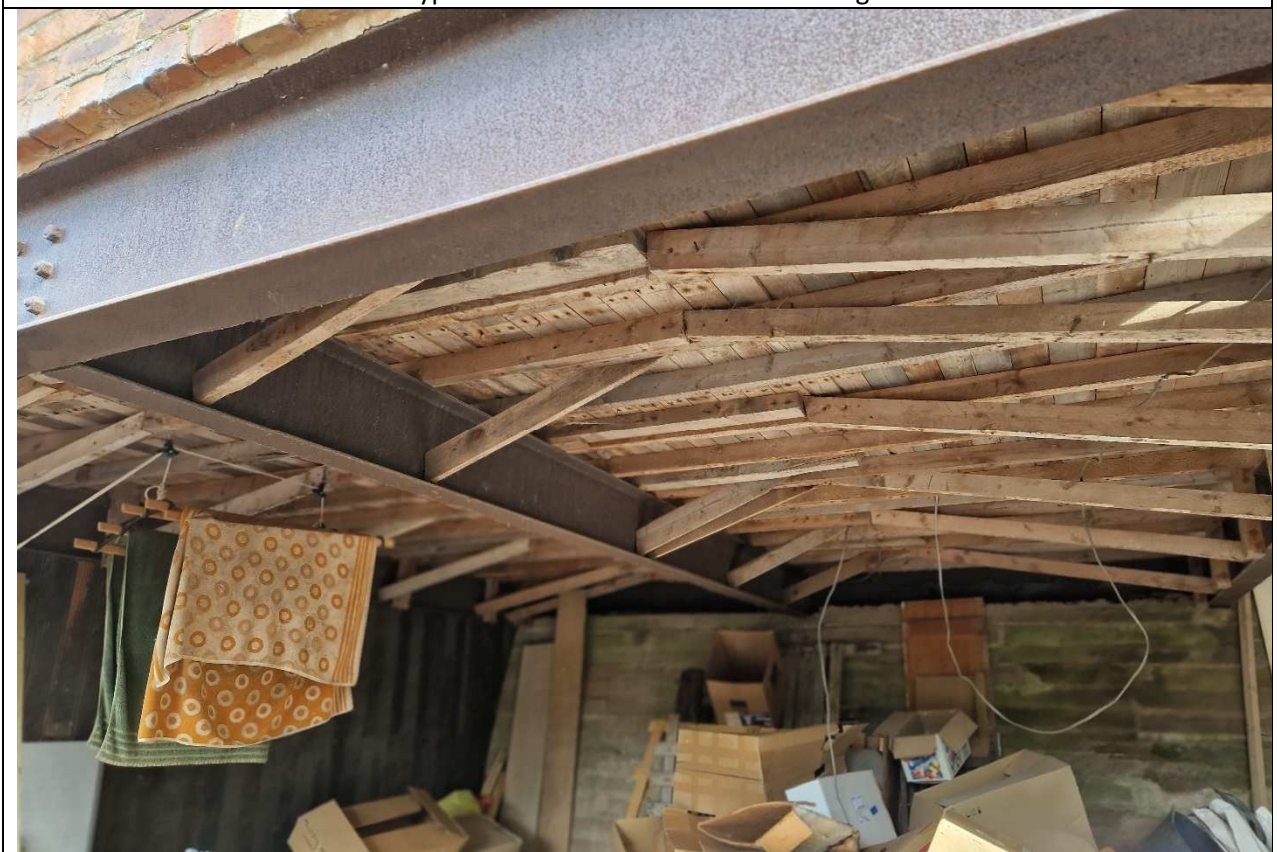
Steel Frame Support to 1st Floor Joists

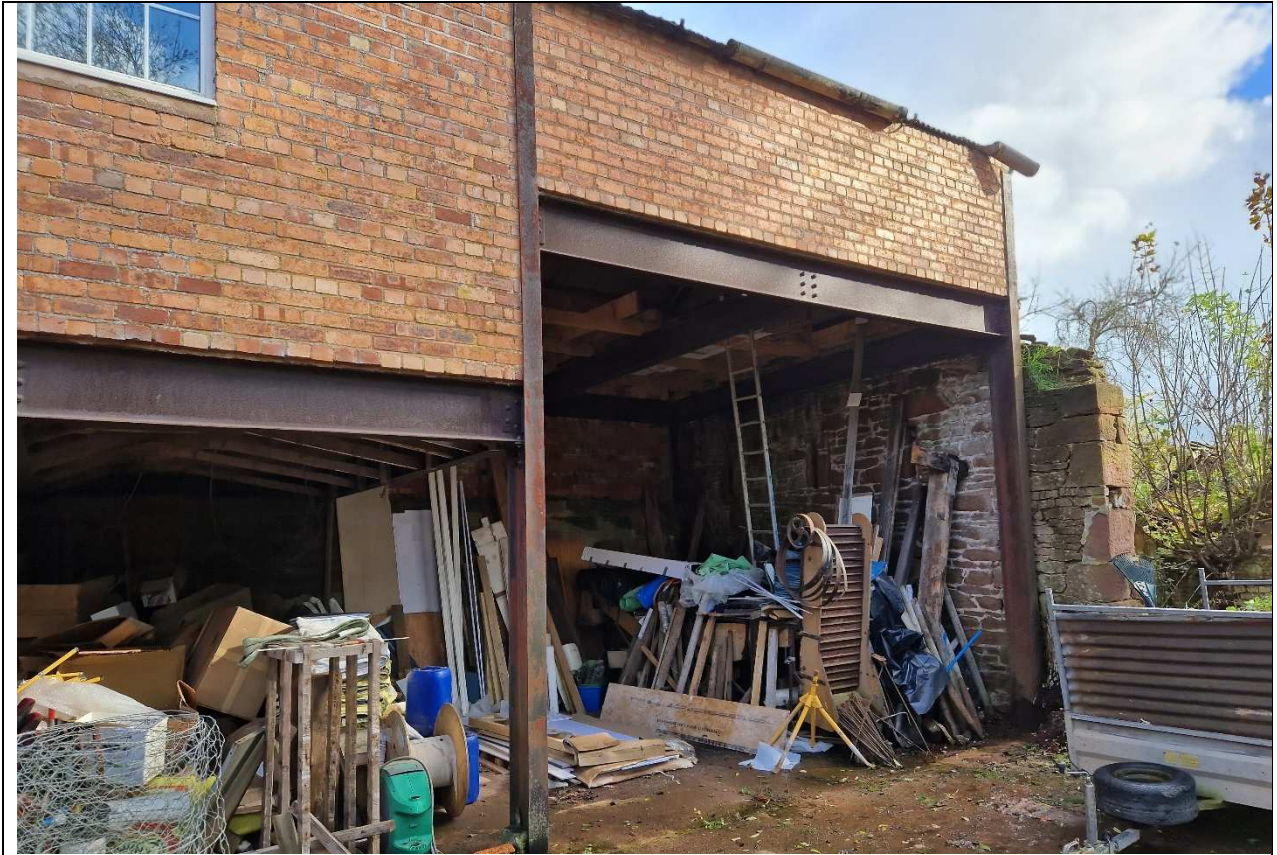
Split Level Frame at Front Right

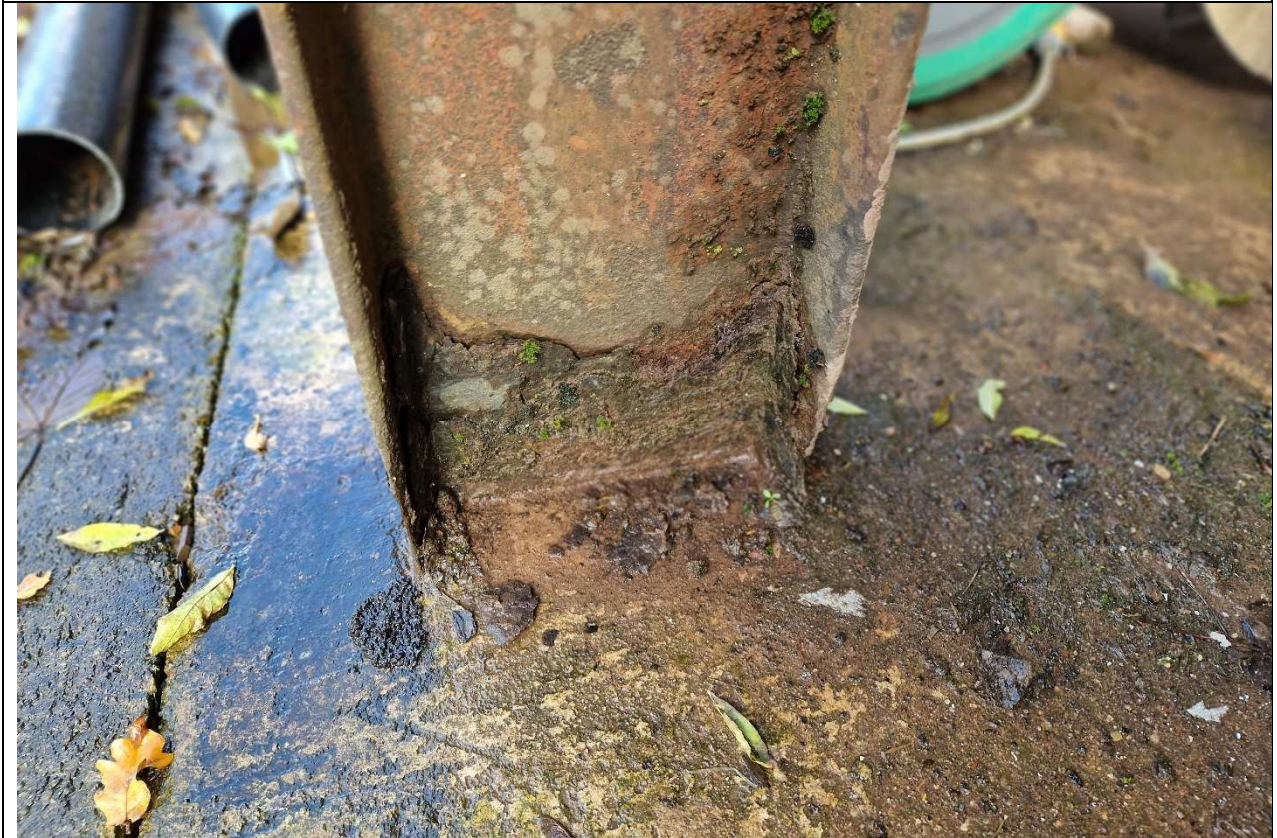
There is some decay evident at the bases of some of the steel columns, however, this appears to be largely confined to the webs, and can be plated.

Steel Breakdown to Webs of Columns at Front

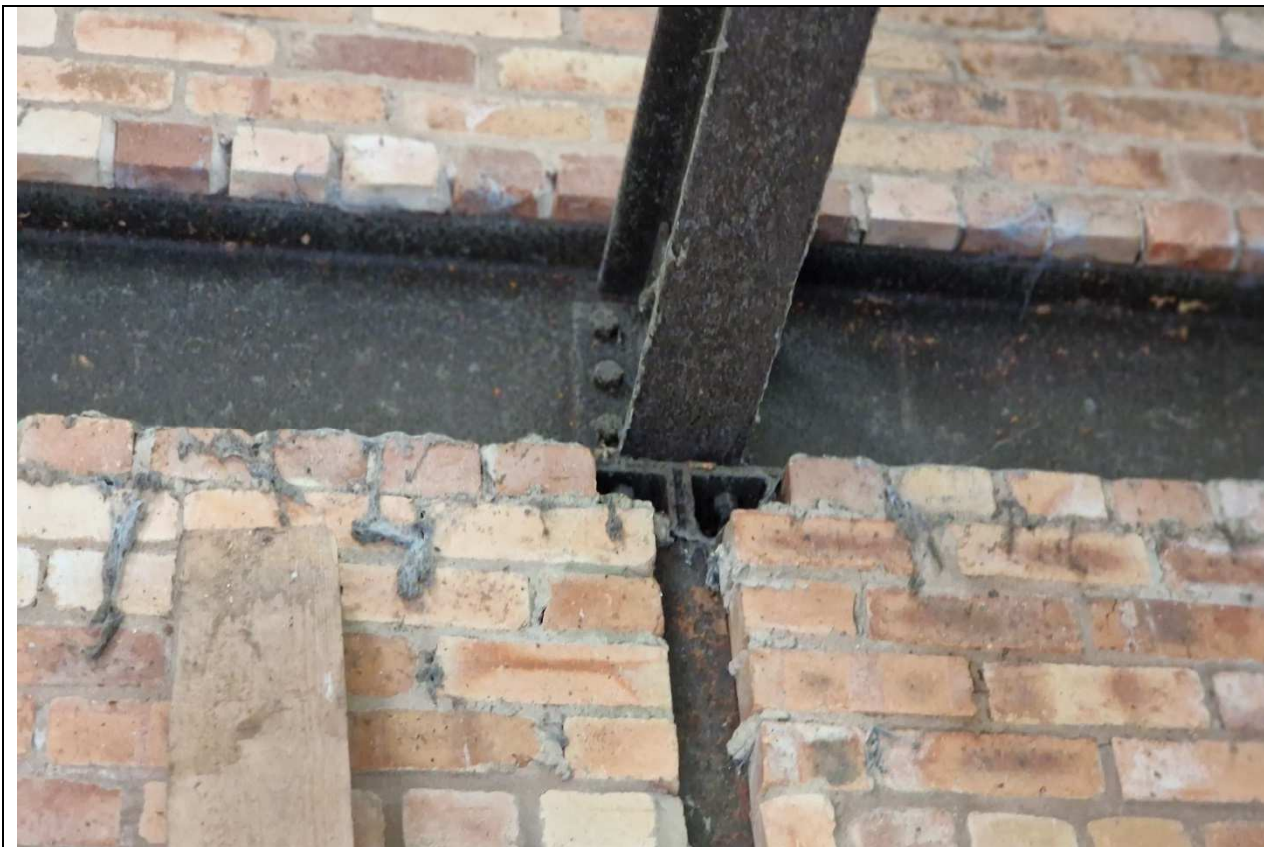
- 1st floor wall exposed only.
- Masonry is reasonably vertical and free of significant structural cracking.
- Steel pots are exposed to the outer flange and has significant surface corrosion.

Secondary Steel Report to Rear Wall

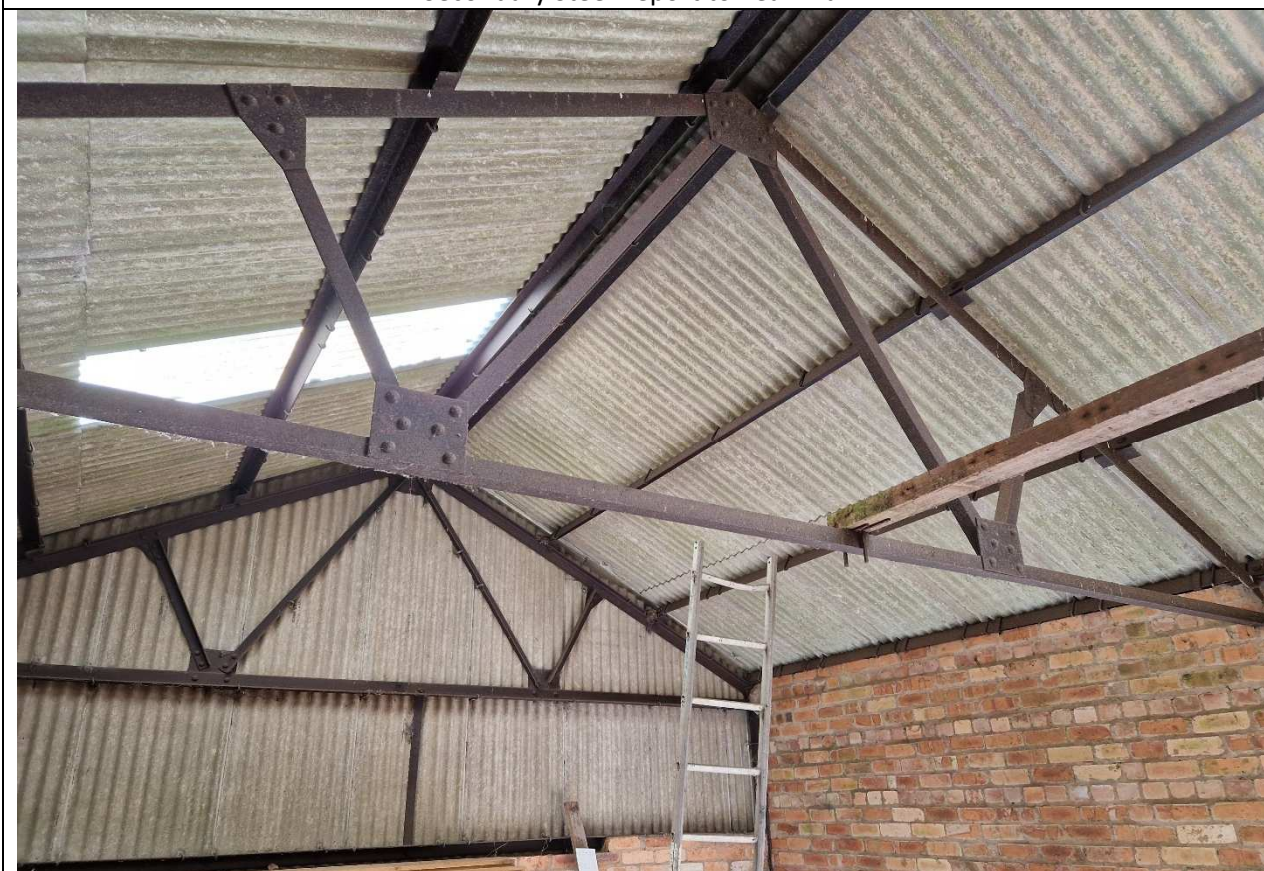
- Exposed trusses to roof have surface corrosion but are in reasonable condition.
- Trusses at some locations sit over the steel columns to the main frames but sit on masonry at other locations.
- Trusses have a 80x80RSA top chord member with the bottom chord and internal members from 60x60RSA. The truss spans 5.25m between walls.
- Purlins to the roof are 80x80RSA spaced at a maximum of 1.2m centres.
- Walls at 1st floor found to be reasonably vertical, but uneven, with no significant structural cracking.

Typical Trusses Supporting Existing Roof

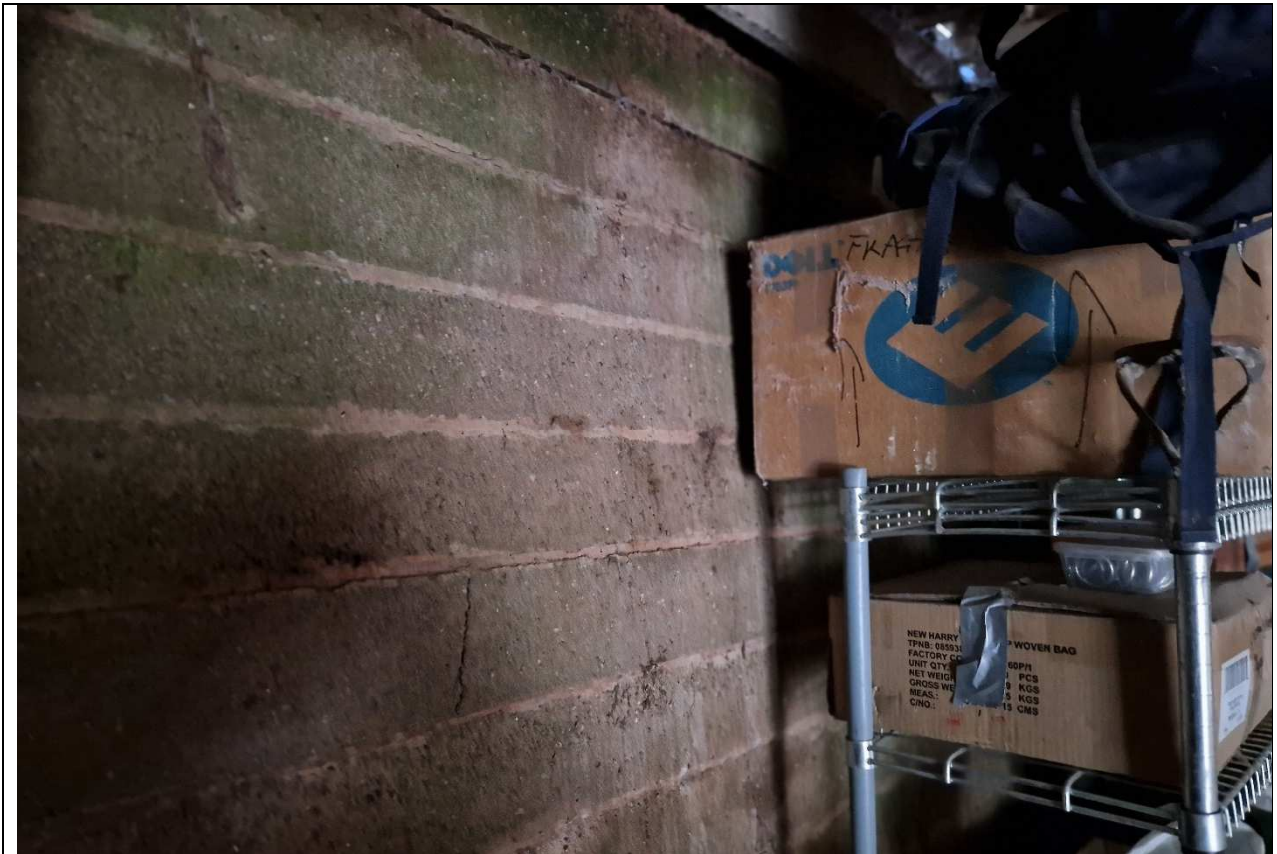
Retaining Wall to Left Side Wall at Ground Floor Level

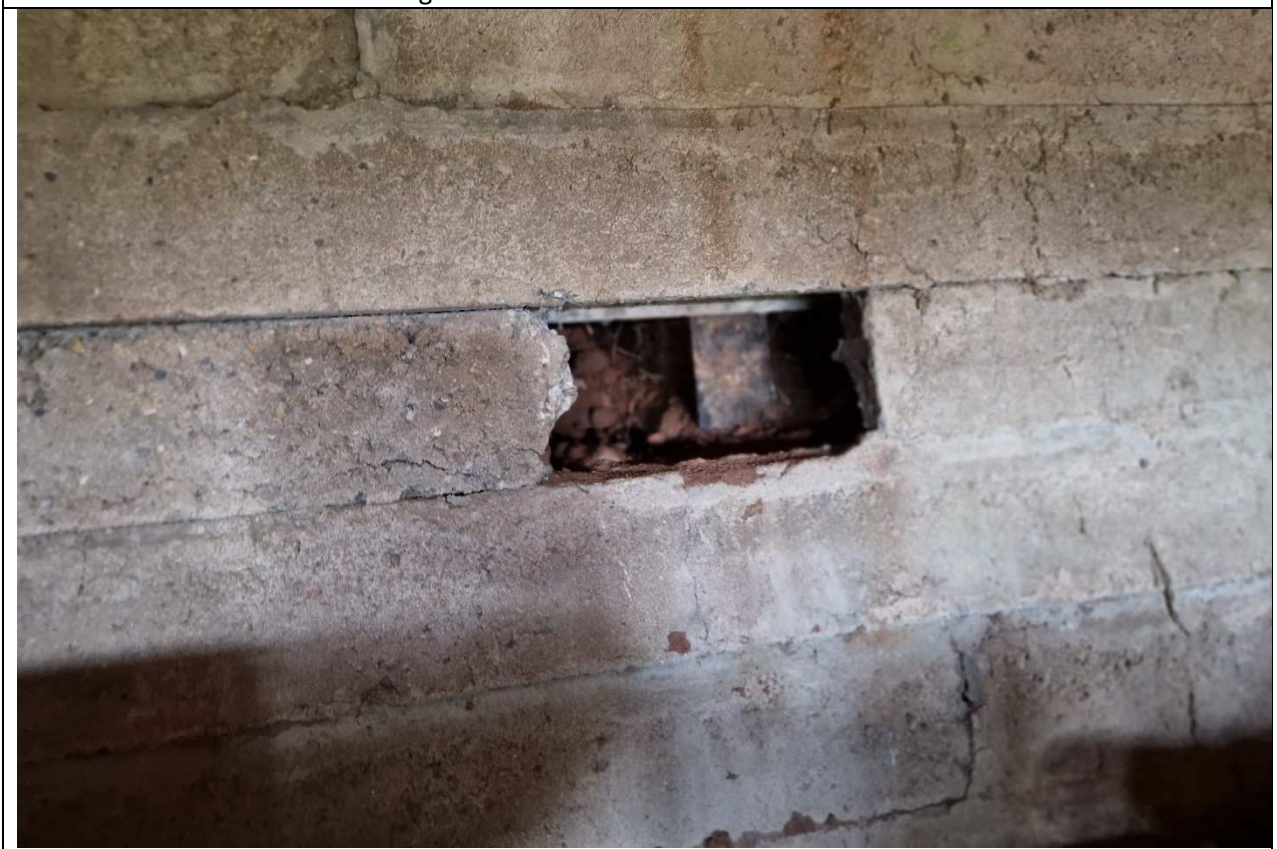
Void in Retaining Wall to Rear Wall

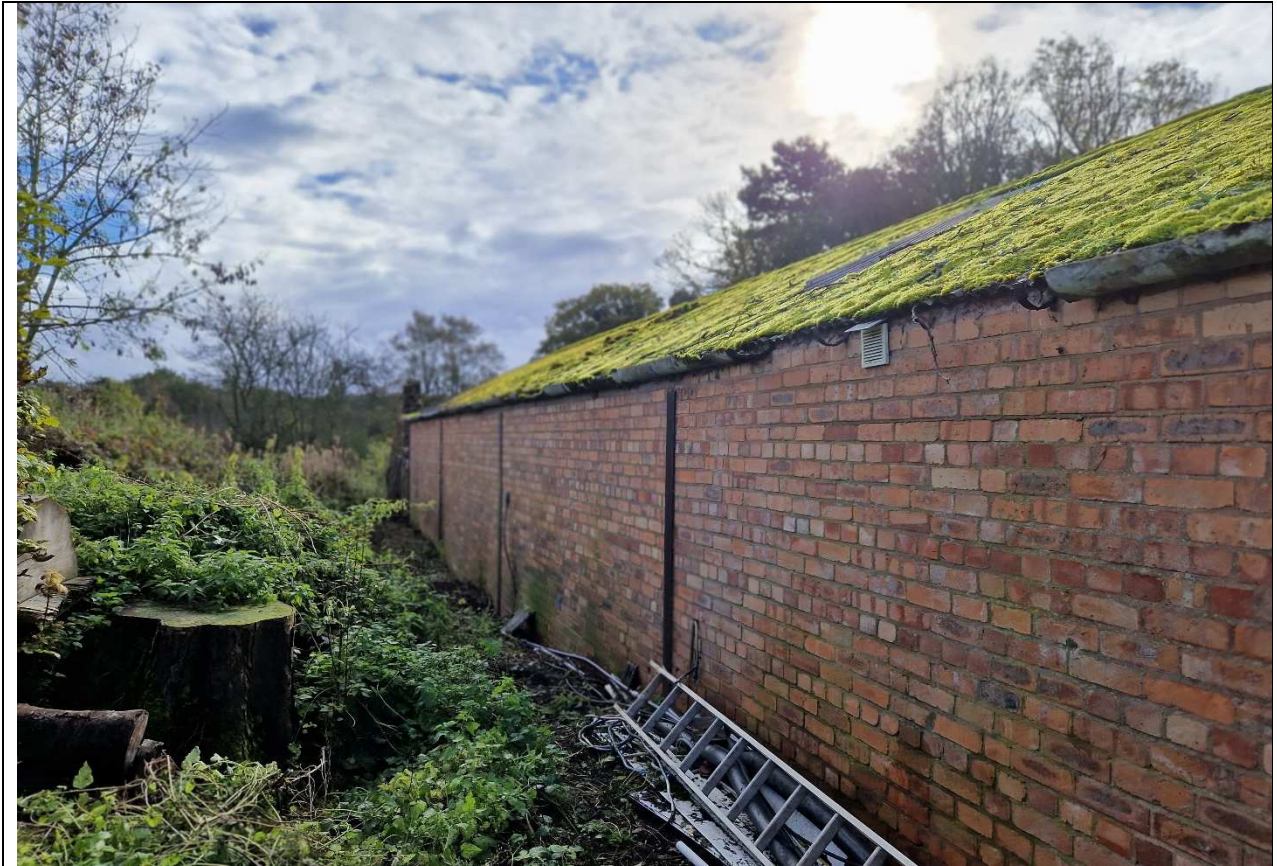
Rear Elevation at High Level

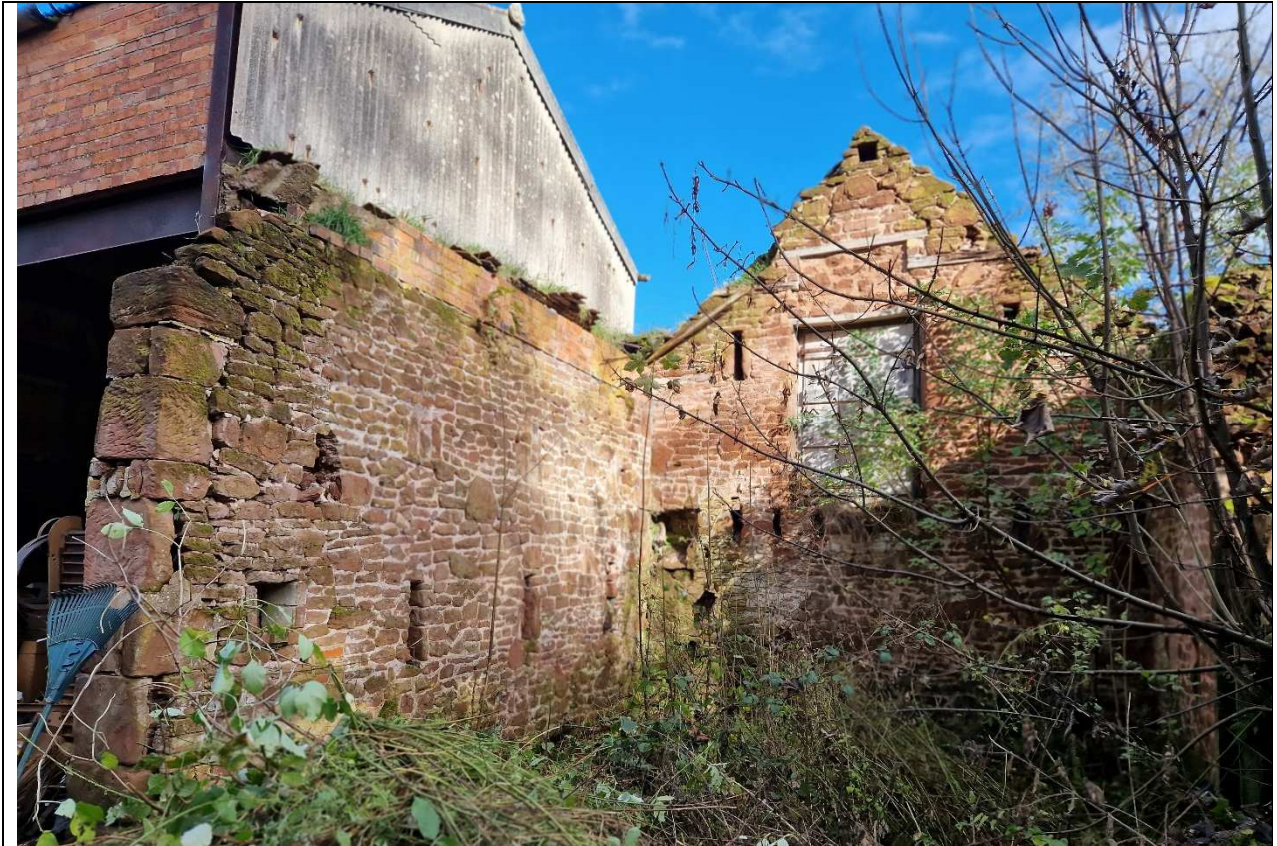
The remaining masonry walling to the old barn is in poor condition. To the East, the wall is retaining the ground beyond. We understand that a new decking area is proposed at this location, the decking should therefore be used to restrain the masonry walling and assist in resisting the retaining effects. The free standing wall above the decking should be reduced to a maximum height of 2.0m.

Old Barn Walls to East

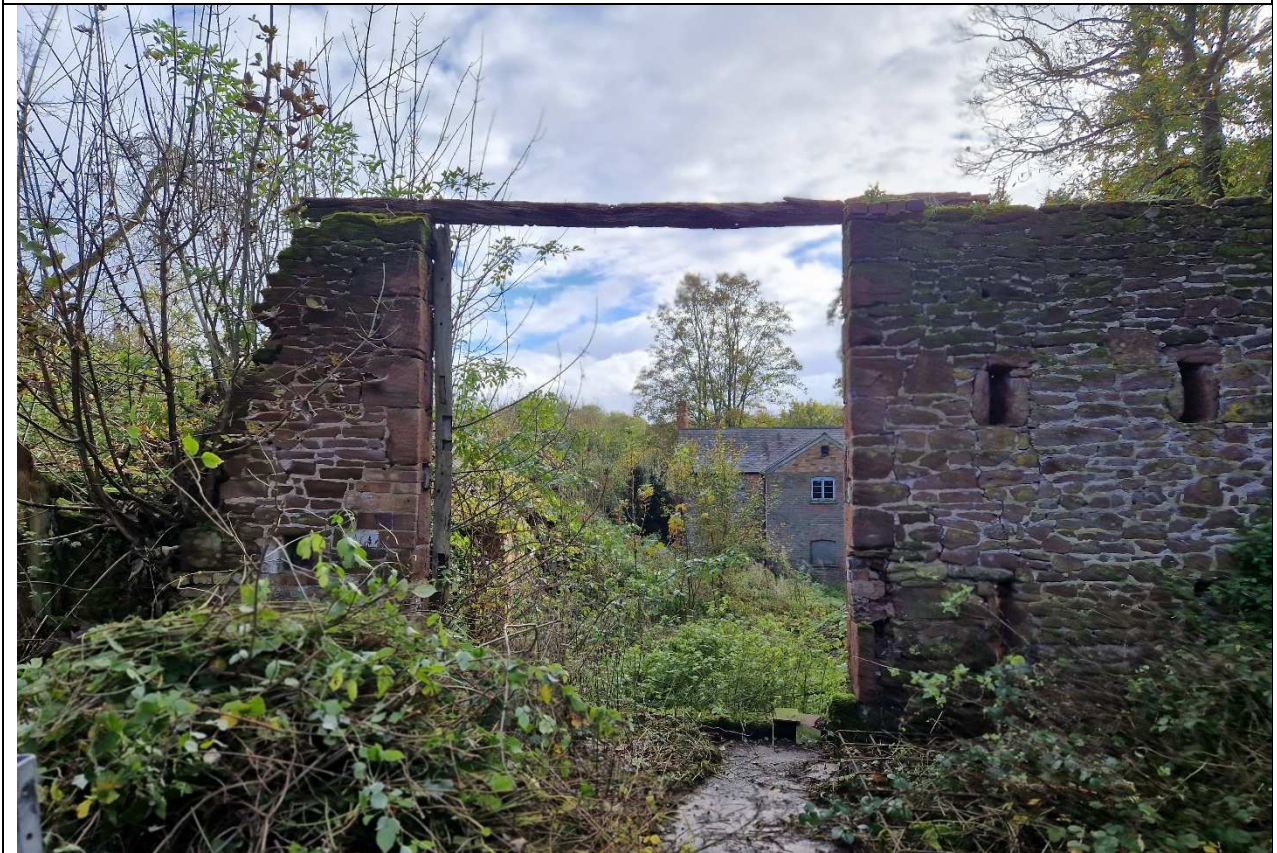
Rear Old Barn Wall With Large Opening

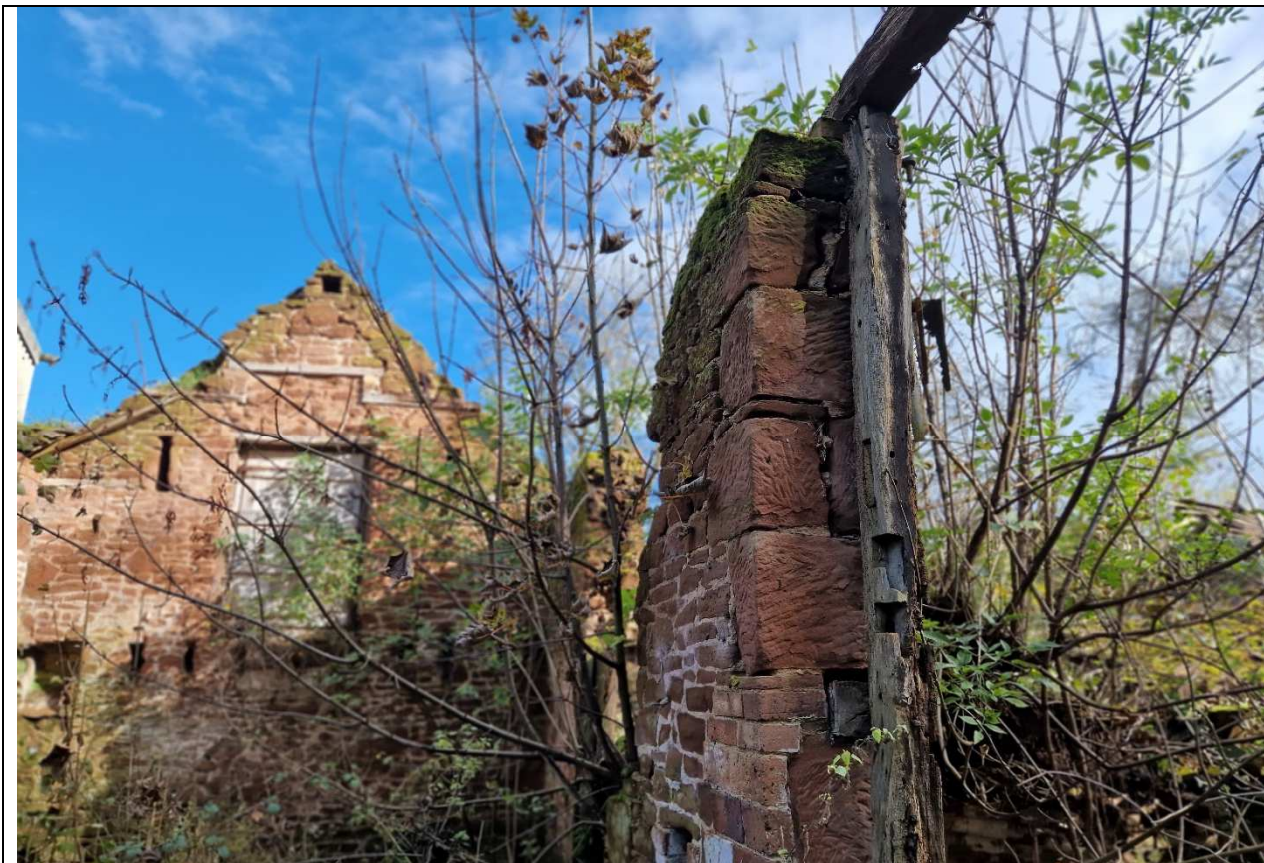
Partial Collapse and Lean to Rear Wall of Old Barn

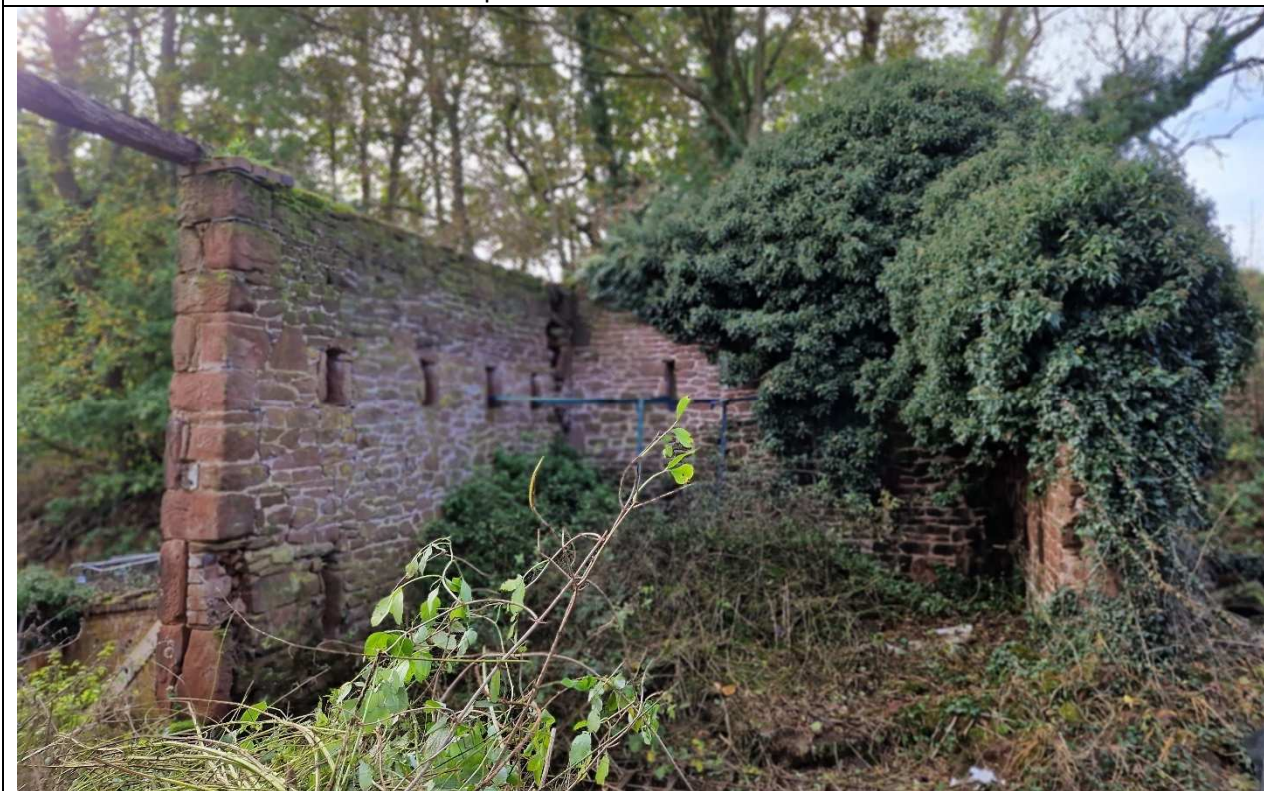
The walls at the West side of the building are in very poor condition and lean significantly. The walls should be reduced in height to a maximum of 2.5m and lateral restraint posts be installed to provide support. This could be done by installing a new canopy frames structure to tie the walls.

Old Barn Walls to West
