# Arboricultural Consultancy for Lloyds Bank

Insured		Address	4 Witley Lodge Close, Cheltenham , GL51 3LW		
Client	Subsidence Management Services	Contact	Brad Jenkins	Claim No.	IFS-LBG-SUB-22-0102485
ES Ref	SA-250762	Consultant	Simon Nash	Contact No.	
Report Date	27/10/2022

# GEOTECHNICAL

# SOIL ANALYSIS

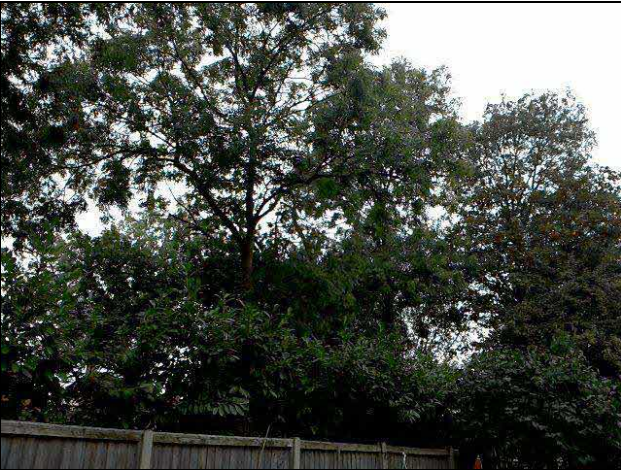
T4 - Ash

With due regards to species profile, size and proximity, T2 (Ash), T4 (Ash) and T5 (Oak) are considered the dominant features proximate to the focal area(s) of movement and accordingly, where vegetation is confirmed as being causal, we have identified them as the primary cause of the current subsidence damage.

Consequently, we have advocated the complete removal of T2 (Ash), T4 (Ash) and T5 (Oak) as it will offer the most certain arboricultural solution likely to restore long-term stability.

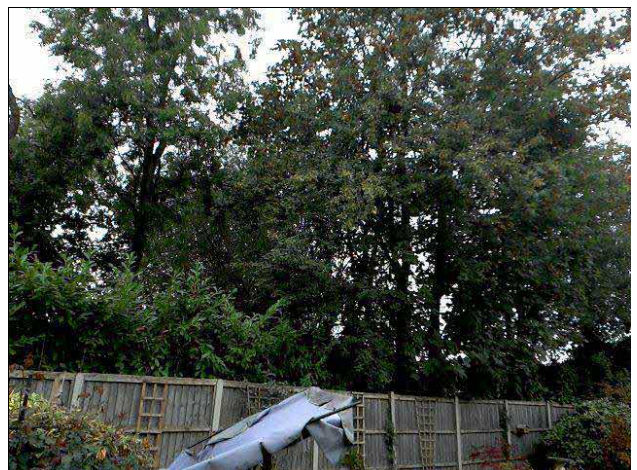
T7 - Damson

T7	Damson	2	10.2	12.3	A - Third Party	No action	No works.
TG1	Mixed Species Group: containing ash, sycamore, willow	3	17	15.1	A - Third Party	Action to avoid future risk	Maintain at broadly current dimensions by way of regular pruning.

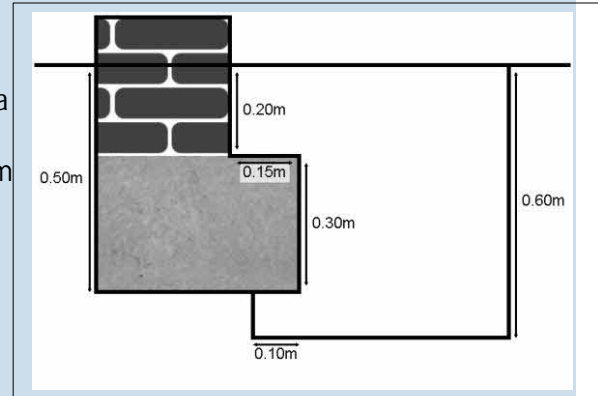
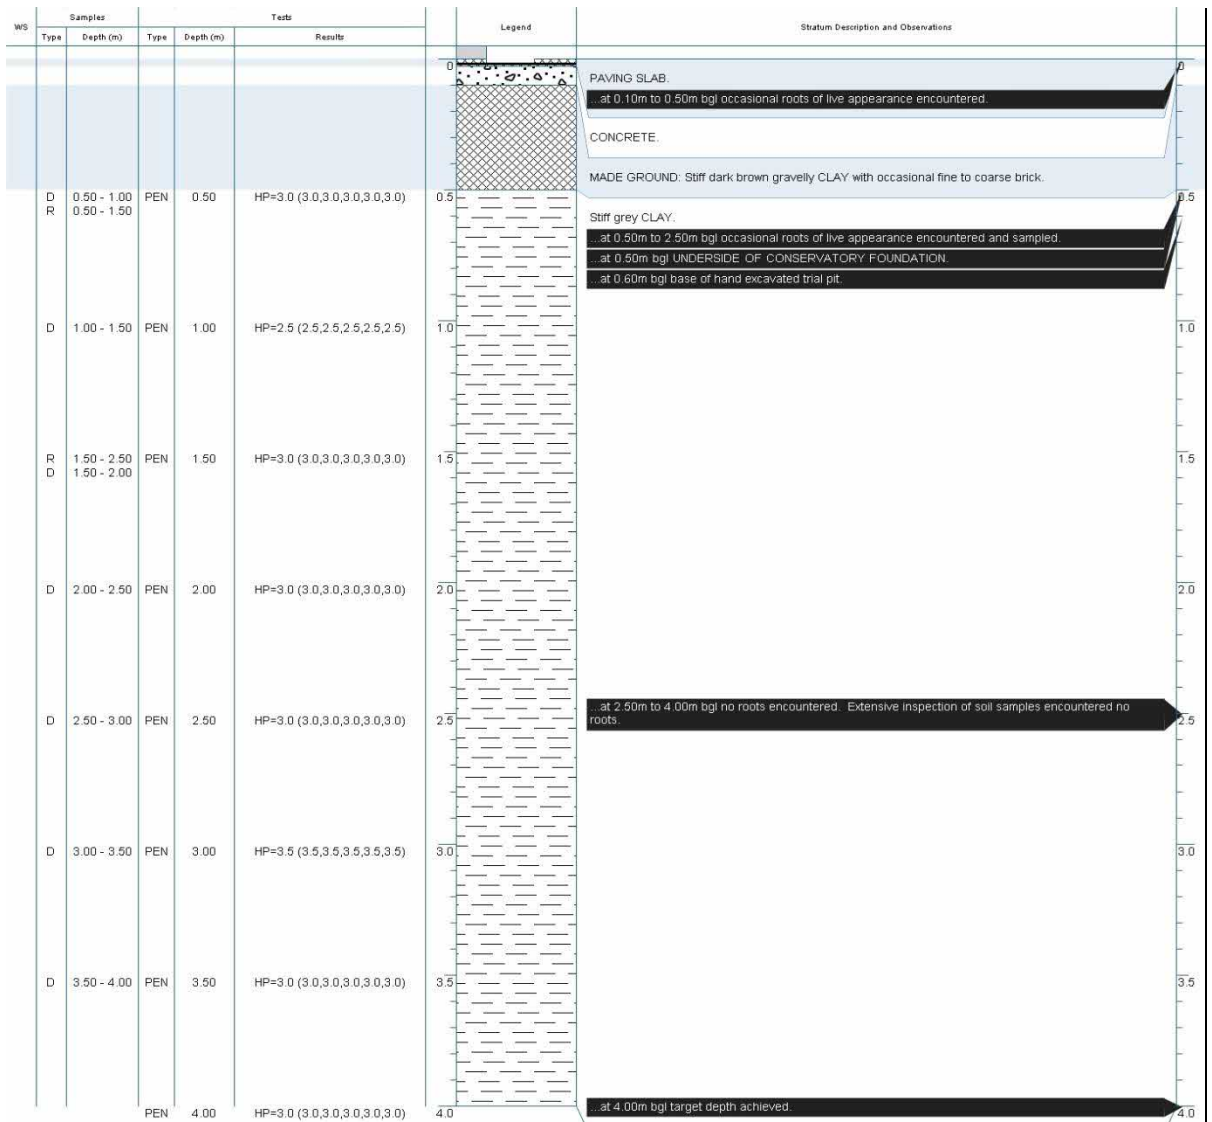
## TP/BH1 Foundation Detail and Borehole Log

Conservatory foundation comprised of brick wall to 200mm bgl, bearing on concrete to 500mm bgl, with a total projection of 150mm from the elevation. Underside of foundation (USF) was exposed to 100mm back from the face of the foundation and probed 300mm back from the face of the foundation.

— End of borehole at 4.00m —  
Trial pit excavated to 0.60m bgl. Borehole completed by hand held percussive window sampler. Roots encountered to 2.50m bgl. Groundwater strikes not encountered.

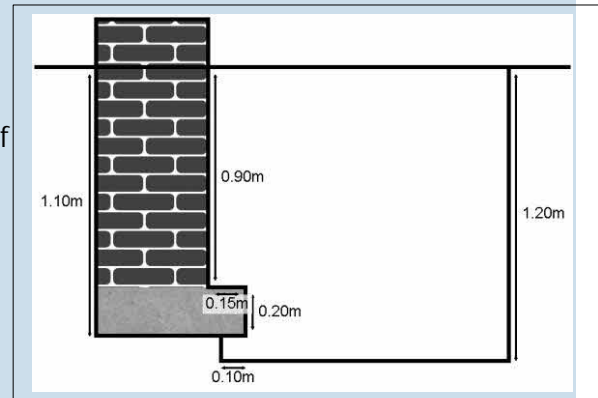
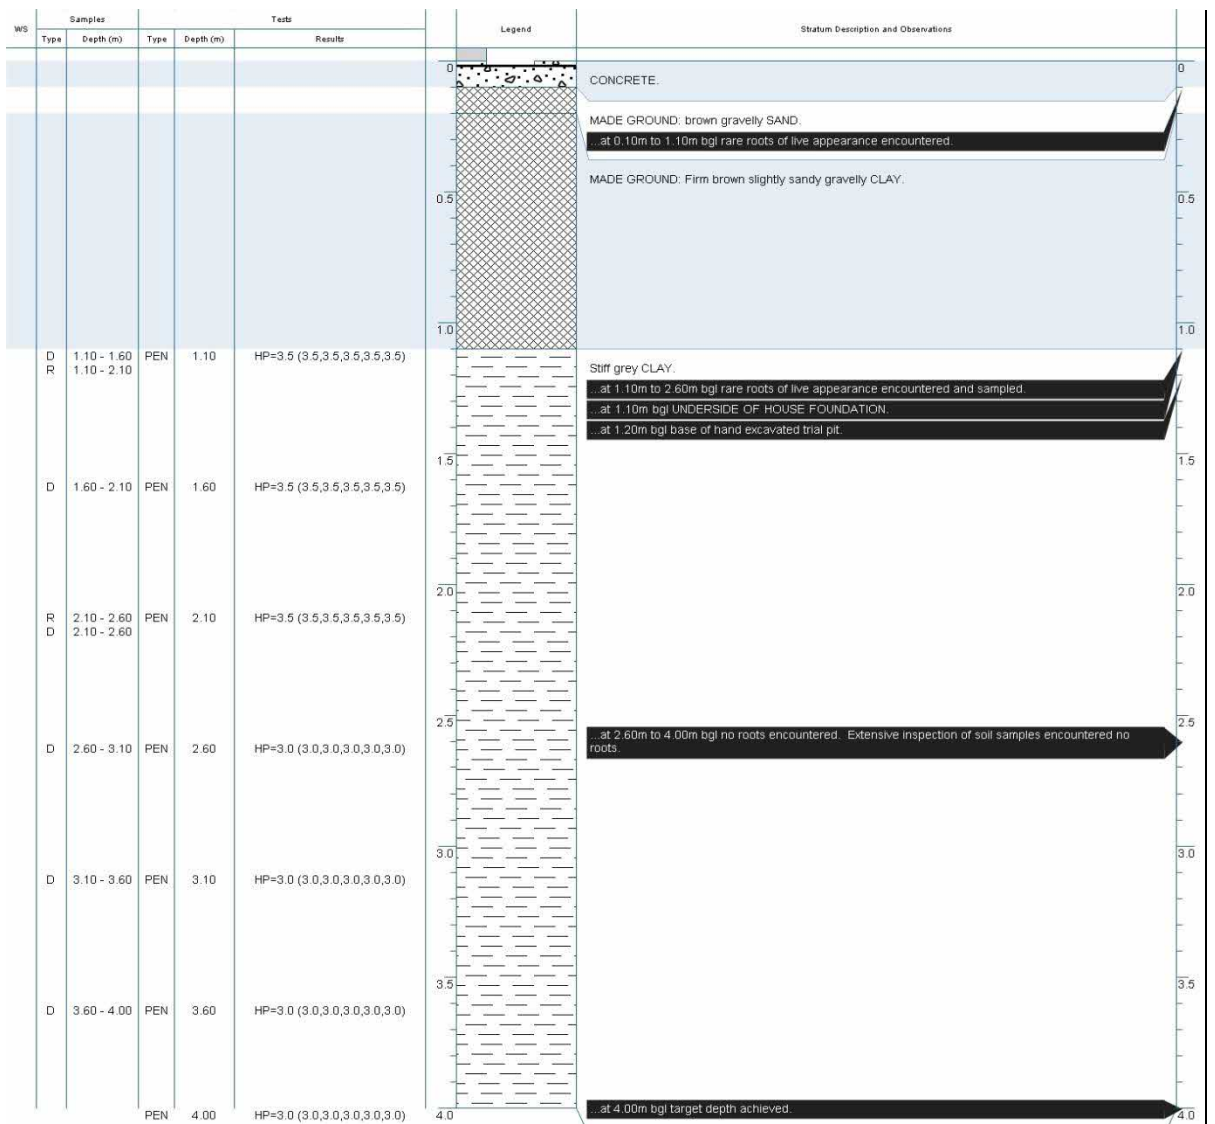
## TP/BH2 Foundation Detail and Borehole Log

House foundation comprised of brick wall to 900mm bgl, bearing on concrete to 1100mm bgl, with a total projection of 150mm from the elevation. Underside of foundation (USF) was exposed to 100mm back from the face of the foundation and probed 300mm back from the face of the foundation.

— End of borehole at 4.00m —  
Trial pit excavated to 1.20m bgl. Borehole completed by hand held percussive window sampler. Roots encountered to 2.60m bgl. Groundwater strikes not encountered.

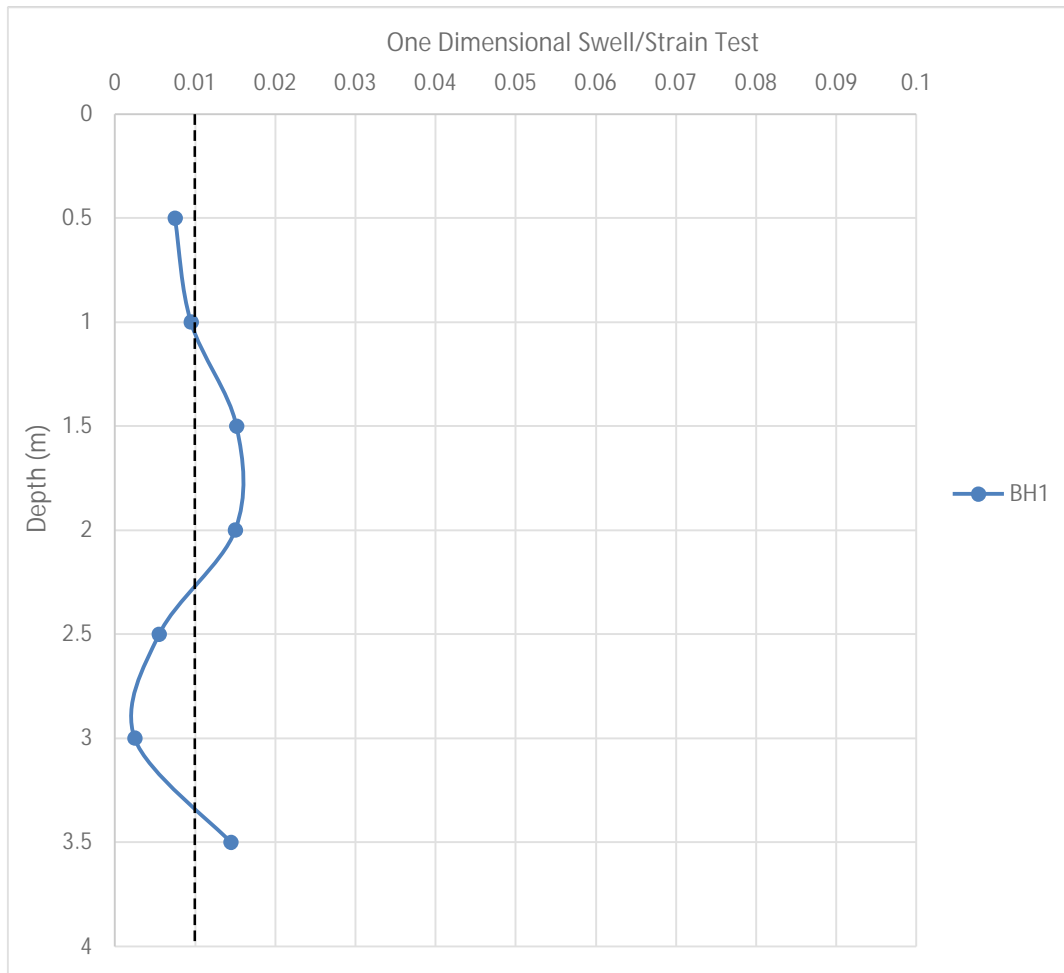
### Summary of Oedometer Testing for BH1

BH 1 estimate of heave	11mm
------------------------	------

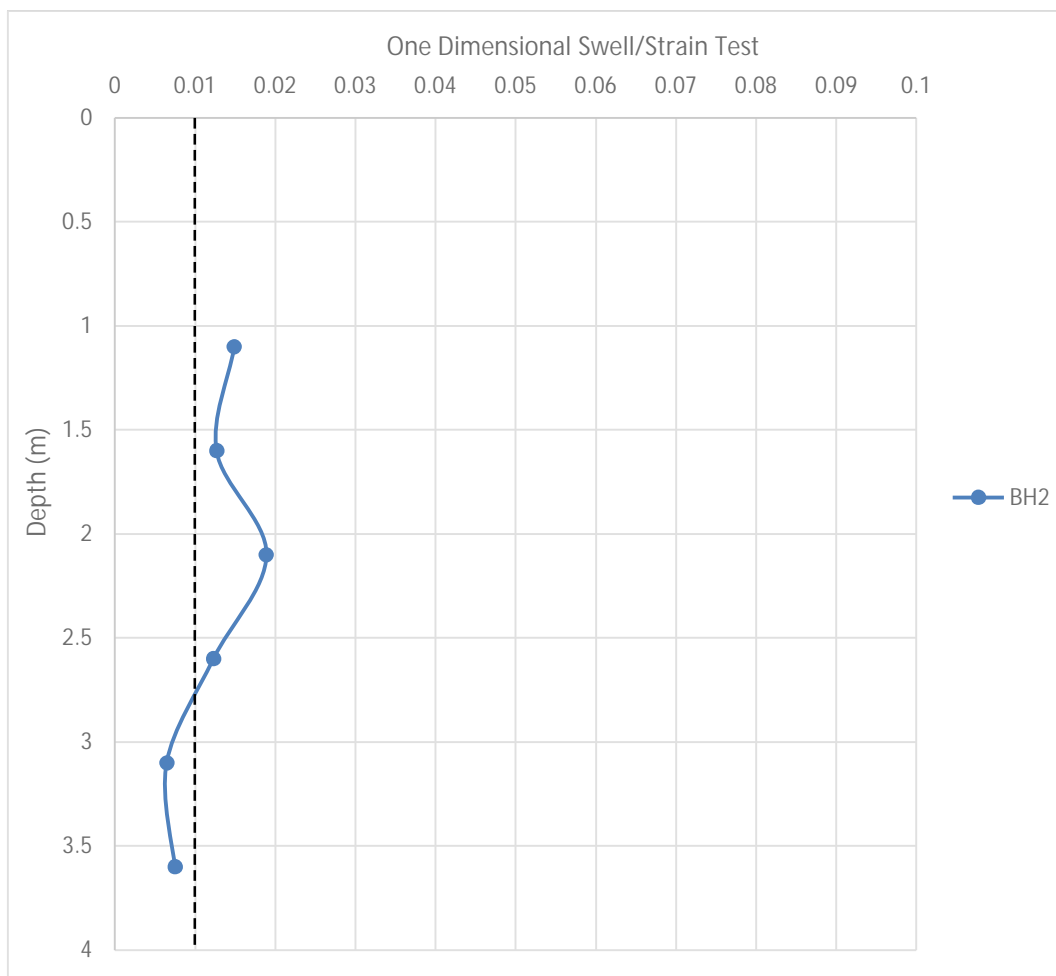
Summary of Oedometer Testing for BH2

BH 2 estimate of heave	19mm
------------------------	------

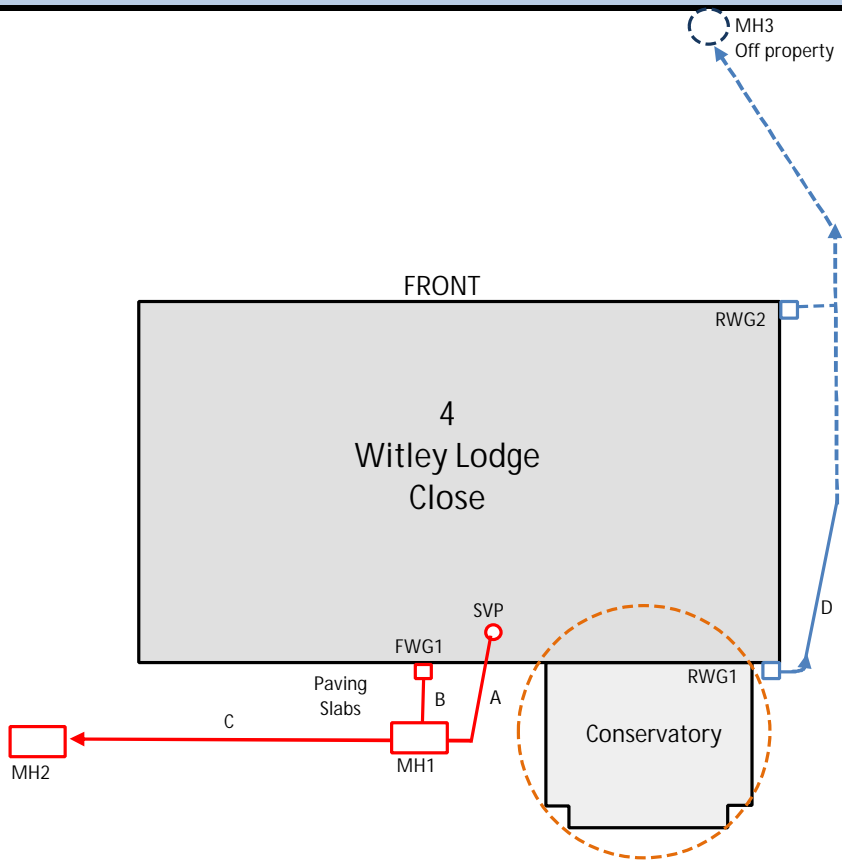
Run D

We have tested the pipework from RWG1 downstream for over 10m and confirmed this is watertight  
We Dye tested the pipework and found this flows into a manhole in the road approxc 30m from the property
