## Structural Survey Report

## Burley Appliances Ltd, 4 Lands End Way, Oakham LE15 6RB

Reference: 82339-01

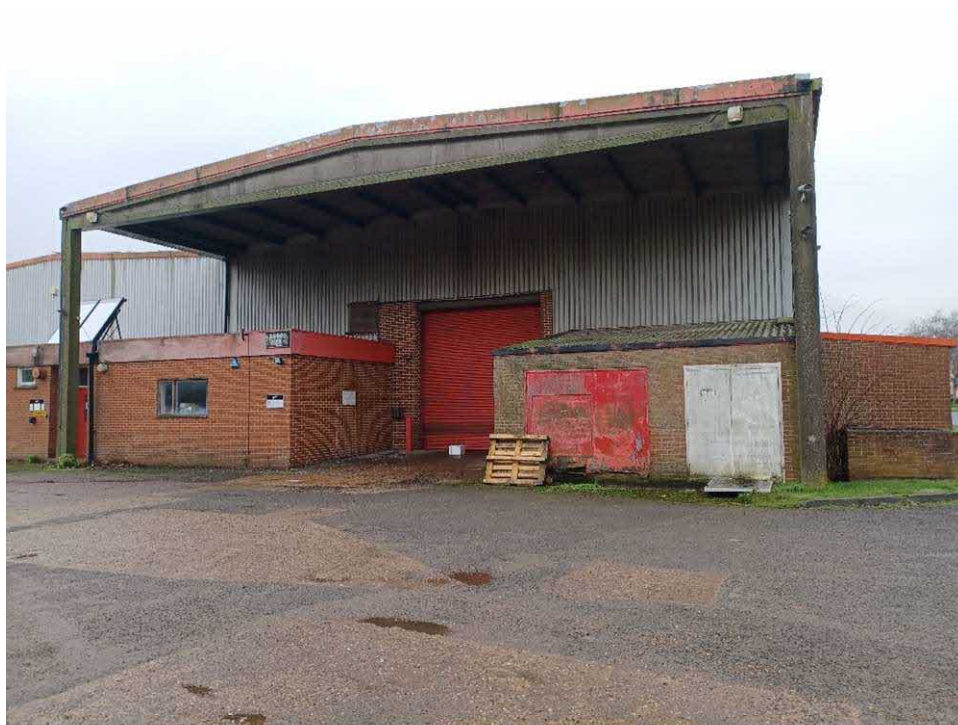
Photograph 1

- 2.1.2 In addition, there were single storey loadbearing masonry office and amenity buildings standing adjacent to the main building.
- 2.1.3 To the rear of the main building there was a steel framed canopy structure, which was independent of the concrete building. This provided protection from the elements over the loading bays (photograph 1)

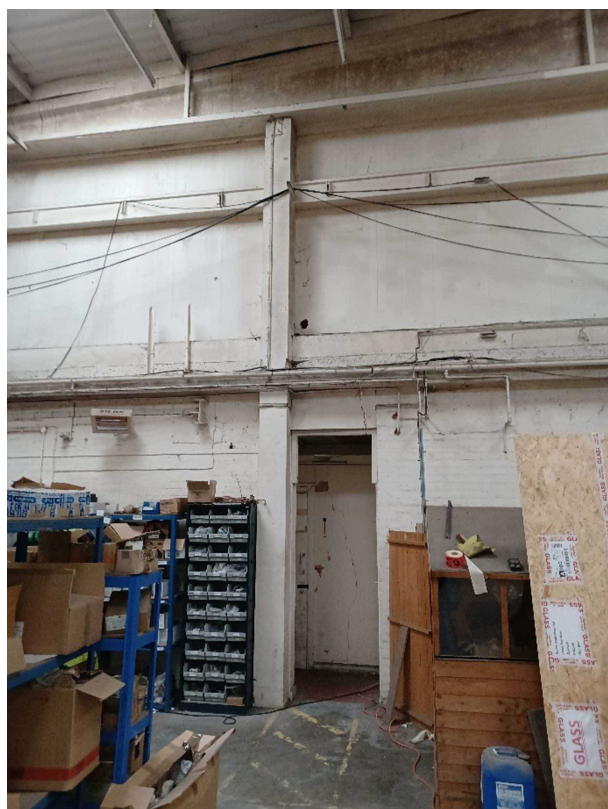
Photograph 2

- 2.1.5 The front gable was formed with brick masonry full height to eaves level, whereas the walls to the sides and rear were brick masonry to part height with sheeting over. The sheeting rails to the sides and rear were of concrete spanning between the portal frames (photograph 2).

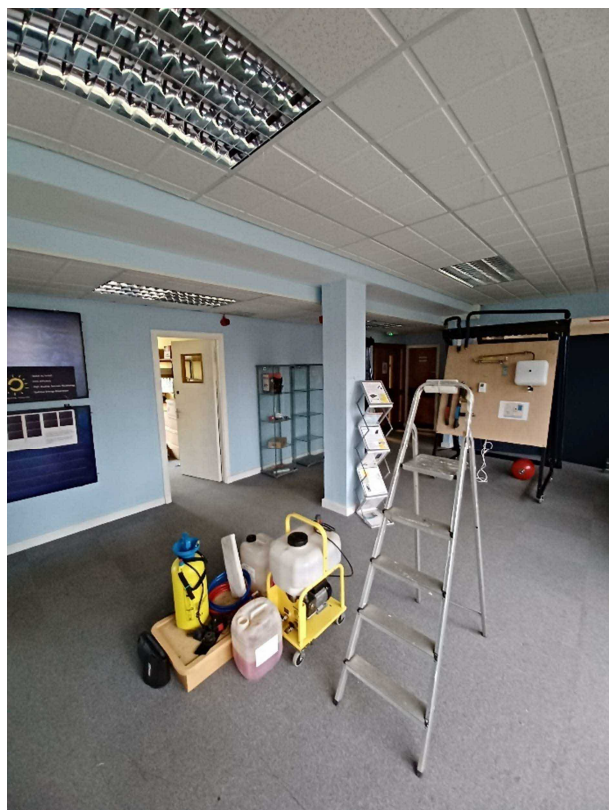
Photograph 3

- 2.2.1 The office building was a two storey concrete framed building in two distinct wings with a central core/stair area. The concrete frames were precast with concrete columns positioned within the external wall constructions and expressed externally. A single row of internal concrete columns extended from ground to first floor, midway between the external walls (photograph 3).

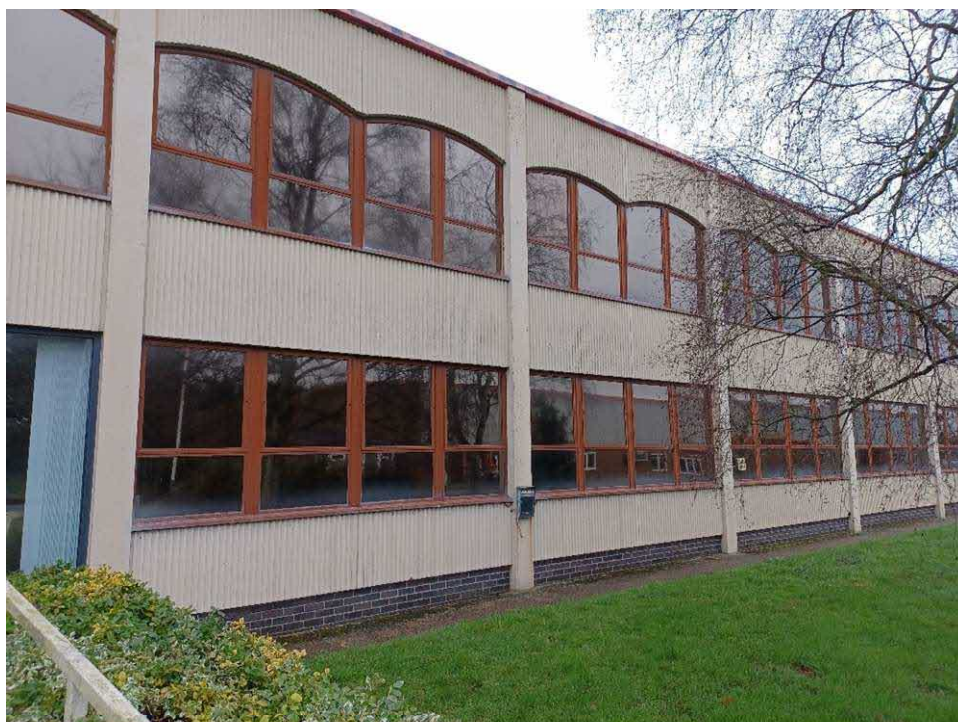
Photograph 4

- 2.2.5 External walls were formed using precast concrete panels, with a profiled textured surface finish to the outer face. The inner leaf was of blockwork. The soffit of the precast concrete panels over the first floor windows was profiled to form a double arch opening (photograph 4).

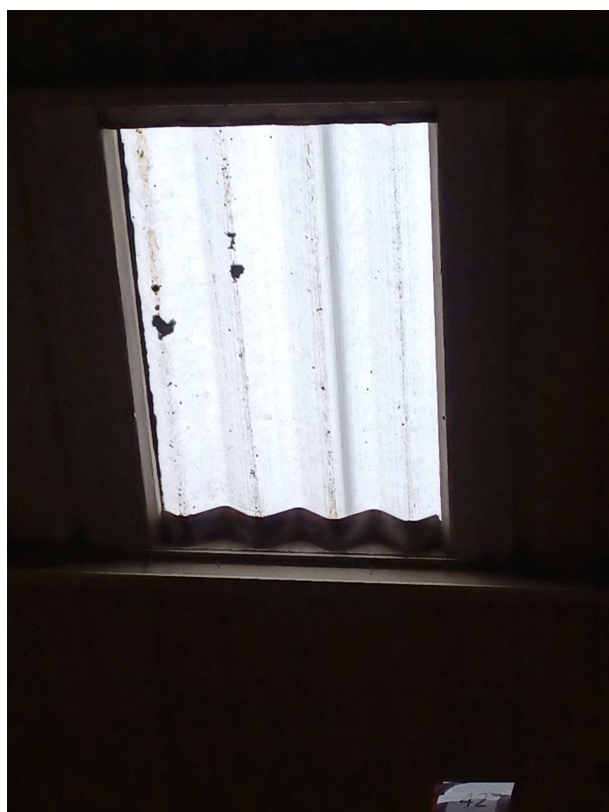
Photograph 6

- 3.1.4 The rooflights were of polycarbonate which deteriorates over time under UV light. Under these conditions the material would become brittle and the loadbearing capacity would deteriorate (photograph 6).

- 4.1.1 The roof covering will need to be replaced to address the issues with water ingress and inadequate thermal properties. The new roof covering may require additional or wholesale new purlins to support the additional loading.

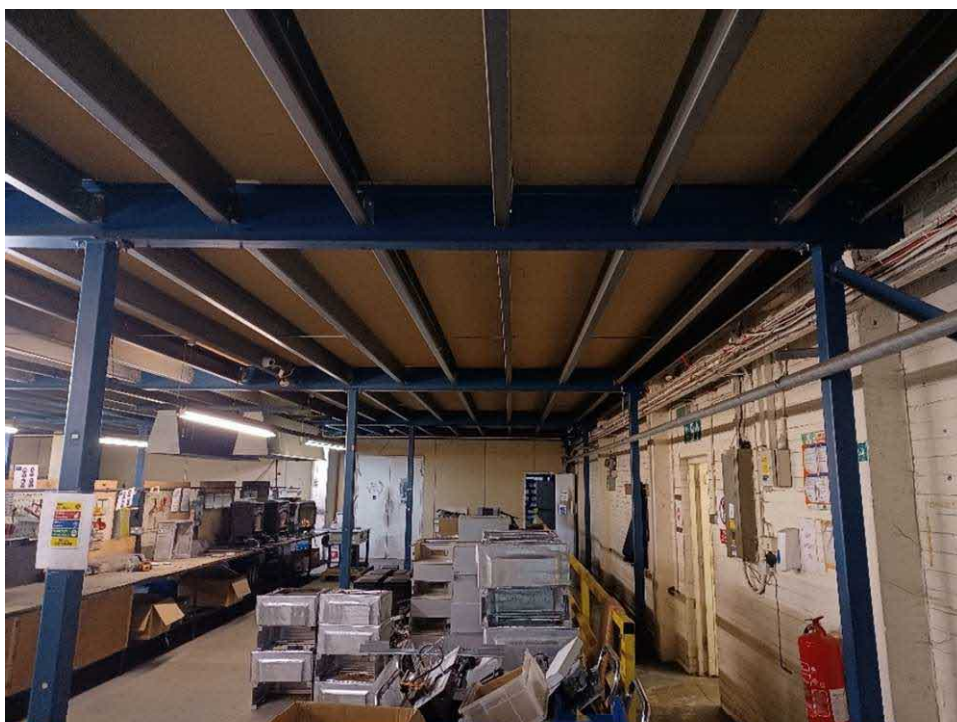
Photograph 8

- 3.1.6 The heat retaining structure was independent of the main building frame and may be removed without compromising the stability of the rest of the structure (photograph 8).

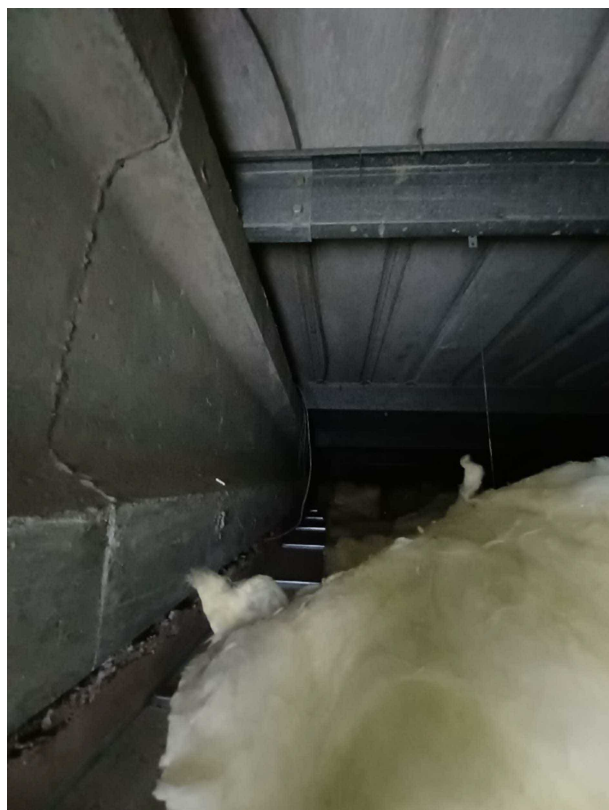
Photograph 9

- 3.2.2 The gutters were leaking in several places resulting in ingress into the buildings. This was due to the position of the gutter being within the external wall line. It appeared this had been an ongoing problem as there were indications that repairs had been attempted previously (photograph 9).

- 4.2.1 The roof coverings will need to be upgraded to address the issues with water ingress and inadequate thermal properties. Over cladding the existing system will be limited by the load capacity of the main concrete roof beams and the cold rolled purlins. This will need to be assessed by a qualified structural engineer.

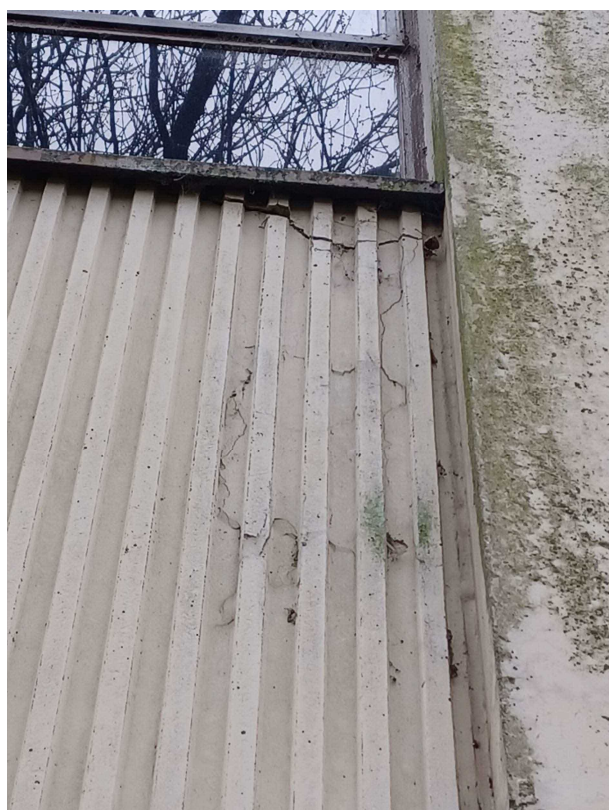
Photograph 10

- 3.2.3 There did not appear to be any issues relating to the principal concrete beams, columns and floors forming the concrete frame.
- 3.2.4 Instances were noted where the precast panels in the external walls were cracked in areas. It is anticipated these defects related to the fixings between the panels and the concrete frame. Intrusive investigation was warranted in a number of locations to determine the condition and nature of the panel fixings together with any remedial measures required (photograph 10).

- 4.2.2 External walls will need to be upgraded to improve their thermal characteristics and to meet current standards for renovated buildings. Intrusive investigations will need to be carried out to determine how the external walls were formed and the method of fixing the precast wall panels to the concrete frame. This will also enable the condition of the fixings to be checked and any remedial works to be determined.

- 4.2.3 Some localised concrete repairs to the external precast concrete wall panels will be required to prevent further deterioration of both the wall panel and to prevent water ingress. These defects may be indicative of a deterioration of the fixings between the concrete panels and the concrete frame. See 4.2.2 above.

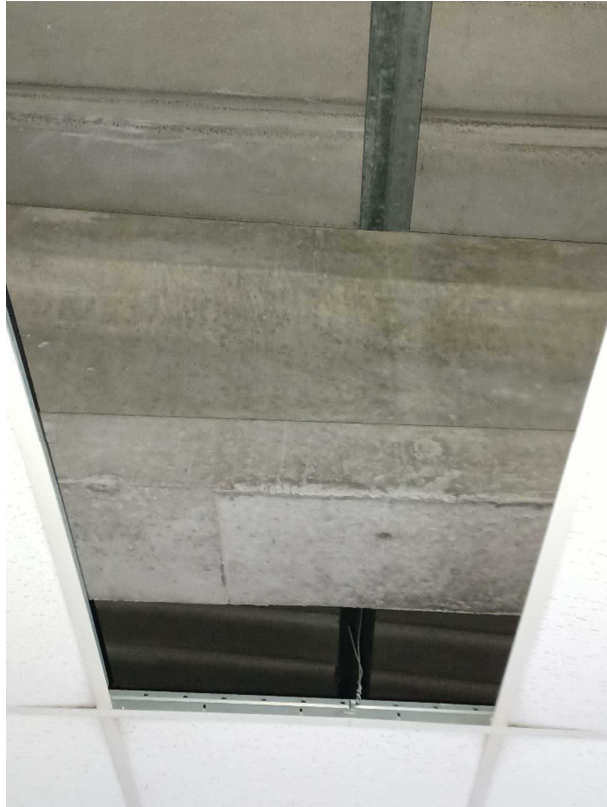
Photograph 11

- 3.3.1 This office building was a similar form of construction to Building 2. The same roof build up was employed with an outer sheet of Bix Six profiled asbestos/cement sheets, spacer bars with insulation between and a profiled liner panel (photograph 11).
- 3.3.2 The insulation noted within the roof construction appeared inadequate in meeting current thermal insulation standards.

- 4.3.1 The roof coverings will need to be upgraded to address the issues with water ingress and inadequate thermal properties. Over cladding the existing system will be limited by the load capacity of the main concrete roof beams and the cold rolled purlins.

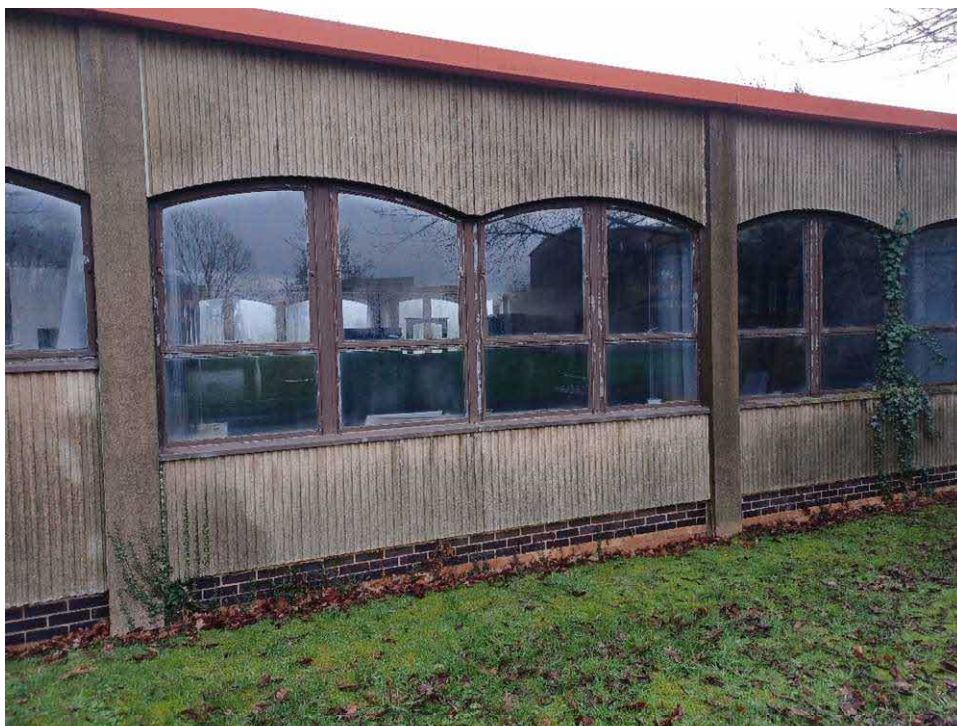
Photograph 12

- 3.3.3 The precast beams above the windows had an arched profile soffit. This same profile was visible internally. It was anticipated that the external wall construction would not meet current standards with regards to thermal insulation (photograph 12).

- 4.3.2 External walls will need to be upgraded to improve their thermal characteristics and to meet current standards for renovated buildings. Intrusive investigations will need to be carried out to determine how the external walls are formed and the method of fixing the precast wall panels to the concrete frame. This will also enable the condition of the fixings to be checked and any remedial works to be determined.
- 4.3.3 The sub division of this building will require new partitions to be introduced. Lightweight partitions may be borne by the ground bearing concrete slab. This may include certain types of walls constructed using lightweight concrete blocks but this should be checked by a qualified engineer.
