JAMES BLAKE ASSOCIATES

Our Ref: JBA 24/006 ECO01 SM

Preliminary roost assessment (PRA) of potential bat roost features of 25 Furze Close, Thurston, Bury St Edmunds

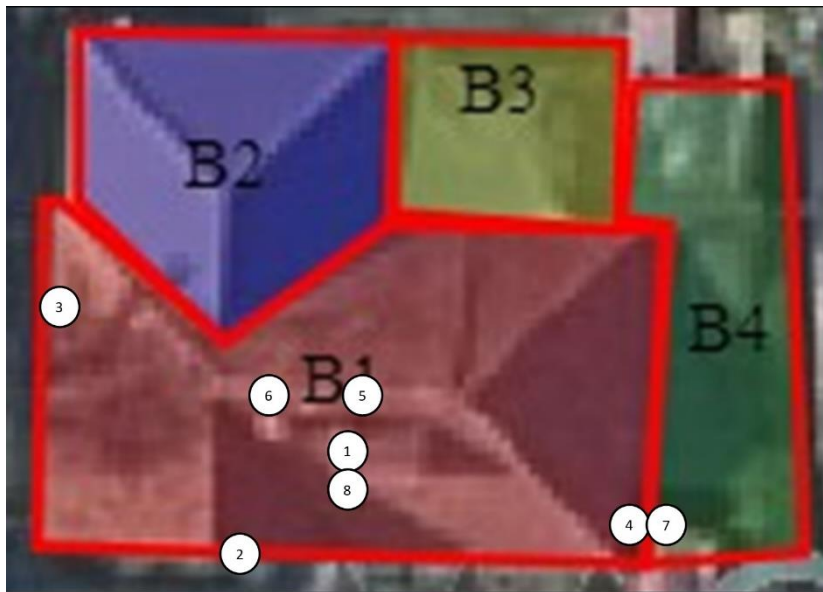
Figure 3: Position of access points to loft and potential roosting features

- 1) Gap between external concrete roof tiles or lead flashing to the west of the loft window, with light visible.
- 2) Gap between bricks under the external security camera at front of B1 above the main window with light visible in roof space.
- 3) Gap at base of roof, possibly a small gap under external tile, with light visible in roof space.
- 4) Gap under roof tiles with space between tiles and fabric with light visible in roof space.

- 5) Two cracked roof ridge tiles on top of B1
- 6) Small gaps under lead flashing around chimney
- 7) Single gap in wooden soffit and cracks in concrete base board on southeast corner of B1
- 8) Small gap under lead flashing around base of dormer window

The cracks within the ridge tiles were difficult to view from the ground but would at best be suitable for a single bat potentially roosting between spring and autumn.

The gaps under the lead flashing were also small and would likely at best offer potential roosting opportunities for 1-2 bats between spring and autumn.

The gap and cracks in the soffit/baseboard were clear of cobwebs, but showed no signs of droppings or staining and would likely be utilised by single or small numbers of roosting bats between spring or autumn. The position of access or potential roosting features can be seen in Figure 3.

B1 is considered to have ‘negligible’ roosting features.

No further surveys are considered necessary, but as a precaution all works/demolition on B1 and B4 should be conducted outside of the breeding season to avoid disturbance of any bats roosting within the limited external or internal roosting features in B1. For clarity, works should be undertaken between October and March/April.

Raised bat tiles could be included within the design of the new roof or bat tubes placed high up on the eastern gable end of B1 to provide future roosting features post-development.

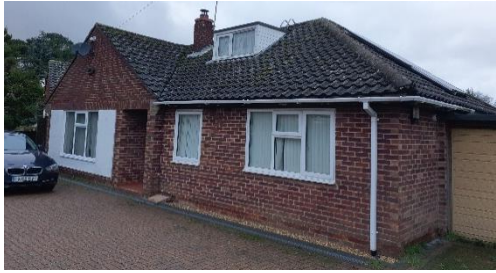
Image 1:B1 external southern/eastern aspect with dormer window and garage B4

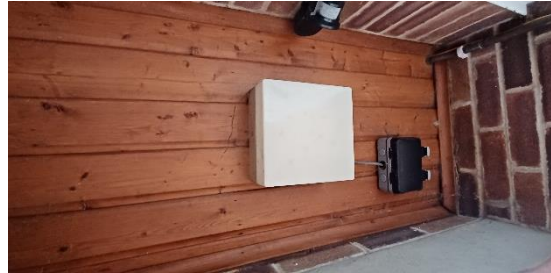
However, the exterior, especially the porch is well lit by motion-sensored lights, with a light directly under the gaps and cracks in the wooden soffit on the southeast corner of B1.

Image 2:B1 Porch underside

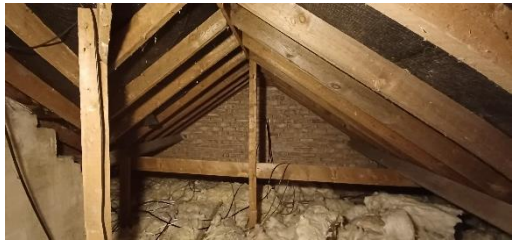
There were no signs of droppings, staining or feeding on the floor, loft insulation beams or other surfaces within the loft. There were also extensive areas of spider webs around all the external access points and spaces within between the lining and roofing tiles or superstructure suggesting the loft space is currently not being used as a maternity roost. The roof space was very cold and unlikely to hold a hibernating roost.

Image 3:B1 Internal loft space W side

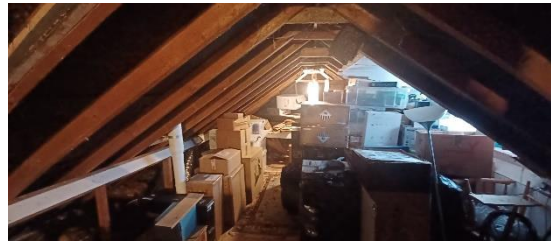
Image 4:B1 internal loft space centre

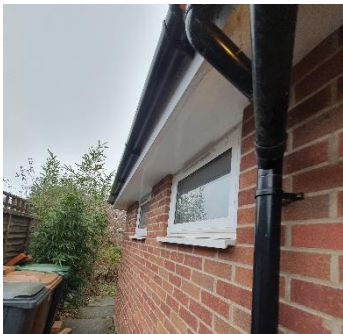
There was no external access or potential roosting features noted during the survey of B2. The concrete roofing tiles were new and well-sealed, there were no gaps or cracks within the soffits, gaps between the guttering and soffits/walls. A single vent is present in the soffits close to the kitchen, but is linked to the stove and had a small mesh covering. The brickwork is well-pointed and in good condition, with no gaps in the brick work providing roosting features.

Image 5:B2 western aspect

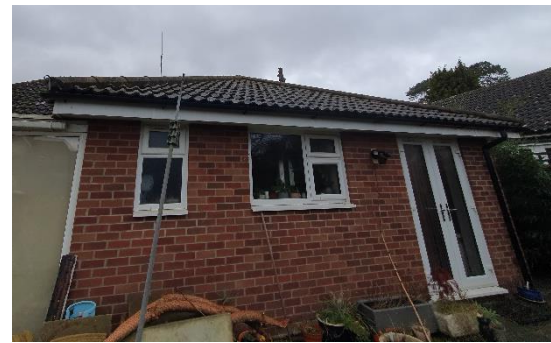
Image 6:B2 northern aspect and roof

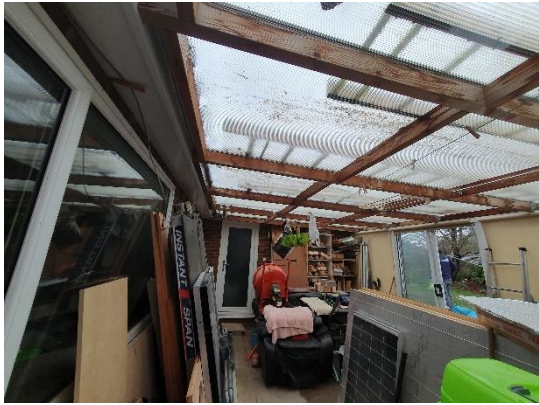
This building is an enclosed single-storey flat-roofed conservatory at the rear of the property, between B2 and B4, has uPVC windows and metal frame, with a timber-framed roof structure and corrugated clear plastic roof. There were no internal or external access points or potential roosting features and no droppings internally or externally.

Image 7:B3 internal

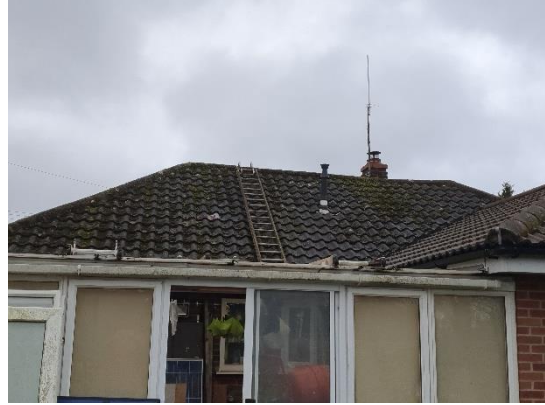
Image 8:B3 external

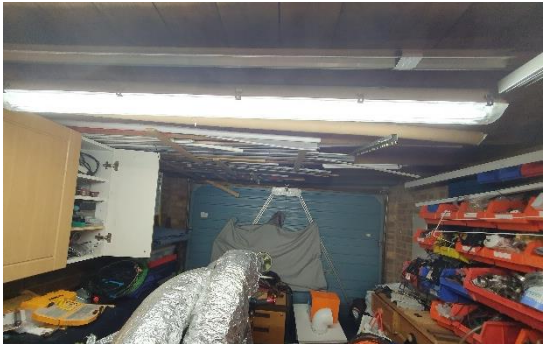
This building is a single-storey brick structure with timber-framed, felt-covered roof, with access through a uPVC door from B3 and metal shutter door at the front of the property. There were no access points or roosting features noted on the exterior or interior of the building. The garage is used as a workshop and is well-lit with strip lighting.

Image 9:B4 internal

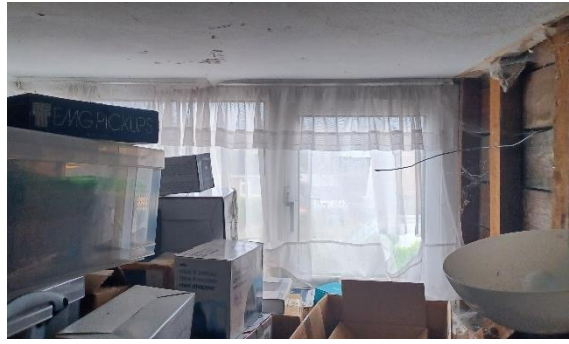
There is a small dormer window at the front of B1 positioned to the east of the porch and small chimney, which provides light within the front of the loft.

Image 10:B1 Internal dormer window
