# Sash Window Surveys Edinburgh

## Condition Survey Report

**DATE:**  
20/03/2024

**Address:**  
19 Heriot Row  
Edinburgh  
EH3 6HP

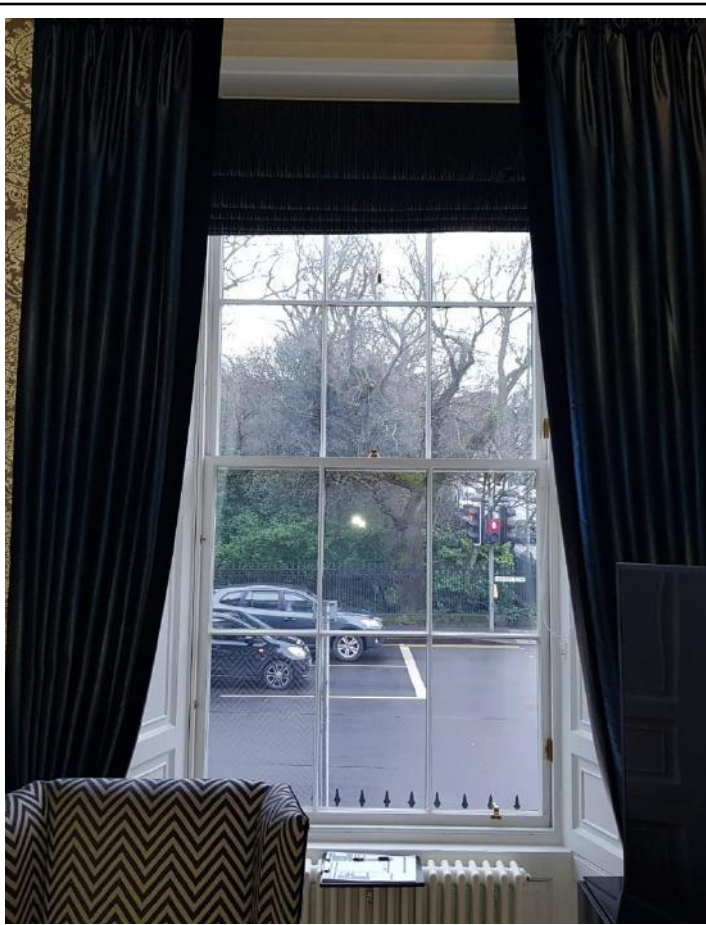
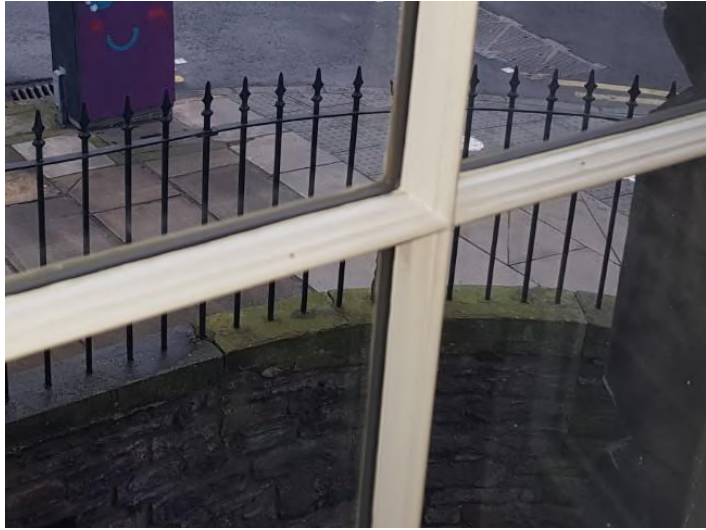
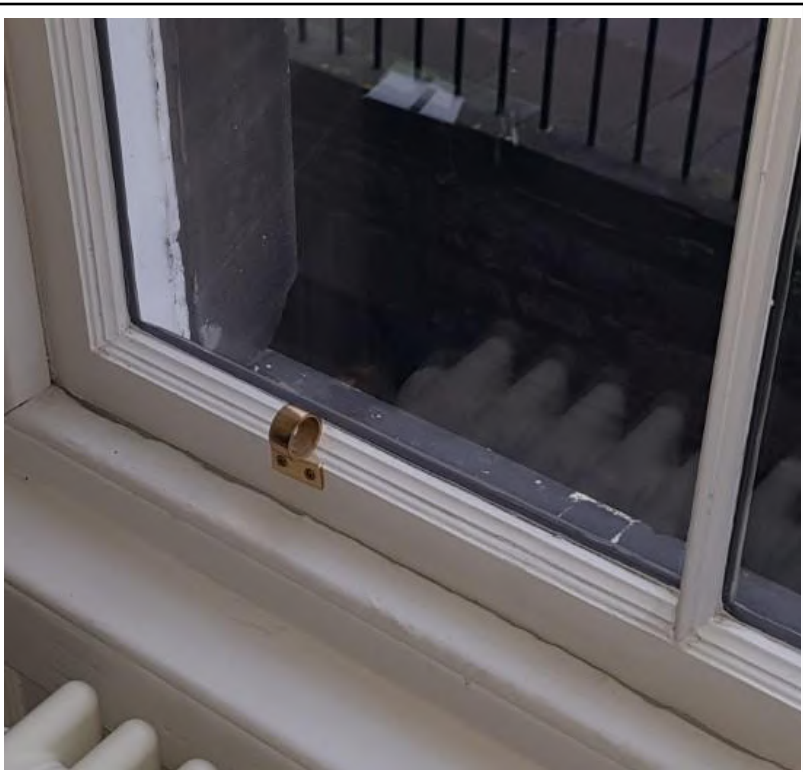
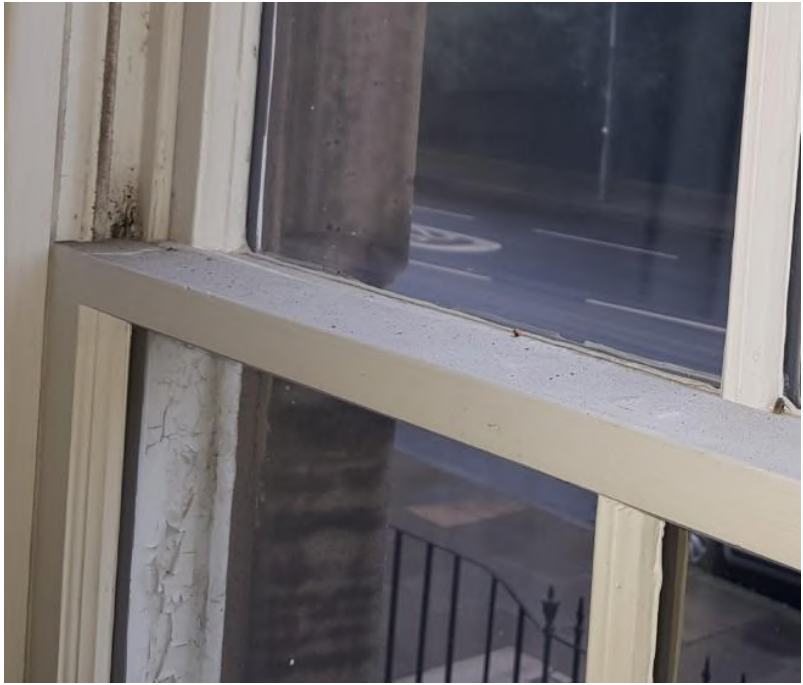
Elevation	Floor	No.	Room
Front	GF	W1	Lounge

- Assessment**
- Lower sash is non-historic and of more recent construction
  - Moulding Detail is sharp and well-defined
  - Lack of overpainting
  - Little sign of general wear and tear points to newer sashes
  - Upper sash has replacement astragals to match the lower
  - Currently has Slimline IGUs

**Proposed**  
Like-for-like replacement custom-fitted with Slimline IGUs

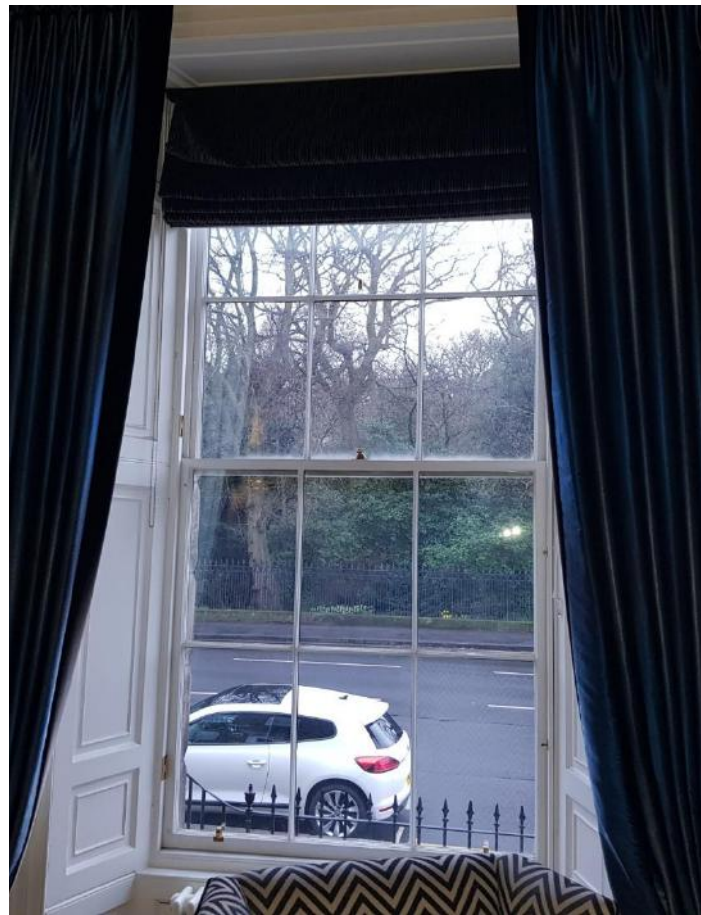
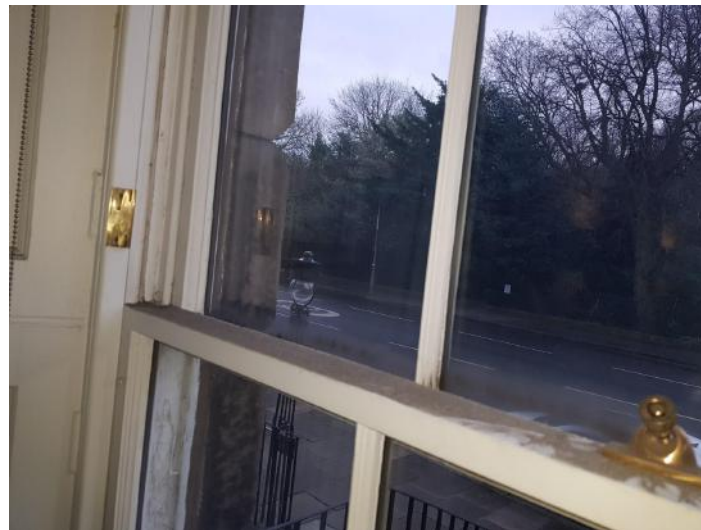
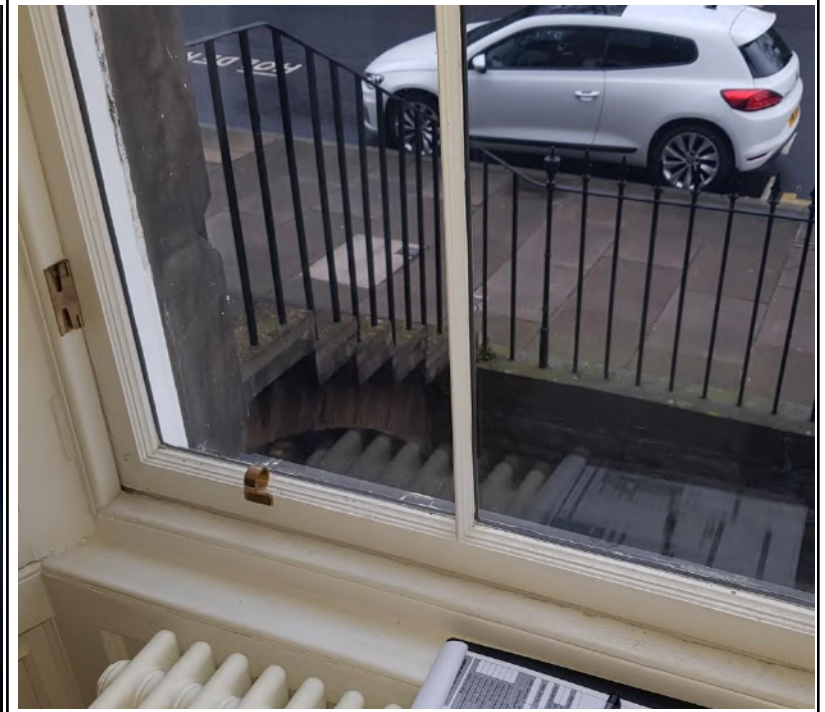
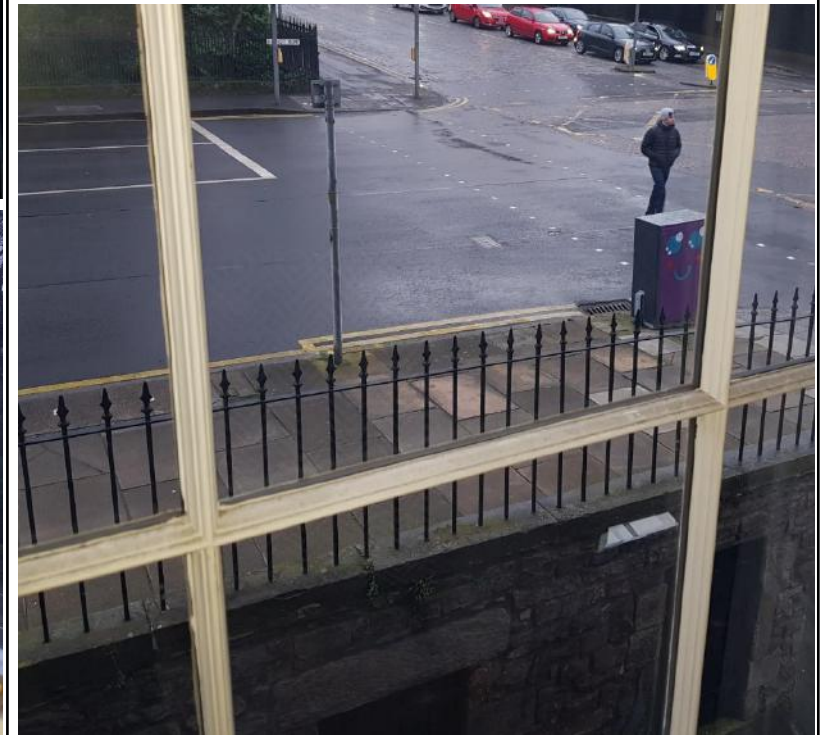
Elevation	Floor	No.	Room
Front	GF	<b>W2</b>	Lounge

- Lower sash is non-historic and of more recent construction
- Moulding Detail is sharp and well-defined
- Lack of overpainting
- Little sign of general wear and tear points to newer sashes
- Upper sash has replacement astragals to match the lower
- Currently has Slimline IGUs

Like-for-like replacement custom-fitted with Slimline IGUs

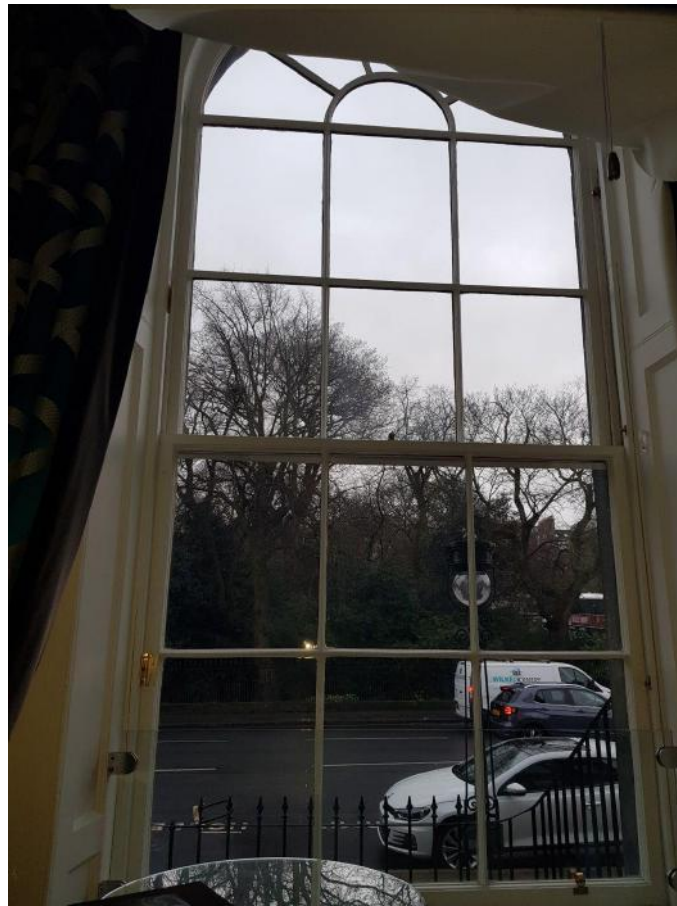
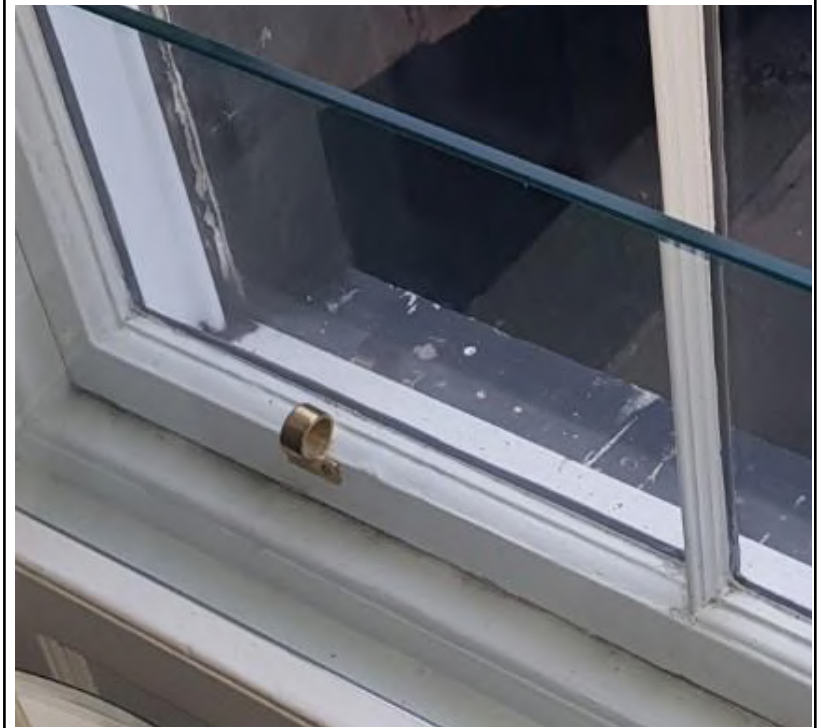
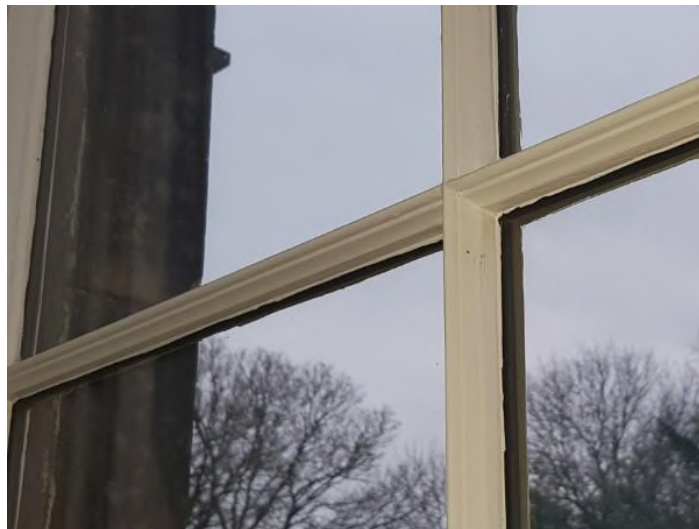
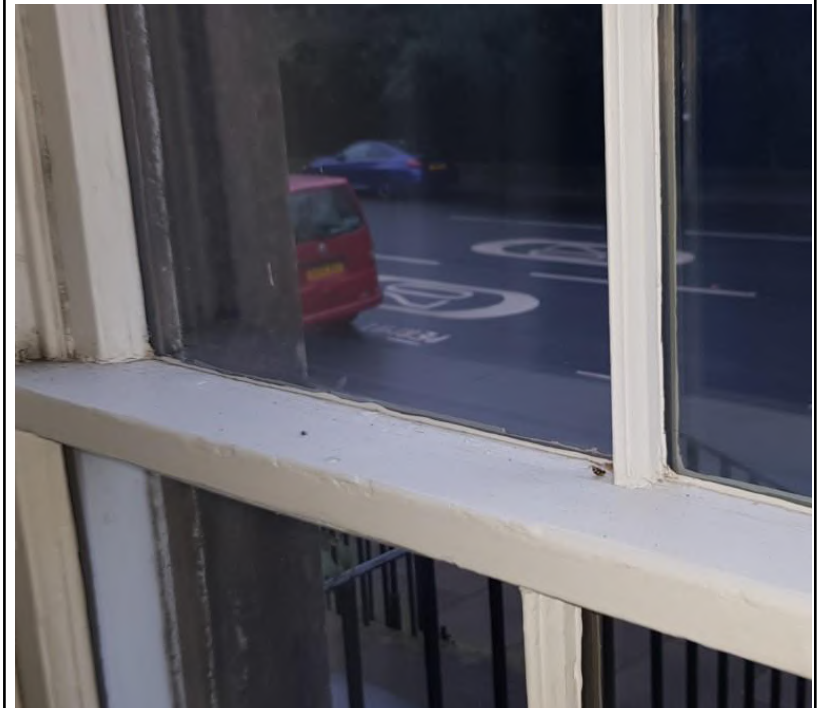
Elevation	Floor	No.	Room
Front	GF	W3	Study

- Astragal moulding Detail is sharp and well-defined
- Lack of overpainting
- Sash frames appear to be older
- Sashes have replacement astragals
- Currently has Slimline IGUs

Upper Sash - Refurbishment and Re-Glaze with Slimline IGUs

Lower Sash - Like-for-like replacement custom-fitted with Slimline IGUs

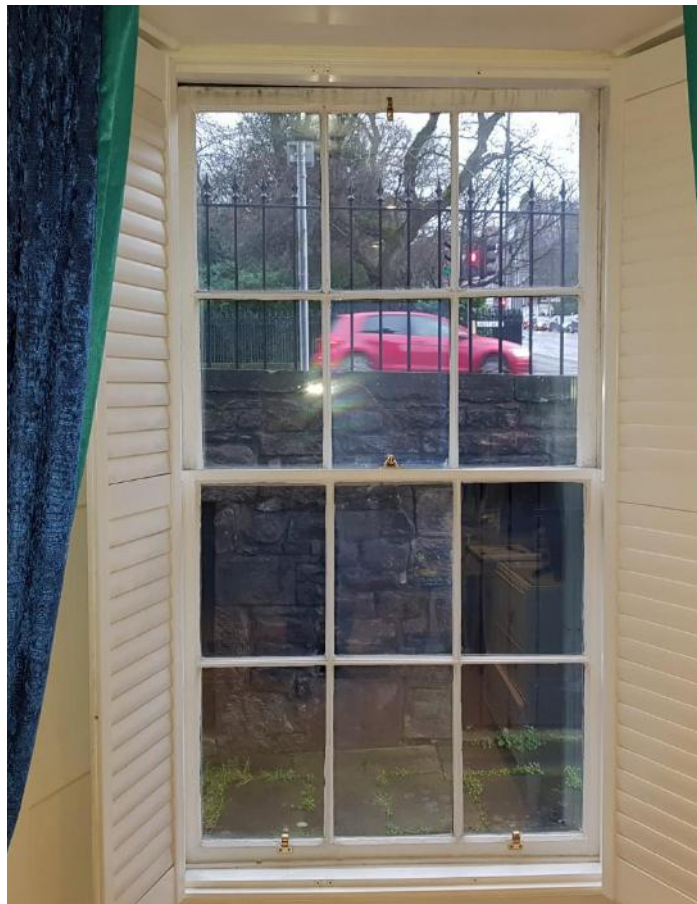
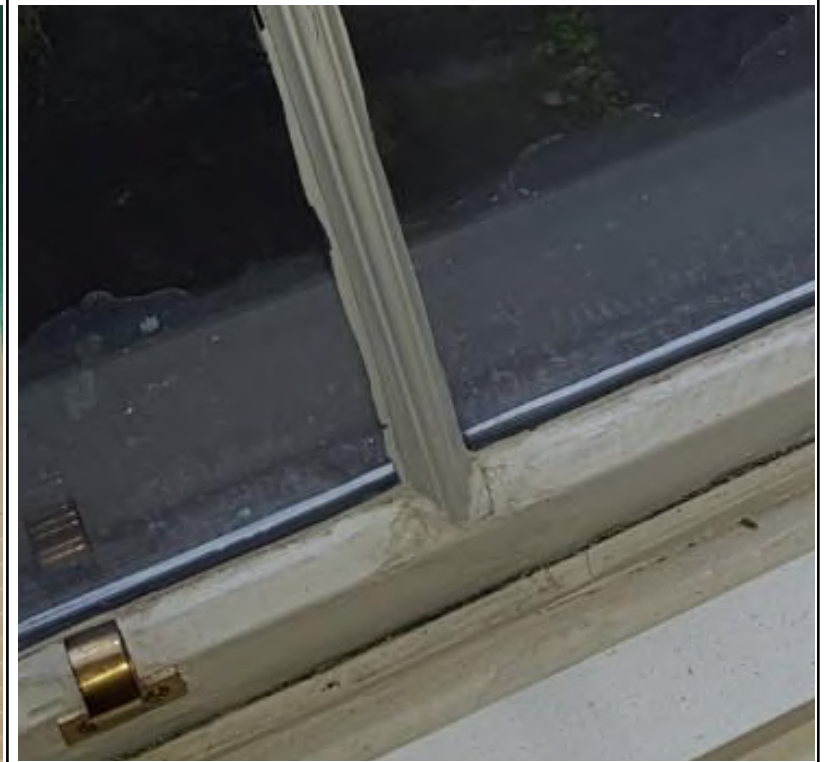
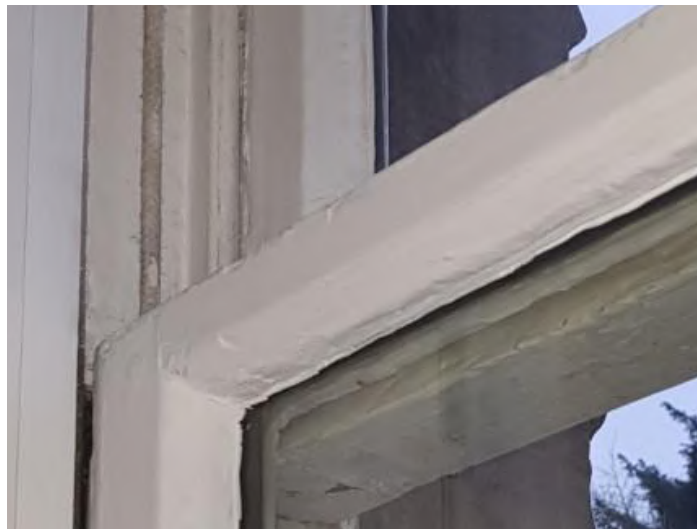
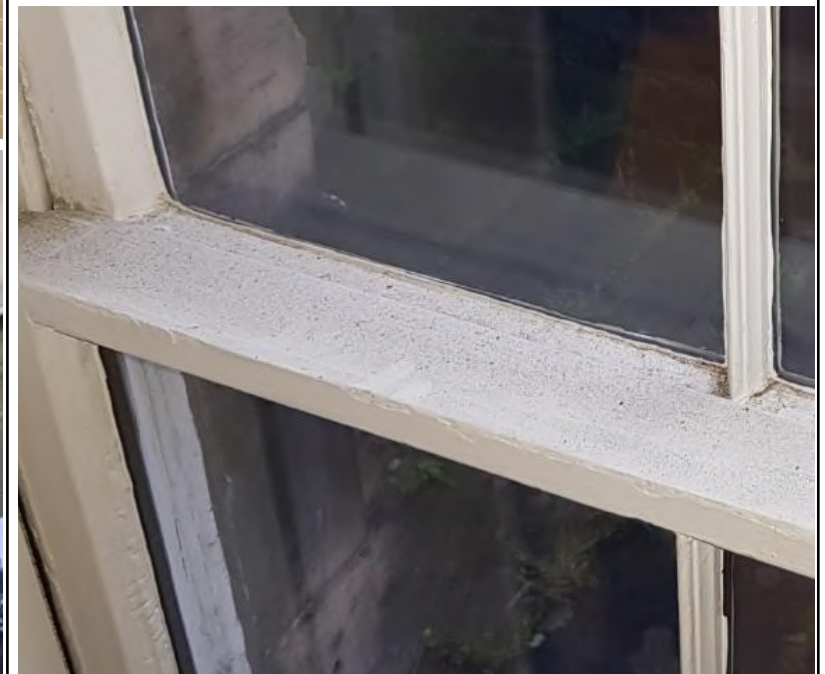
Elevation	Floor	No.	Room
Front	BF1	<b>W4</b>	Front Bed 1

- Astragal moulding detail is sharp and well-defined
- Lack of overpainting
- Both sashes have replacement astragals
- Astragal installation appears to have been poorly implemented with visible patching/filling around the joinery
- Currently has Slimline IGUs
- Moisture permeation of the horizontal rails and extending to the lower stiles.
- Condensation damage to horizontal rails and stiles.
- Previous patch repair work visible under paint
- Loss of moulding detail around the sash perimeters due to previous filling/sanding

Like-for-like replacement custom-fitted with Slimline IGUs

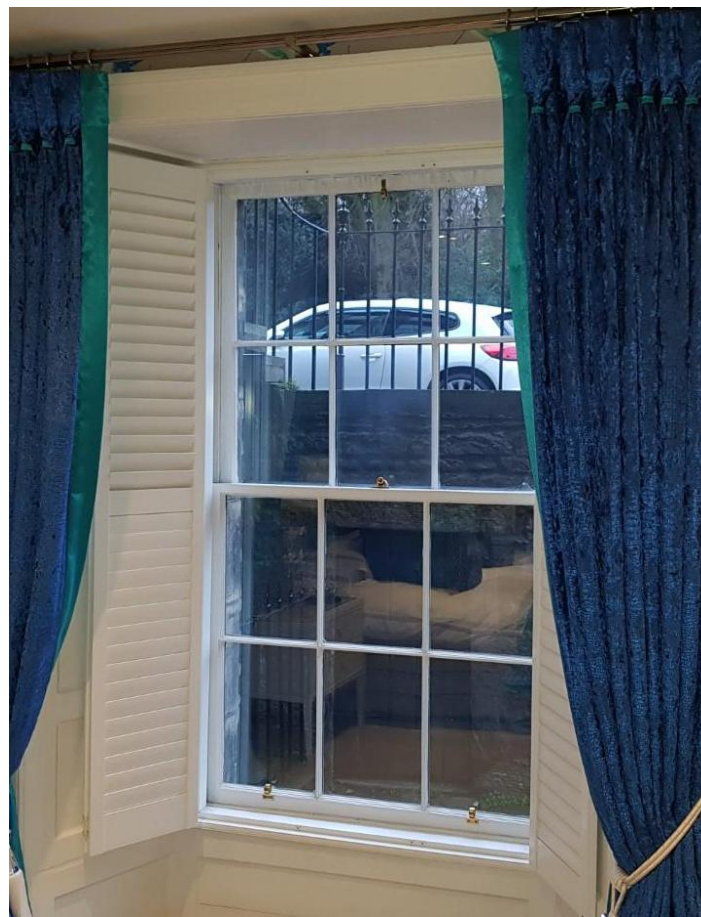
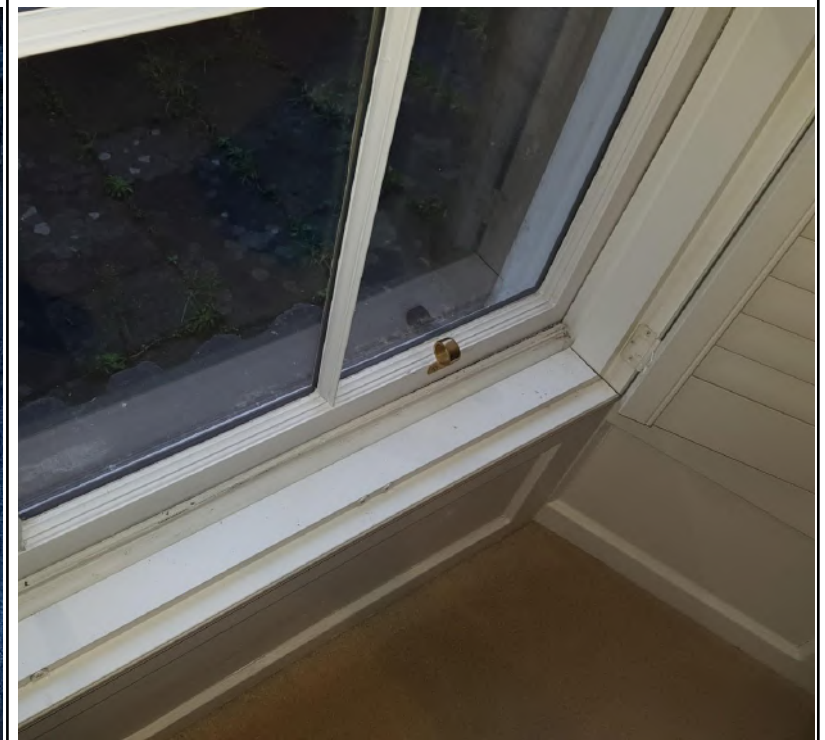
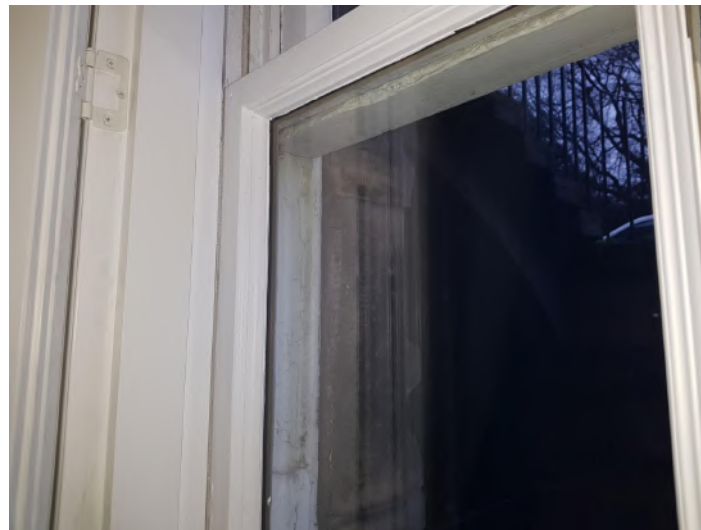
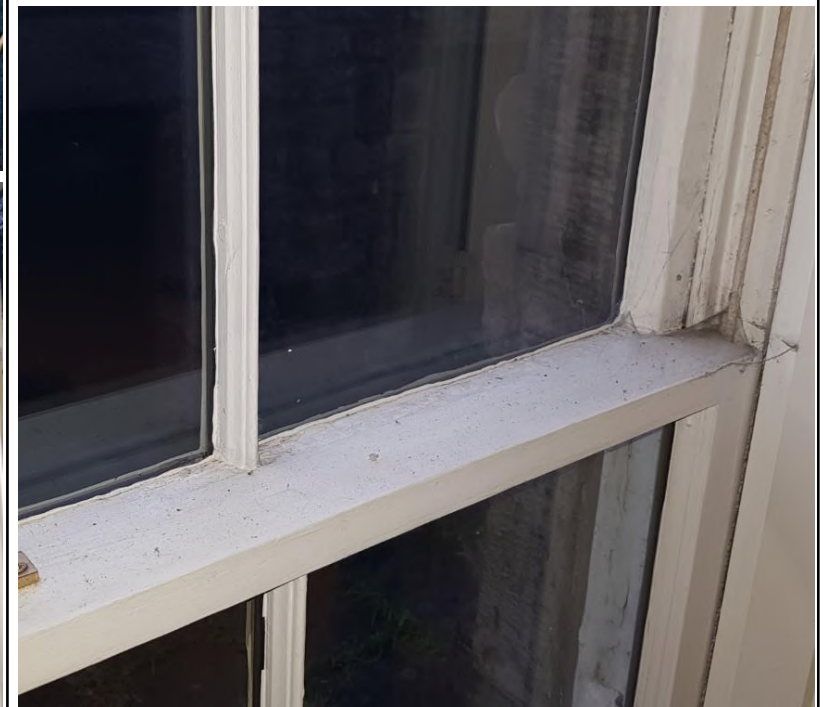
Elevation	Floor	No.	Room
Front	BF1	<b>W5</b>	Front Bed 1

- Lower sash is non-historic and of more recent construction
- Astragal moulding detail is sharp and well-defined
- Lack of overpainting and little sign of general wear and tear on lower sash points to more recent construction
- Upper sash has replacement astragals to match the lower
- Astragal installation appears to have been poorly implemented with visible patching/filling around the joinery
- Currently has Slimline IGUs .
- Loss of perimeter moulding detail around upper sash frame due to previous filling/sanding/overpainting
- Condensation damage to upper sash meeting rail

Like-for-like replacement custom-fitted with Slimline IGUs

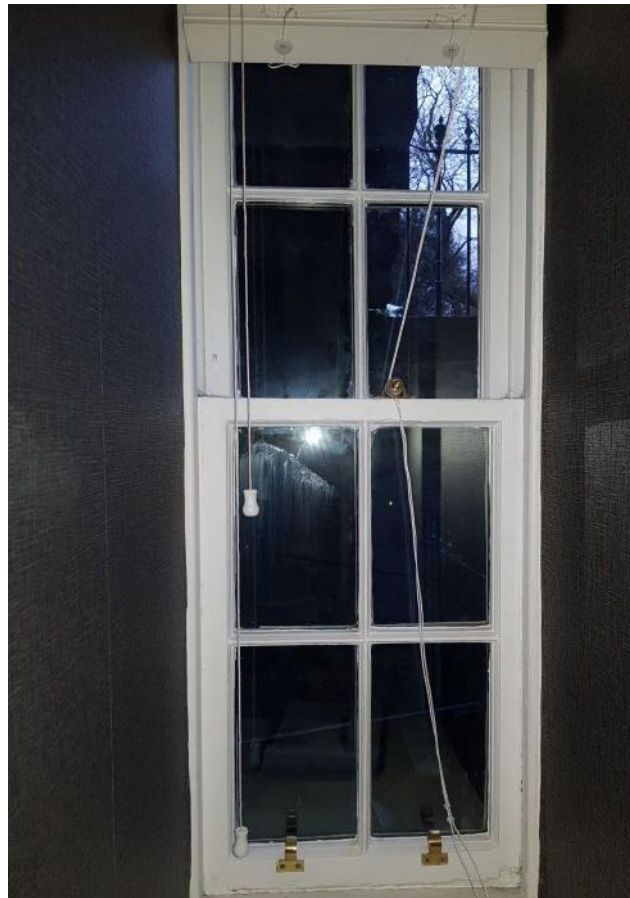
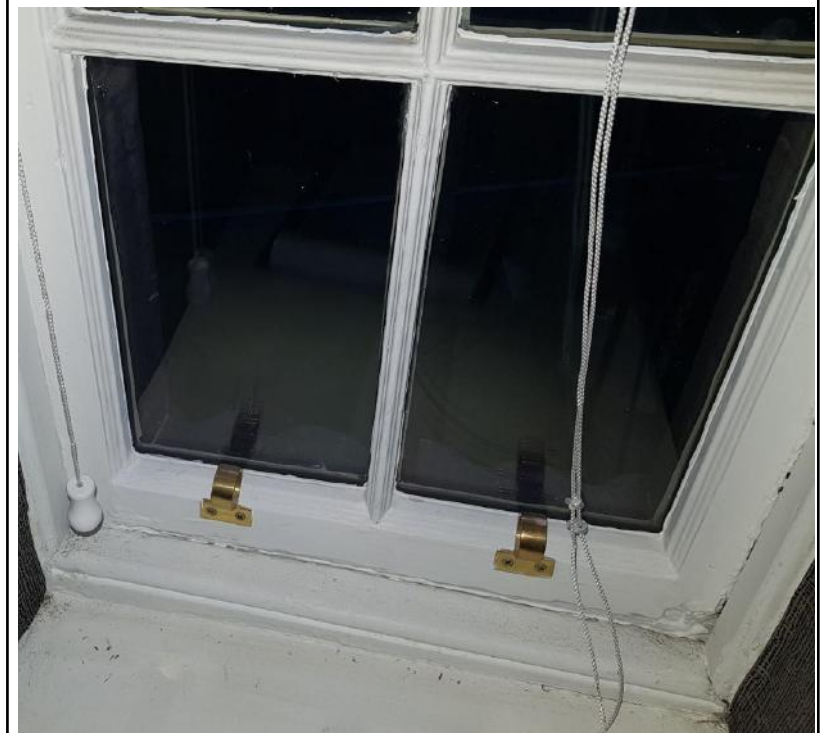
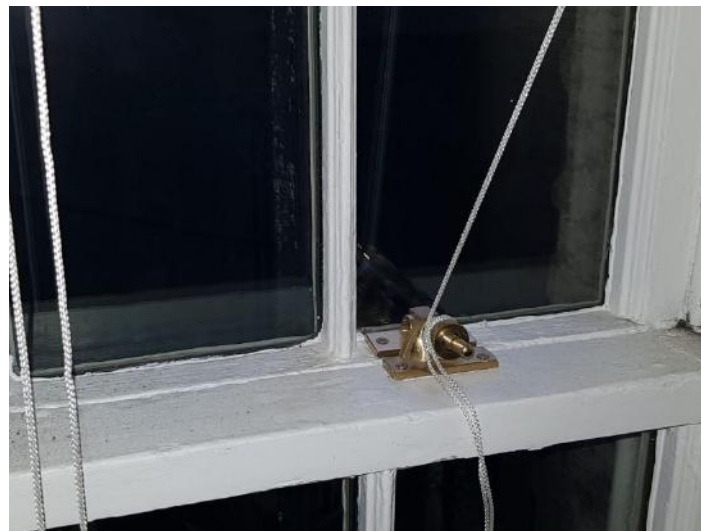
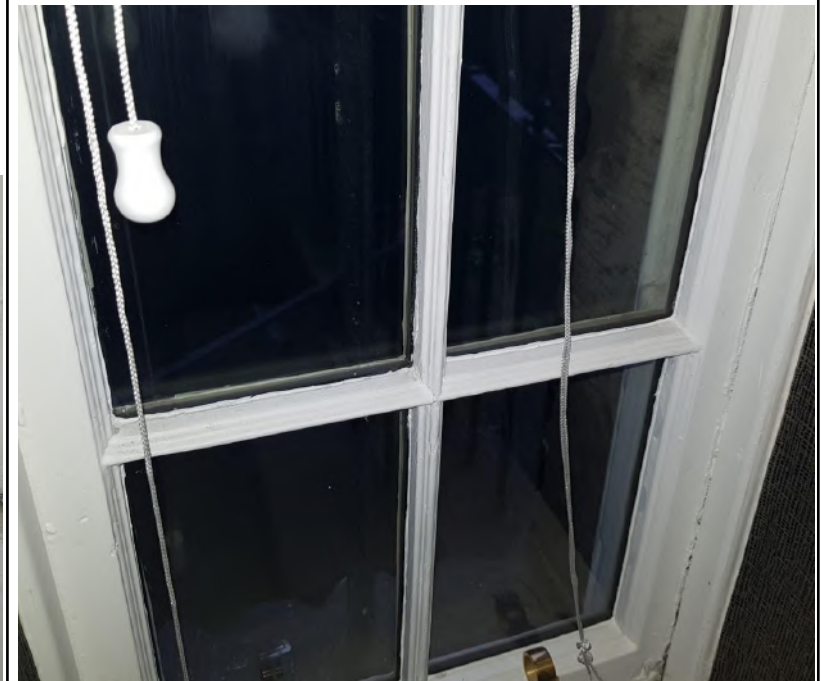
Elevation	Floor	No.	Room
Front	BF1	<b>W6</b>	Front Bed 2

- Moisture permeation of the horizontal rails and extending to the lower stiles.
- Loss of moulding detail around the sash perimeters due to previous filling/sanding
- Cracking of paint along the joins is indicative of shrinkage/swelling and a weakening of the structure.
- Currently has Slimline IGUs

Like-for-like replacement custom-fitted with Slimline IGUs

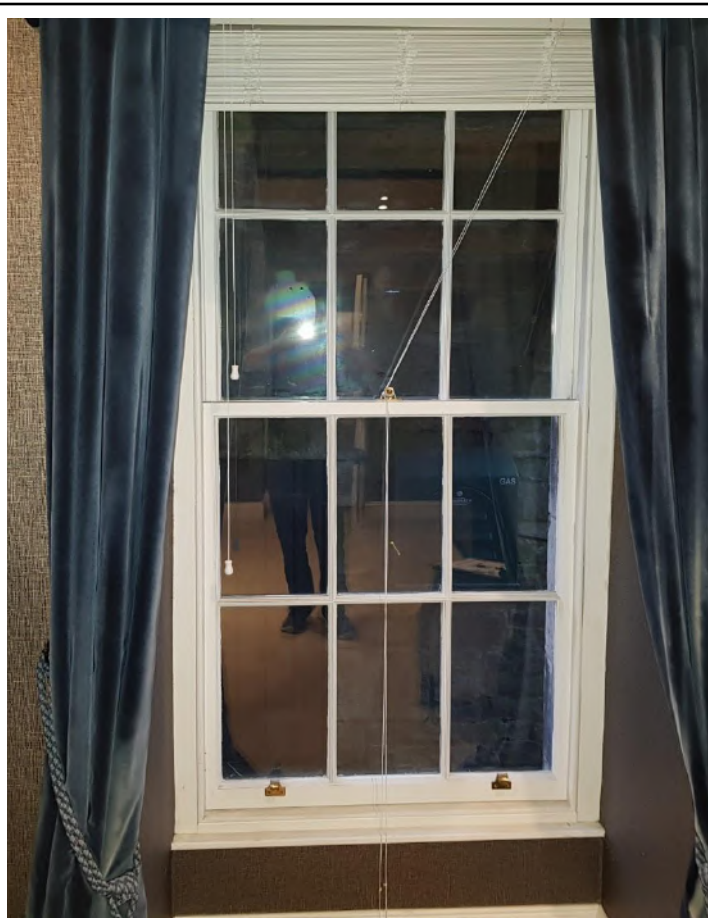
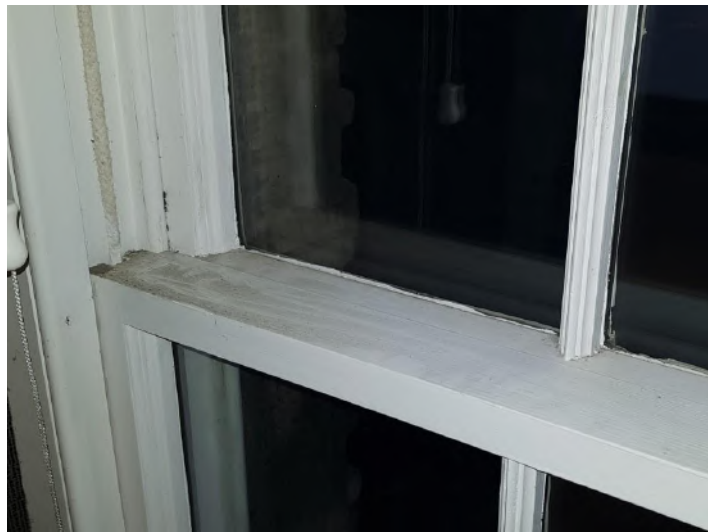
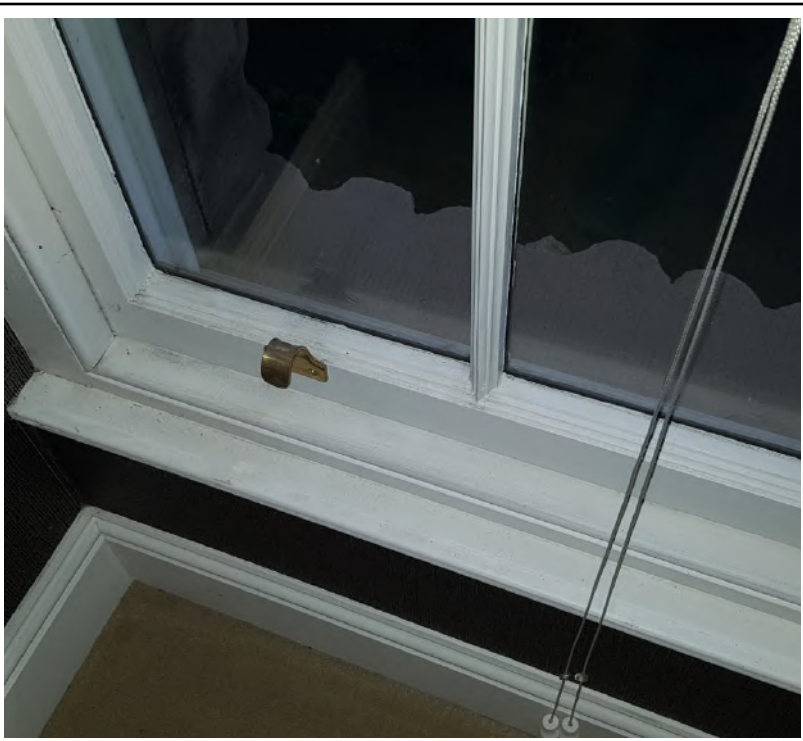
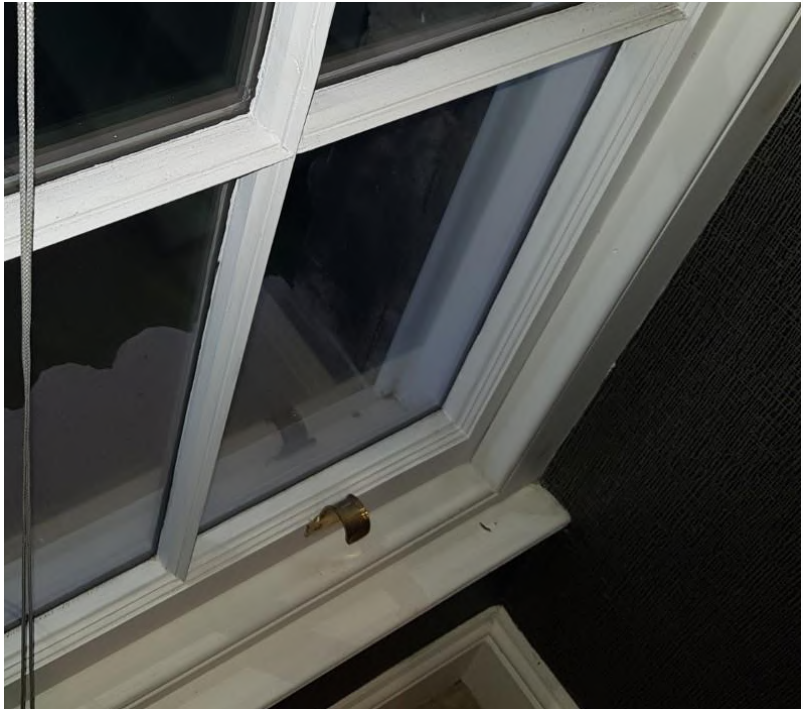
Elevation	Floor	No.	Room
Front	BF1	<b>W7</b>	Front Bed 2

- Assessment**
- Sashes appear to be of more recent construction
  - Moulding Detail is sharp and well-defined
  - Lack of overpainting
  - Little sign of general wear and tear points to newer sashes
  - Currently has Slimline IGUs

**Proposed**  
Like-for-like replacement custom-fitted with Slimline IGUs

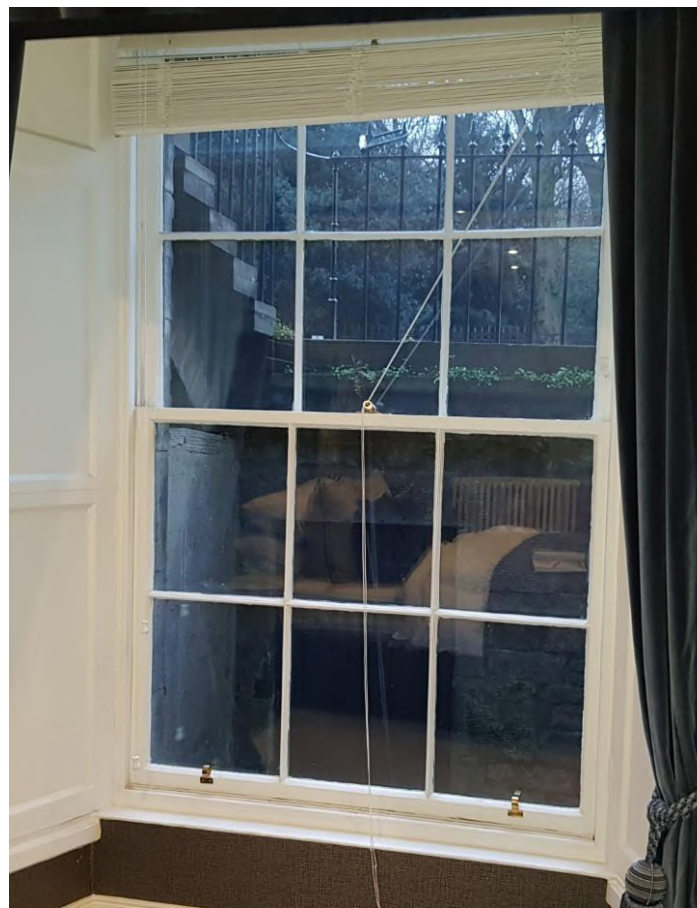
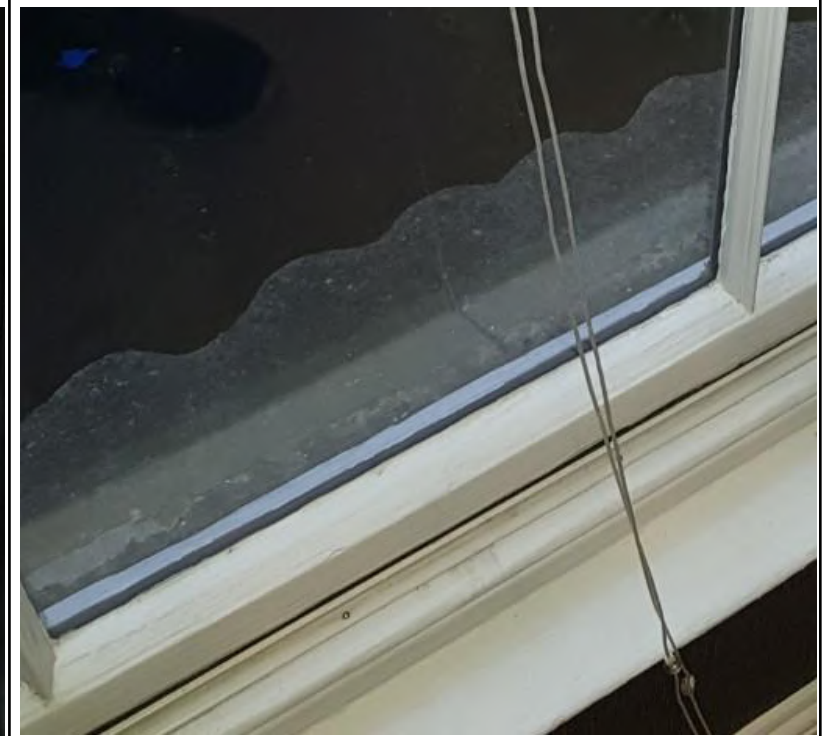
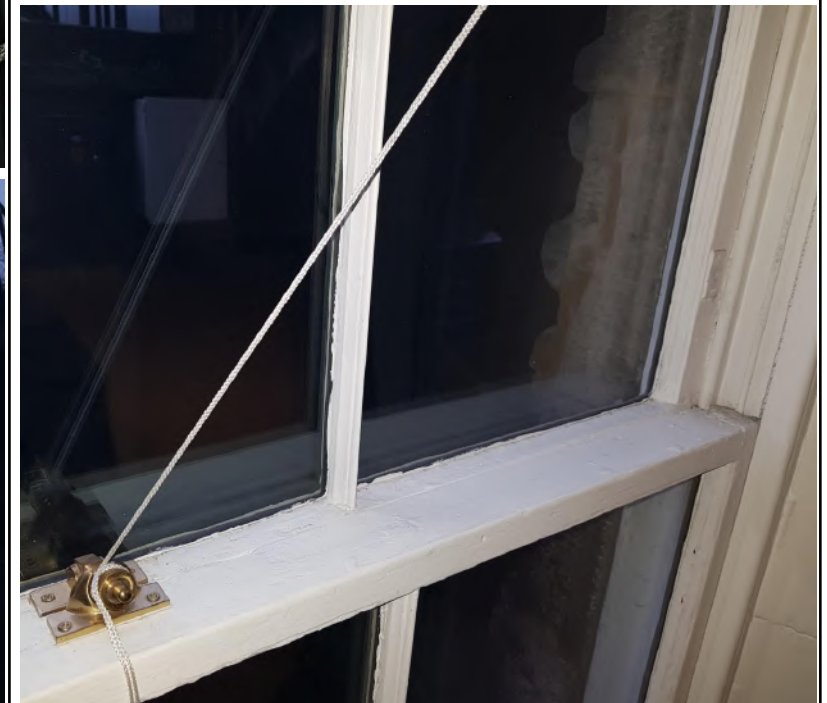
Elevation	Floor	No.	Room
Front	BF1	<b>W8</b>	Front Bed 2

- Moisture permeation of the horizontal rails and extending to the lower stiles
- Condensation damage internally on horizontal rails.
- Loss of moulding detail around the sash perimeters due to previous filling/sanding
- Condensation damage to horizontal rails
- Previous patch repairs visible under paintwork
- Cracking of paint along the joins is indicative of shrinkage/swelling and a weakening of the structure.
- Currently has Slimline IGUs

Like-for-like replacement custom-fitted with Slimline IGUs

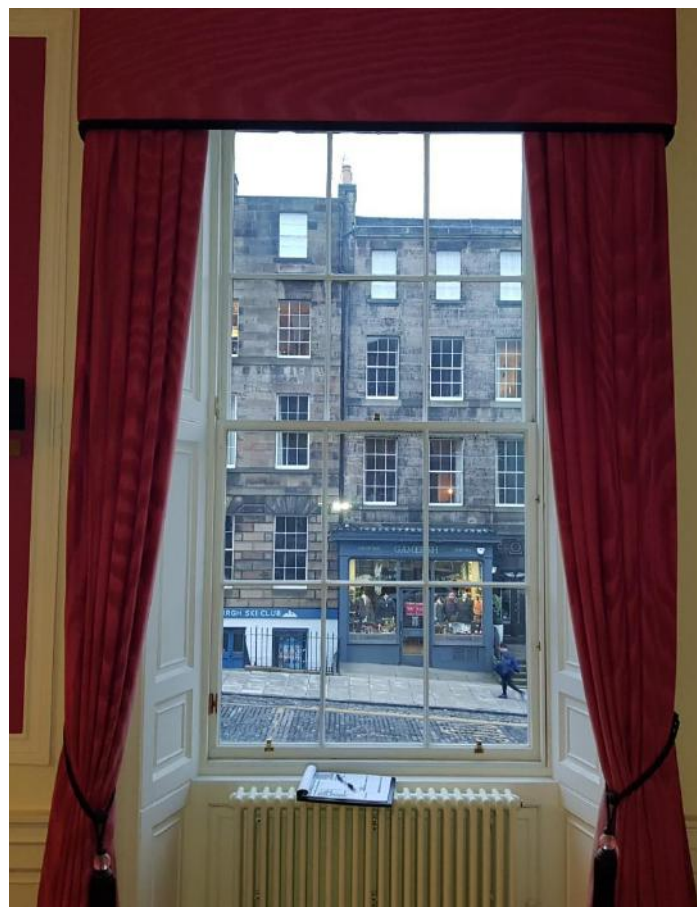
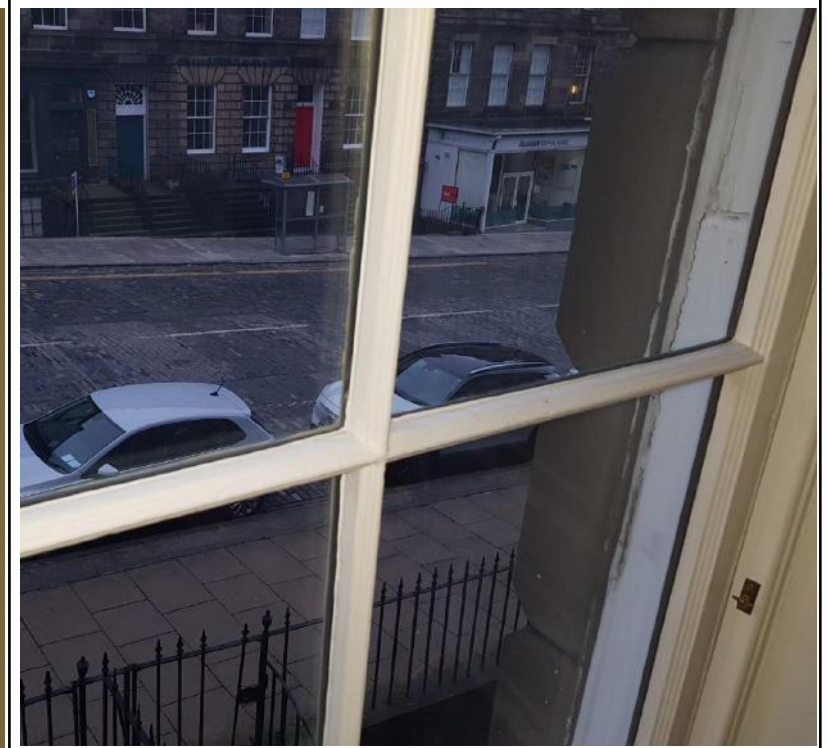
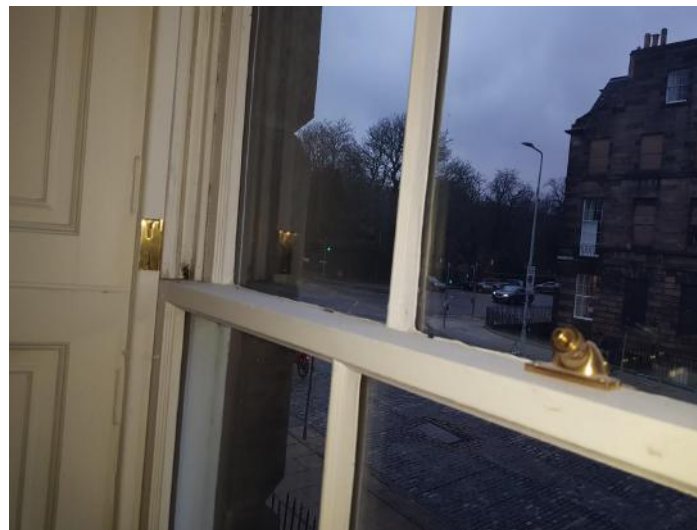
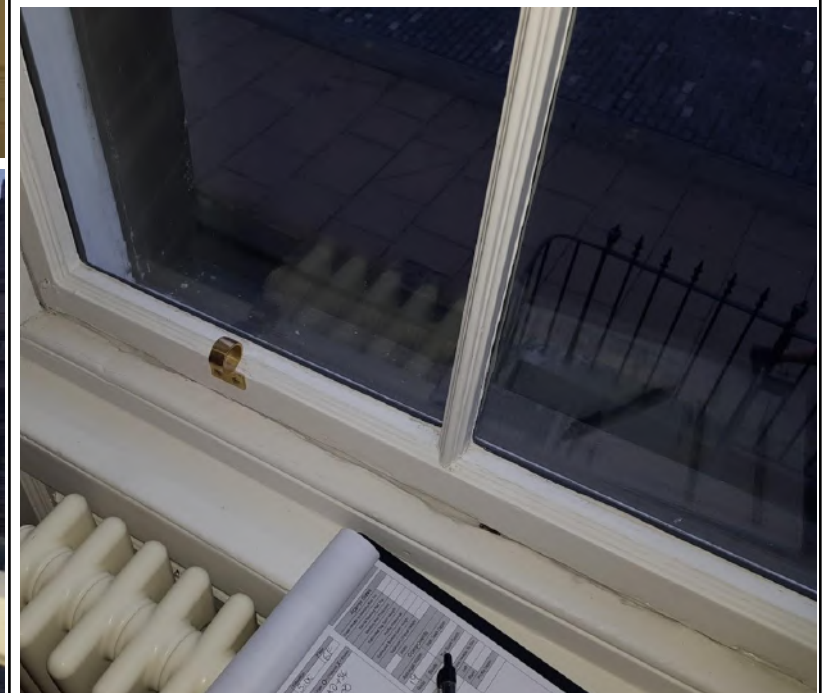
Elevation	Floor	No.	Room
Side	GF	<b>W9</b>	Dining Room

- Moisture permeation of the horizontal rails and extending to the lower stiles
- Cracking of paint along the joins is indicative of shrinkage/swelling and a weakening of the structure.
- Loss of moulding detail in place due to over-sanding/filling and overpainting.
- Currently has Slimline IGUs

Like-for-like replacement custom-fitted with Slimline IGUs

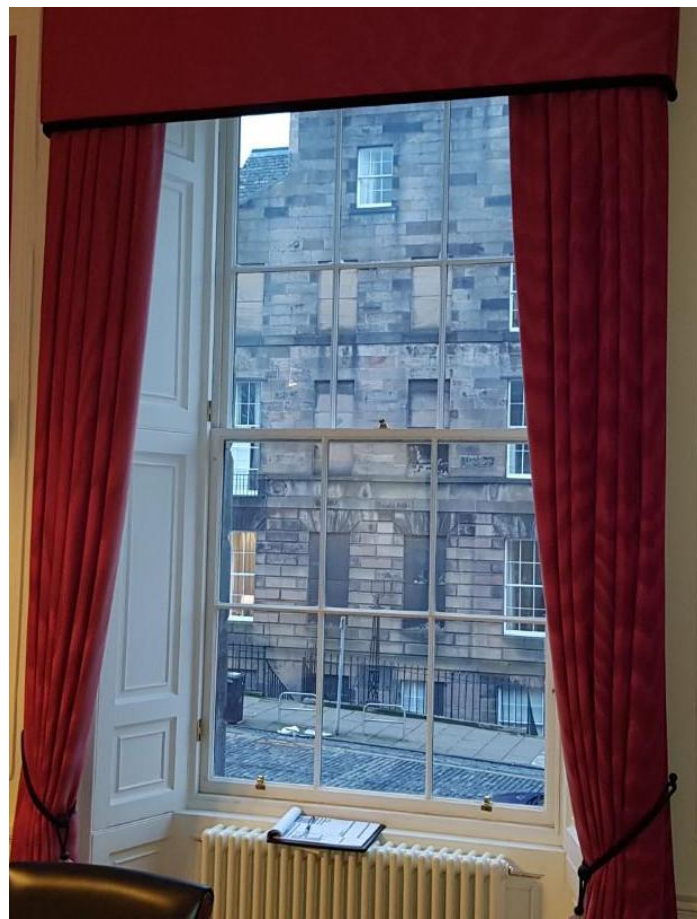
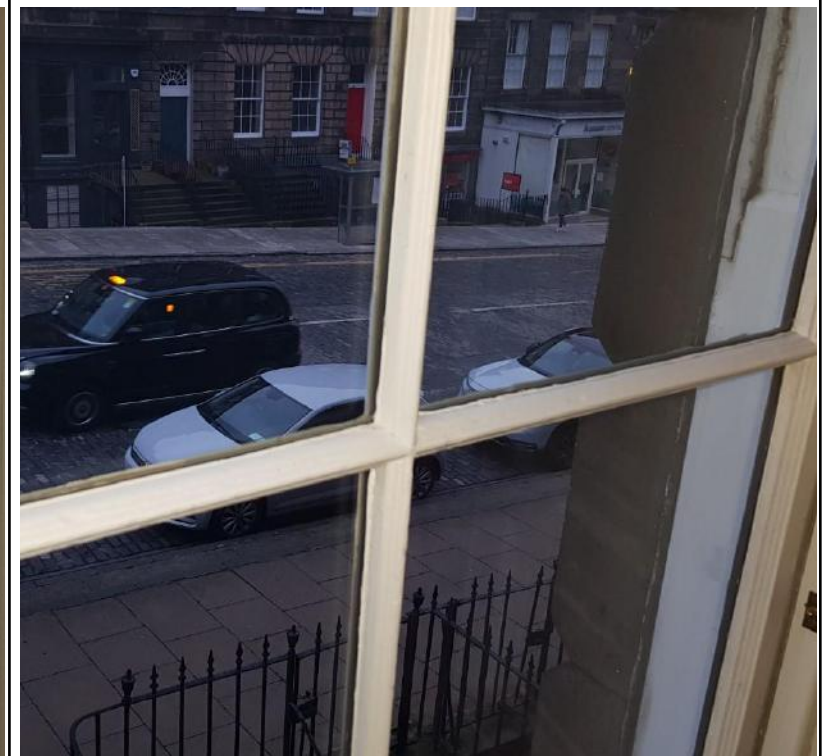
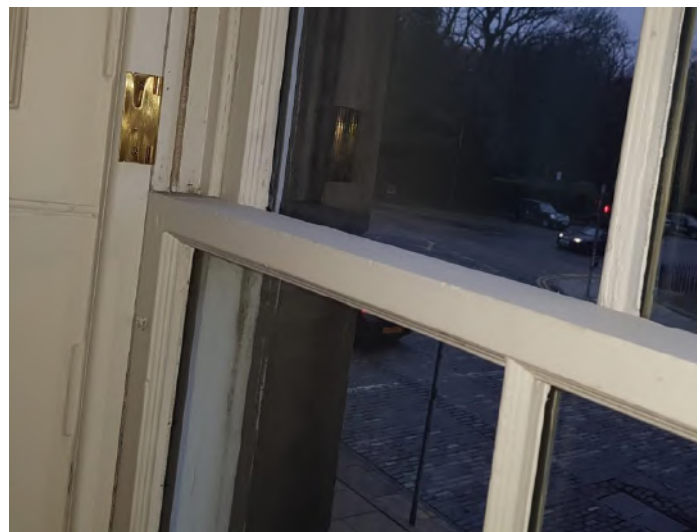
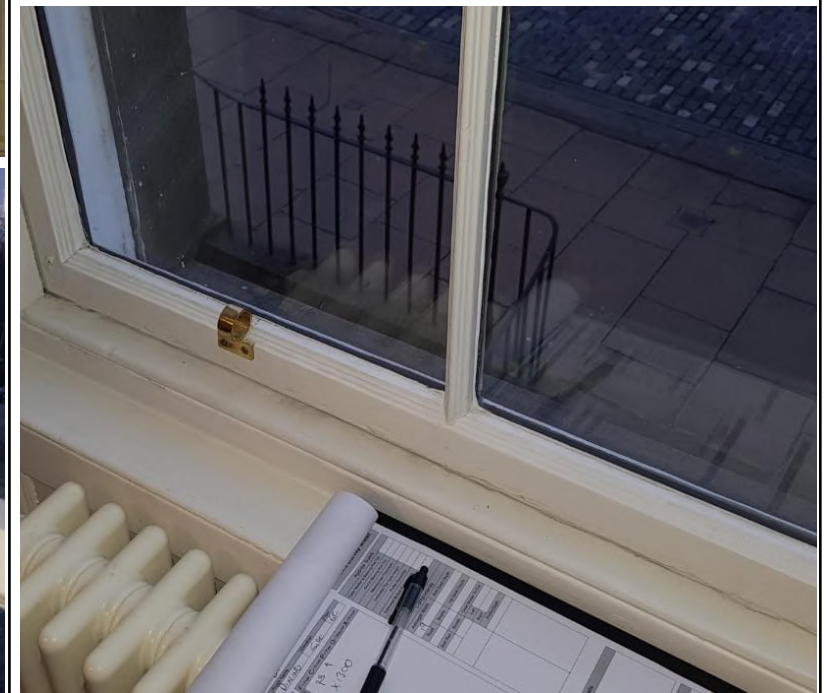
Elevation	Floor	No.	Room
Side	GF	<b>W10</b>	Dining Room

- Moisture permeation of the horizontal rails and extending to the lower stiles
- Cracking of paint along the joins is indicative of shrinkage/swelling and a weakening of the structure.
- Loss of moulding detail in place due to over-sanding/filling and overpainting.
- Currently has Slimline IGUs

Like-for-like replacement custom-fitted with Slimline IGUs
