# Sash Window Surveys Edinburgh

## Condition Survey Report

**DATE:**  
20/03/2024

**Address:**  
19 Heriot Row  
Edinburgh  
EH3 6HP

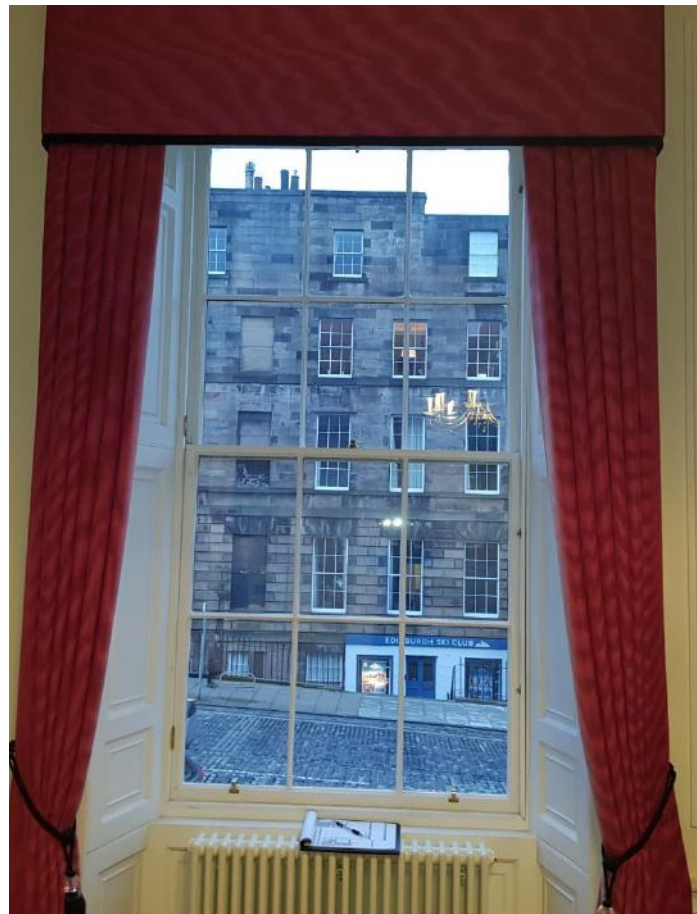
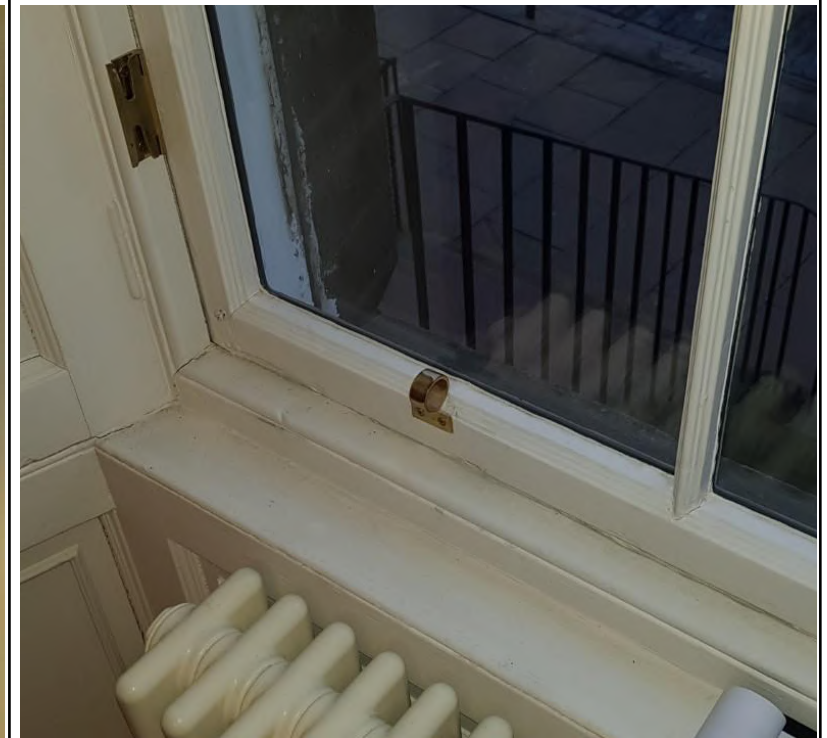
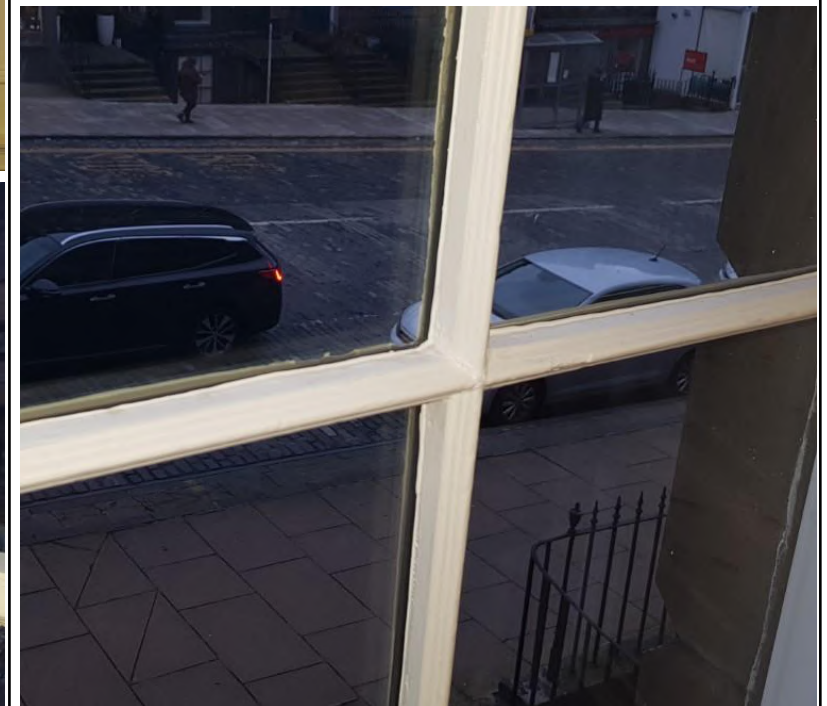
Elevation	Floor	No.	Room
Side	GF	<b>W11</b>	Dining Room

- Moisture permeation of the horizontal rails and extending to the lower stiles
- Cracking of paint along the joins is indicative of shrinkage/swelling and a weakening of the structure.
- Loss of moulding detail in place due to over-sanding/filling and overpainting.
- Currently has Slimline IGUs

Like-for-like replacement custom-fitted with Slimline IGUs

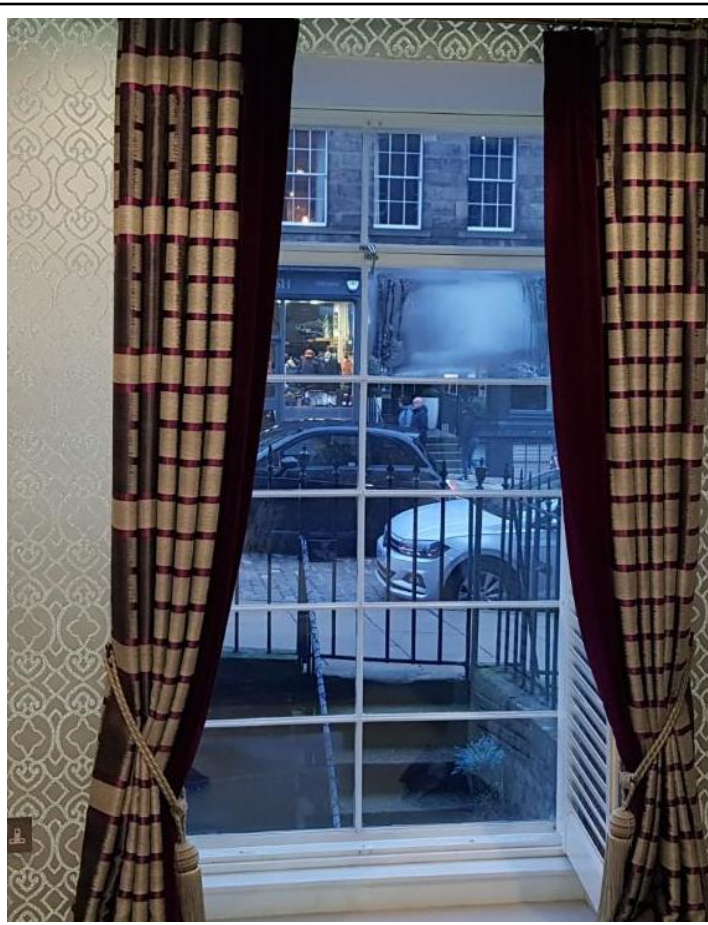
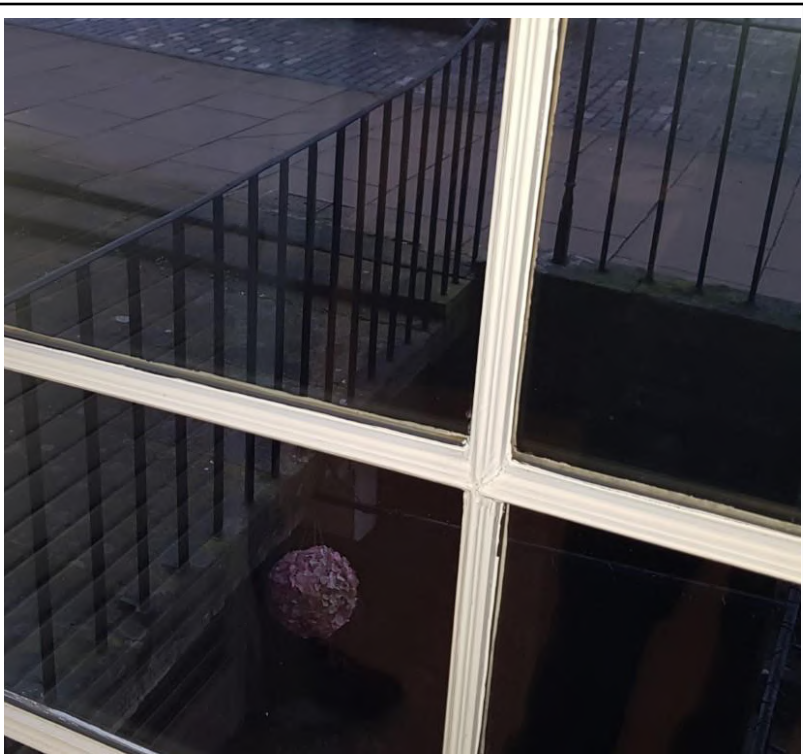
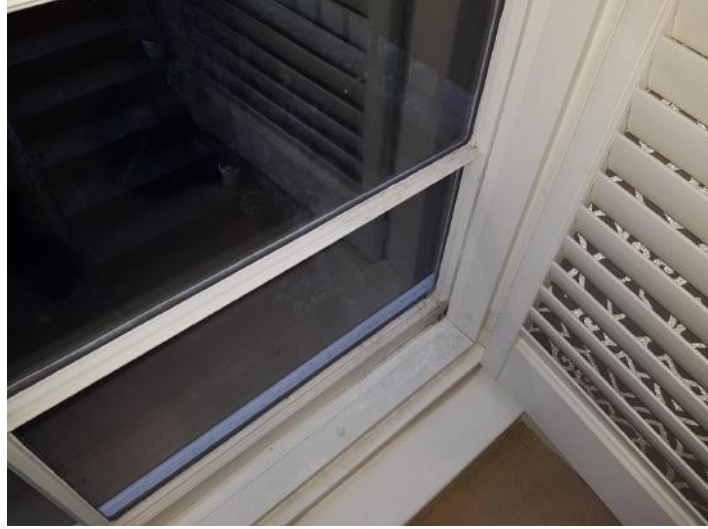
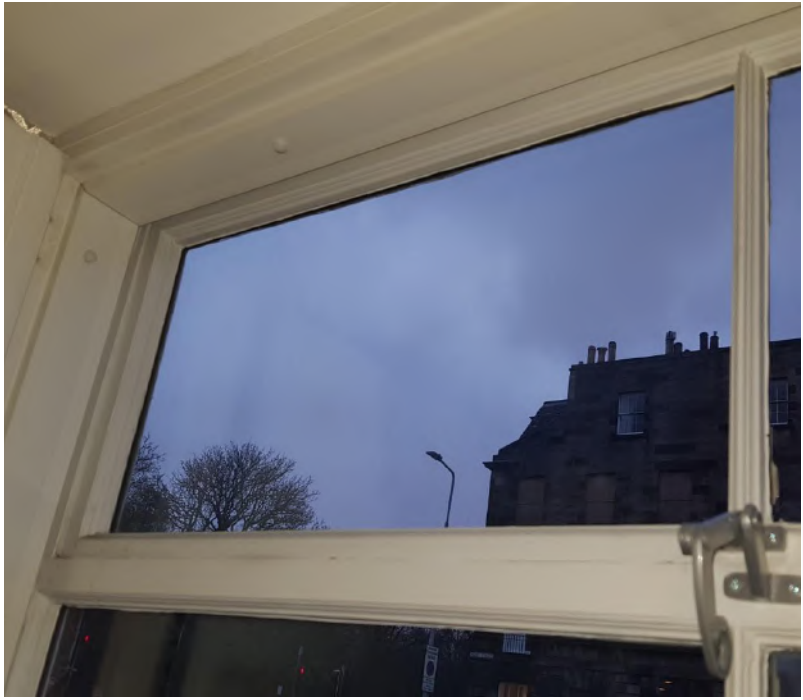
Elevation	Floor	No.	Room
Side	BF1	<b>W12</b>	Rear Bed 1

- Assessment**
- Window appears to be non-historic and of more recent construction
  - Moulding Detail is sharp and well-defined
  - Lack of overpainting
  - Little sign of general wear and tear points to newer sashes
  - Currently has Slimline IGUs

**Proposed**  
 Like-for-like replacement custom-fitted with Slimline IGUs

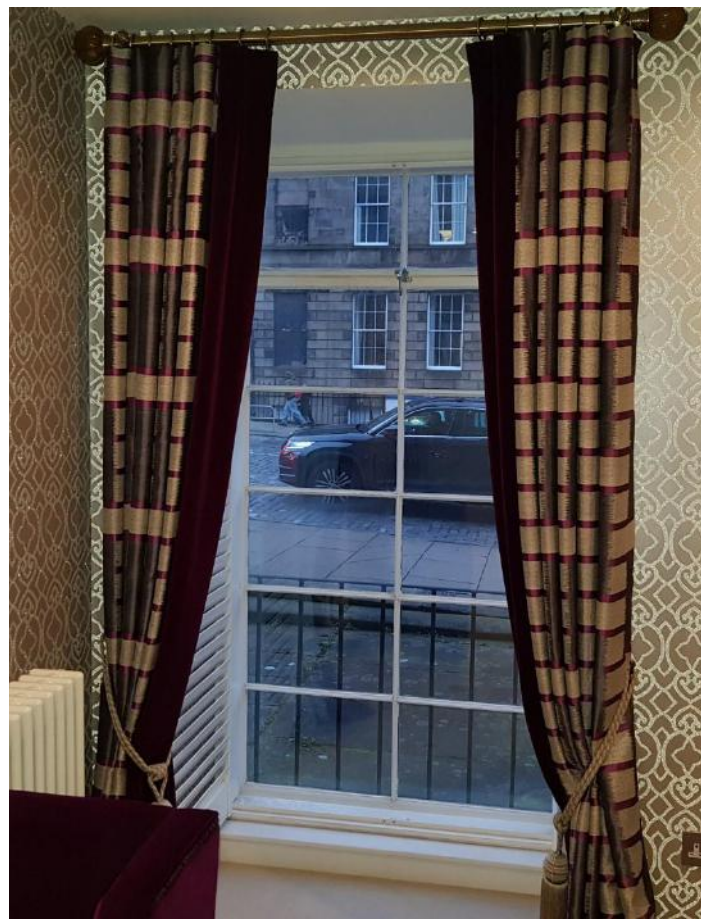
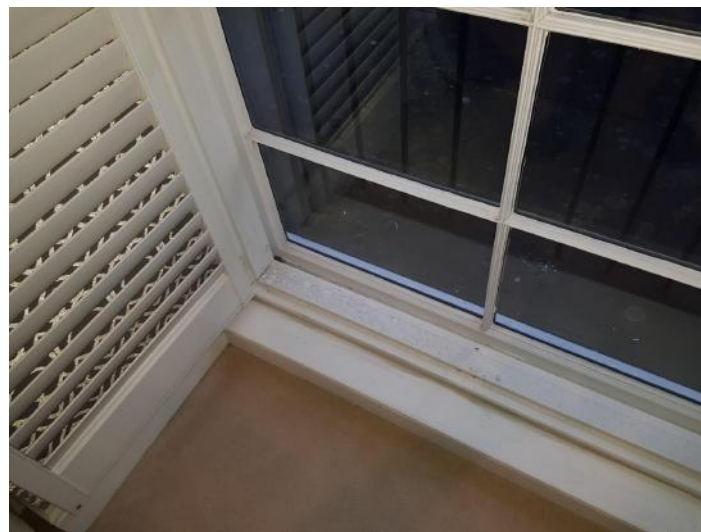
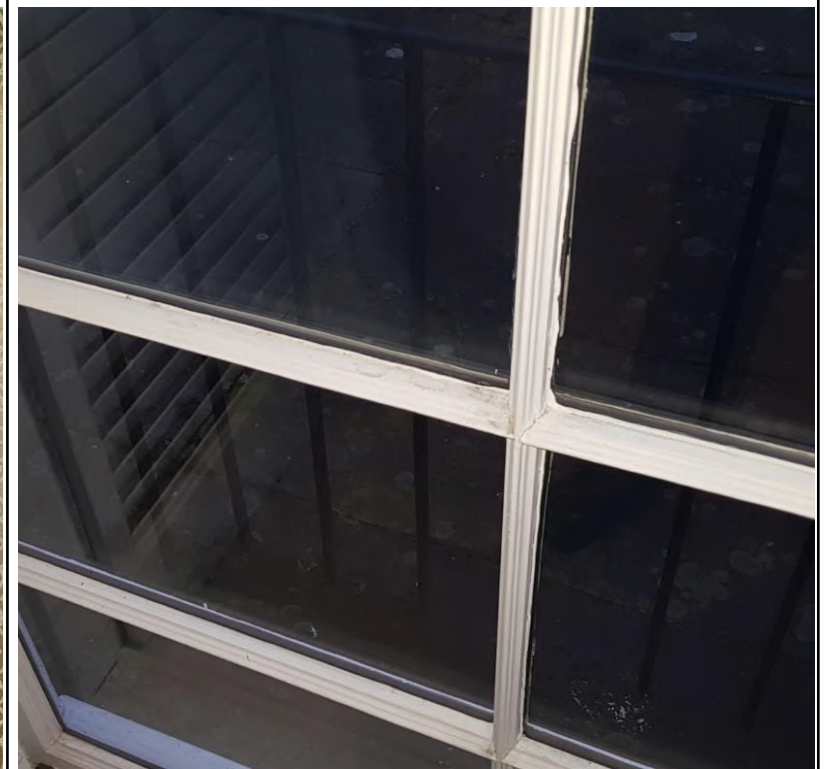
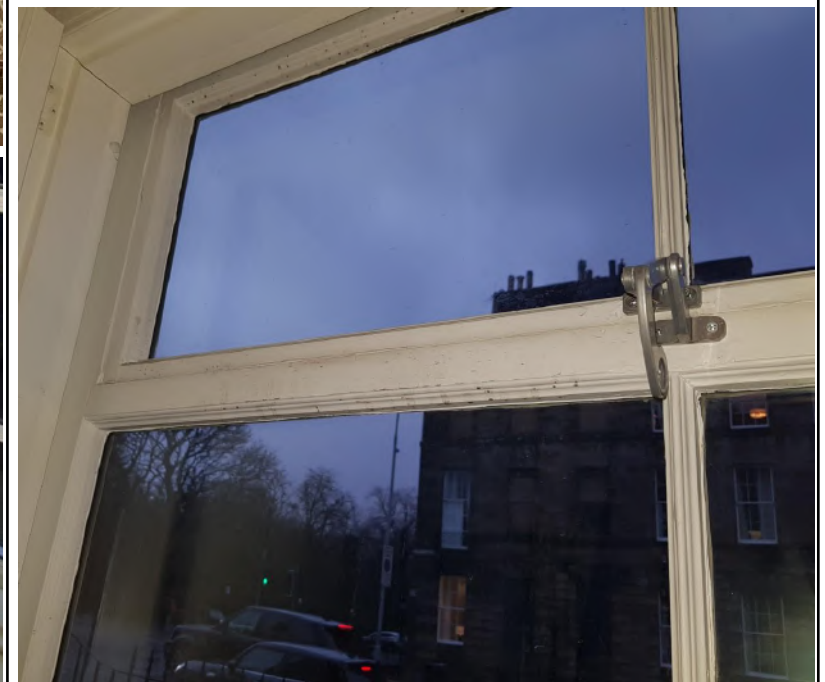
Elevation	Floor	No.	Room
Side	BF1	<b>W13</b>	Rear Bed 1

- Window appears to be non-historic and of more recent construction
- Moulding Detail is sharp and well-defined
- Lack of overpainting
- Little sign of general wear and tear points to newer sashes
- Currently has Slimline IGUs

Like-for-like replacement custom-fitted with Slimline IGUs

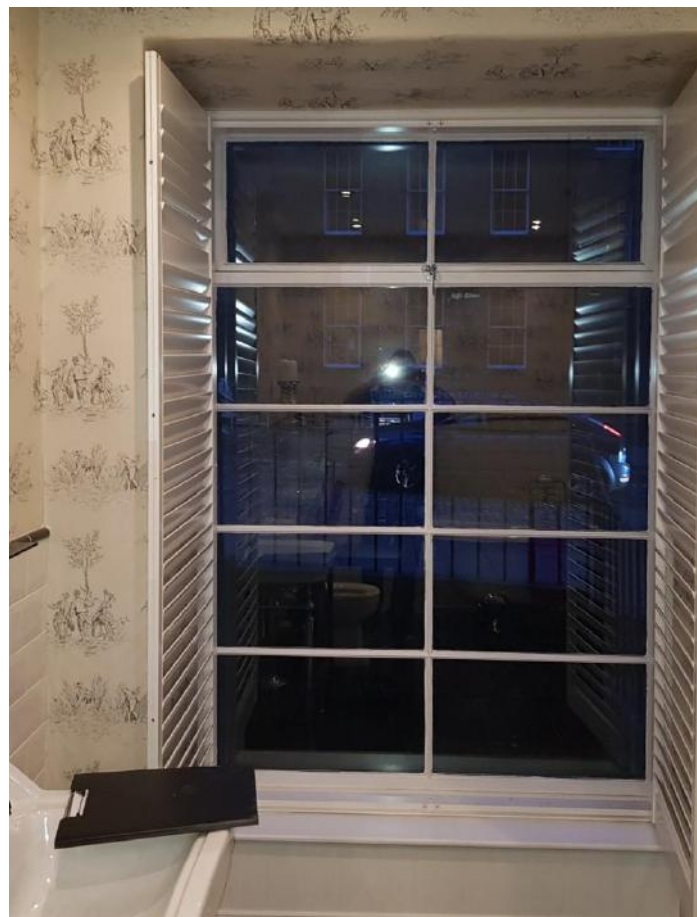
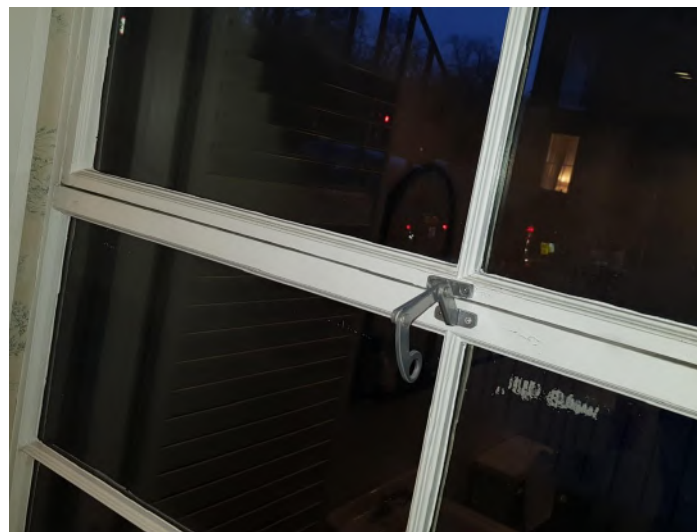
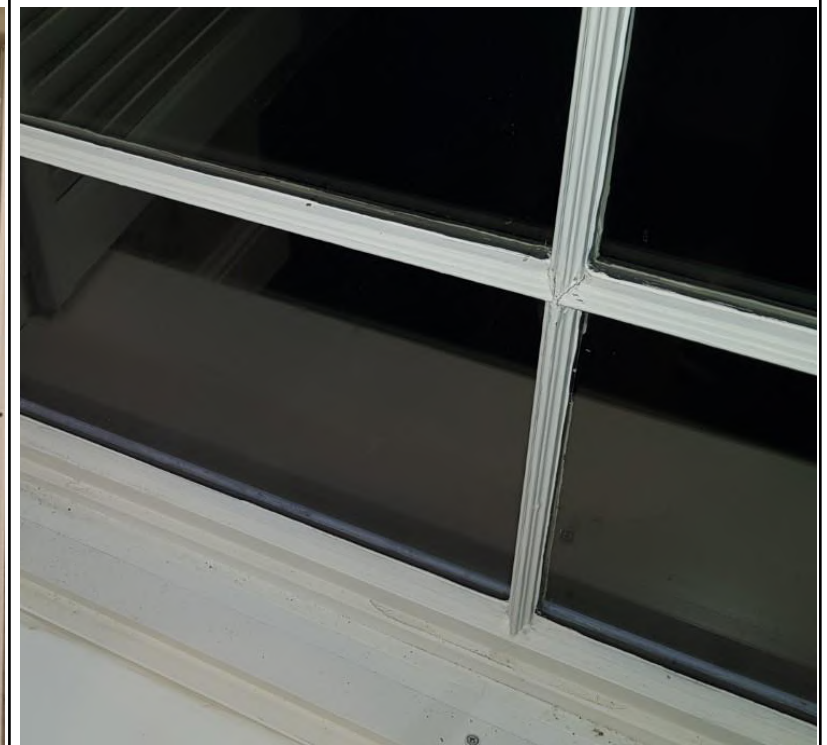
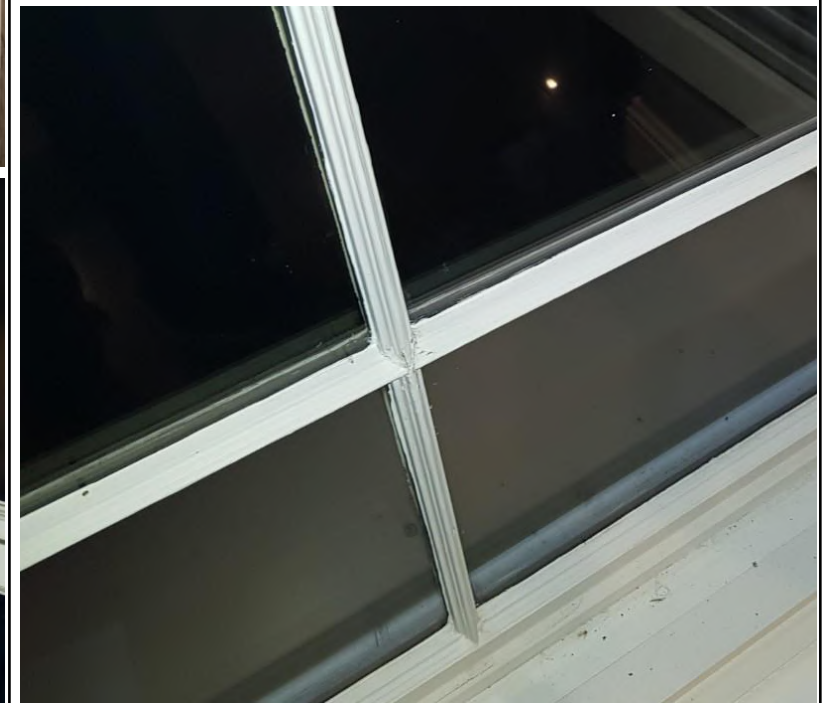
Elevation	Floor	No.	Room
Side	BF1	<b>W14</b>	Rear Bed 1, Ensuite

- Window appears to be non-historic and of more recent construction
- Moulding Detail is sharp and well-defined
- Lack of overpainting
- Little sign of general wear and tear points to newer sashes
- Currently has Slimline IGUs

Like-for-like replacement custom-fitted with Slimline IGUs

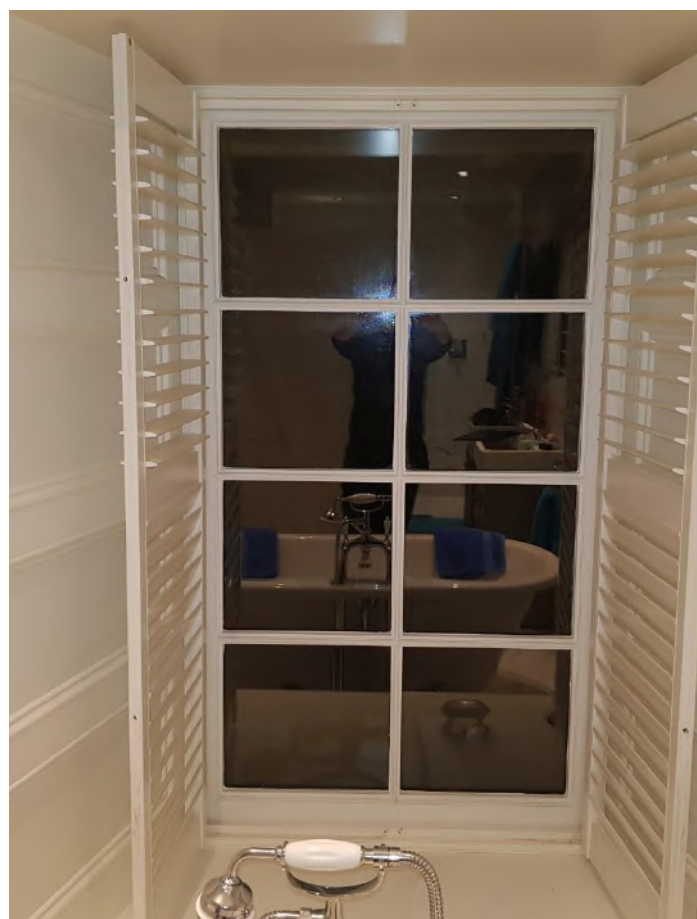
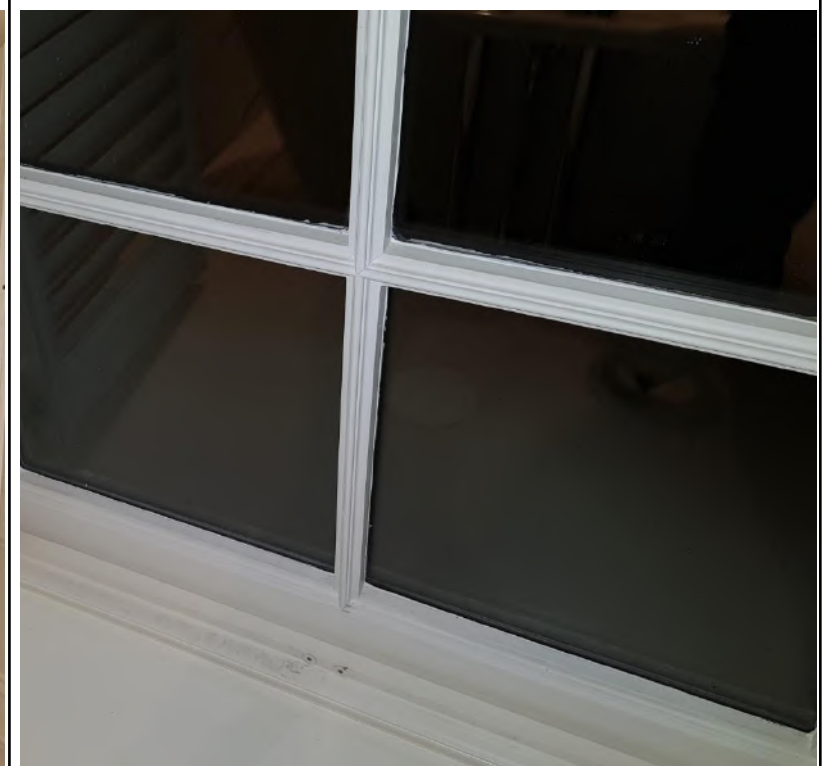
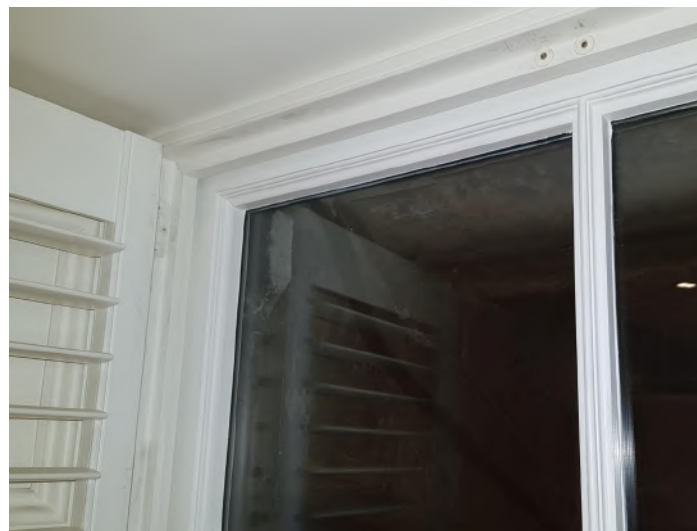
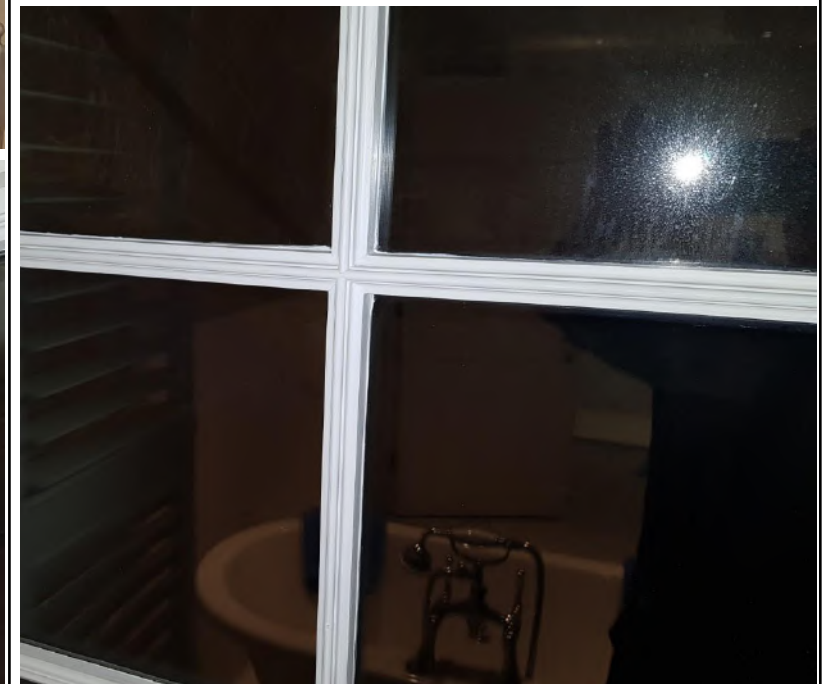
Elevation	Floor	No.	Room
Side	BF1	<b>W15</b>	Front Bed 1, Ensuite

- Window appears to be non-historic and of more recent construction
- Moulding Detail is sharp and well-defined
- Lack of overpainting
- Little sign of general wear and tear points to newer sashes
- Currently has Slimline IGUs

Like-for-like replacement custom-fitted with Slimline IGUs

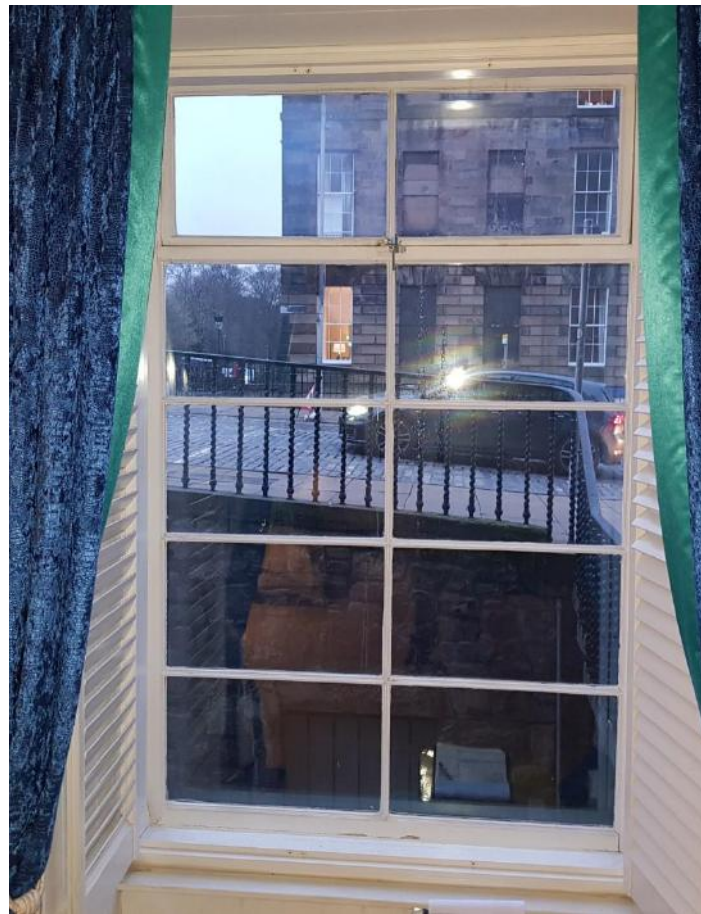
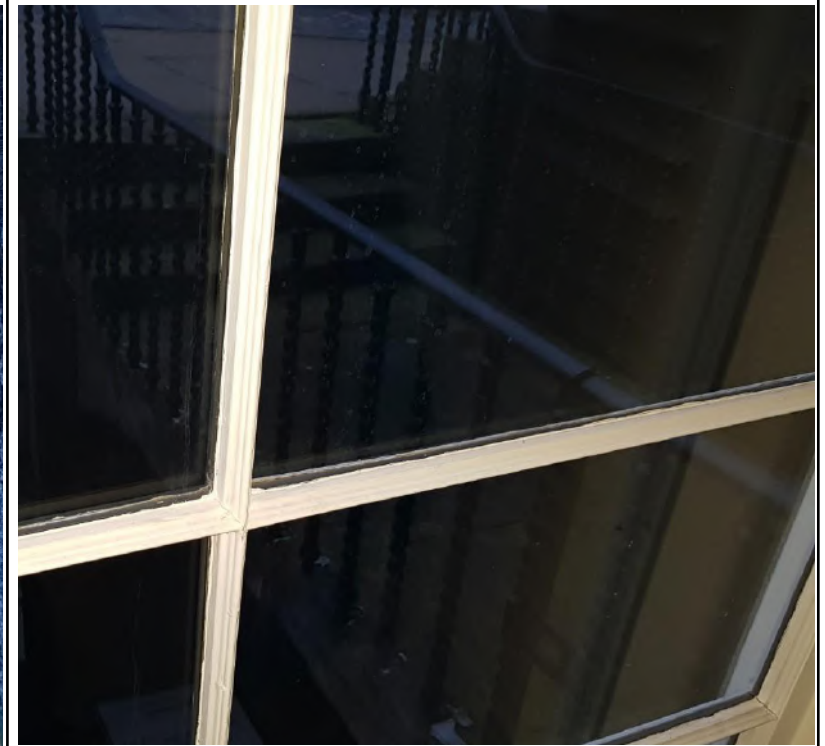
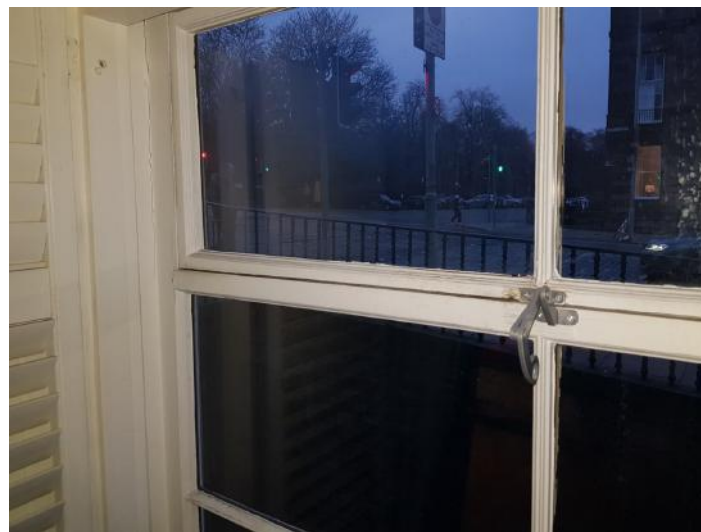
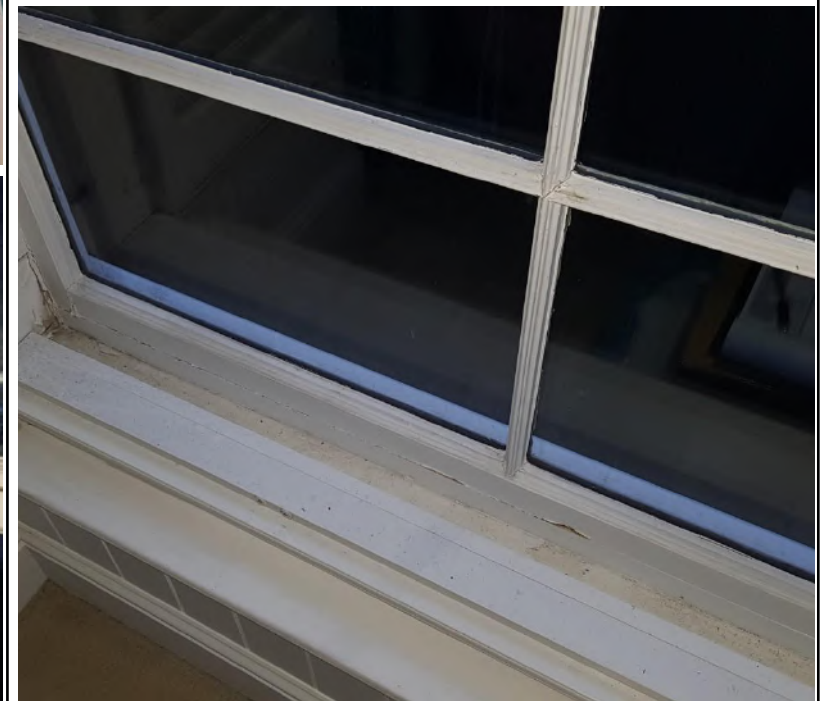
Elevation	Floor	No.	Room
Side	BF1	<b>W16</b>	Front Bed 1

- Sashes are non-historic and of more recent construction
- Moulding Detail is sharp and well-defined
- Lack of overpainting
- Little sign of general wear and tear points to newer sashes
- Currently has Slimline IGUs

Like-for-like replacement custom-fitted with Slimline IGUs

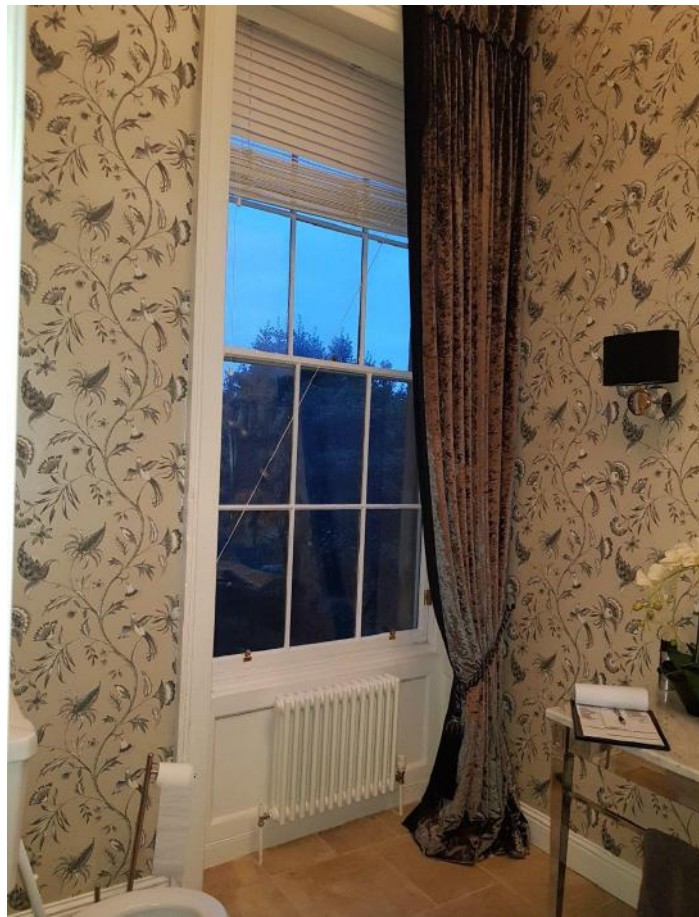
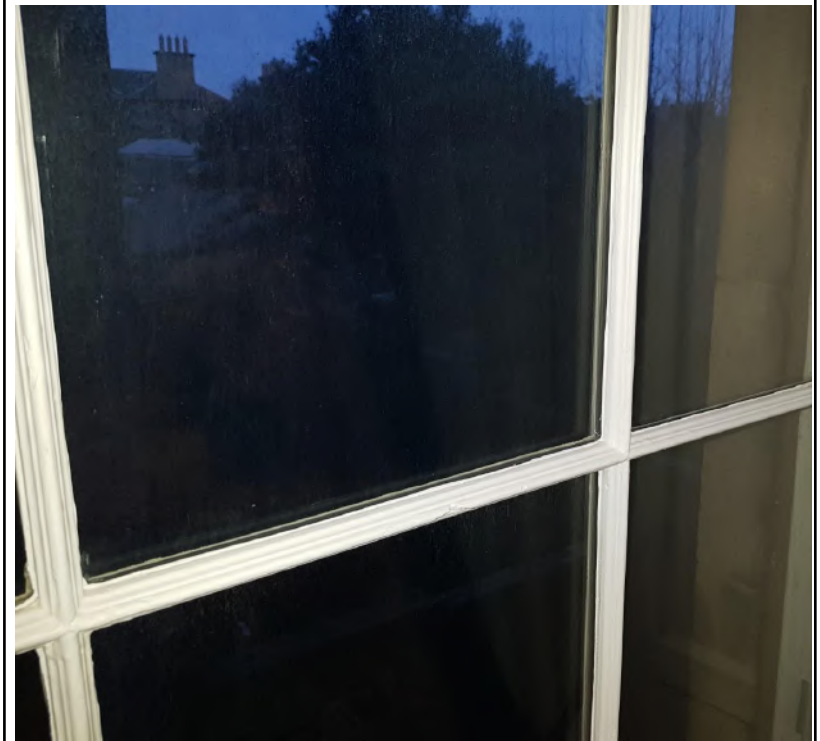
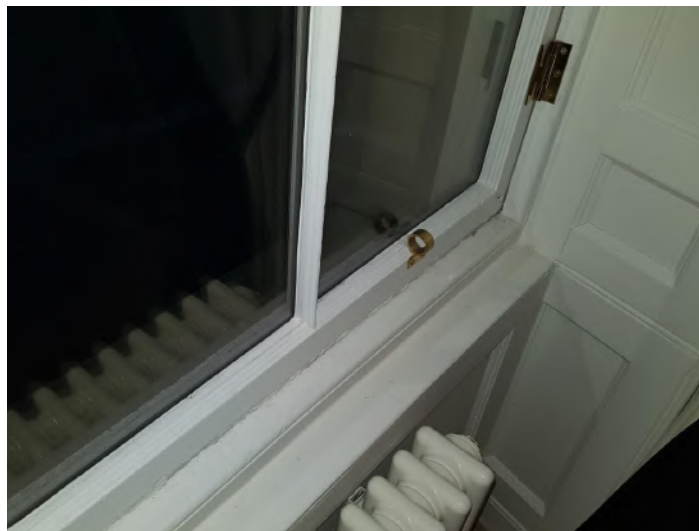
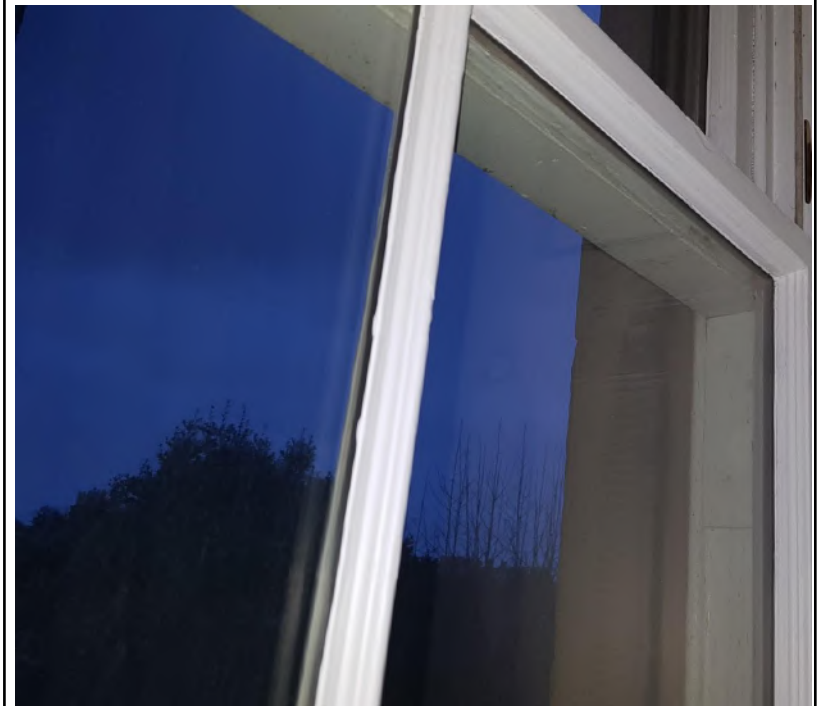
Elevation	Floor	No.	Room
Rear	GF	<b>W17</b>	Bathroom

- Moisture permeation of the horizontal rails and extending to the lower stiles
- Lower astragal joinery is swollen
- Cracking of paint along the joins is indicative of shrinkage/swelling and a weakening of the structure.
- Currently has Slimline IGUs

Like-for-like replacement custom-fitted with Slimline IGUs

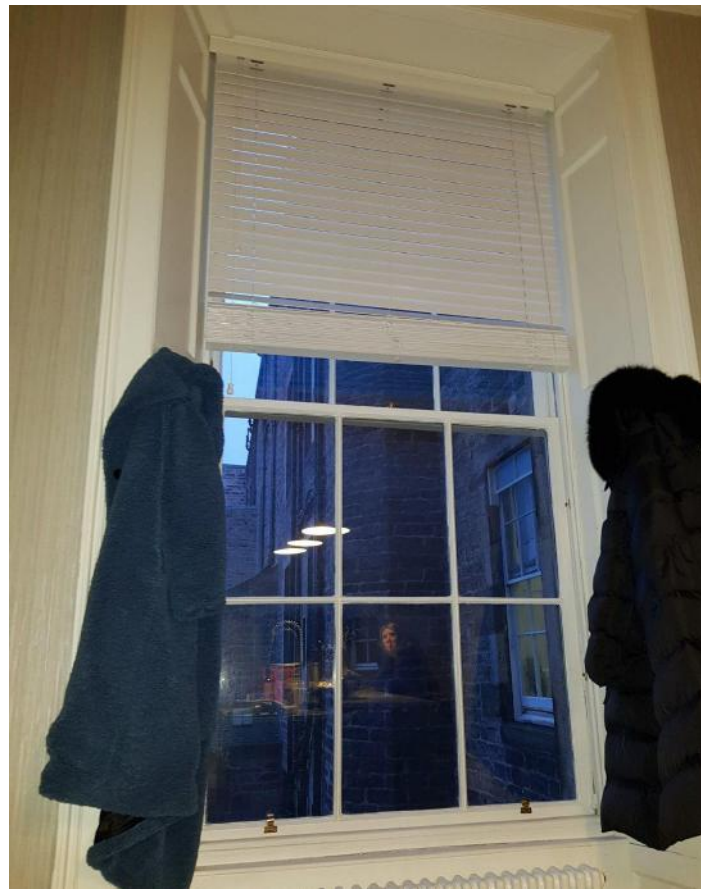
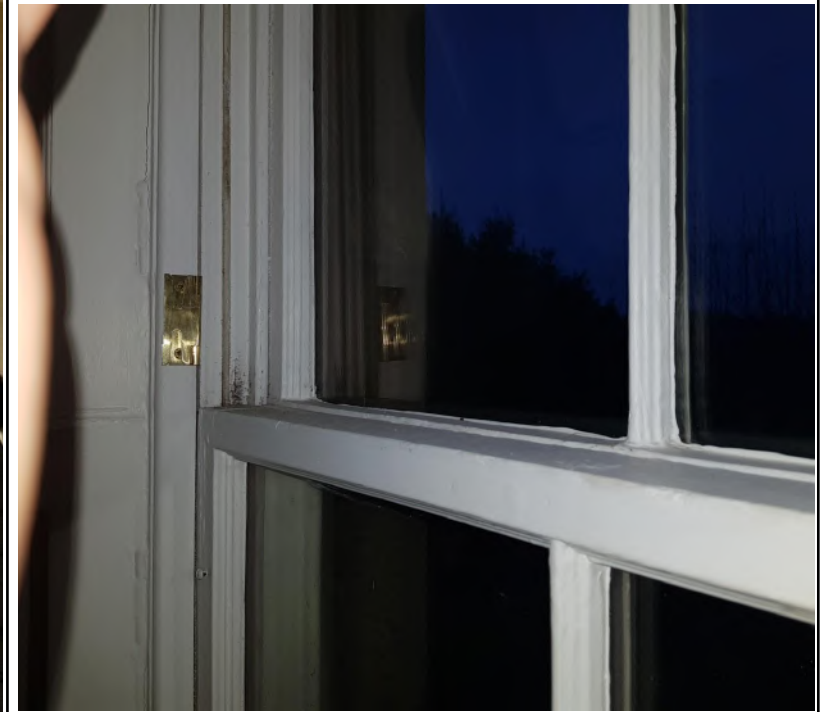
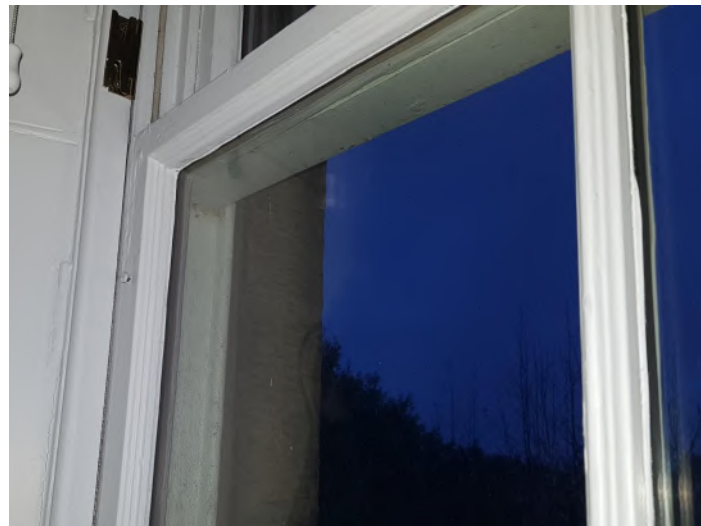
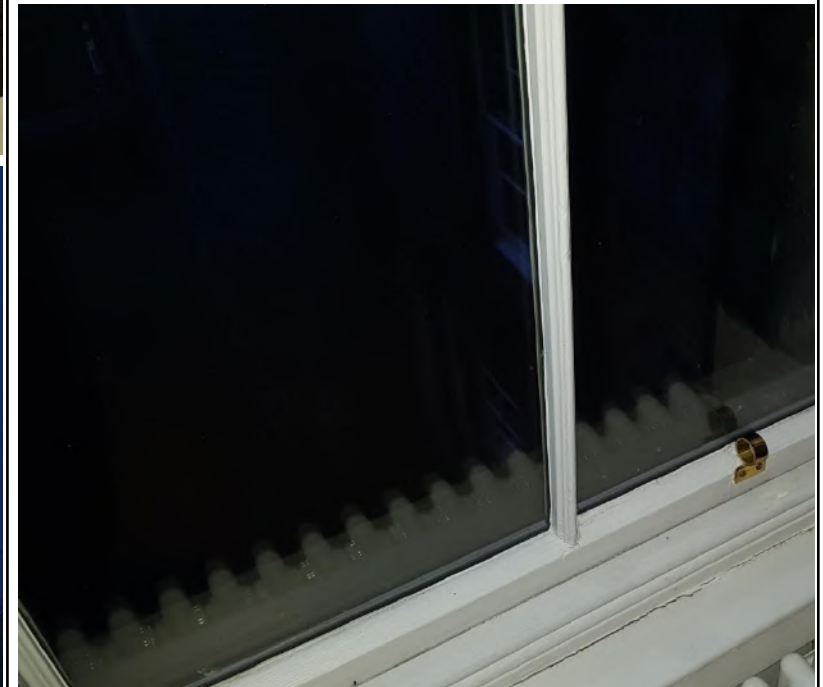
Elevation	Floor	No.	Room
Rear	GF	<b>W18</b>	Kitchen

- Moisture permeation of the horizontal rails and extending to the lower stiles
- Lower astragal joinery is swollen
- Cracking of paint along the joins is indicative of shrinkage/swelling and a weakening of the structure.
- Currently has Slimline IGUs

Like-for-like replacement custom-fitted with Slimline IGUs
