Lime Cottage, Cassington, Oxfordshire

Listed building consent for the replacement of seven windows and one door

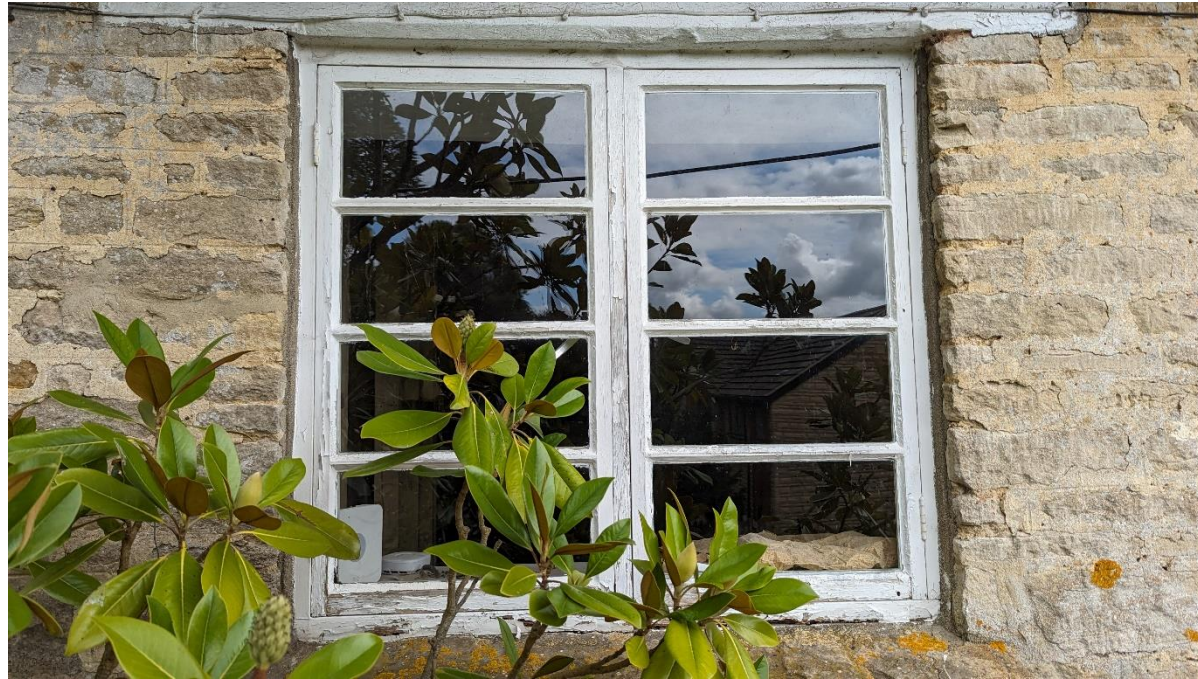
Window W1

Window type:	8 pane timber casement
Lintel construction:	Chamfered oak beam
Sill construction:	Stone slates with Portland cement mortar
Window condition:	Fair – visible signs of minor decay
Heritage value:	Low: Mid C20th, probably 1960s in the style of the earlier windows to the ground floor.

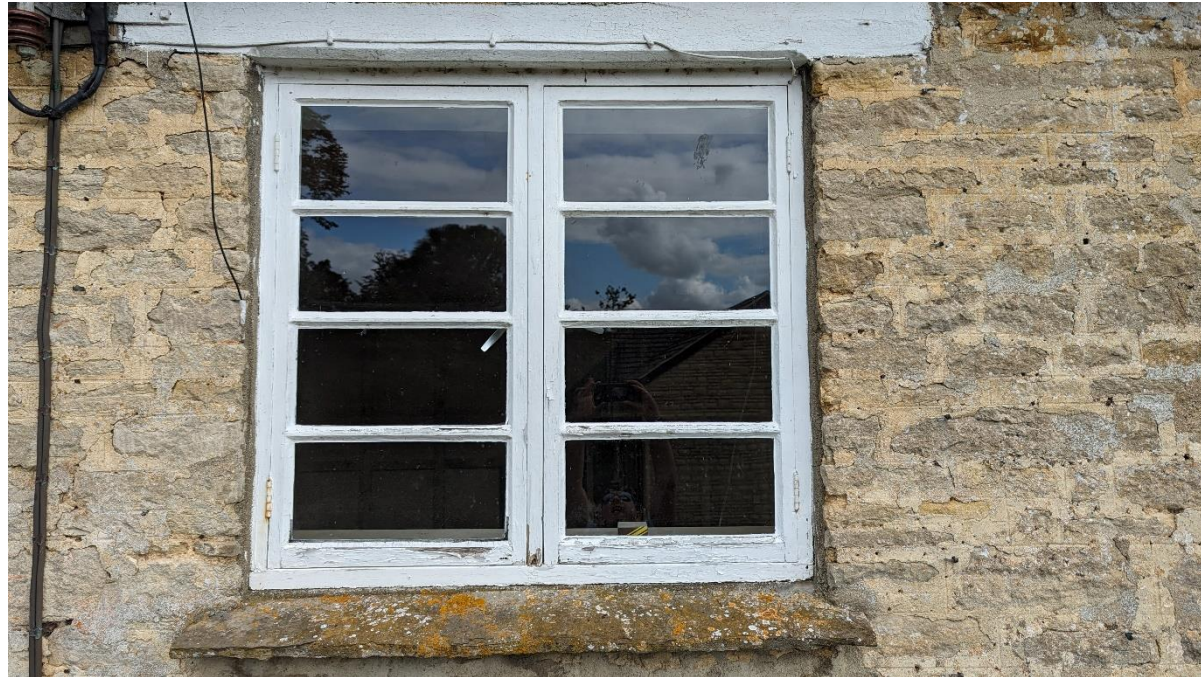
Window W2

Window type: 8 pane timber casement
Lintel construction: Chamfered oak beam
Sill construction: Stone slates with Portland cement mortar
Window condition: Poor – visible signs of more significant decay
Heritage value: Low: Mid C20th, probably 1960s in the style of the earlier windows to the ground floor.

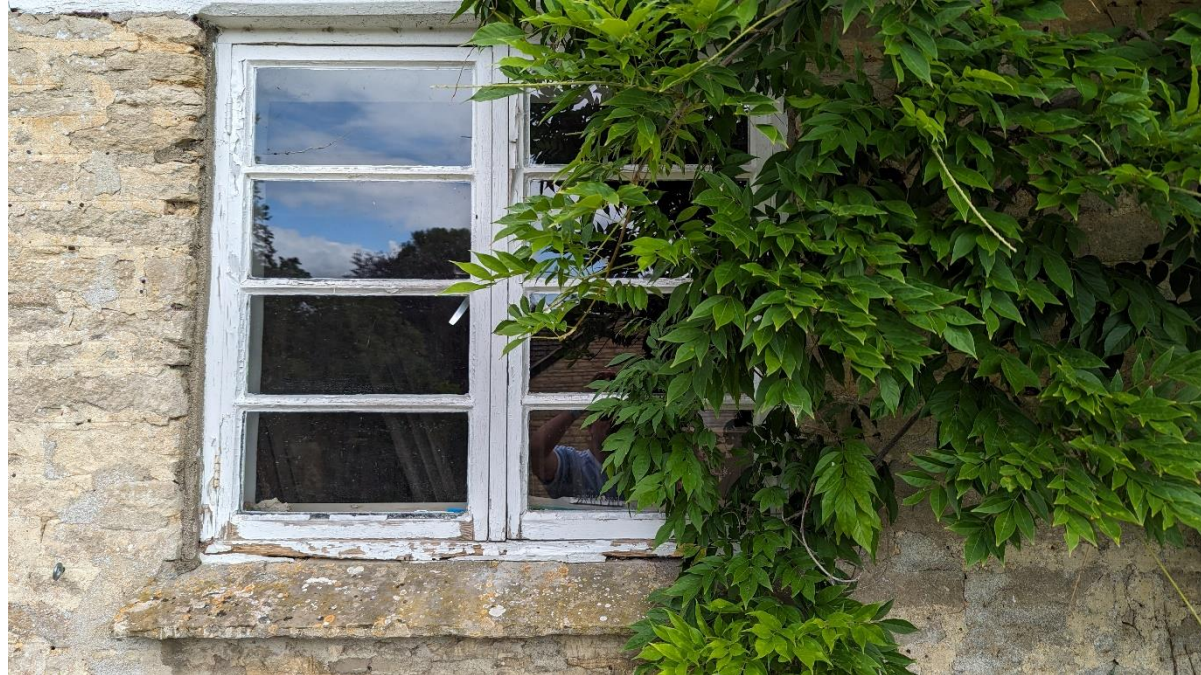
Window W3

Window type: 8 pane timber casement
Lintel construction: Chamfered oak beam
Sill construction: Stone slates with Portland cement mortar
Window condition: Poor – visible signs of more significant decay
Heritage value: Low: Mid C20th, probably 1960s in the style of the earlier windows to the ground floor.

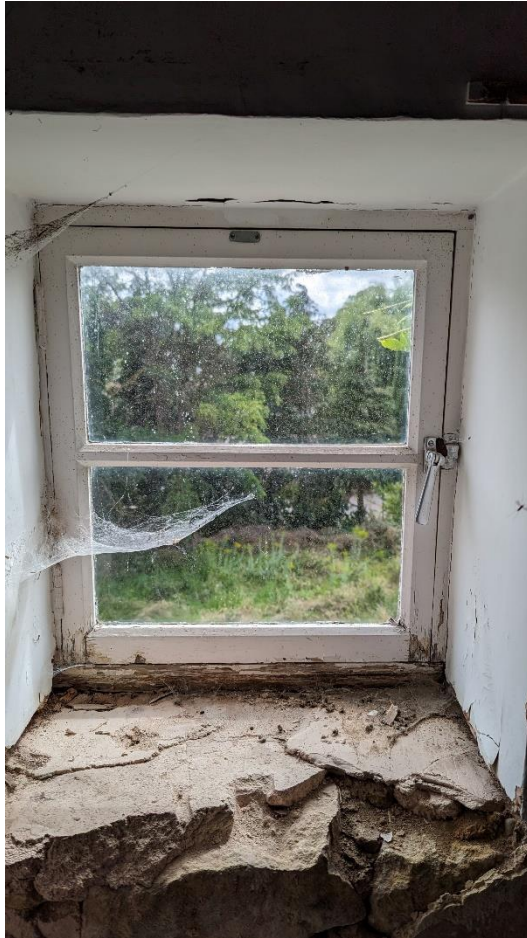
Window W4

Window type:	2 pane timber casement
Lintel construction:	Poured concrete beam (C. 20 th century)
Sill construction:	Stone slates with Portland cement mortar
Window condition:	Poor – visible signs of more significant decay
Heritage value:	Low: Mid C20th, probably 1960s in the style of the earlier windows to the ground floor front elevation.

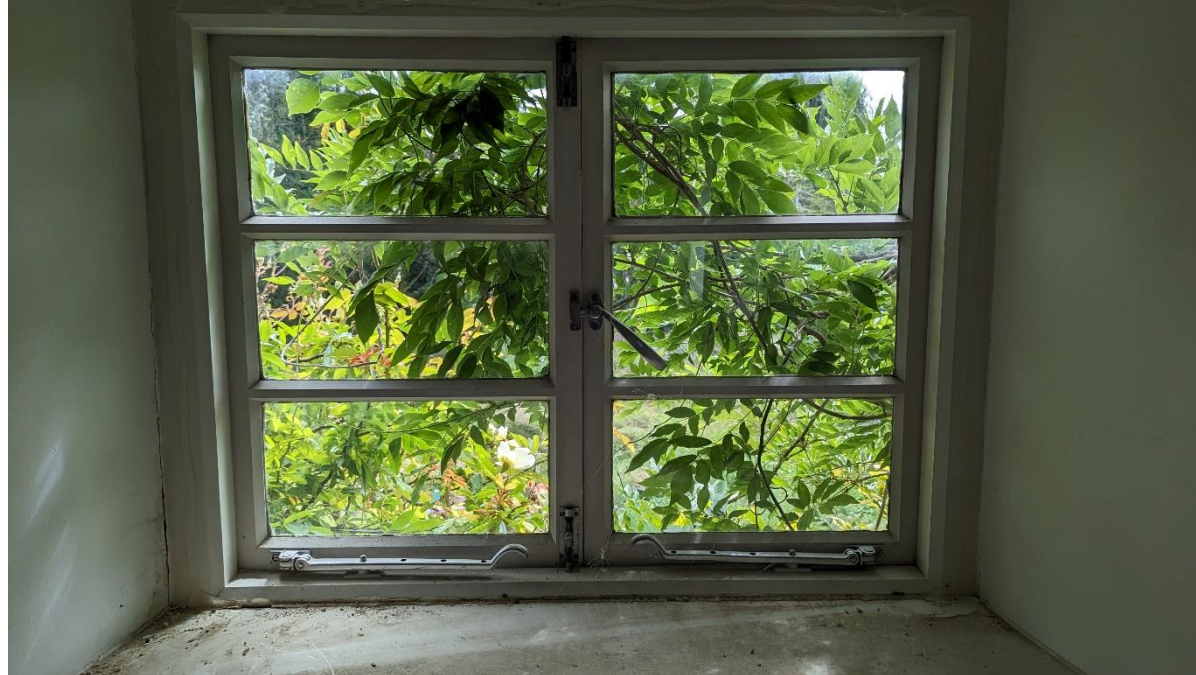
Window W5

- Window type: 6 pane timber casement
Lintel construction: Poured concrete beam (C. 20th century)
Sill construction: Stone slates with Portland cement mortar
Window condition: Fair – visible signs of minor decay.
Heritage value: Low: Mid C20th, probably 1960s in the style of the earlier windows to the ground floor front elevation.

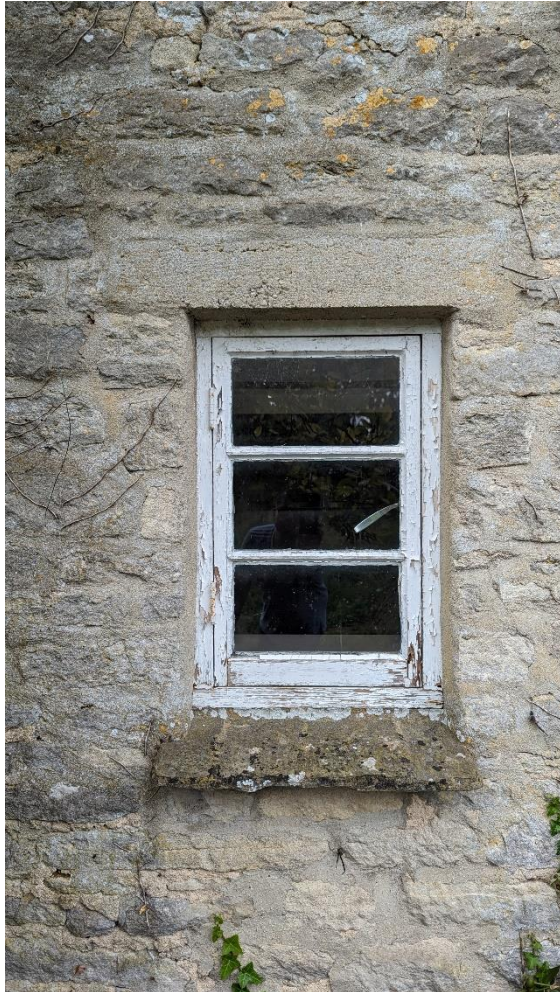
Window W5

Window type:	3 pane timber casement
Lintel construction:	Poured concrete beam (C. 20 th century)
Sill construction:	Stone slates with Portland cement mortar
Window condition:	Poor – visible signs of more significant decay
Heritage value:	Low: Mid C20th, probably 1960s in the style of the earlier windows to the ground floor front elevation.

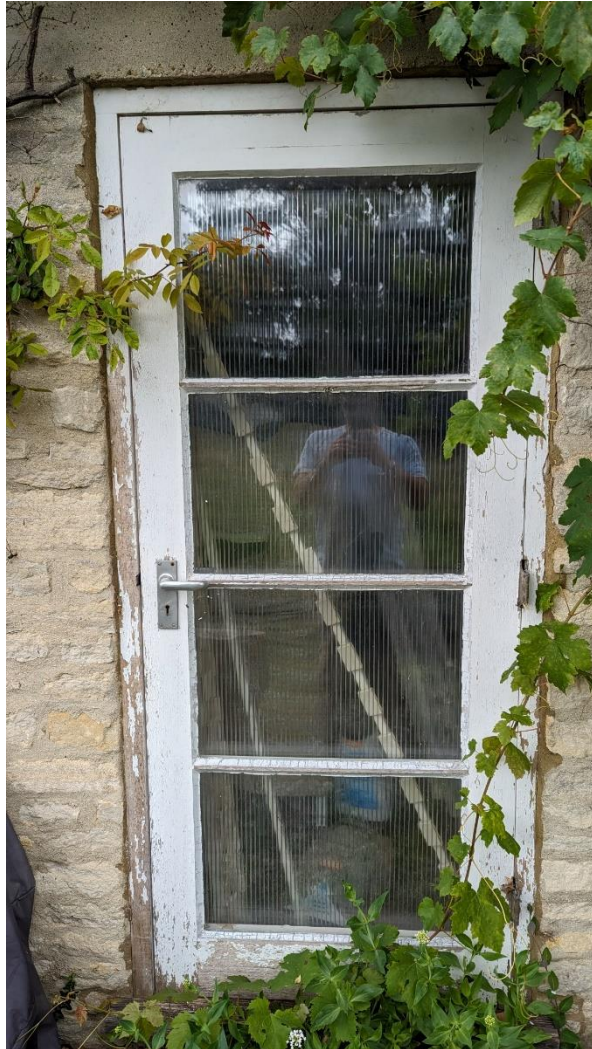
Door D1

Door type:	4 pane timber door
Lintel construction:	Poured concrete beam (C. 20 th century)
Sill construction:	Softwood timber (C. 20 th century)
Door condition:	Poor – visible signs of more significant decay
Heritage value:	Low: Mid C20th, probably 1960s in the style of the earlier windows to the ground floor front elevation.

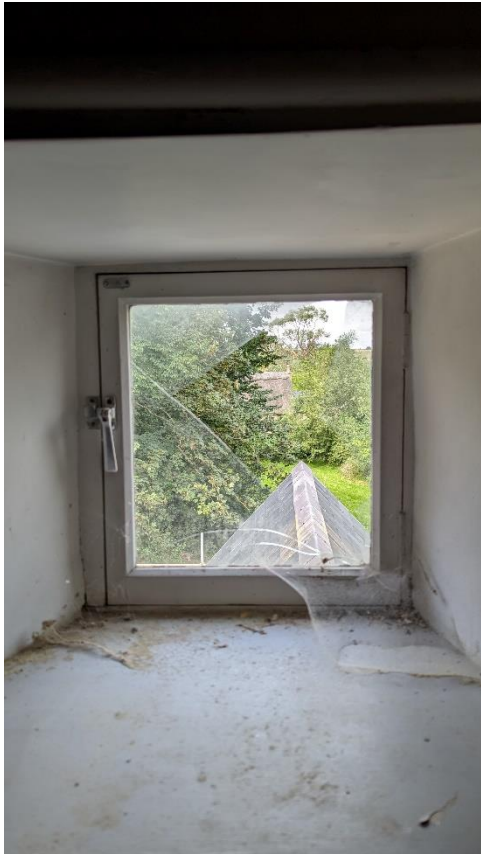
Window W7

Window type:	Single pane timber casement
Lintel construction:	Poured concrete beam (C. 20 th century)
Sill construction:	Stone slates with Portland cement mortar
Window condition:	Fair – visible signs of minor decay.
Heritage value: Low:	Mid C20th, probably 1960s in the style of the earlier windows to the ground floor front elevation.
