Tree Safety Survey and Report

South Cave Play Area
South Cave

DECEMBER 2018

RICHARD LANCASTER: TREES & LANDSCAPE
ENVIRONMENTAL CONSULTANCY

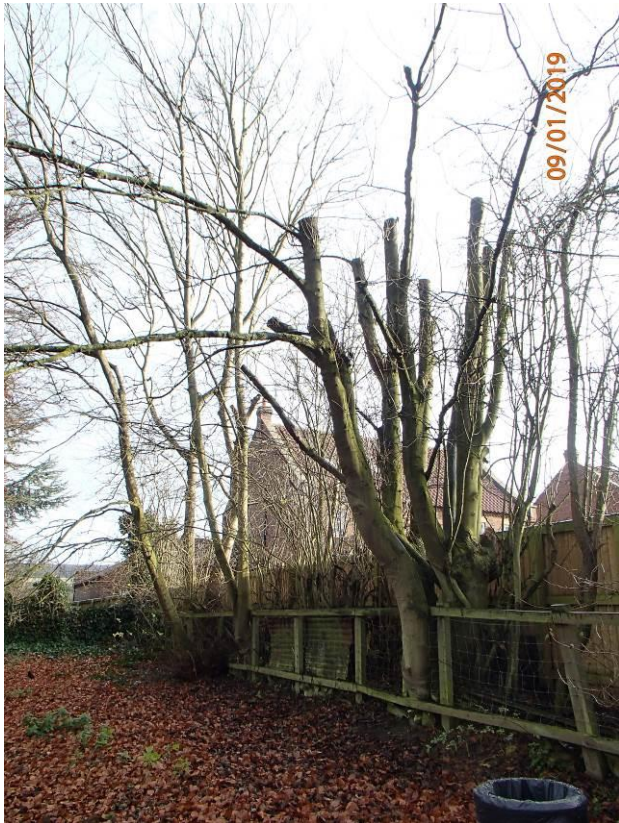
Tree No.	Species	Approx Height (m)	Diam (mm)	Life Stage	Physiological and Structural Condition. Preliminary management Recommendations	Est. RC years	Grade BS5837	Photo
G1	Ash Sycamore Hawthorn Elder	4 - 12	100-300	M	Old hedge line, degraded and grown out. Heavenly pruned by neighbours to south, including partially-topped Sycamore. Section to north leaning out and towards equipment. Some Elm remaining from stump and leaning north; and minor deadwood throughout length of boundary. Suggest Sycamore is fully pollarded, some Ash reduced and leaning Elm removed (before it dies); all for management reasons rather than high-risk safety issues.	10-20	C	1
T1	Beech <i>Fagus sylvatica</i>	22	1000	LM	Apparently sound and healthy, fair form. Minor crossing branches and typical minor deadwood. Fungus in ground to south side, very degraded, but doesn't appear to be <i>Meripilus</i> or <i>Armillaria</i> . Small growth of probable charcoal fungus in buttress to south. <i>No immediate safety works recommended. Suggest</i> crown cleaning and lifting of branches to nominal 4m AGL. Check junction at 12m AGL. Monitor fungal brackets to confirm.	20-30	B	2, 3

Photo 1 G1, Pollarded Sycamore; Leaning Elm and multi-stem Ash

Ref.	Species	Recommendations	Priority
G1	Various	Suggest Sycamore is fully pollarded, Ash and Thorn pruned, and Elm removed	Low/Medium
T1	Beech	Suggest crown cleaning and lifting of branches, to a nominal 4m AGL	Low
T2	Beech	Suggest crown cleaning and lifting of branches, to a nominal 4m AGL	Low
T3	Beech	Suggest crown cleaning and lifting of branches, to a nominal 4m AGL	Low
T4	Beech	TBC Probable fell. TPO Approval already received.	Low/Medium
T5	Ash	Suggest crown cleaning and lifting of branches, to a nominal 4m AGL	Low
T6	Beech	Suggest crown cleaning and lifting of branches, to a nominal 4m AGL.	Low
T7	Beech	Suggest crown cleaning and lifting of branches, to a nominal 4m AGL.	Low
T8	Beech	Suggest remove and replace, as part of an overall management plan.	Low
T11	Beech	Suggest crown cleaning and lifting of branches, to a nominal 4m AGL	Low
T12	Beech	Recommend various pruning works, as scheduled.	Low/Medium

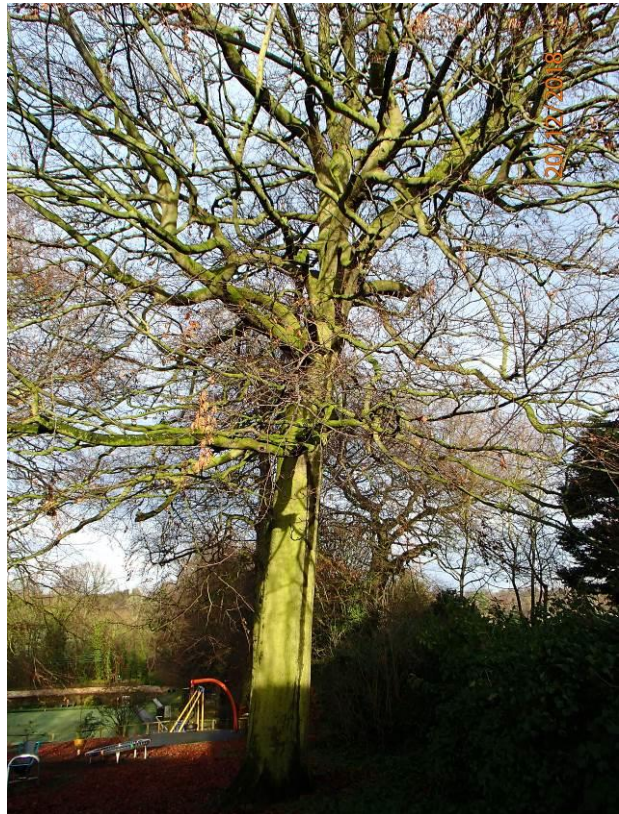
Photo 2 T1 Beech

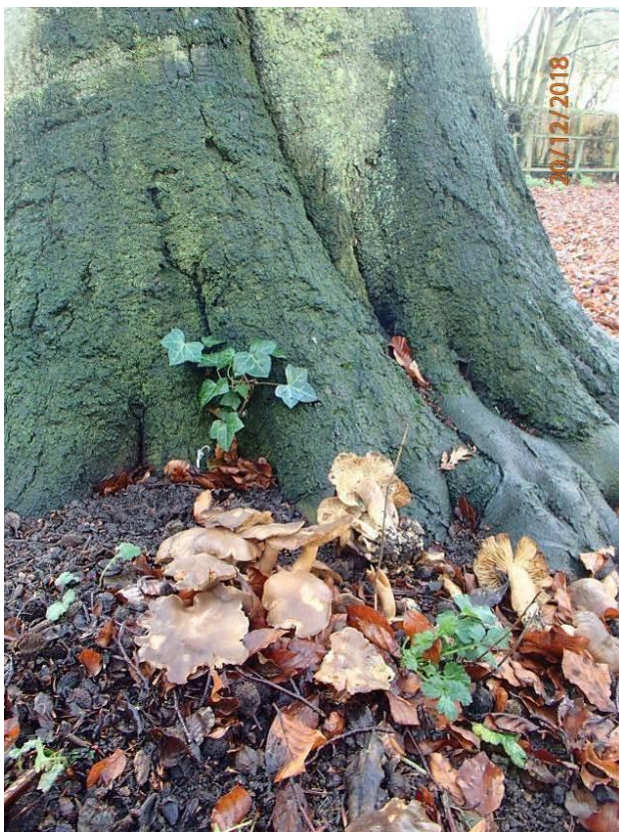
Photo 3 T1 Beech, stem base, toadstool growth (possible Charcoal fungus in buttress to left)

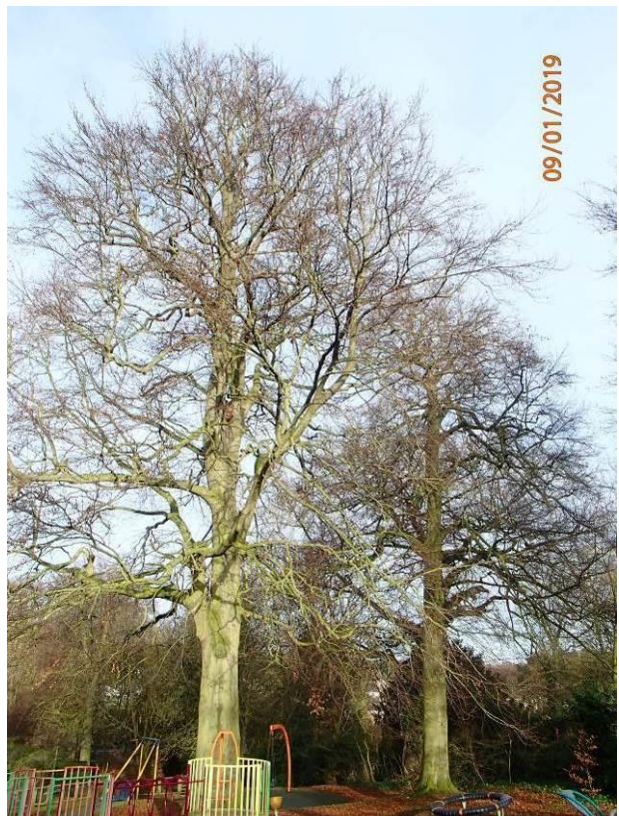
T2	Beech <i>Fagus sylvatica</i>	20	900	LM	Apparently sound and healthy, fair form. Self-brace at 12m protects junction. Hanging dead branch at 11m east, plus other very minor deadwood. Low growth over and towards playground. <i>No immediate safety works recommended. Suggest</i> crown cleaning and lifting of branches to nominal 4m AGL.	20-30	B	4
T3	Beech <i>Fagus sylvatica</i>	22	850	LM	Good form, foliage health good, may be showing signs of bark disease but not structurally significant. Typical minor deadwood. <i>No immediate safety works recommended. Suggest</i> crown cleaning and lifting of branches to nominal 4m AGL.	20-30	B	4
T4	Beech <i>Fagus sylvatica</i>	20	1100	LM	Boundary tree, ownership not confirmed. Fair foliage health and form, significant scar and bark loss to east side ground level to 4m AGL. Wood deterioration appears fairly shallow. Ivy has been cut- possible stem hole? Probable Charcoal fungus brackets at base of stem scar – but may be actual (bark) charcoal caused by adjacent fire? TBC. Note: Approval for felling of this tree has already given by EWRYC under the TDD (dead or dangerous) procedure. <i>Probable Recommend</i> fell – TBC monitor & re-assess	10-20	C	5, 6, 7

Photo 4 T2 Beech LHS; T3 Beech RHS

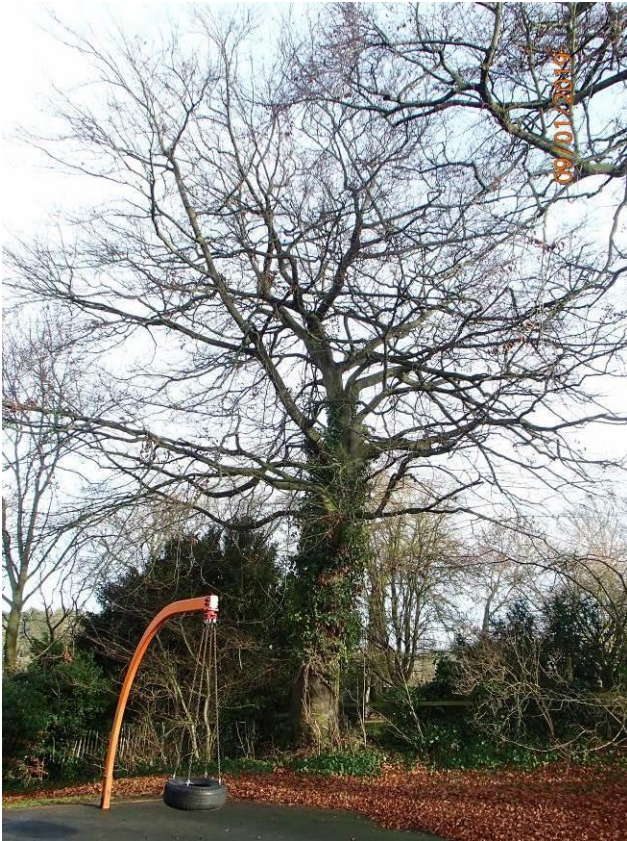
Photo 5 T4 Beech, on east boundary. Probable Fell

Clarification on the ownership of the boundary T4 is suggested, notwithstanding the suggested decision on its status pending re-assessment. Approval for removal under TDD criteria has already been given by East Riding of Yorkshire Council.

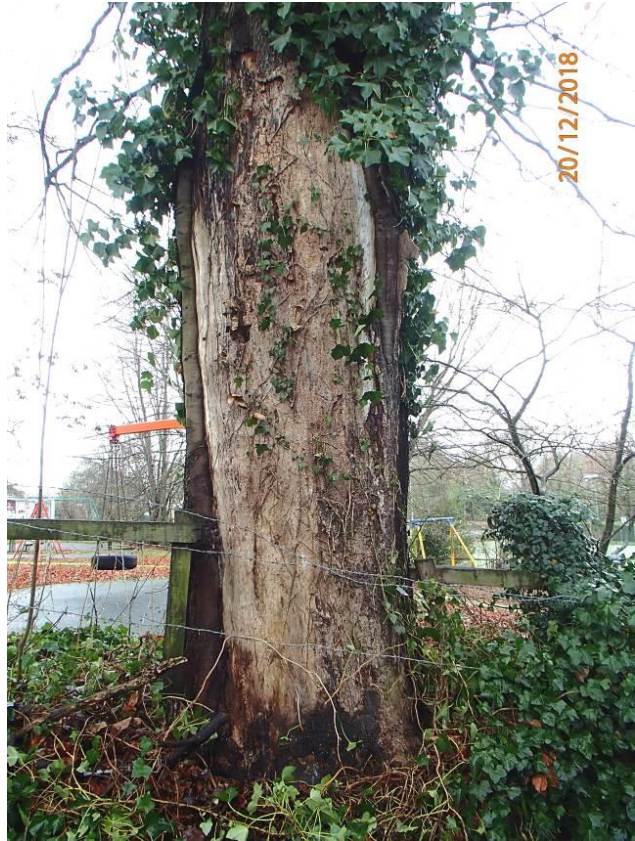
Photo 6 T4 Beech, east of stem, from adjacent garden (possible Charcoal fungus in buttress at base)

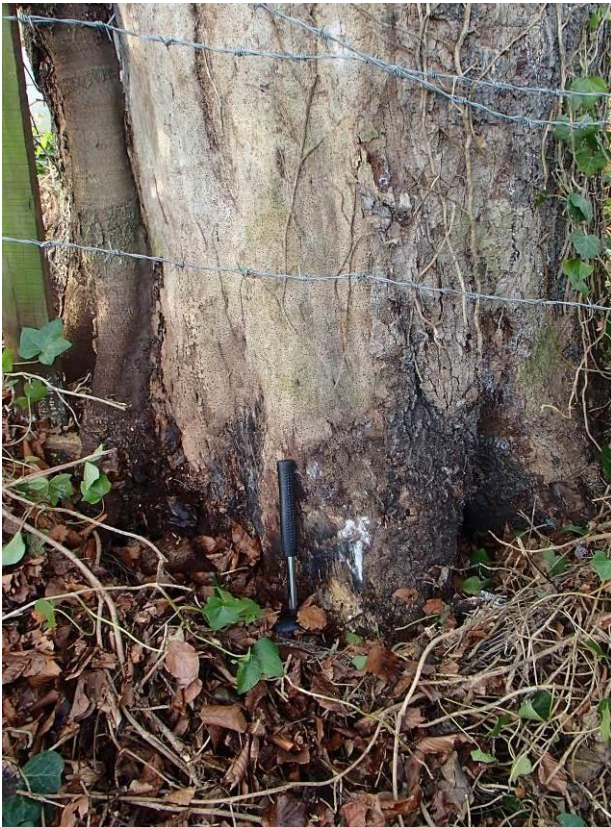
Photo 7 T4 Beech, possible charcoal fungus

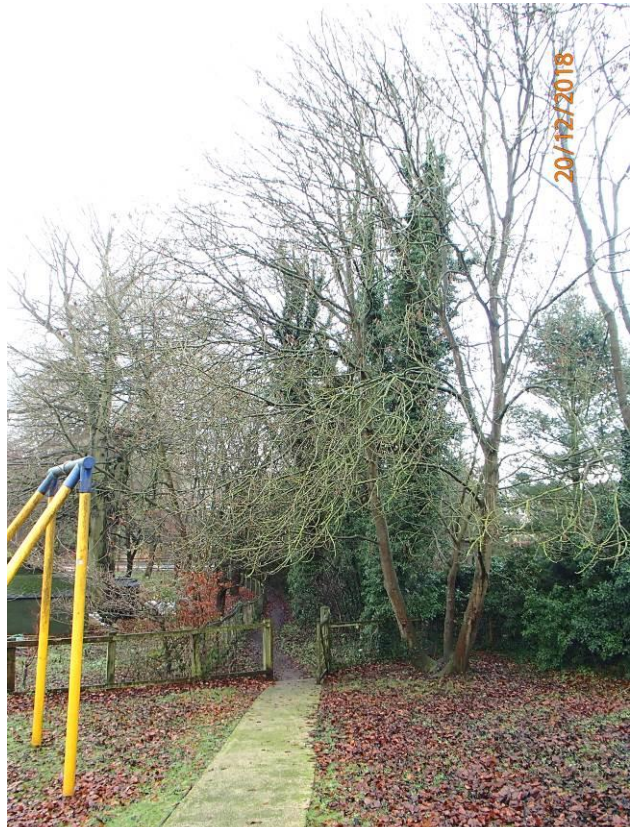
T5	Ash <i>Fraxinus excelsior</i>	14	150 - 300	M	Smaller, multi-stem tree in corner, probable hedge remnant. Junctions at ground level all appear sound. Low growth over approach path. Suggest crown lifting of branches to nominal 4m AGL	10-20	C	8

Photo 8 T5 multi-stem Ash

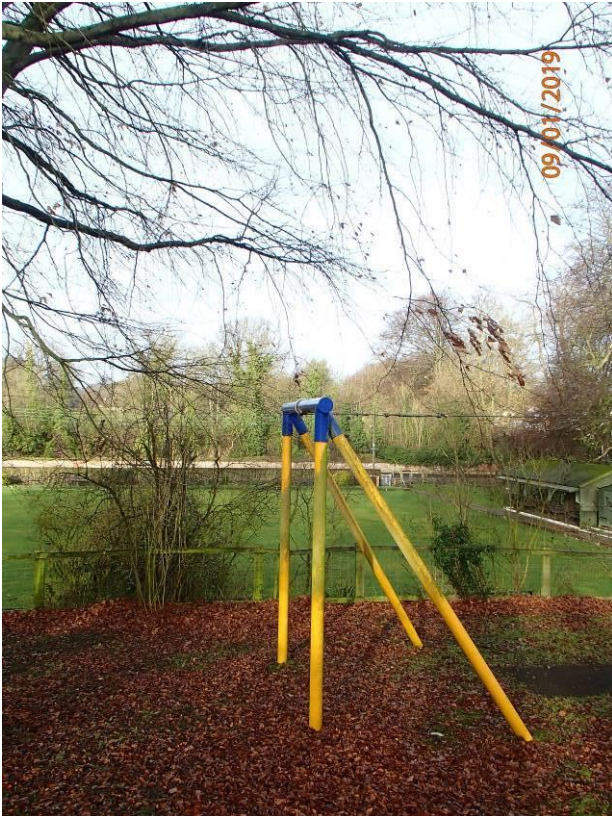
Tree No.	Species	Approx Height (m)	Diam (mm)	Life Stage	Physiological and Structural Condition. Preliminary management Recommendations	Est. RC years	Grade BS5837	Photo
T6	Beech <i>Fagus sylvatica</i>	18	700	M	Younger mature tree, crown slightly compromised by group location. Good foliage health, stem splits to 4 at 2m AGL, sound junction at present. <i>No immediate safety works recommended. Suggest crown lifting of branches to nominal 4m AGL where towards zip wire.</i>	20-30	B	9
T7	Beech <i>Fagus sylvatica</i>	18	700	M	Younger mature tree, crown slightly compromised by group location. Good foliage health, stem splits to 3 at 2m AGL, sound junctions at present. <i>No immediate safety works recommended. Suggest crown lifting of branches to nominal 4m AGL where towards playground.</i>	20-30	B	10, 15
T8	Beech <i>Fagus sylvatica</i>	18	450	M	Younger mature tree, crown slightly compromised by group location, thinner stem. Good foliage health, stem splits to 2 at 2m AGL, sound junctions at present. Minor deadwood to be cleaned. <i>No immediate safety works recommended. Suggest crown cleaning & lifting of branches to nominal 4m AGL where towards playground.</i>	20-30	B	10, 11, 15

Photo 9 Beech T6, growth above zip wire.

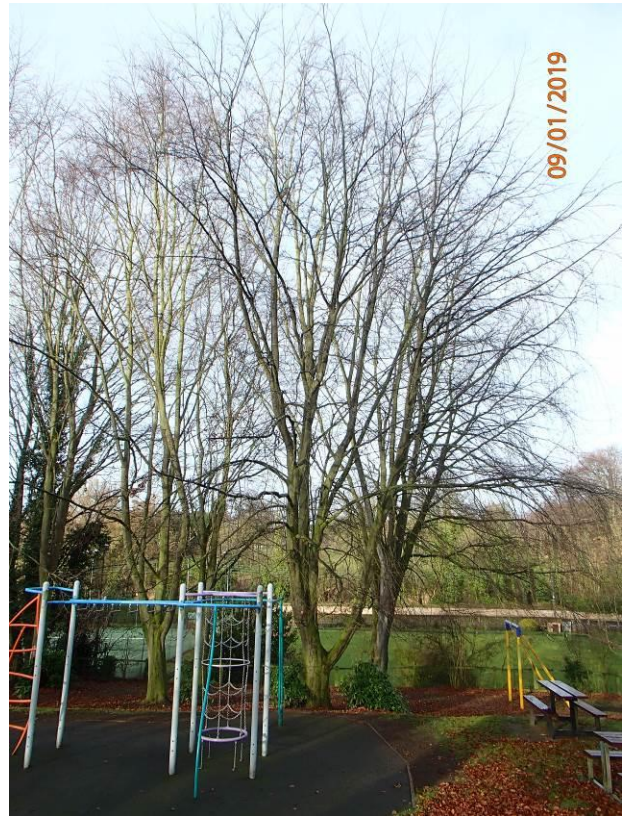
Photo 10 Beech group, T6 RHS to T9 LHS

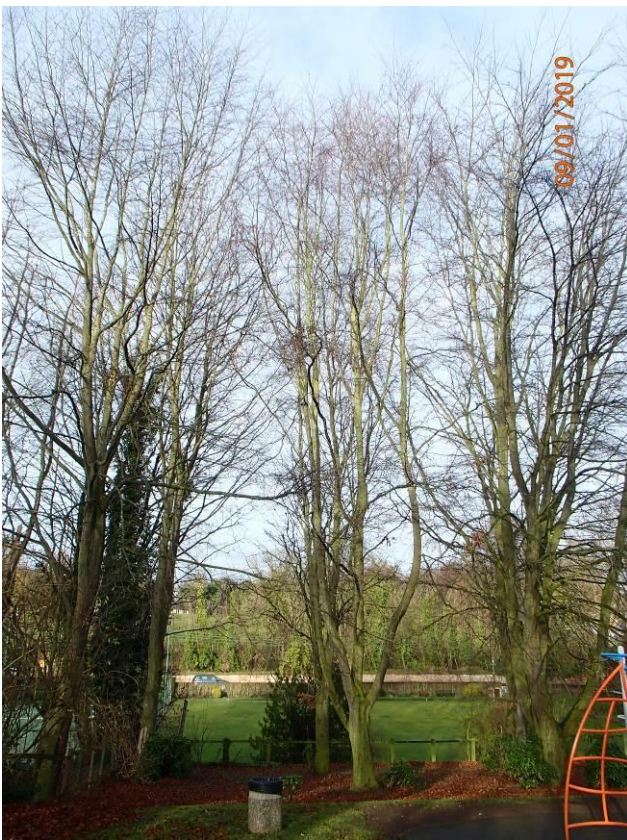
T9	Beech <i>Fagus sylvatica</i>	18	550	M	Younger mature tree, multi stem form OK. Good foliage health, sound junctions at present. Very minor deadwood. <i>No immediate safety works recommended.</i>	20-30	B	11, 15
T10	Beech <i>Fagus sylvatica</i>	18	450	M	Younger mature tree, crown slightly compromised by group location. Stem scar at 500 to 1.5m north side, wood not significantly compromised. Good foliage health, stem splits to 2 at 4m AGL, junction appears sound. <i>No immediate safety works recommended.</i>	20-30	B	11
T11	Beech <i>Fagus sylvatica</i>	16	600	M	Boundary tree, ownership not confirmed. Fair foliage health and form, unbalanced growth in places due to location and adjacent trees. Twin-stem is twisted on itself from 1m to 3m, creating some self-bracing. Suggest crown lifting of branches to nominal 4m AGL, and minor reductions of extended branches.	20-30	B	11
T12	Beech <i>Fagus sylvatica</i>	20	900	LM	Mature tree, sound and healthy, large callus/burr at 5m AGL south side. Low over playground. Very minor deadwood. Close to T13 – assumed to be removed - and impacted by it. Suggest crown cleaning and lifting of branches to nominal 4m AGL. <u>Assuming removal of T13</u> , include branch reduction of extended limbs to east and west and (if practical) twisted branches at top of crown. Branch reductions to be nominal 3 to 4m, or maximum 15%, all to suitable branch junctions.	20-30	B	13

Photo 11 Beech group, T8 RHS to T11 LHS

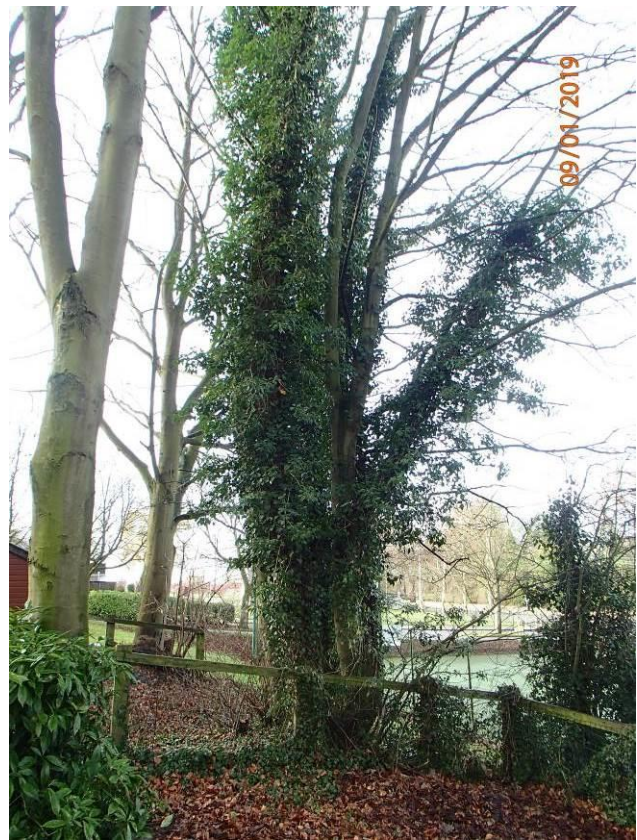
Tree No.	Species	Approx Height (m)	Diam (mm)	Life Stage	Physiological and Structural Condition. Preliminary management Recommendations	Est. RC years	Grade BS5837	Photo
T13	Beech <i>Fagus sylvatica</i>	22	900	LM	Good foliage health but hollowing stem and possibly structurally unsound within. Risk of failure may be low but location is extremely high risk. Recommend fell including stump grinding. Main tree section could be retained as log feature on the ground, subject to approvals? Replacement tree required; plant in south-west corner.	0-10	U	13, 14
T14	Sycamore	18	M/S	M	Just off site, straddling boundary, not owned, not fully inspected. <i>Suggest Ivy is cut, to allow full inspection of stem bases.</i>	-	-	12

Photo 12 Neighbouring tree, north-west corner, T14, recommend ivy is cut/removed.

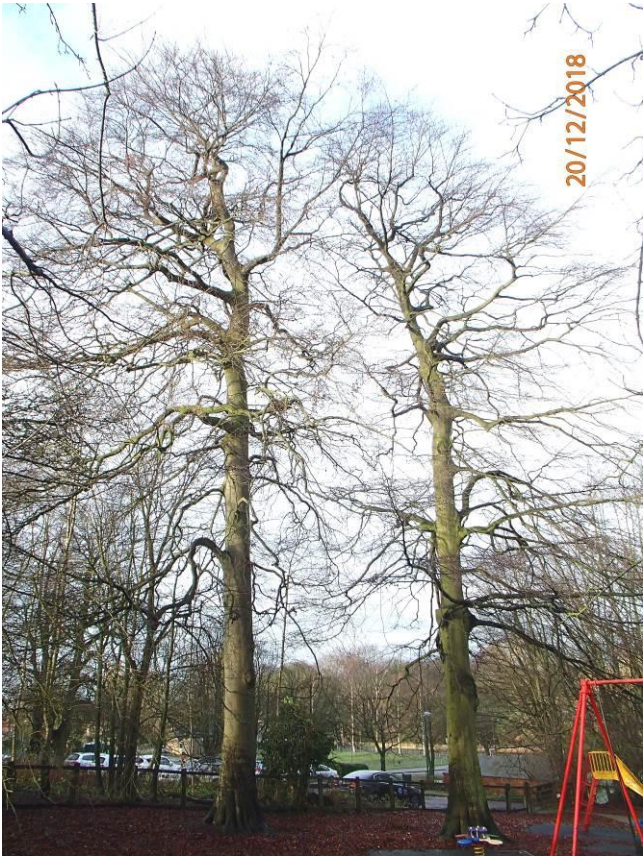
Photo 13 T12 Beech RHS; T13 Beech to fell, LHS

Assuming T13 is felled then some pruning is also recommended on the adjacent T12, as it will be more vulnerable without the protection from south west winds offered by T13.

T13	Beech	Recommend felling and removal.	Medium/High

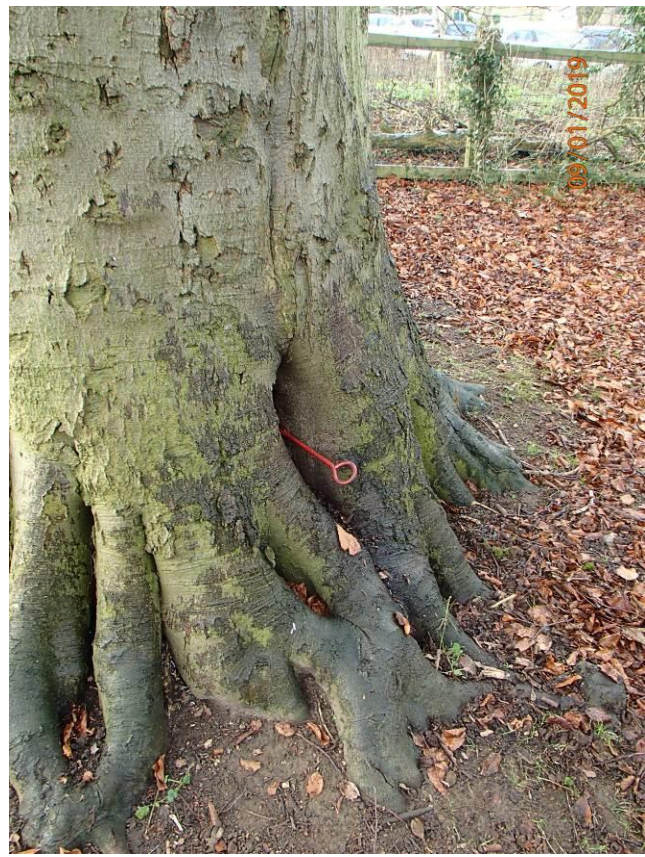
Photo 14 T13 Beech, stem cavity, north side.
Honey fungus in buttress to left side

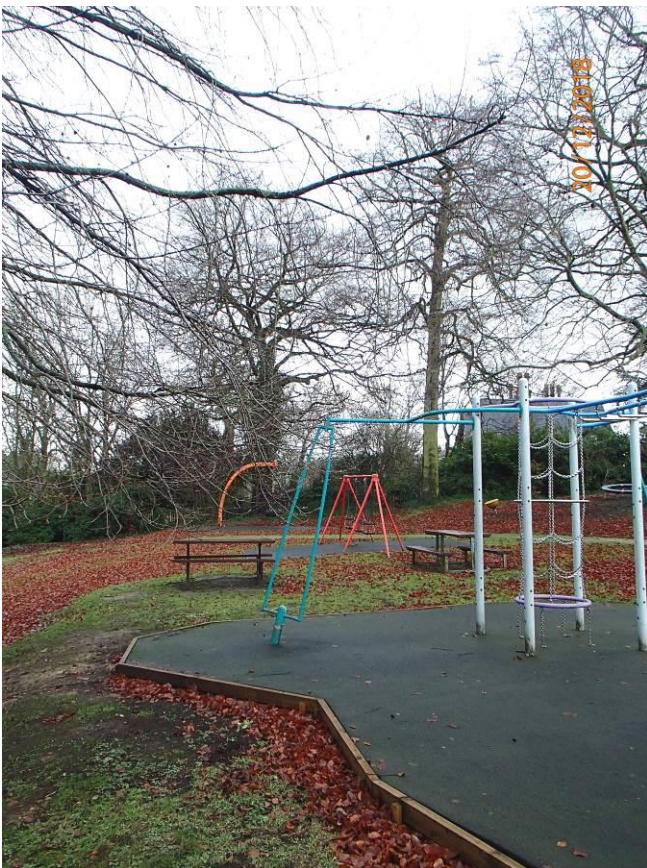
Photo 15 Beech groups; low growth throughout

A range of lesser-priority management items are suggested, mainly crown lifting where low branches are above or close to equipment. The extent of this work is best agreed on site with specific reference to each tree, but a nominal 4m clear above ground is suggested.
