T4 This was tested in June 2019 and its ratings were:
Age rating was M (Mature)
Tree Life Stage rating was 6/F
Safe Life Expectancy 20+ Years

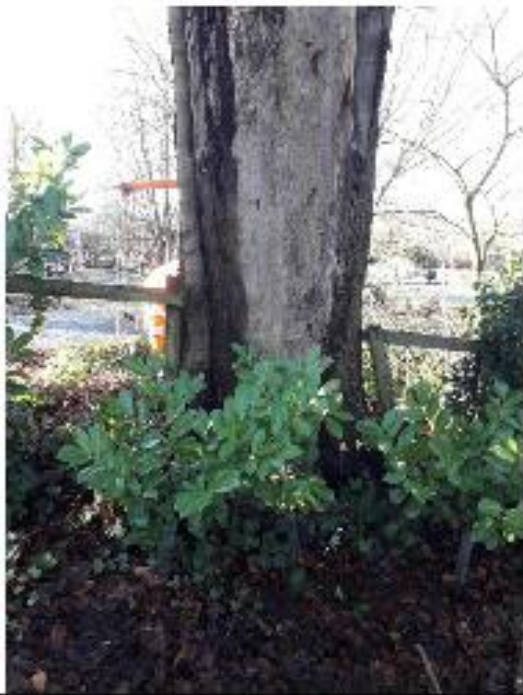
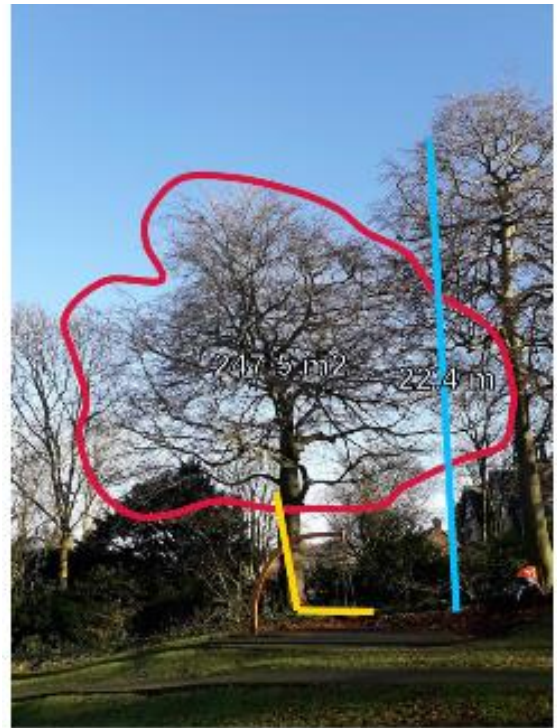
The electrical tomography test result shows the tree is hosting small amounts of surface decay in the area of the tree wounding.

The eastern side of the stem has bark loss 900mm at its widest and 3.8m in height from ground level, presumed to be historic fire damage.

The assessment was carried out as low as practicable however, the eastern buttress, when mallet tested, sounded decayed, suggesting its structural support has ceased.

The stem has a 12deg lean to the east due to group pressure and bias canopy to the south and east, with limb loss at 10m and Dryads Saddle (*Cerioporus squamosus*) visible on the floor beneath suggesting decay. Dark deposits which, given the lack of additional burnt material on site found, were identified as potential Brittle Cinder fungus (*Kretzschmaria deusta*) which is not surprising given the wounding and species type.

Scaled image showing the calculated canopy area in red. The yellow 'lean' line has been altered to 11° to an eastern direction within the software.

The report recommends that a stability assessment is carried out to understand whether the suspected Brittle Cinder fungus and necrotic eastern buttress is influencing the tree's stability.

It is also recommended that the tree is inspected on an annual basis restricted to late summer / autumn where the chances of identifying such principal decay / fungi is more likely if present.
