Structural Report for Feasibility of Conversion

Project Ref: 219269
Site: Millshop Ebridge Mill, Happisburgh Road,
White Horse Common, North Walsham, NR28
9LJ
Client: Mr G. Trevatt, 14 Station Road, North
Walsham, NR28 0EA

Prepared By:   Aaron Smith EngTech TIStructE

Checked By:   Nathan Blowers BEng (Hons) MSc CEng MICE
Date of Report: 6 October 2023
Date of Inspection: 27 September 2023

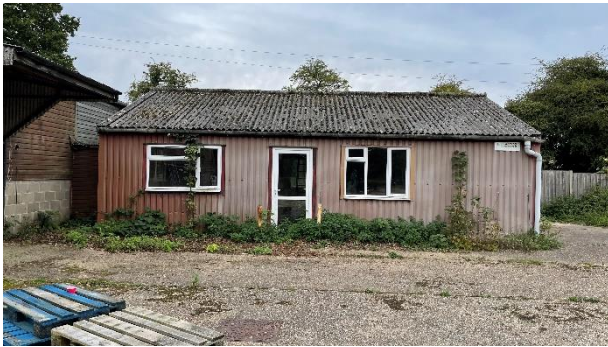
Building A was previously used as the commercial area for the shop that previously resided on the site. See photograph 1. It is composed of 4No. steel portal frames, spaced roughly equally along the length of the building. The walls are formed of masonry infill panels between posts (see photograph 2), with vertical sheet cladding to the external face. The building is mostly open plan, although an office, W.C. and storage room have been added to the West facing elevation.

Photograph 1
East Elevation of Building A

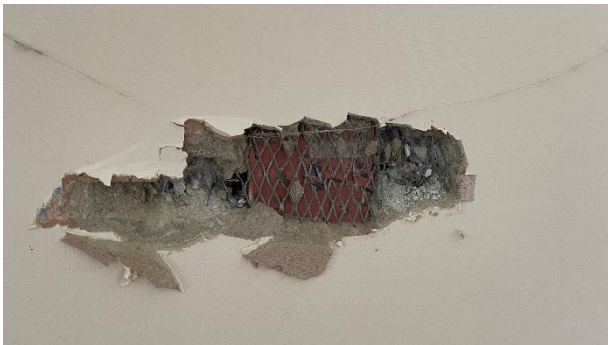
Photograph 2
Exposed Column in Wall of Building A

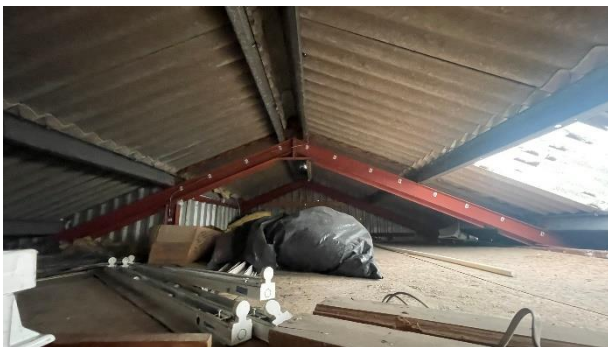
The building is comprised of the following construction: corrugated asbestos cement sheet roof covering, supported by cold rolled steel purlins, supported by 152x89 UB steel rafters spanning across the building between 152x89 UB steel posts. See photograph 3. The ground floor slab is of a concrete construction, although the thickness is uncertain at this stage. See photograph 4. The foundations were not exposed or inspected during our visit.

Photograph 3
Roof Construction of Building A

The steel portal frames can remain however, they may require modifying or strengthening to accommodate the new roof build up.

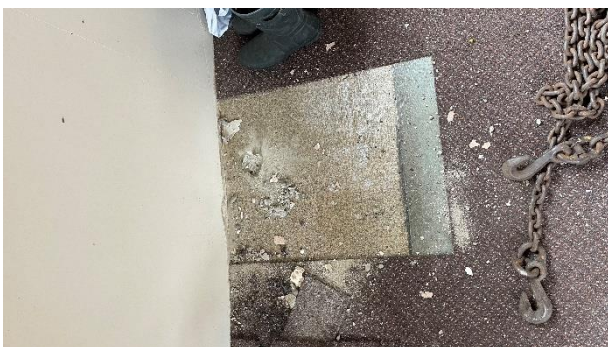
Photograph 4
Top of Ground Floor Slab in Building A

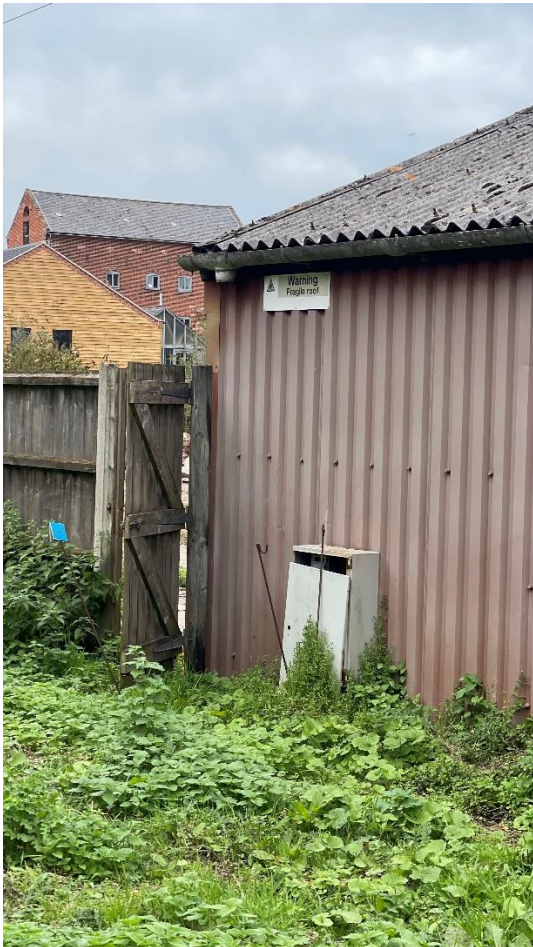
Photograph 5

A rainwater pipe from the West elevation has been removed from the gutter hopper. See photograph 5.

Removed Rainwater Pipe from Building A

An investigation into the surface water drainage should be carried out to identify areas of damage and repairs required.

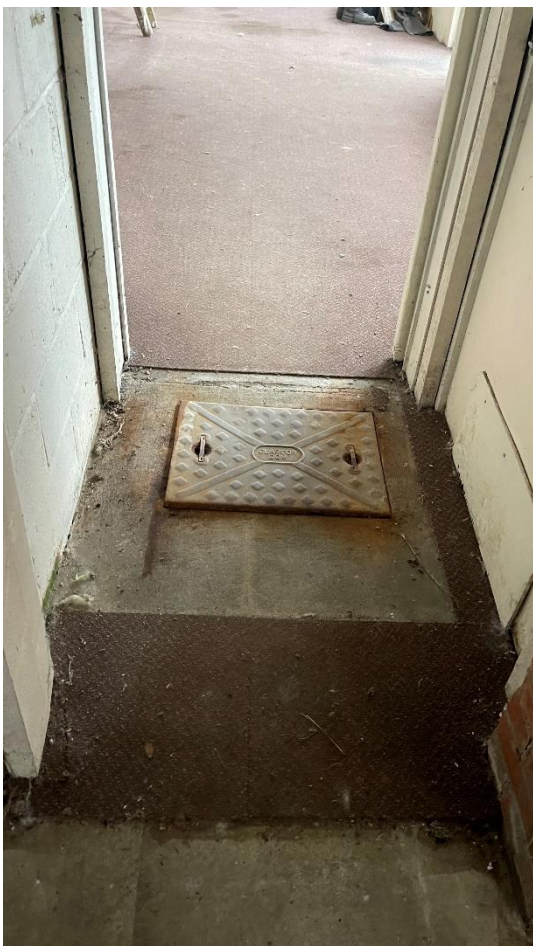
Photograph 6

Buildings A & B are separated by approximately 1 metre. There is a link corridor between the buildings which is of a masonry construction, with the same corrugated asbestos cement sheet roof covering as the main buildings. It is uncertain if the buildings were always linked or if this was a later addition, however an inspection chamber cover is present within the ground floor slab (see photograph 6), which may suggest that this was added at a later date.

Inspection Chamber Cover in Link Structure

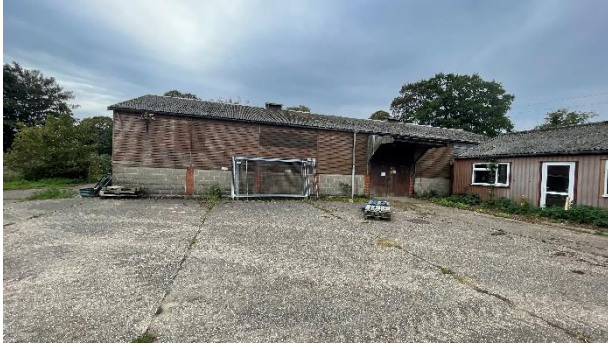
Building B was previously used as the storage / further commercial area for the shop that previously resided on the site. See photograph 7. It is composed of 7No. steel and timber frames, spaced roughly equally along the length of the building. The walls are formed of a 1.35m high masonry dwarf wall, with timber infill over to eaves. See photograph 8.

Photograph 7
North Elevation of Building B

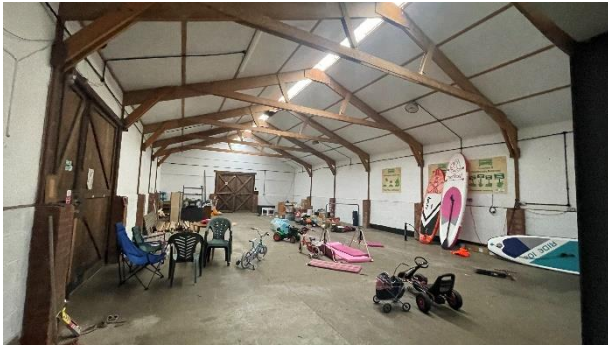
Photograph 8
Internal View of Building B

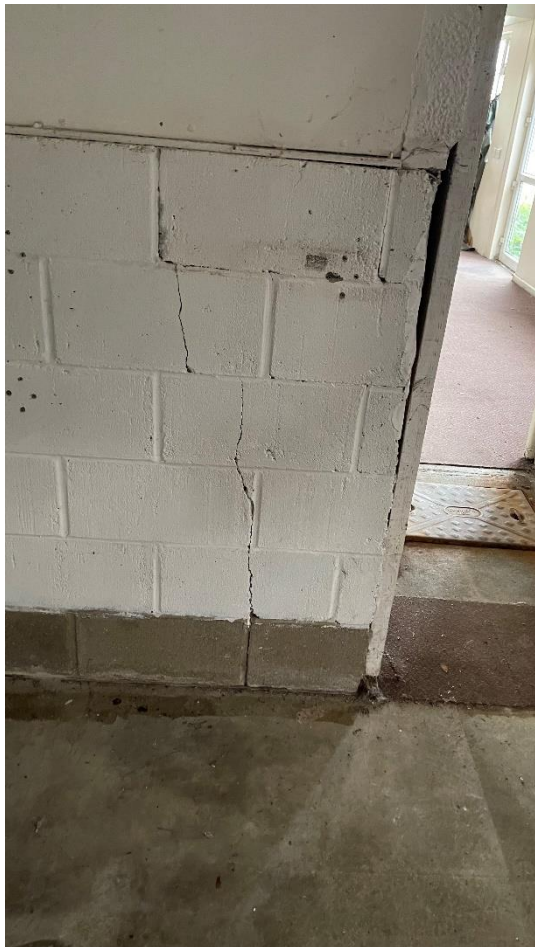
Minor cracking can be witnessed in 2No. locations in the dwarf wall along the North elevation of Building B. See photographs 9 & 10. Neither are considered to be severe, and we suspect are a function of thermal movement. The crack seen in photograph 9 is immediately adjacent to the opening into the link corridor, which may be a result of the opening being created.

Photograph 9
Cracking to North Elevation of Building B

Repairs to the masonry blockwork should be undertaken, which would consist of crack stitch repairs and replacing damaged bricks.

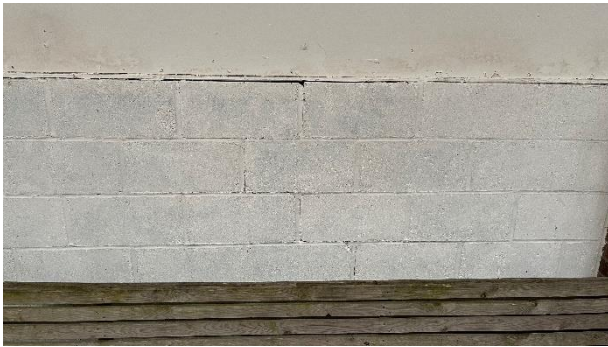
Photograph 10
Cracking to North Elevation of Building B

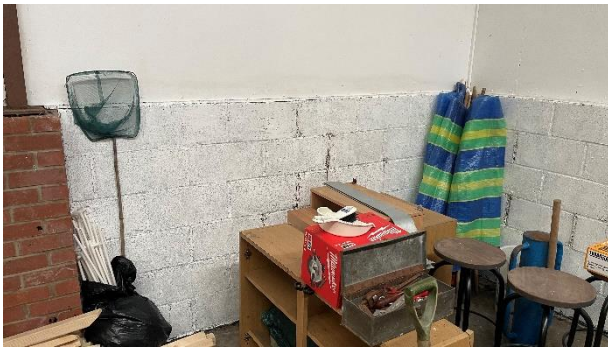
One bay of the masonry wall at the Northeastern corner of Building B shows signs of crazing to the paint. See photograph 11. There is no clear cause of this, however we suspect this may be a function of the previous use of the building, likely caused by heat transfer.

Photograph 11
Paint Cracking to Northeast Corner Building B

Areas of damage and damp will require attention.

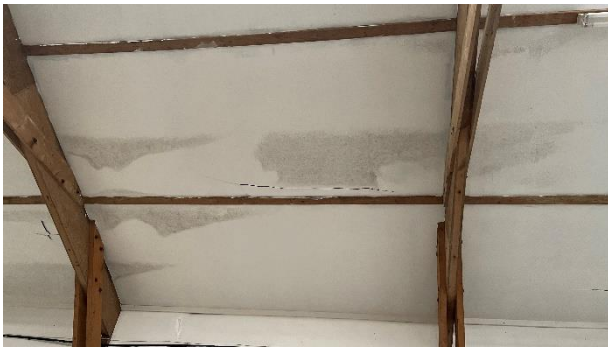
At roof level, an internal ceiling spans between timber purlins. The sheeting used to form this has cracked in a number of locations, and areas would appear to show signs of damp penetration. See photograph 12. It is suspected that there is very little, if any, insulation between the ceiling and roof sheeting.

Photograph 12
Cracking to Ceiling of Building B

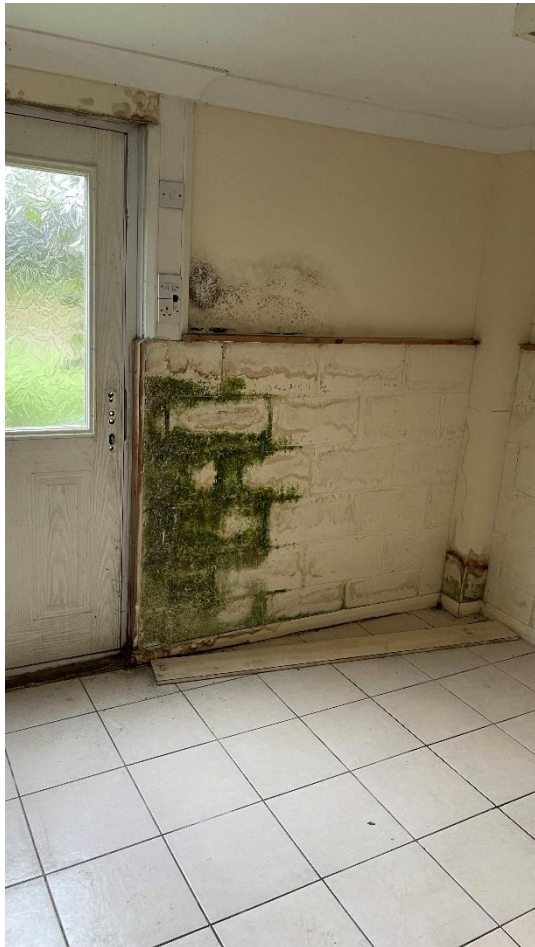
The kitchen area has severe damp issues to the masonry of the South elevation. See photograph 13. This damp is immediately adjacent to an external personnel door, which may be a poor fit and allowing water ingress. Externally, the area is overgrown with vegetation which may be limiting airflow to the masonry.

Photograph 13
Damp Ingress in Kitchen of Building B
