M & C Leggett.  
Plot 1 / 2 Ash Tree Farm  
Well Street  
Witton  
North Walsham  
NR28 9TR

Date: 04/04/2024

My Ref: 103088

### **Ash Tree Farm Witton Plots 1 & 2 Garden Validation report**

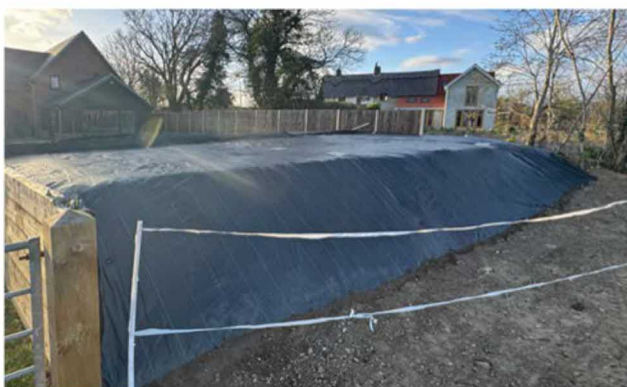
Plot 1 Pseudo clamp

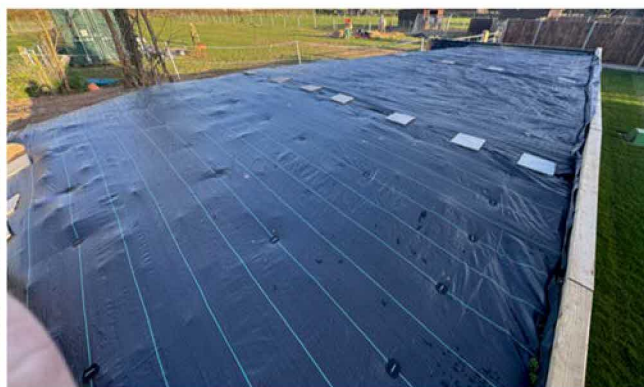
Plot 1 Pseudo clamp

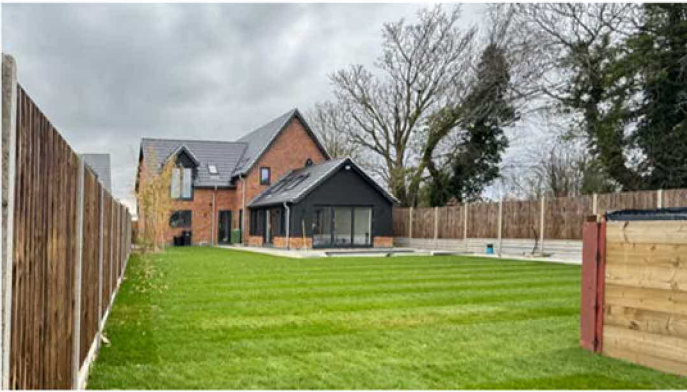
Plot 1 Completed

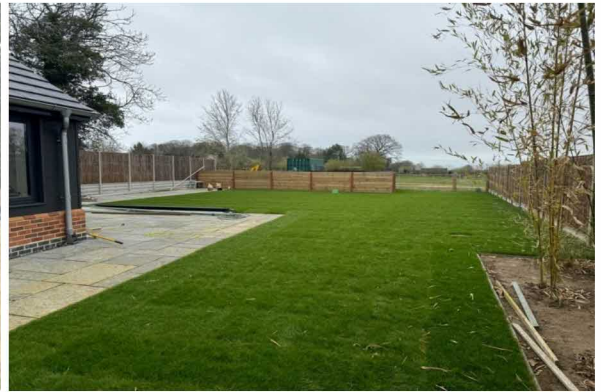
Plot 1 Completed

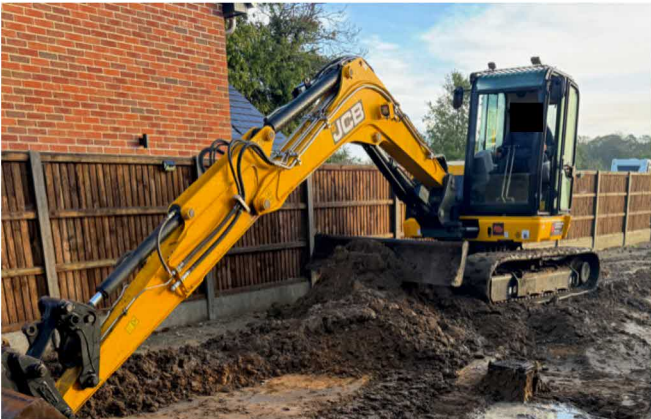
Plot 2 soil removal

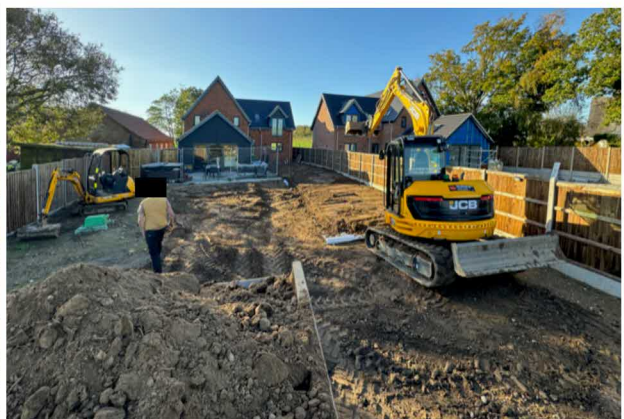
Plot 2 Soil placement

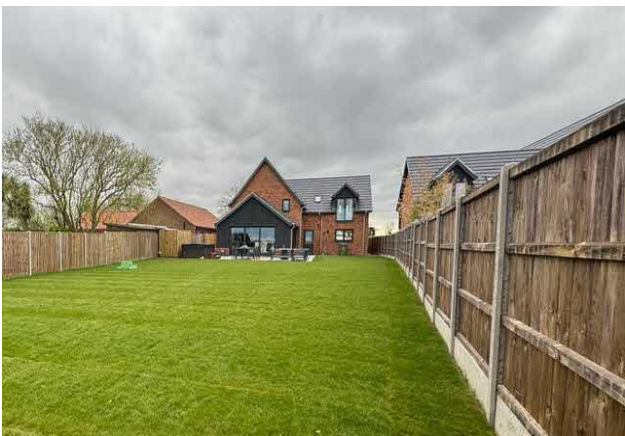
Plot 2 completed

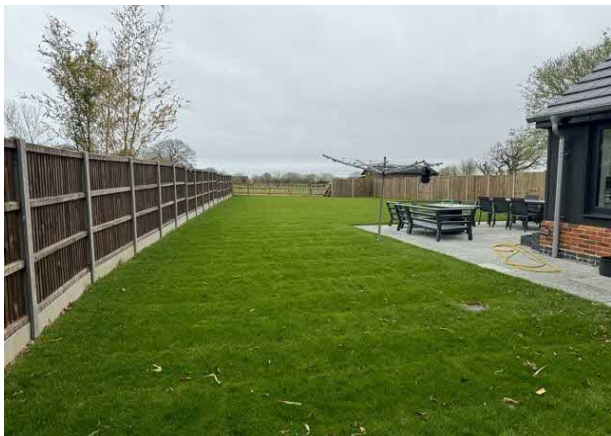
Plot 2 completed
