The Huntly Arms Hotel
Charlestown Road
Aboyne

Windows Survey and Condition Report
27/10/2023 (revised 23/01/24)

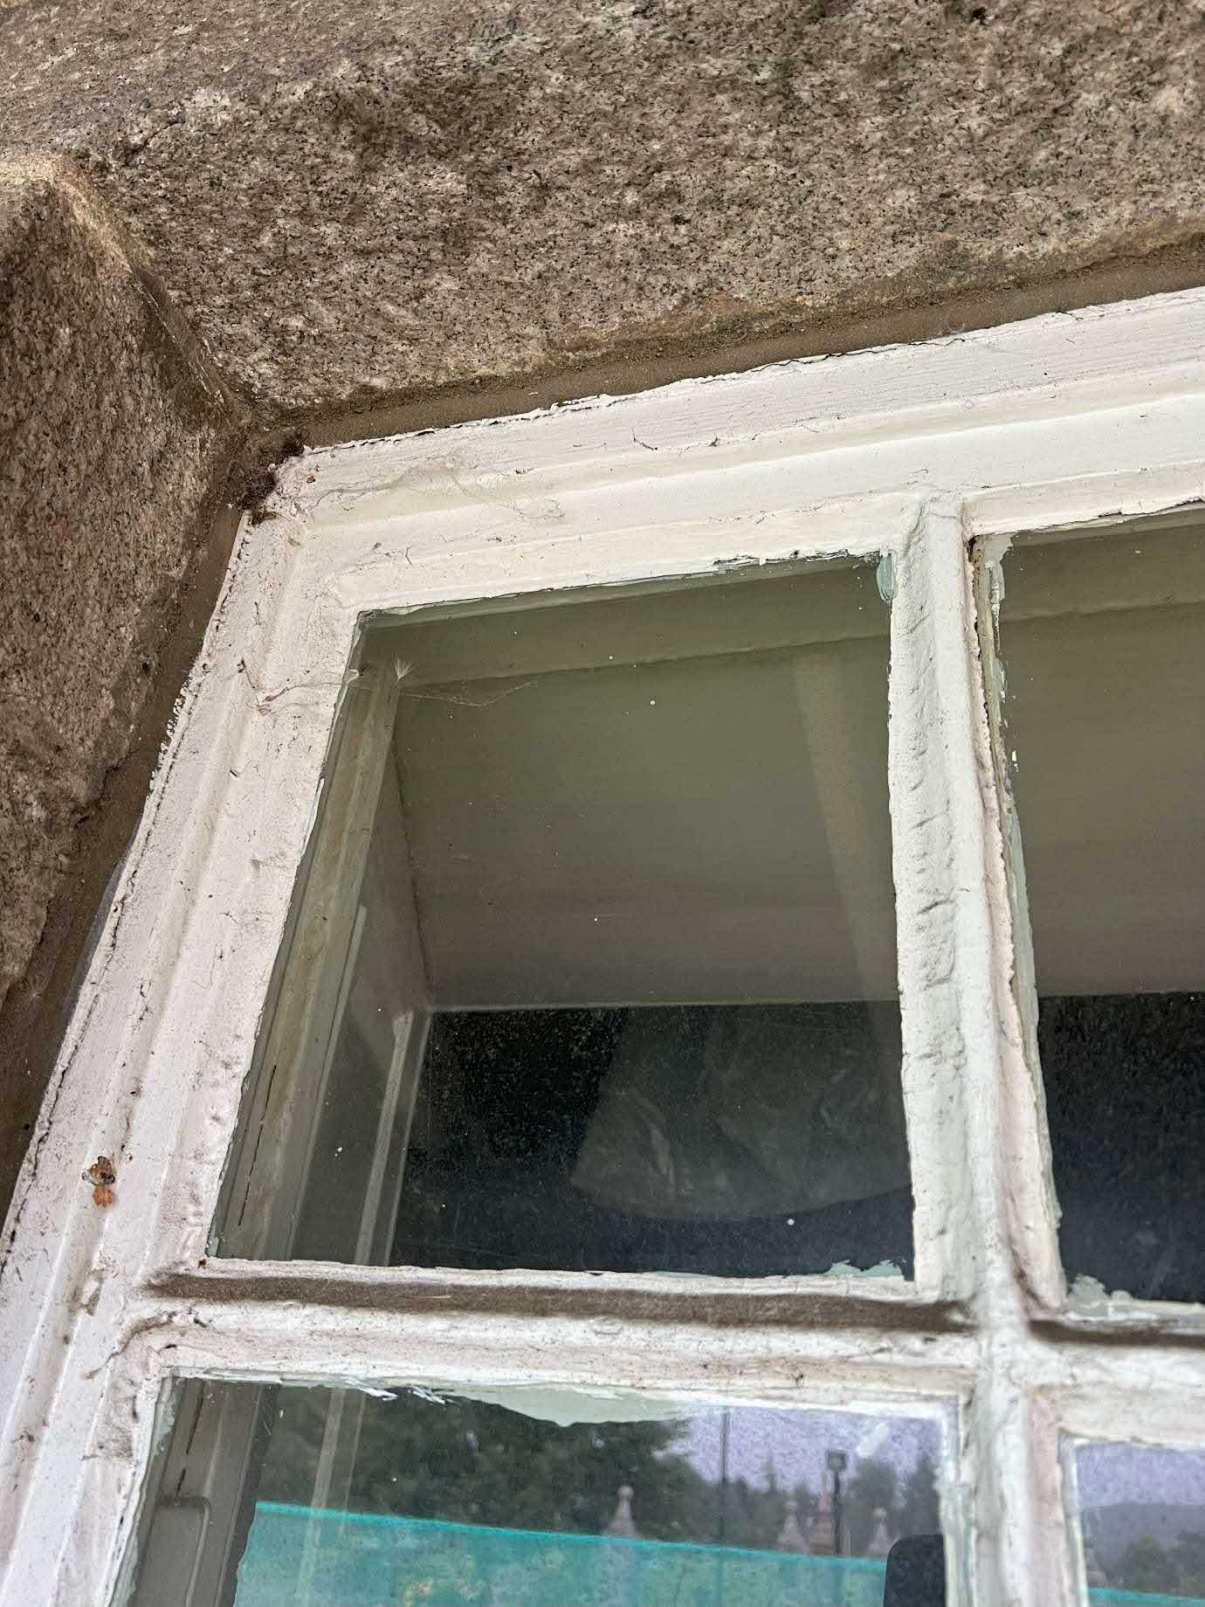
Photo 1 :Example of overpainting to window including astragals and putty sealant

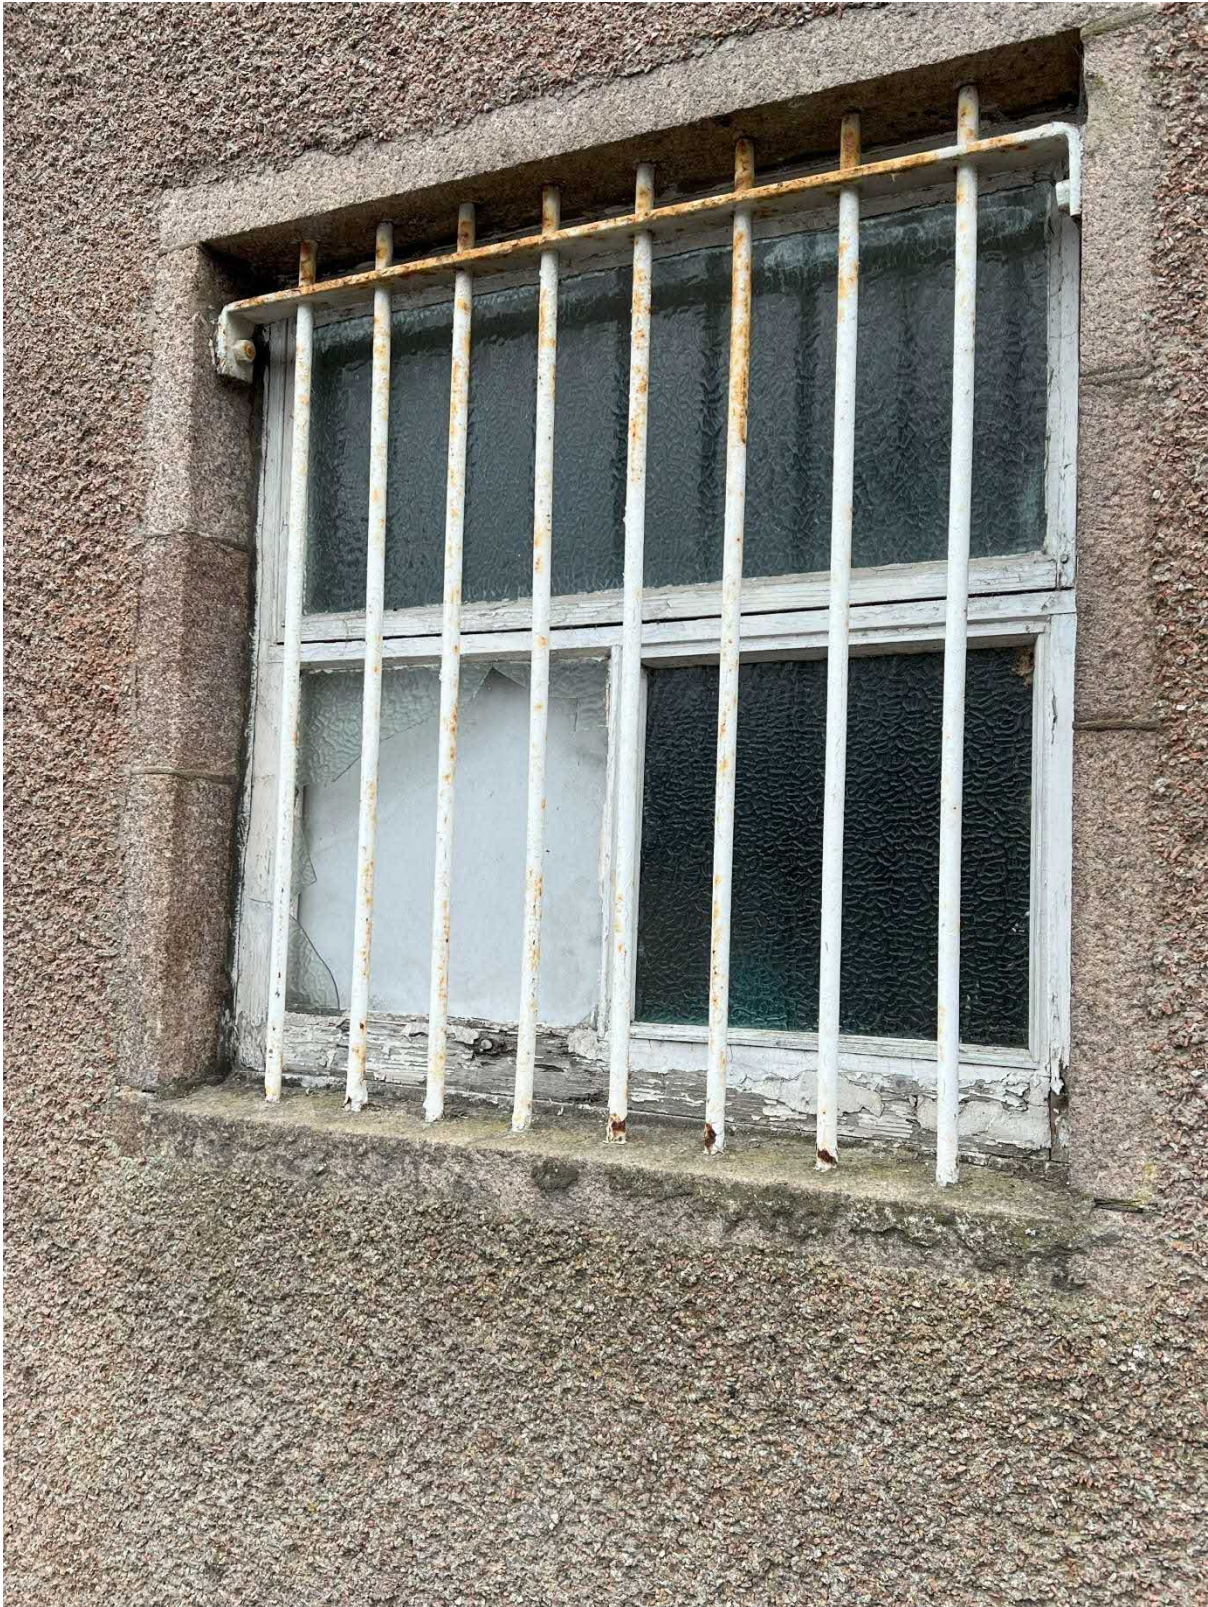
Photo 2 : Example of heavily decayed timber non-sash & case window with security bars

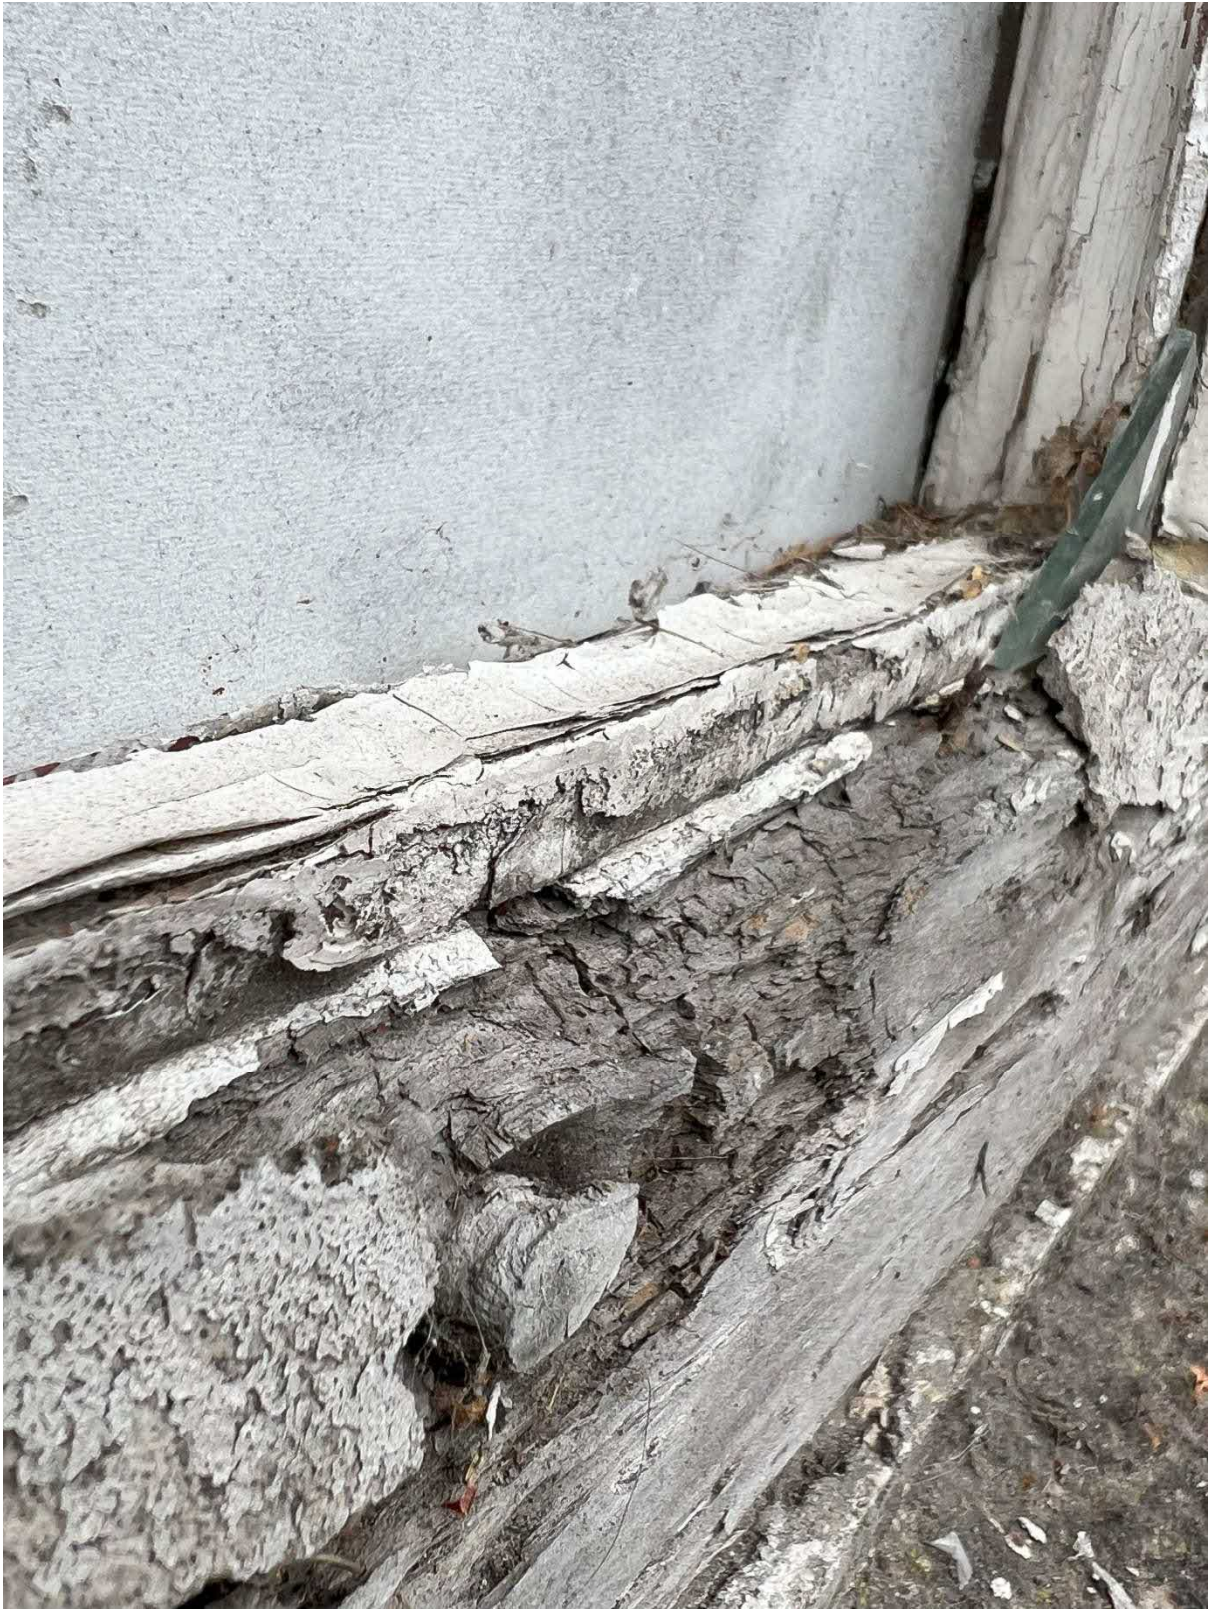
Photo 3 : Example of heavily decayed window frame / cill typical of various windows

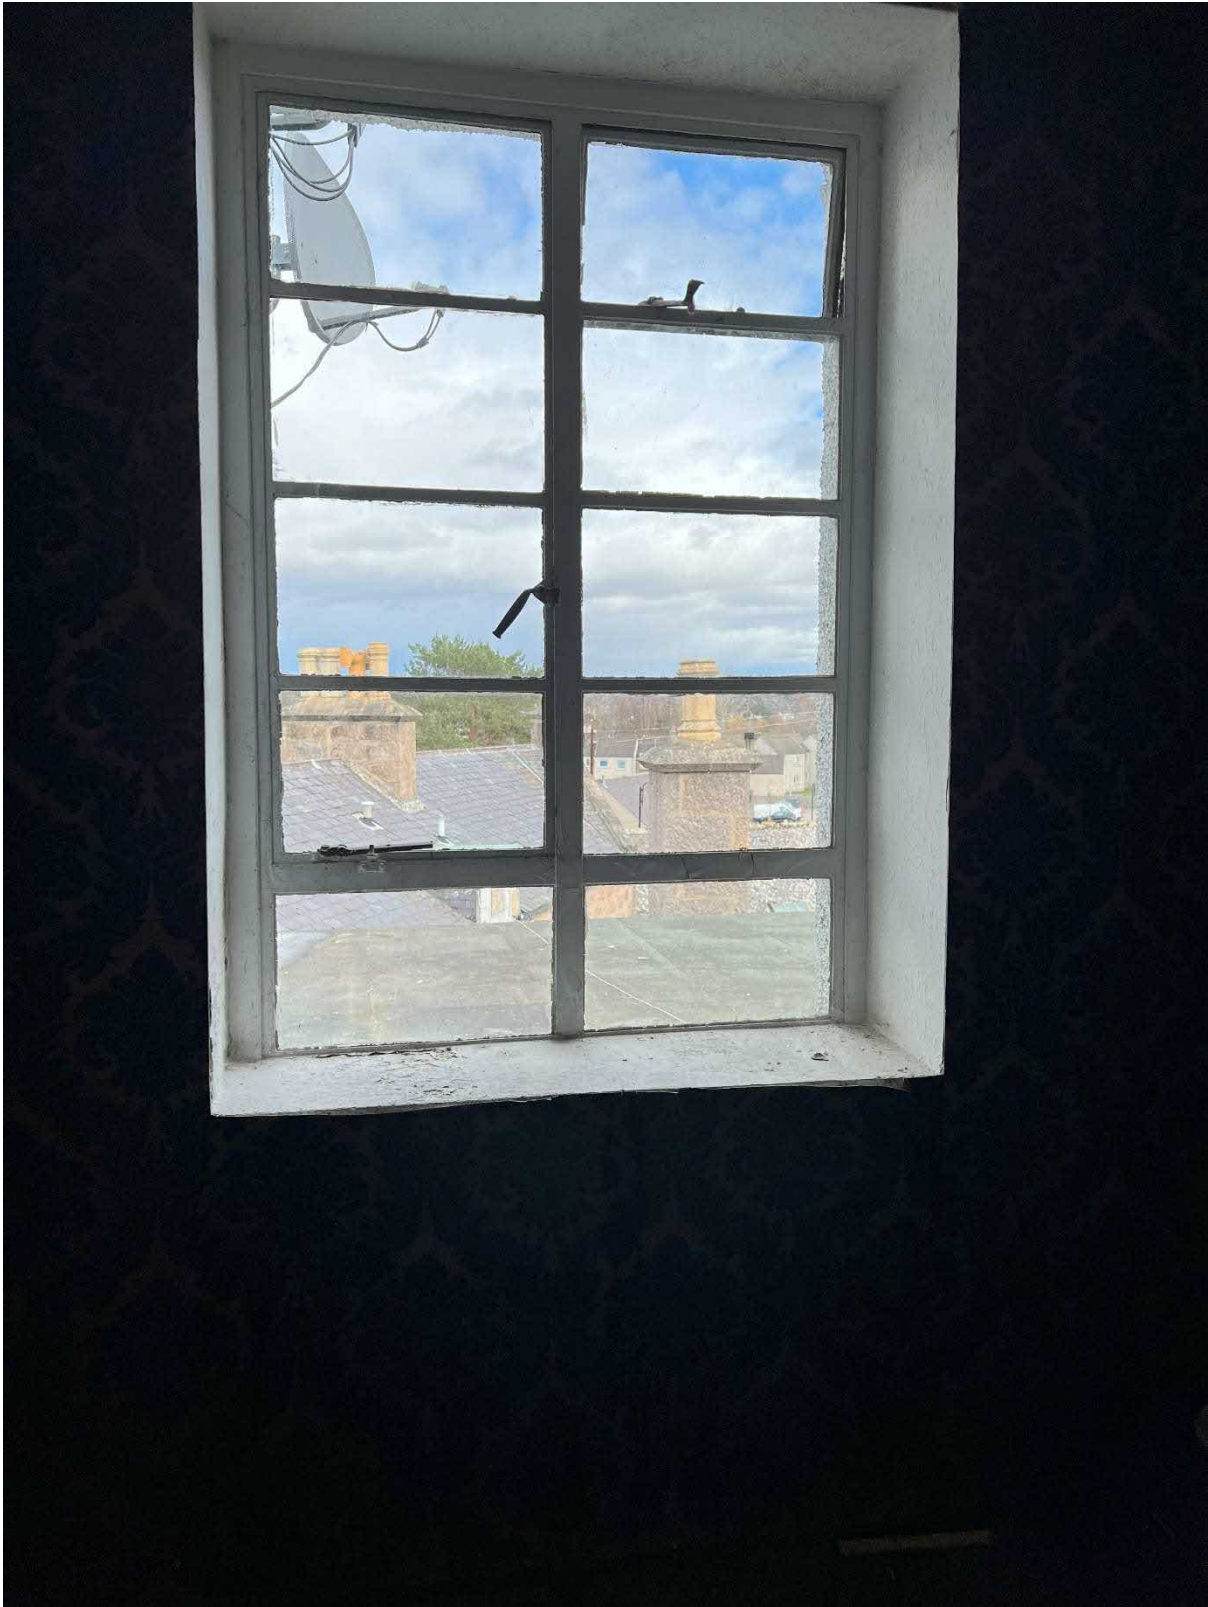
Photo 4 : Example of single glazed steel window to rear of the building.

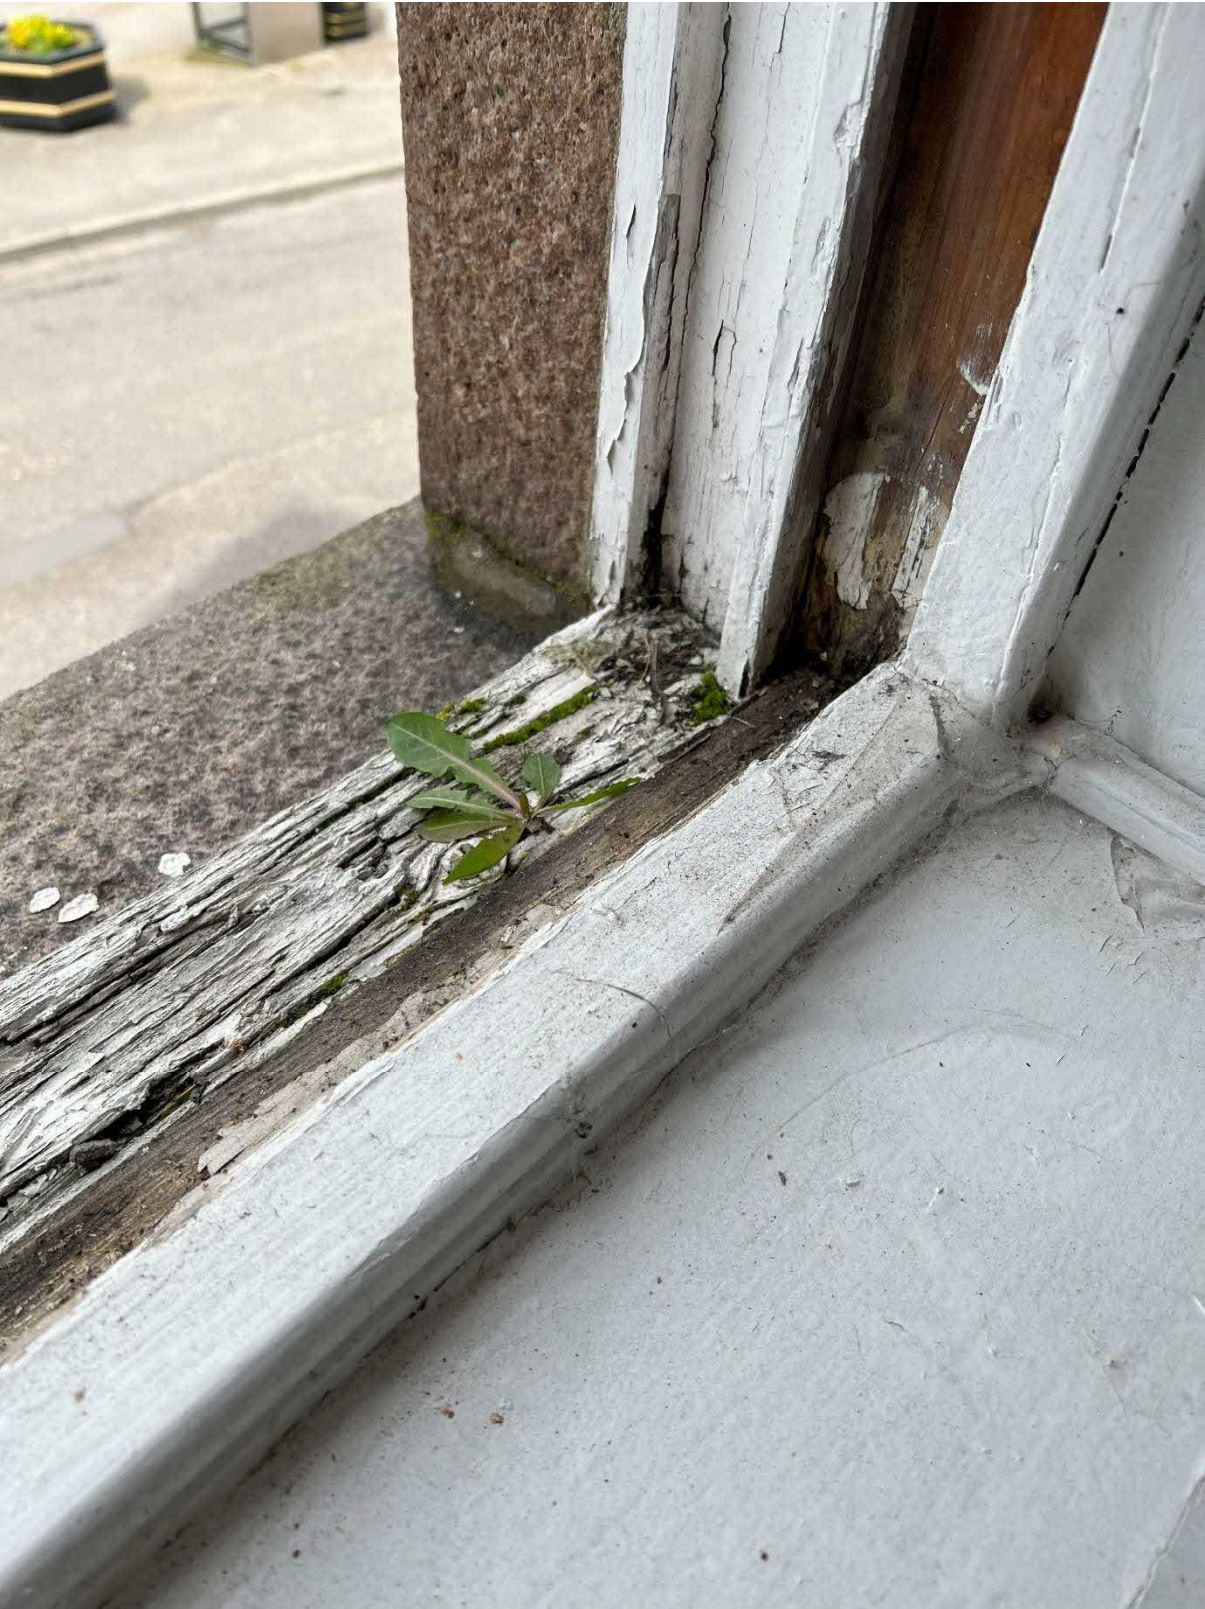
Photo 5 : Example of heavily decayed bottom rail and cill to timber sash and case window to side of building.

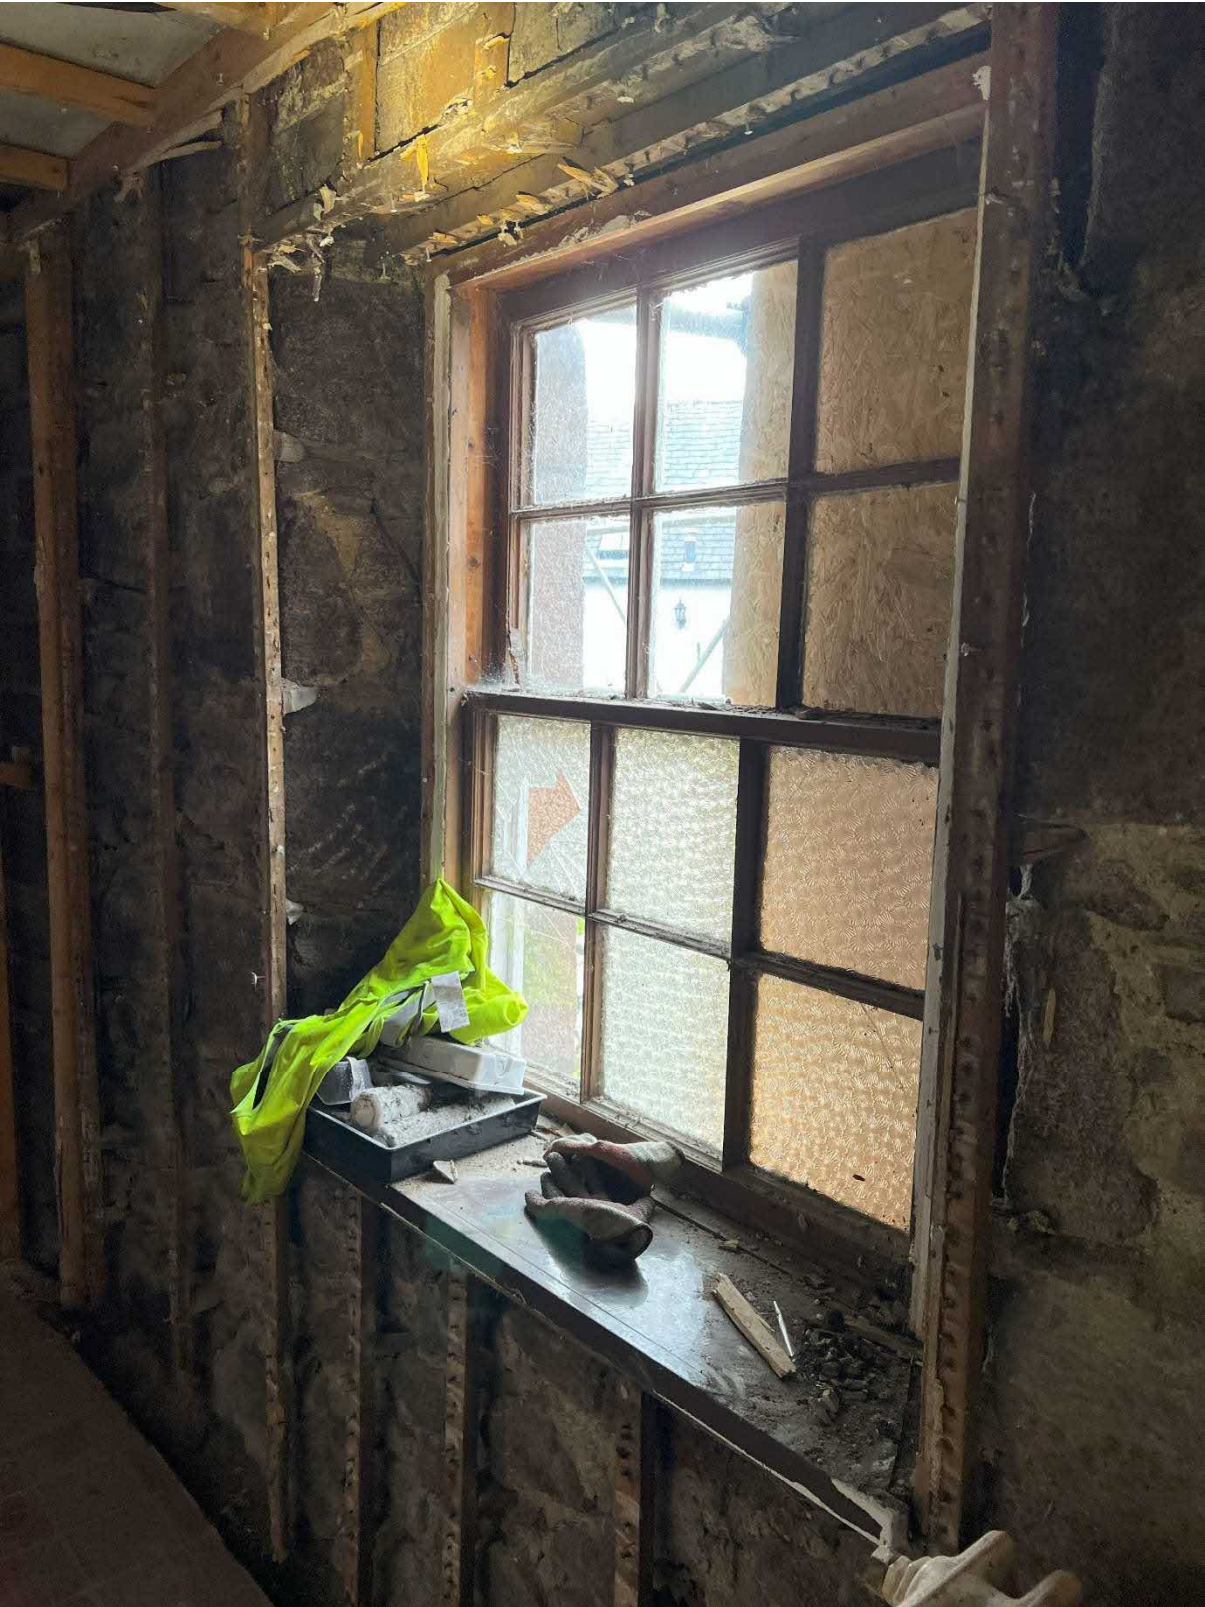
Photo 6 : Example of unfinished and insecure timber sash and case window to rear of building.

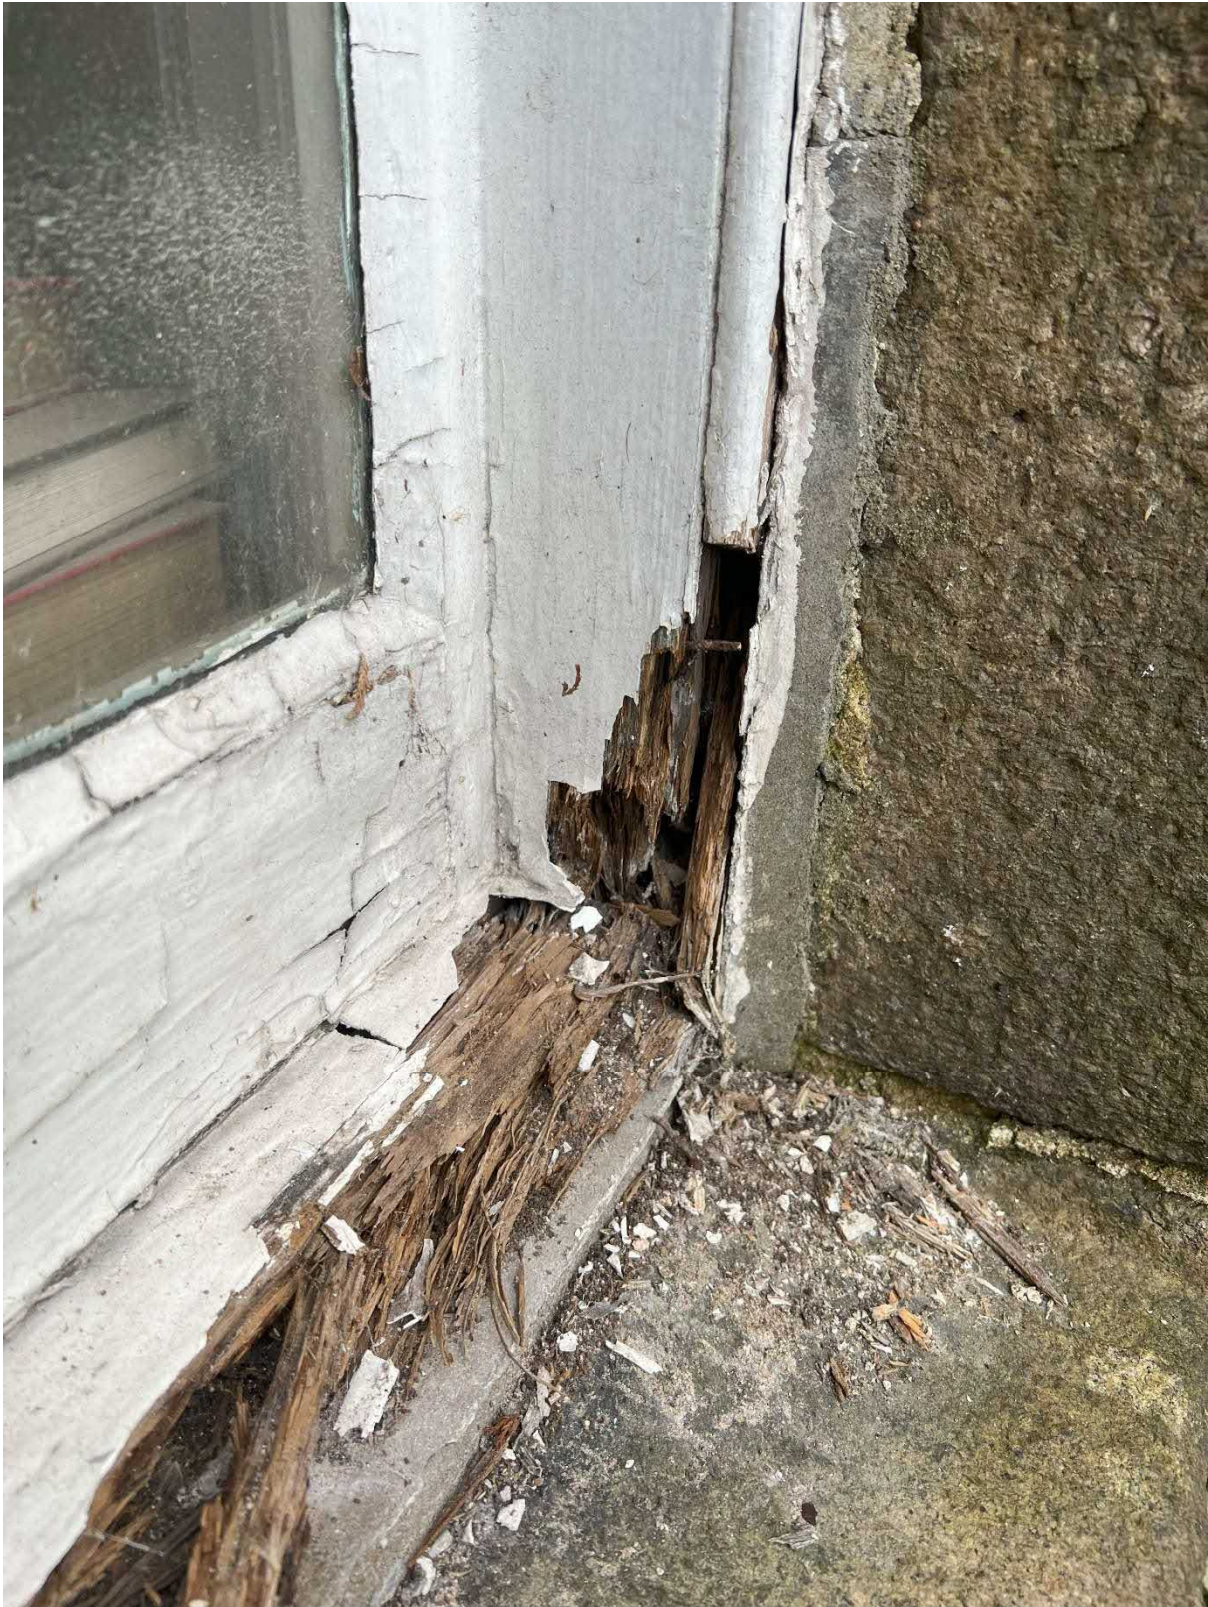
Photo 7 : Example of heavily decayed bottom rail and cill to timber sash and case window to front of building.

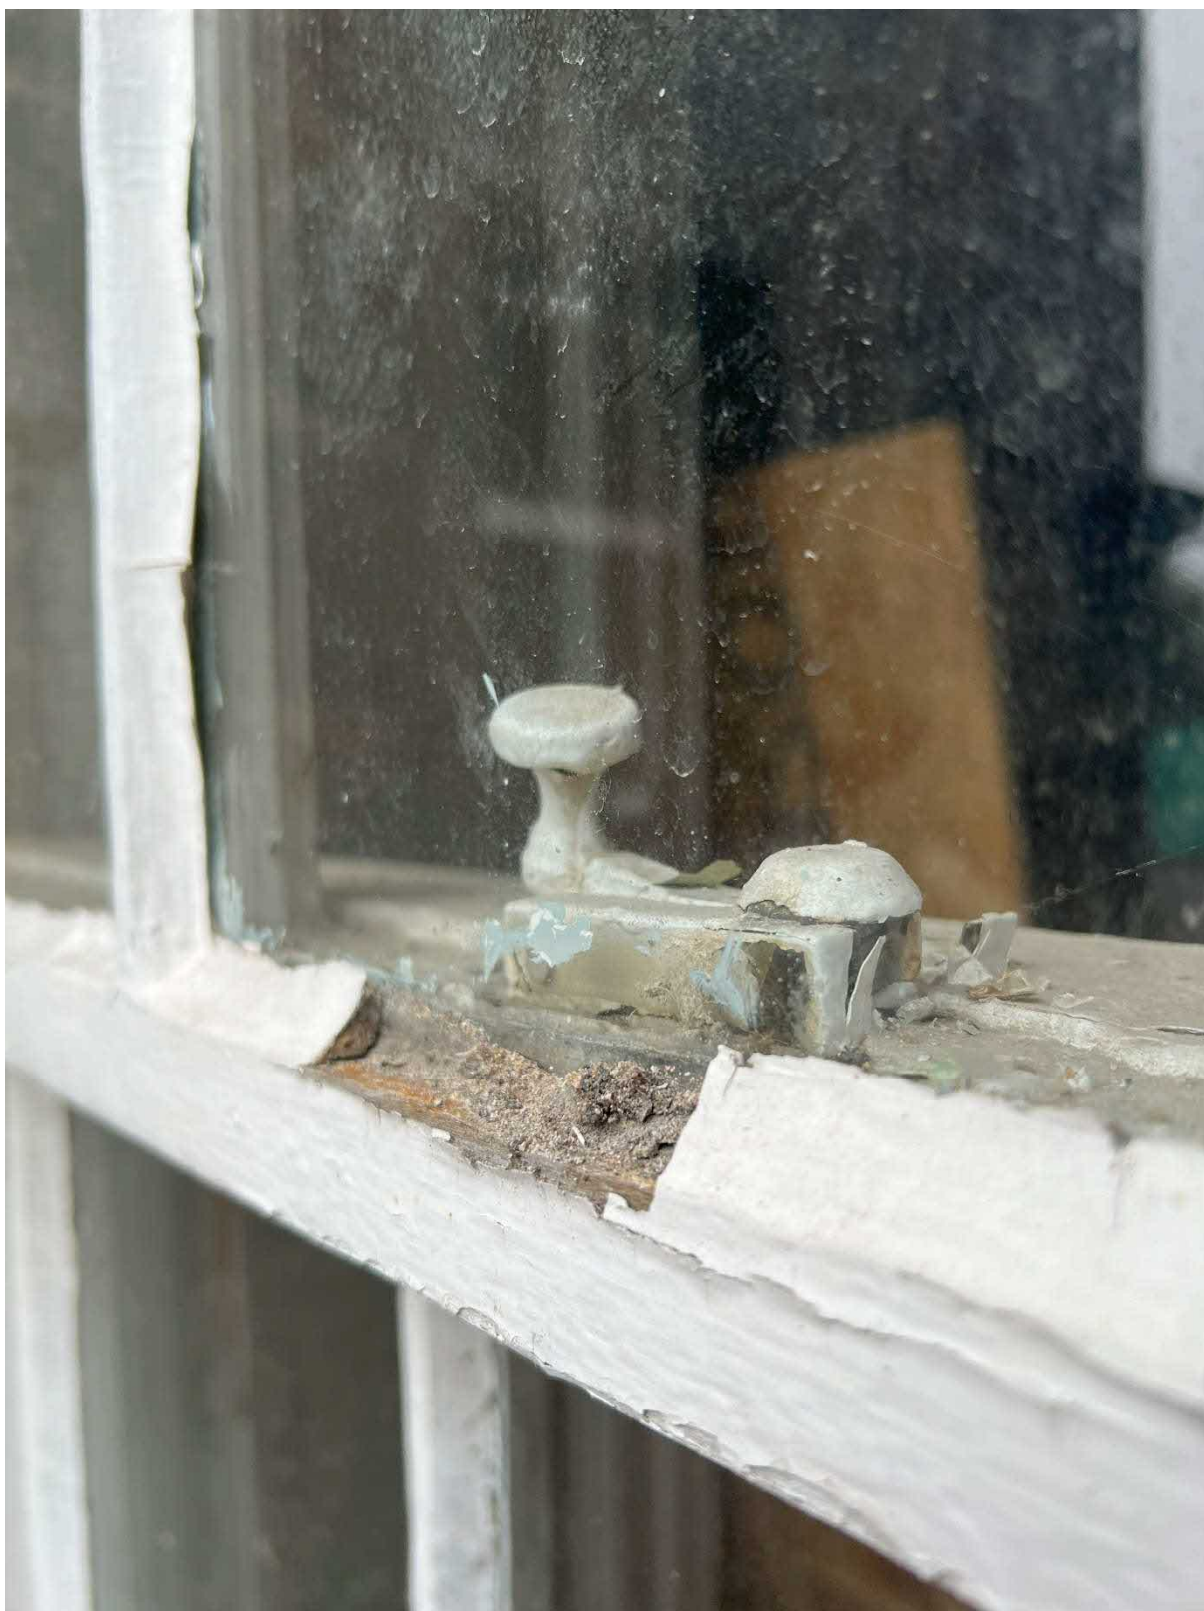
Photo 8 : Example of perished putty sealant with flaking paint and broken ironmongery to timber sash and case window to front of building.

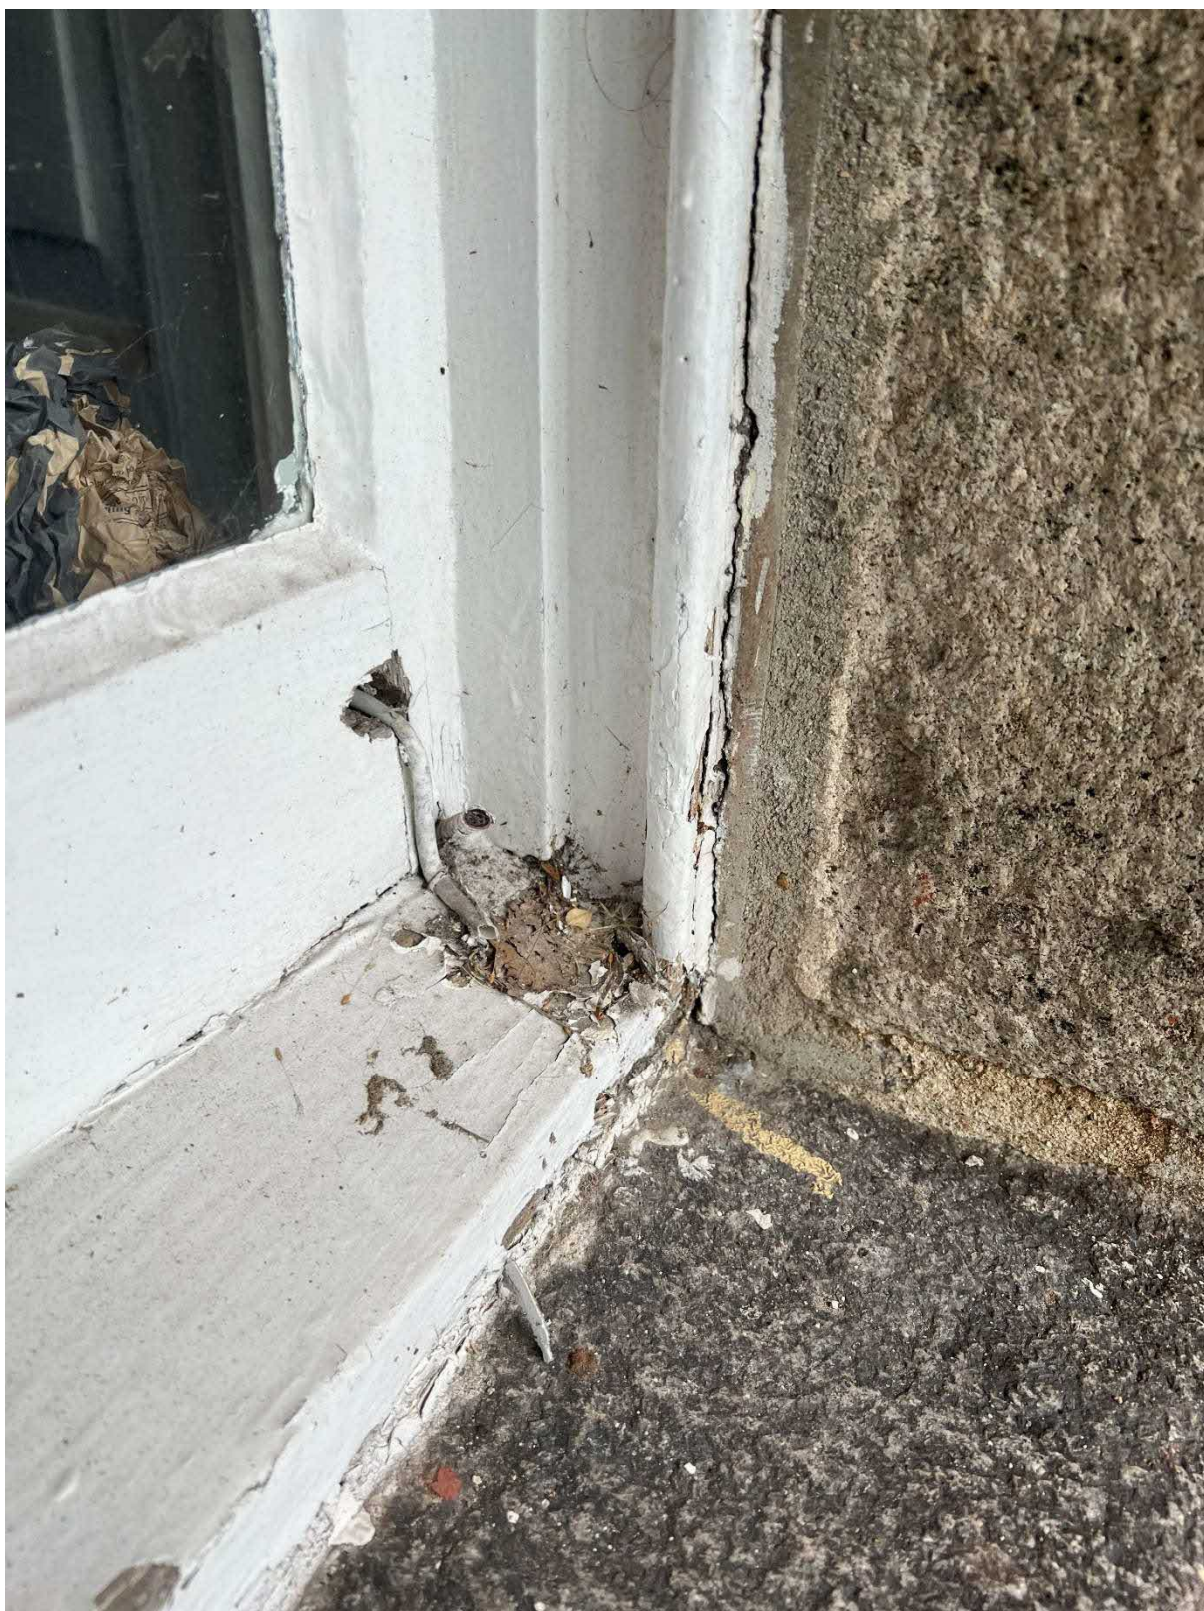
Photo 9 : Example of damaged window bottom sash and decayed bottom rail and cill to timber sash and case window to front of building.

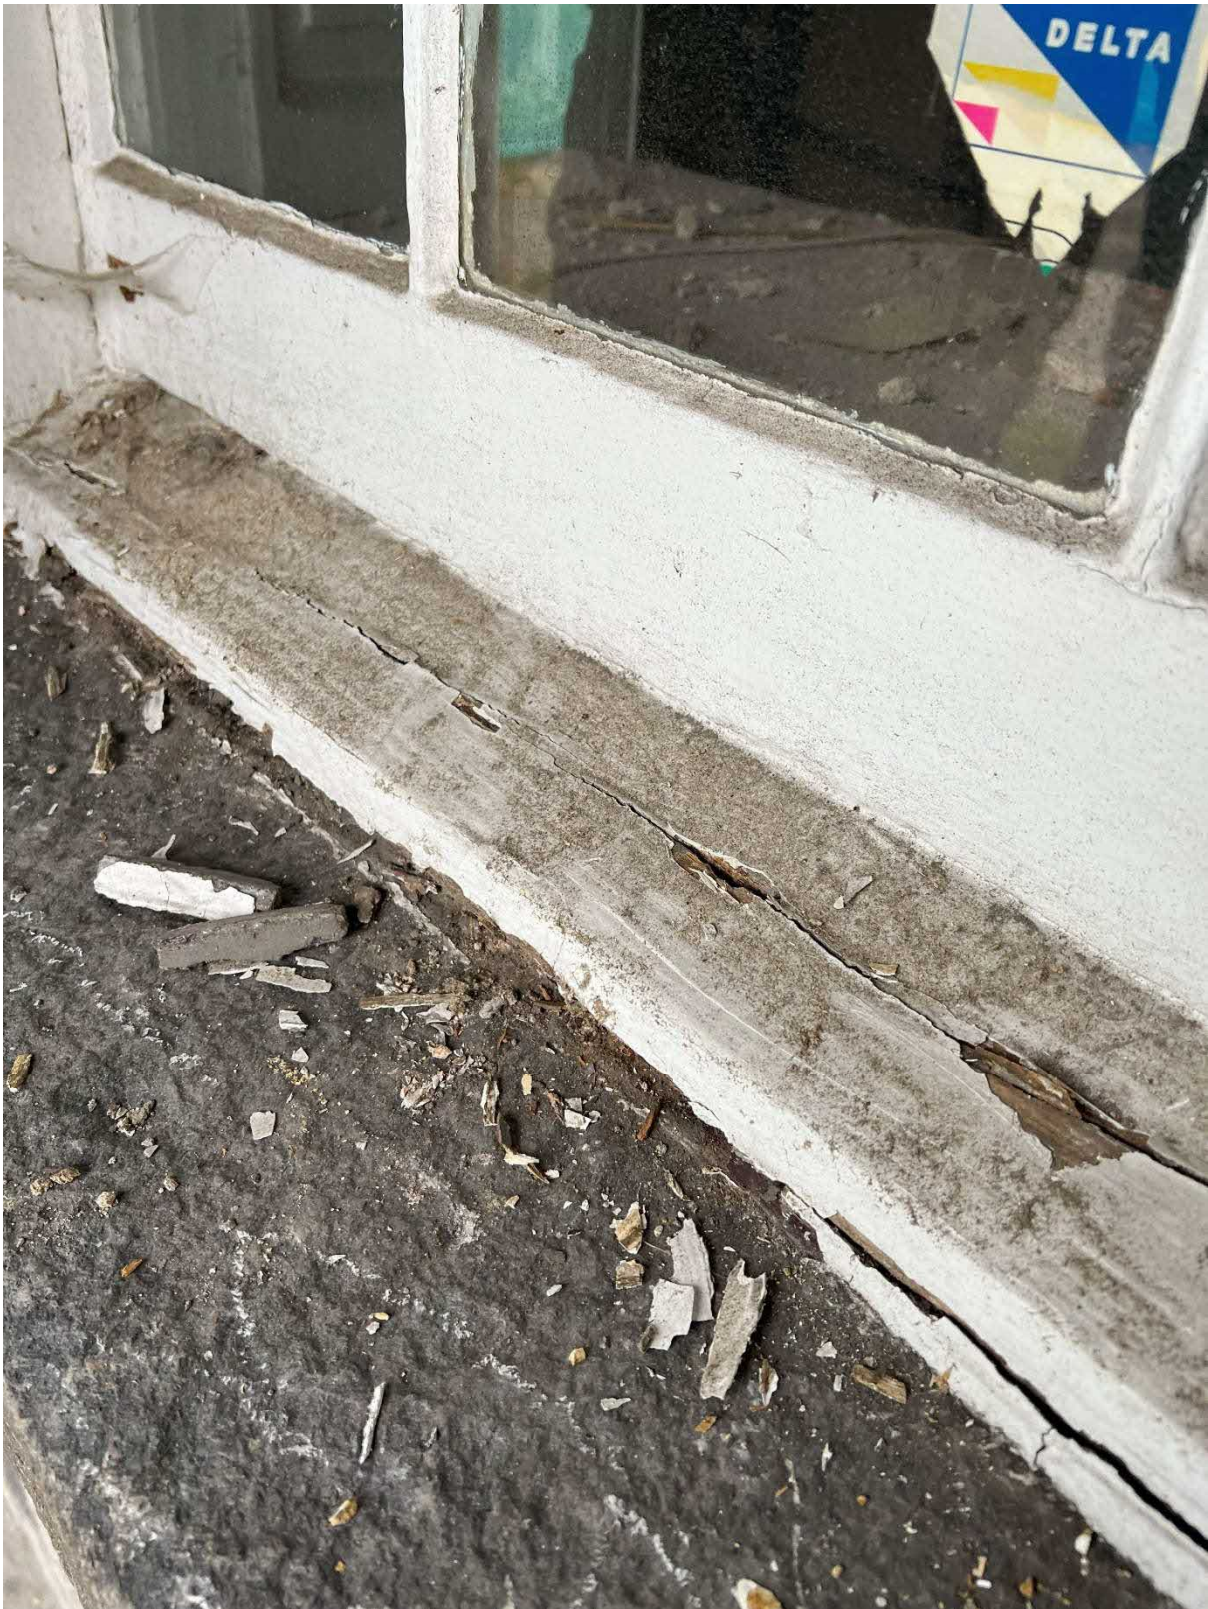
Photo 10 : Example of damaged window bottom sash and decayed bottom rail and cill to timber sash and case window to front of building.

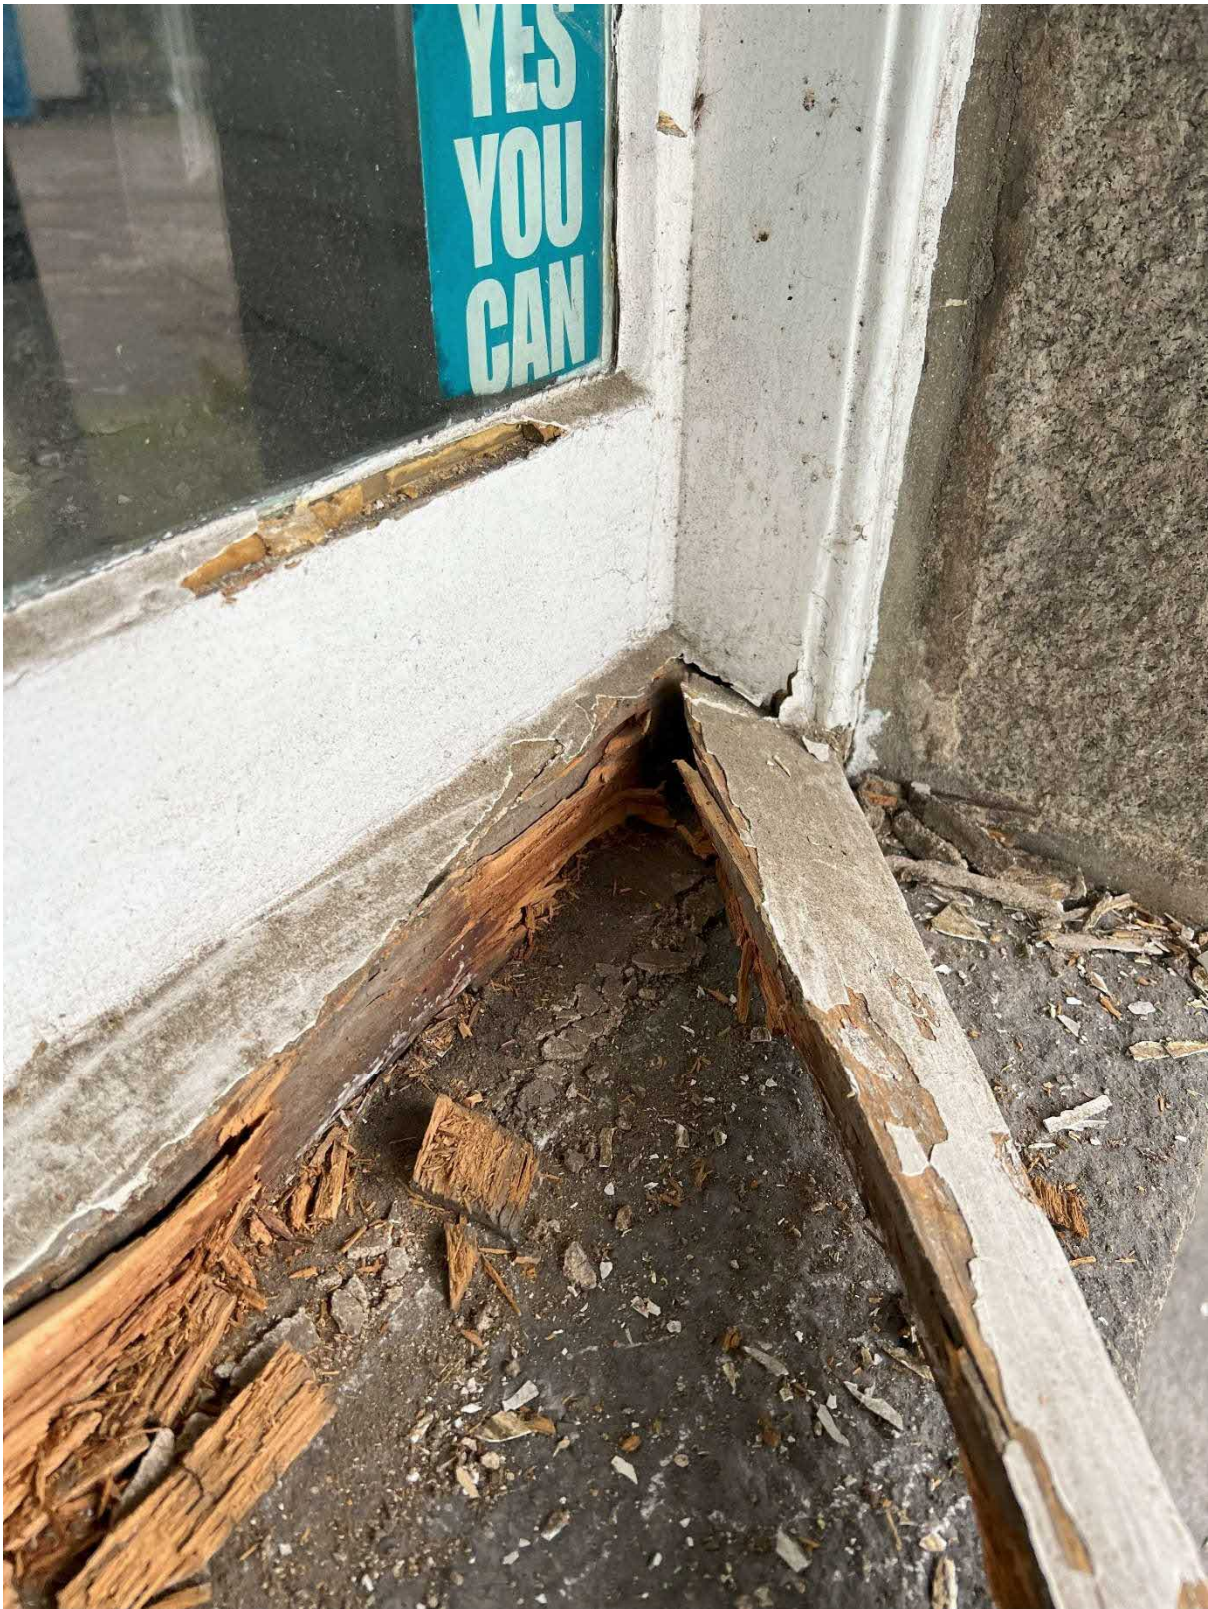
Photo 11 : Example of perished putty sealant and broken window bottom and cill to timber sash and case window to front of building.
