The Huntly Arms Hotel
Charlestown Road
Aboyne

Windows Survey and Condition Report
27/10/2023 (revised 23/01/24)

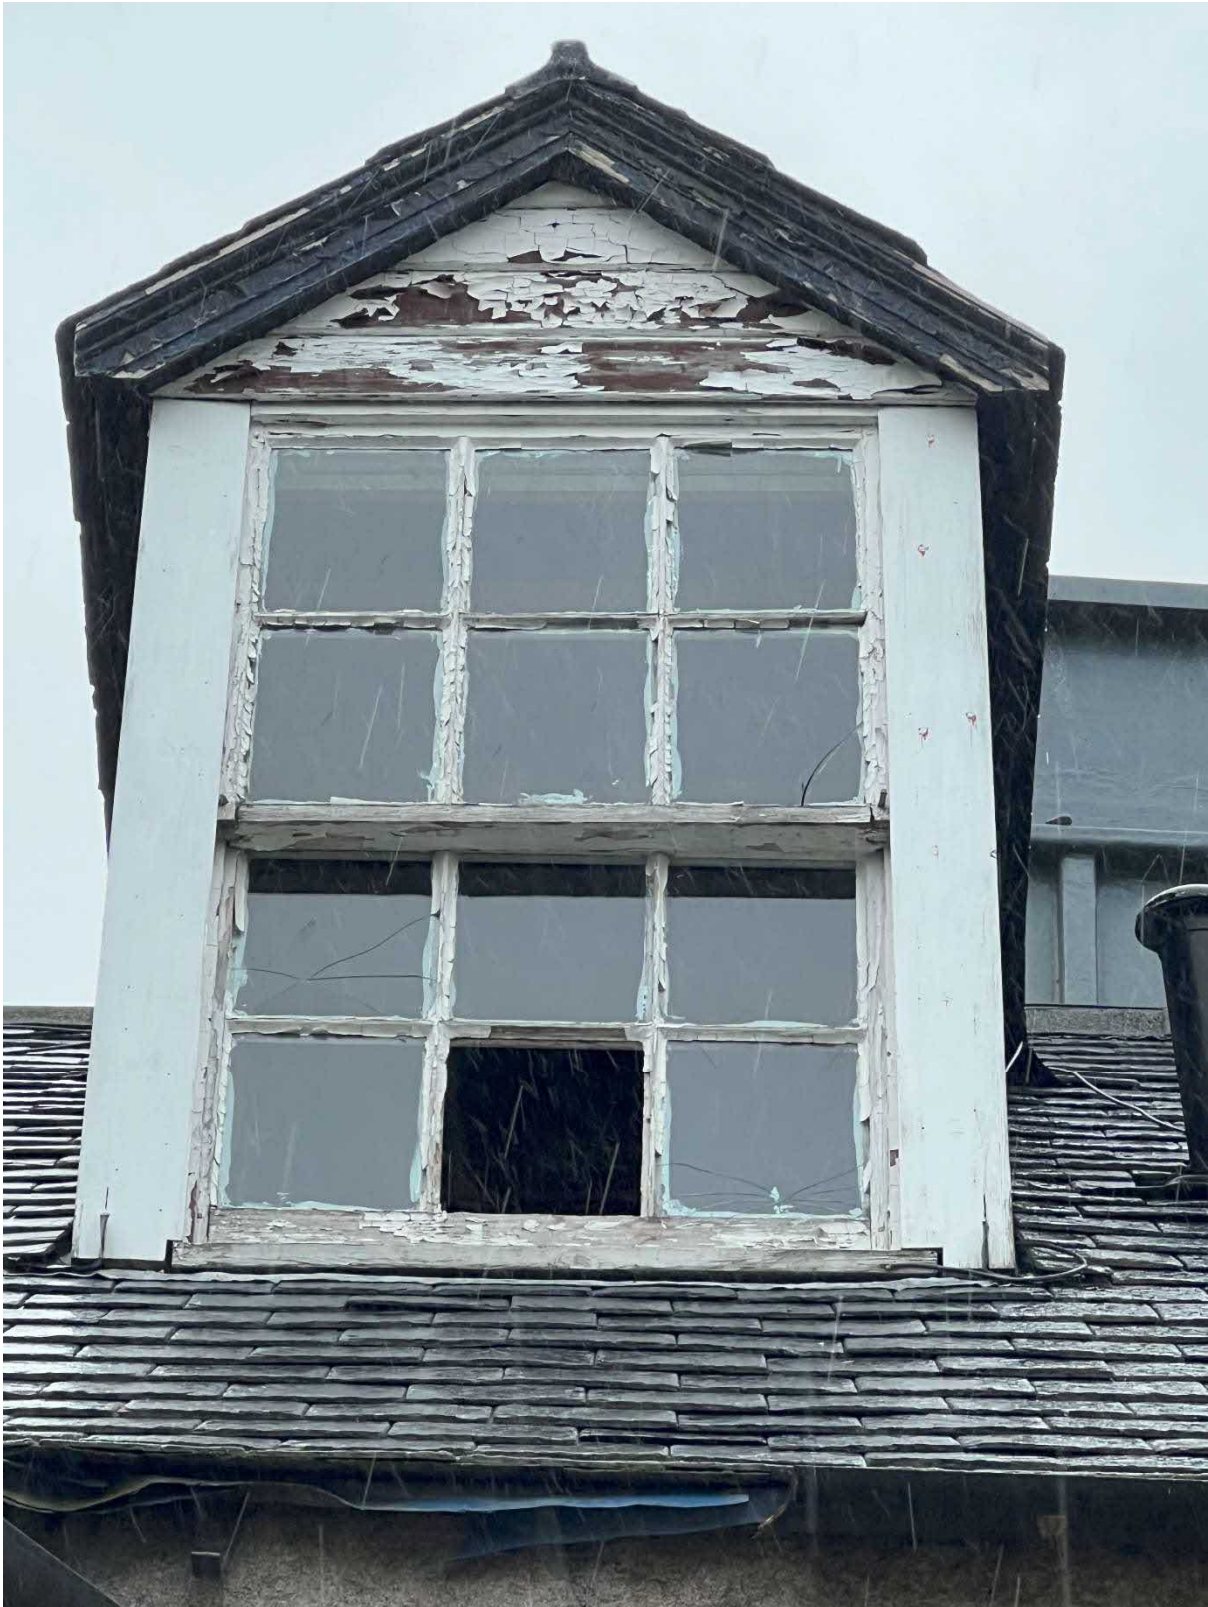
Photo 12 : Example of heavily decayed timber sash and case dormer window to front of building.

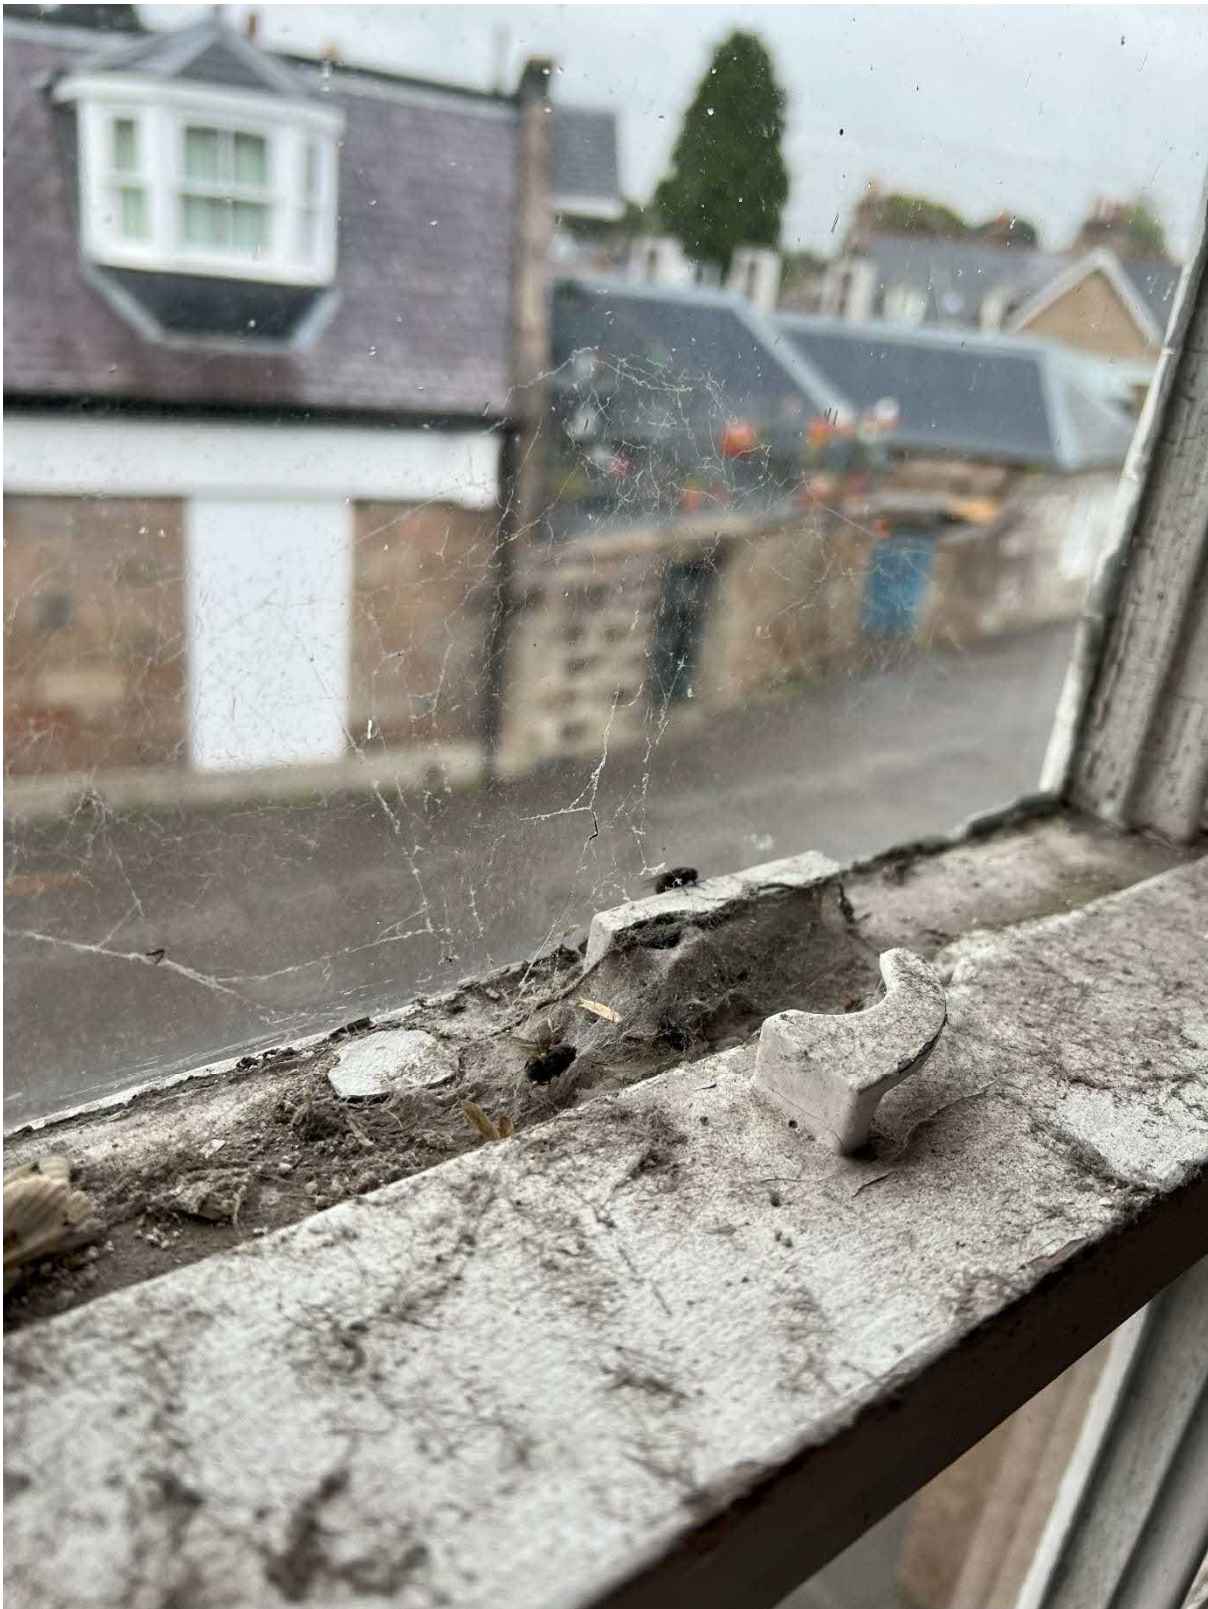
Photo 13 : Example of perished putty sealant with flaking paint and broken ironmongery to timber sash and case window to side of building.

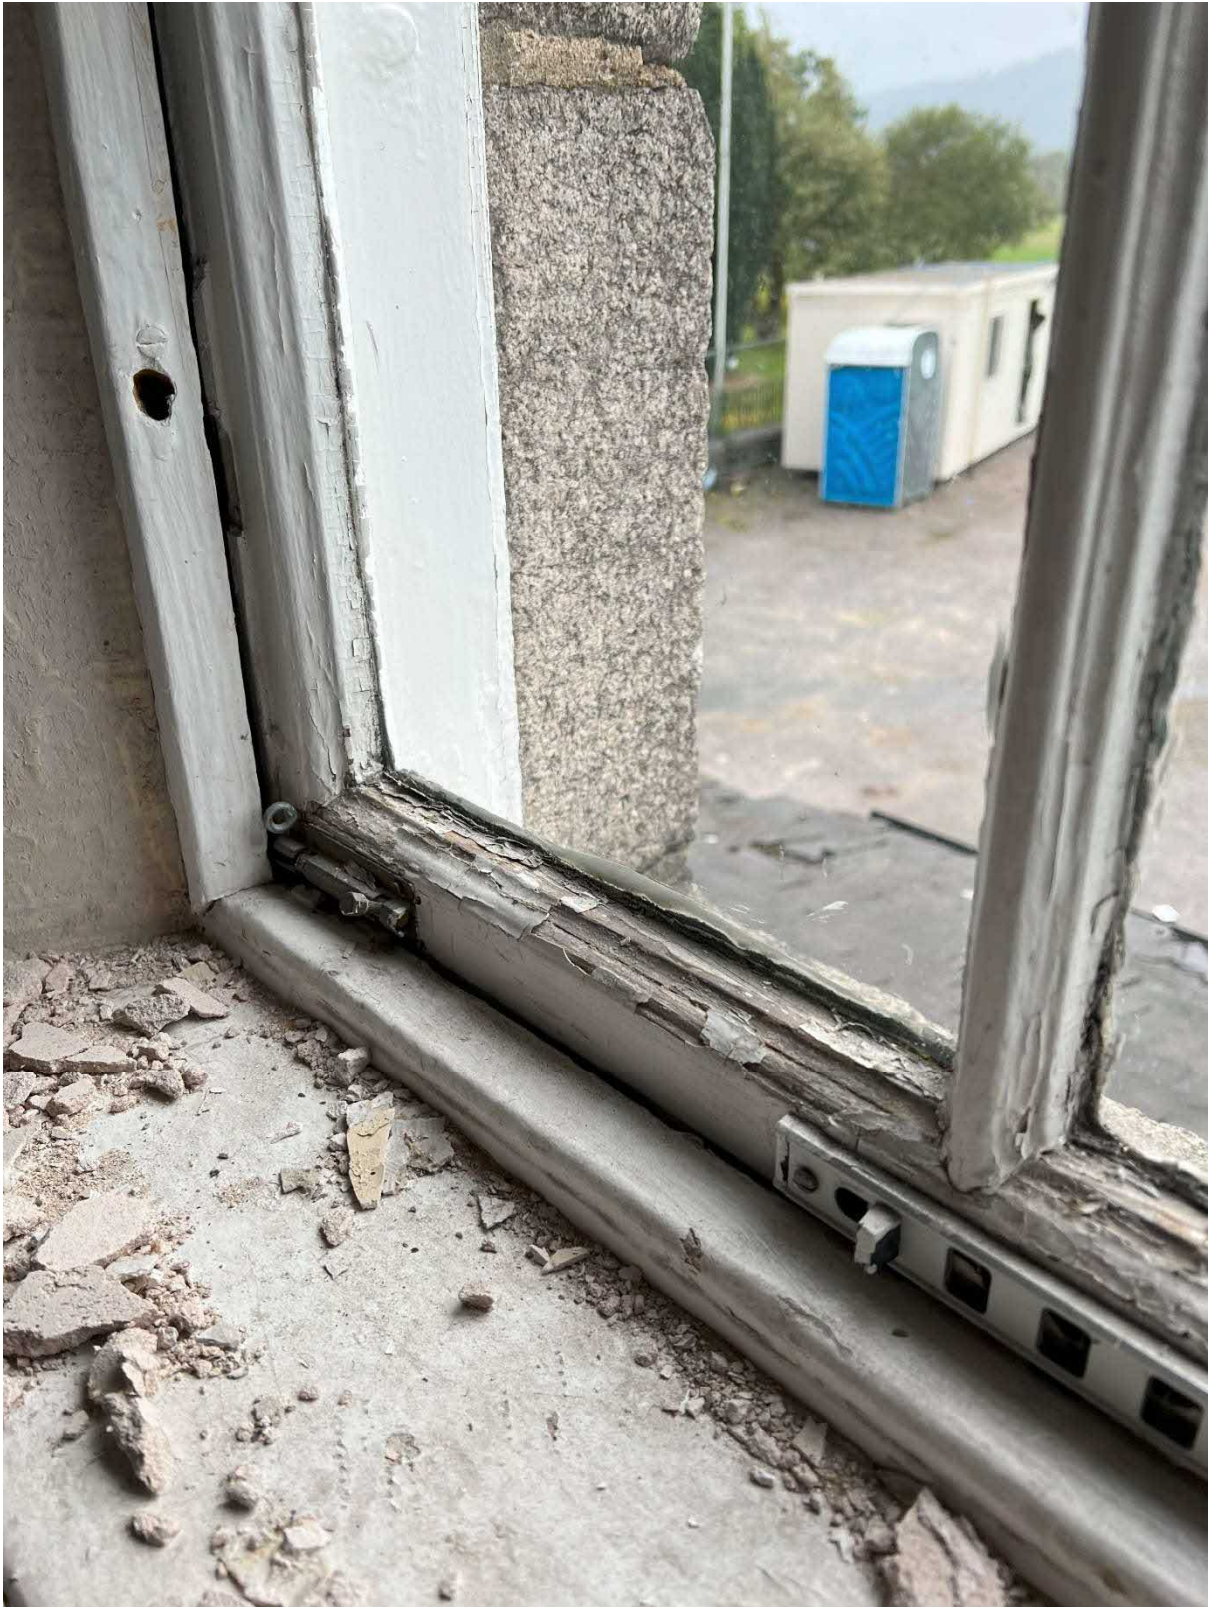
Photo 14 : Example of perished window sash with flaking paint and ironmongery and non-original permanent ventilator that has been fitted to timber sash and case windows to front of the building in attempt to prevent condensation.

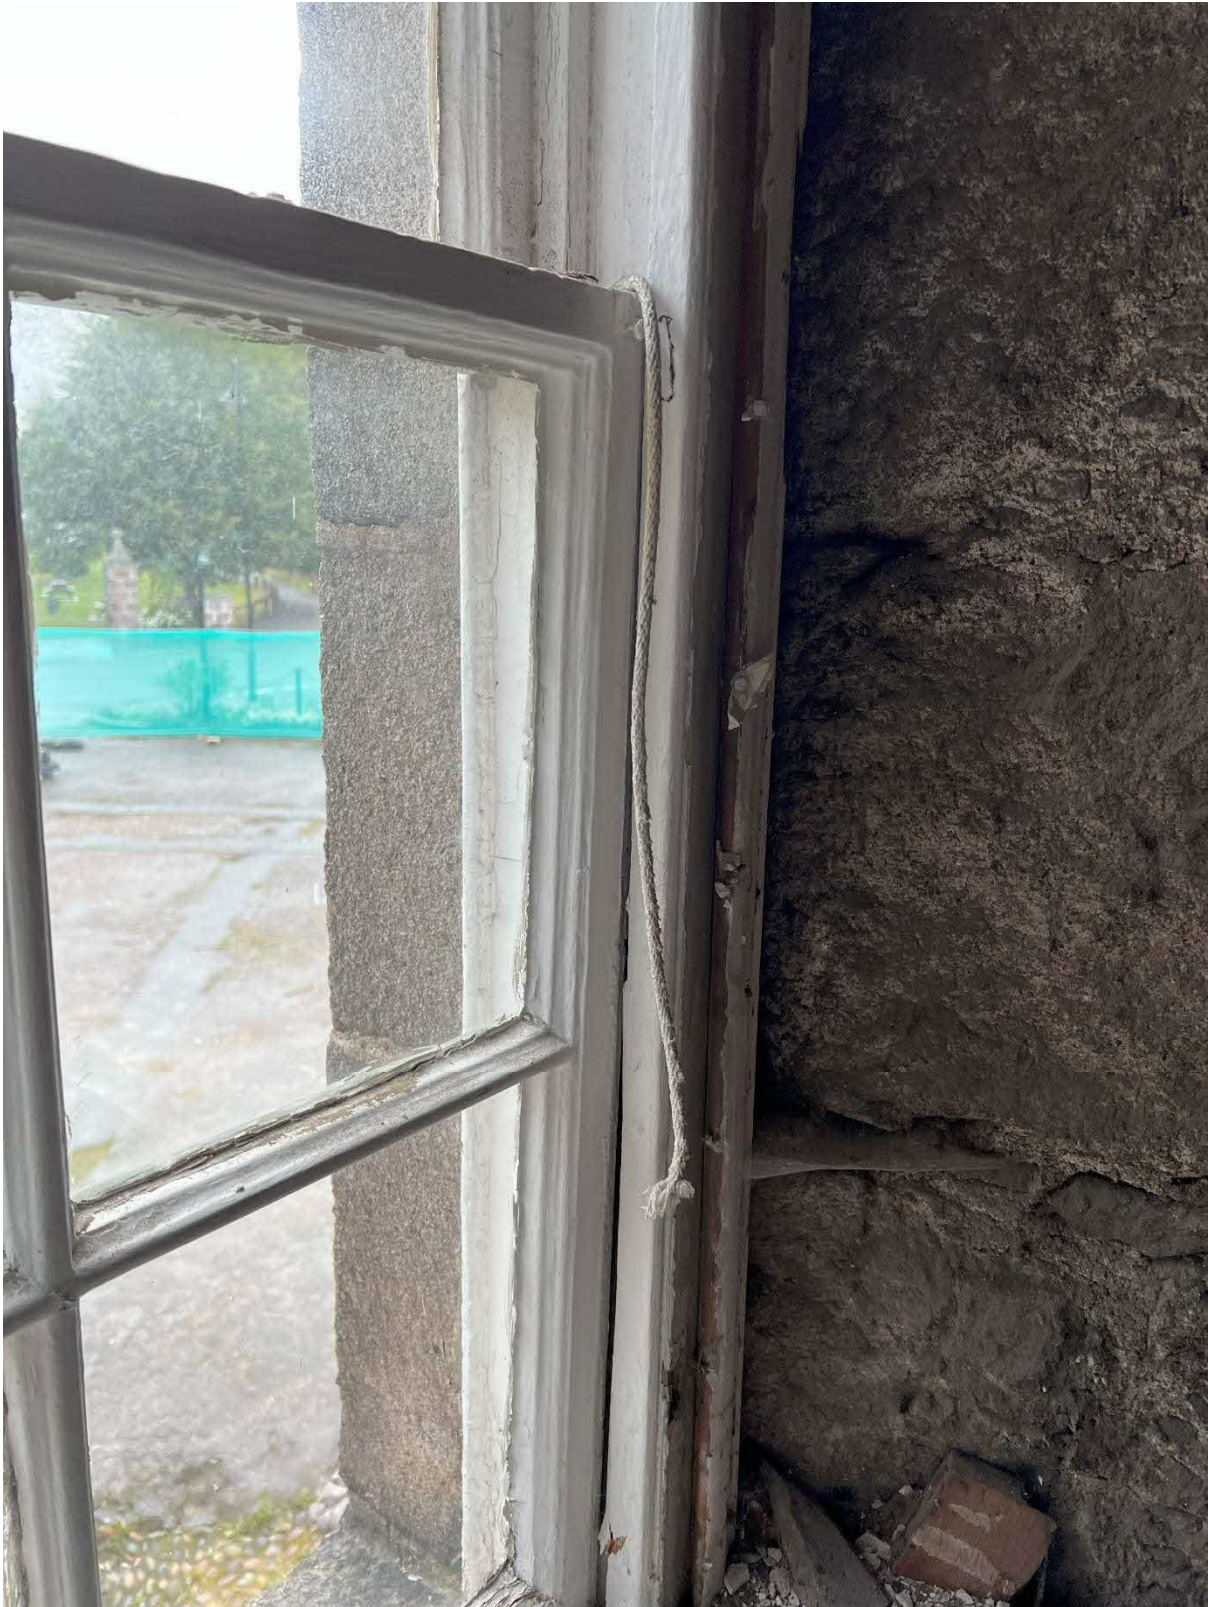
Photo 15 :Example of perished window sash with flaking paint and broken sash cord to timber sash and case window to front of the building.

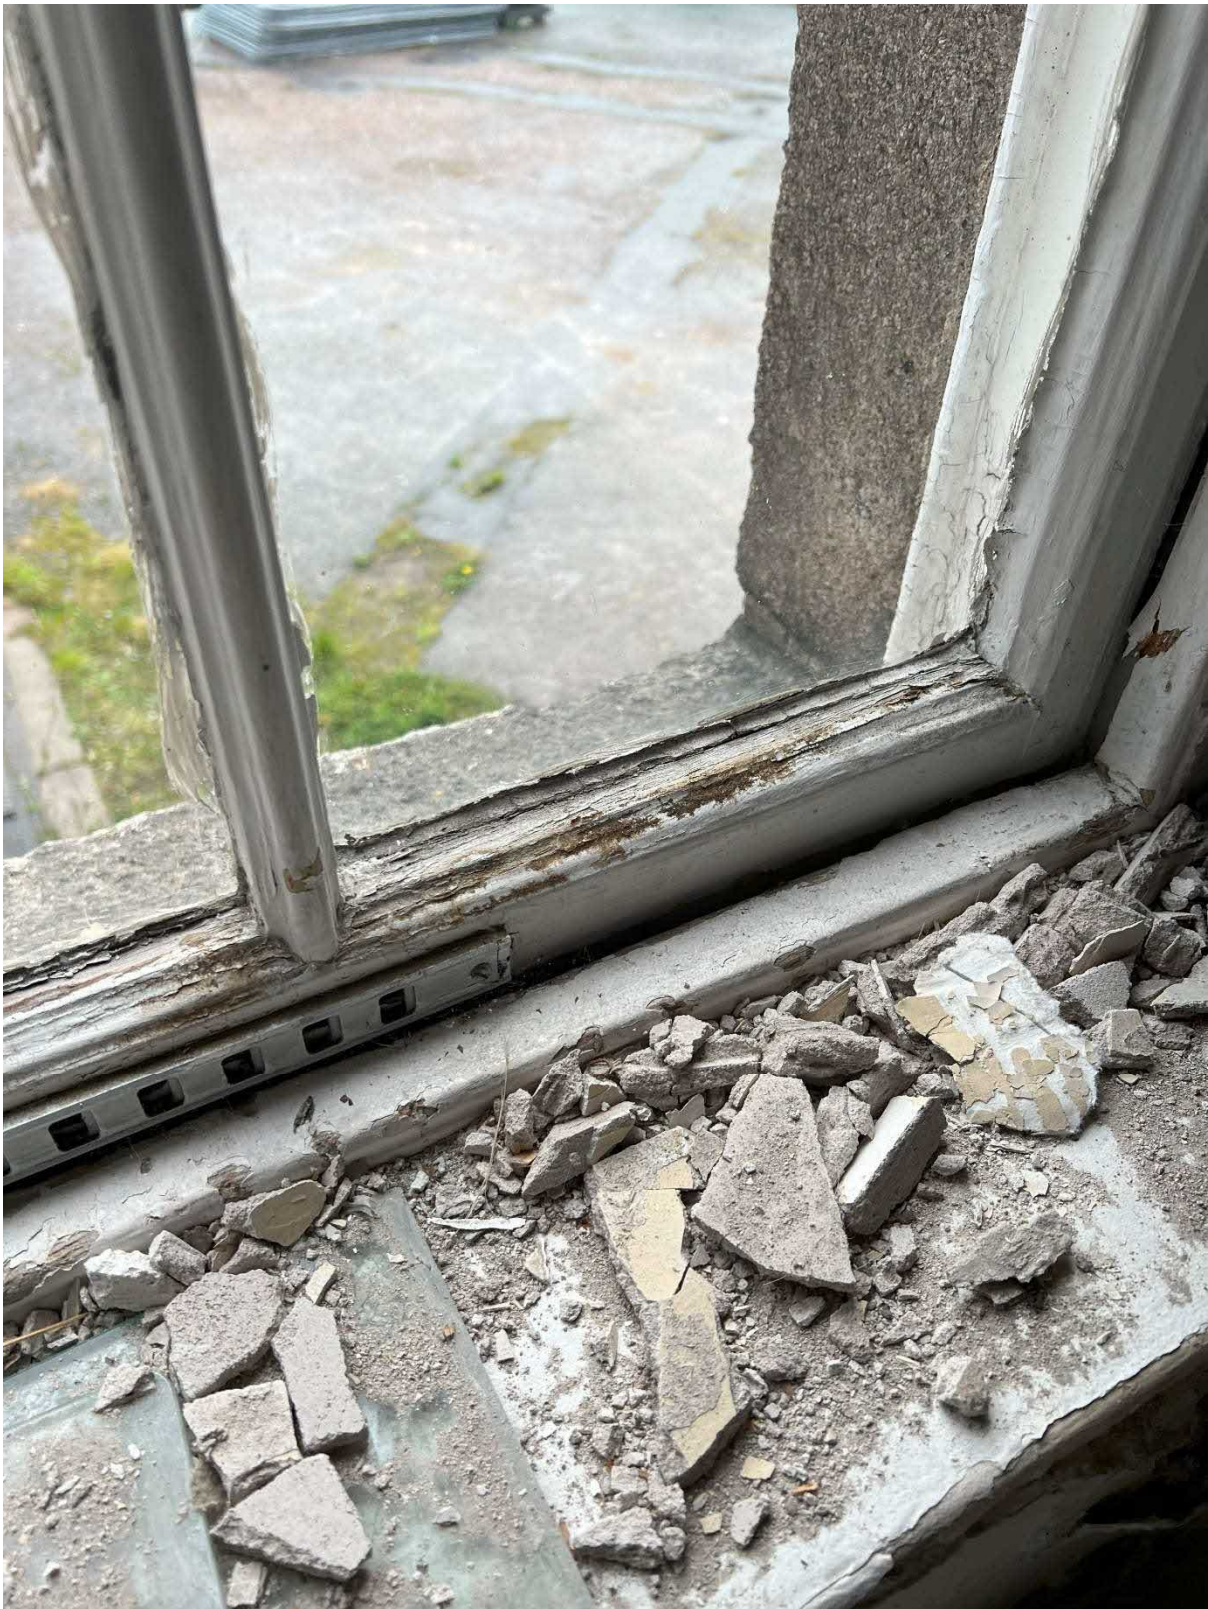
Photo 16 : Example of perished window sash with flaking paint and ironmongery and non-original permanent ventilator that has been fitted to timber sash and case windows to front of the building in attempt to prevent condensation.

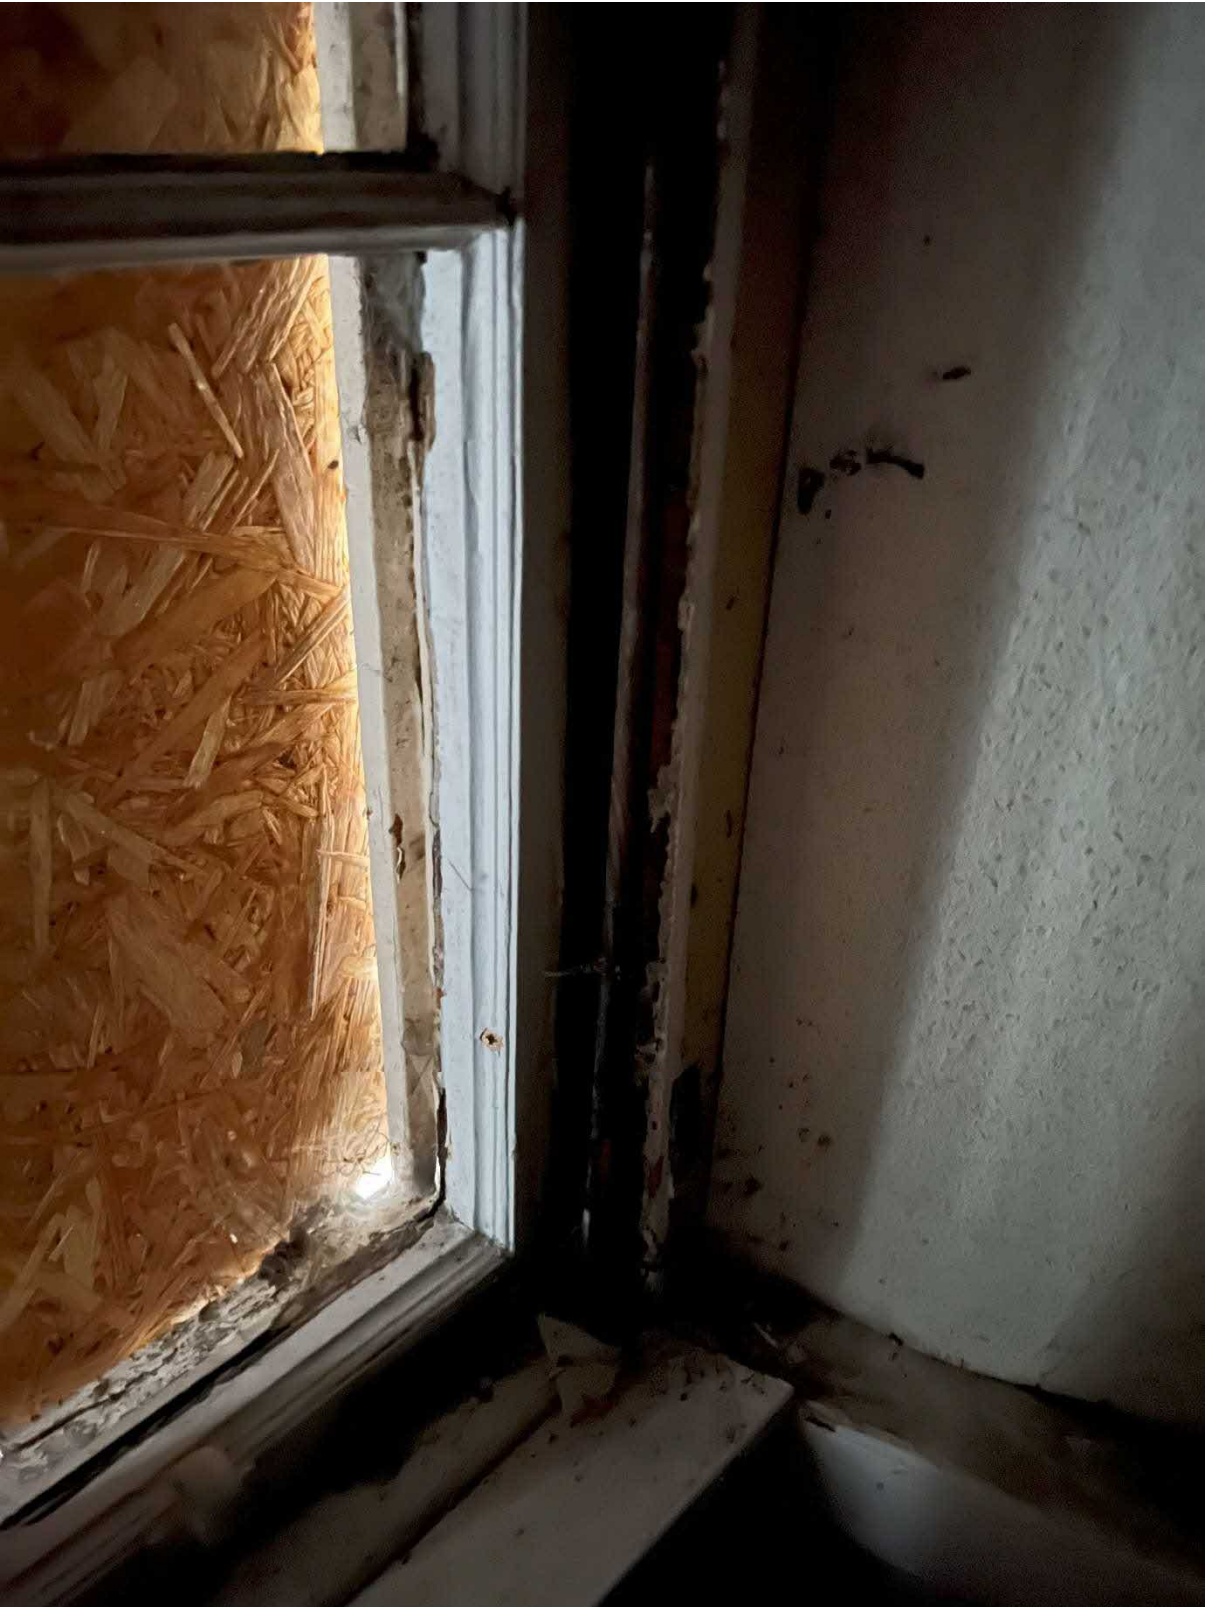
Photo 17 : Example of heavily decayed timber sash and case windows to front of the building damaged by water ingress.

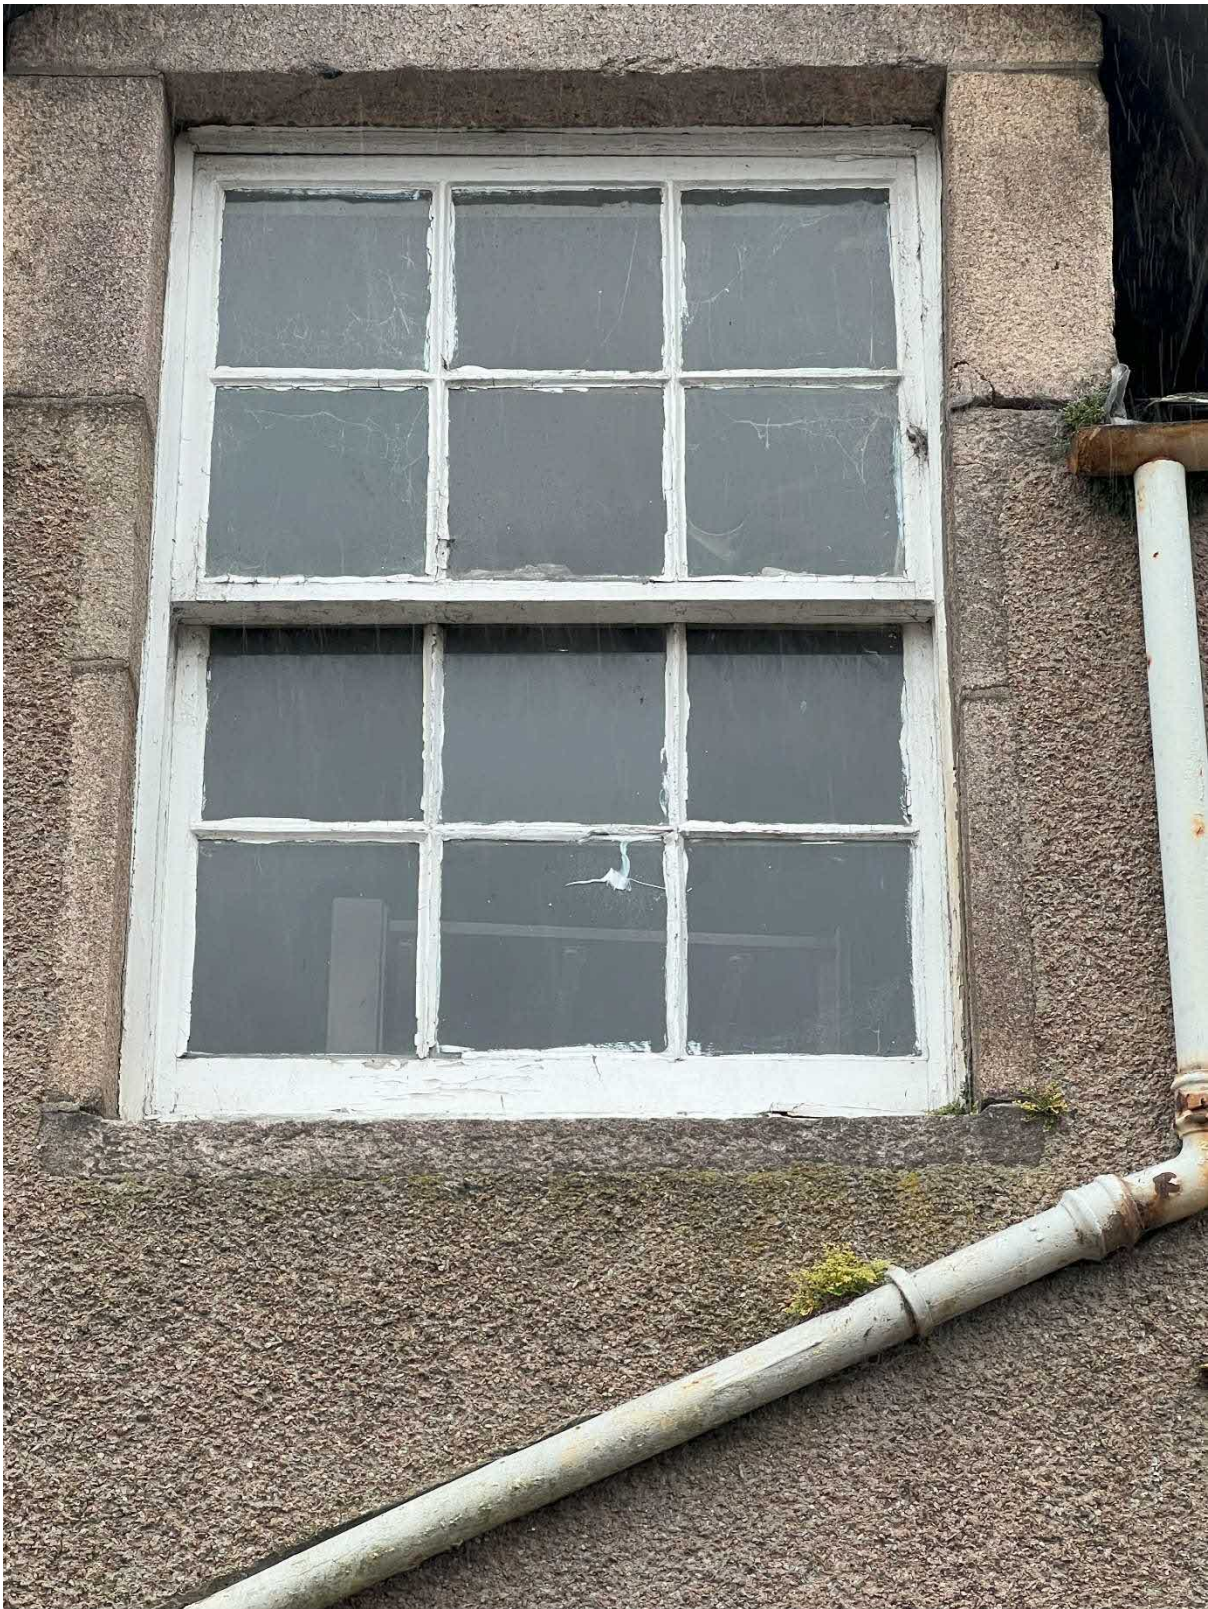
Photo 18 : Example of overpainting to window including astragals and putty sealant to timber sash and case window to side of building.

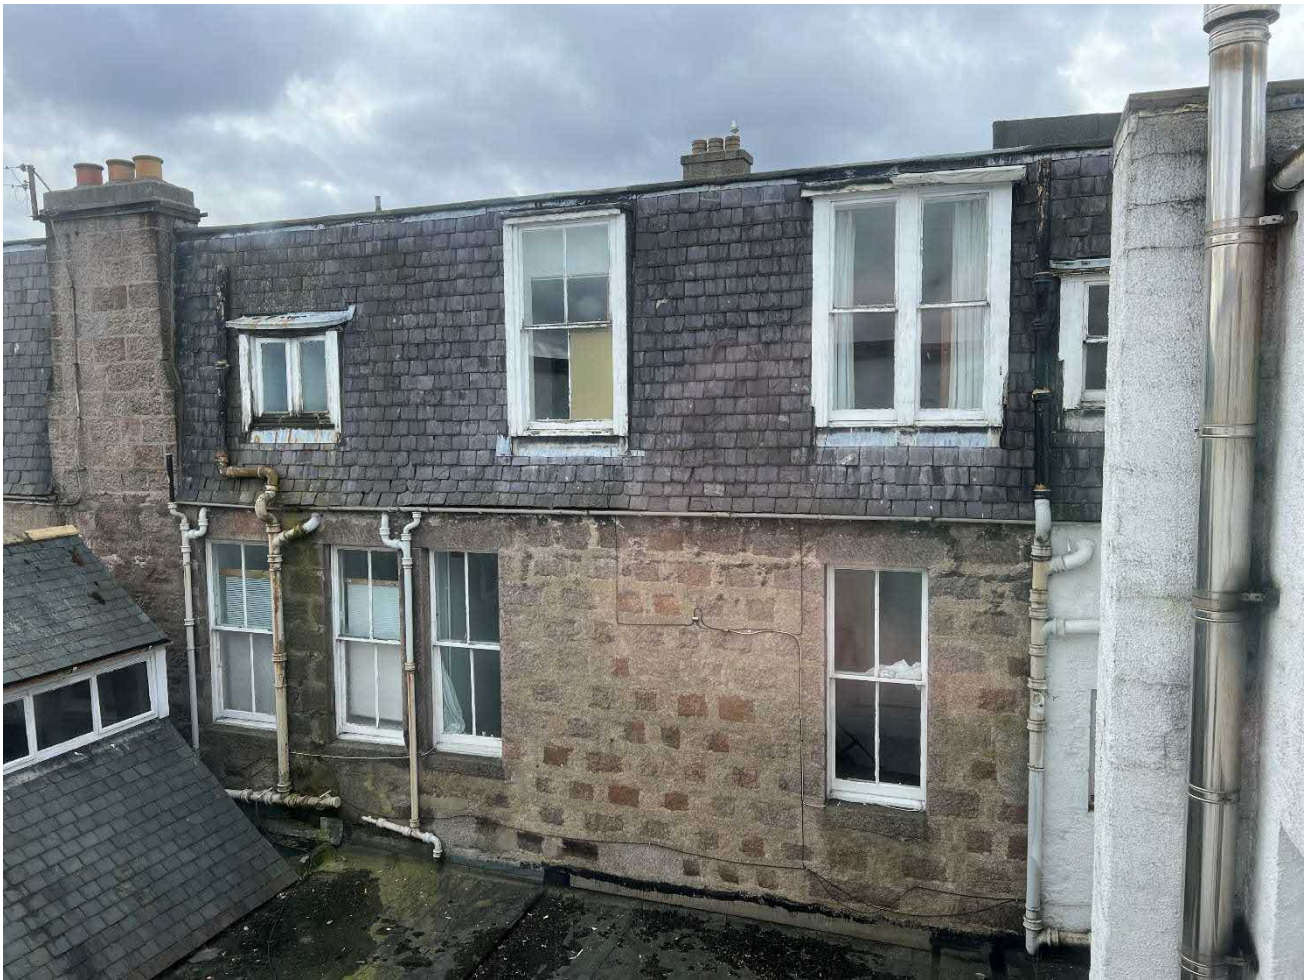
Photo 21 : Photograph of internal rear elevation over courtyard showing the array of window designs and all in extremely poor condition. A mixture of white timber sash and case, white timber casement and white pvc.

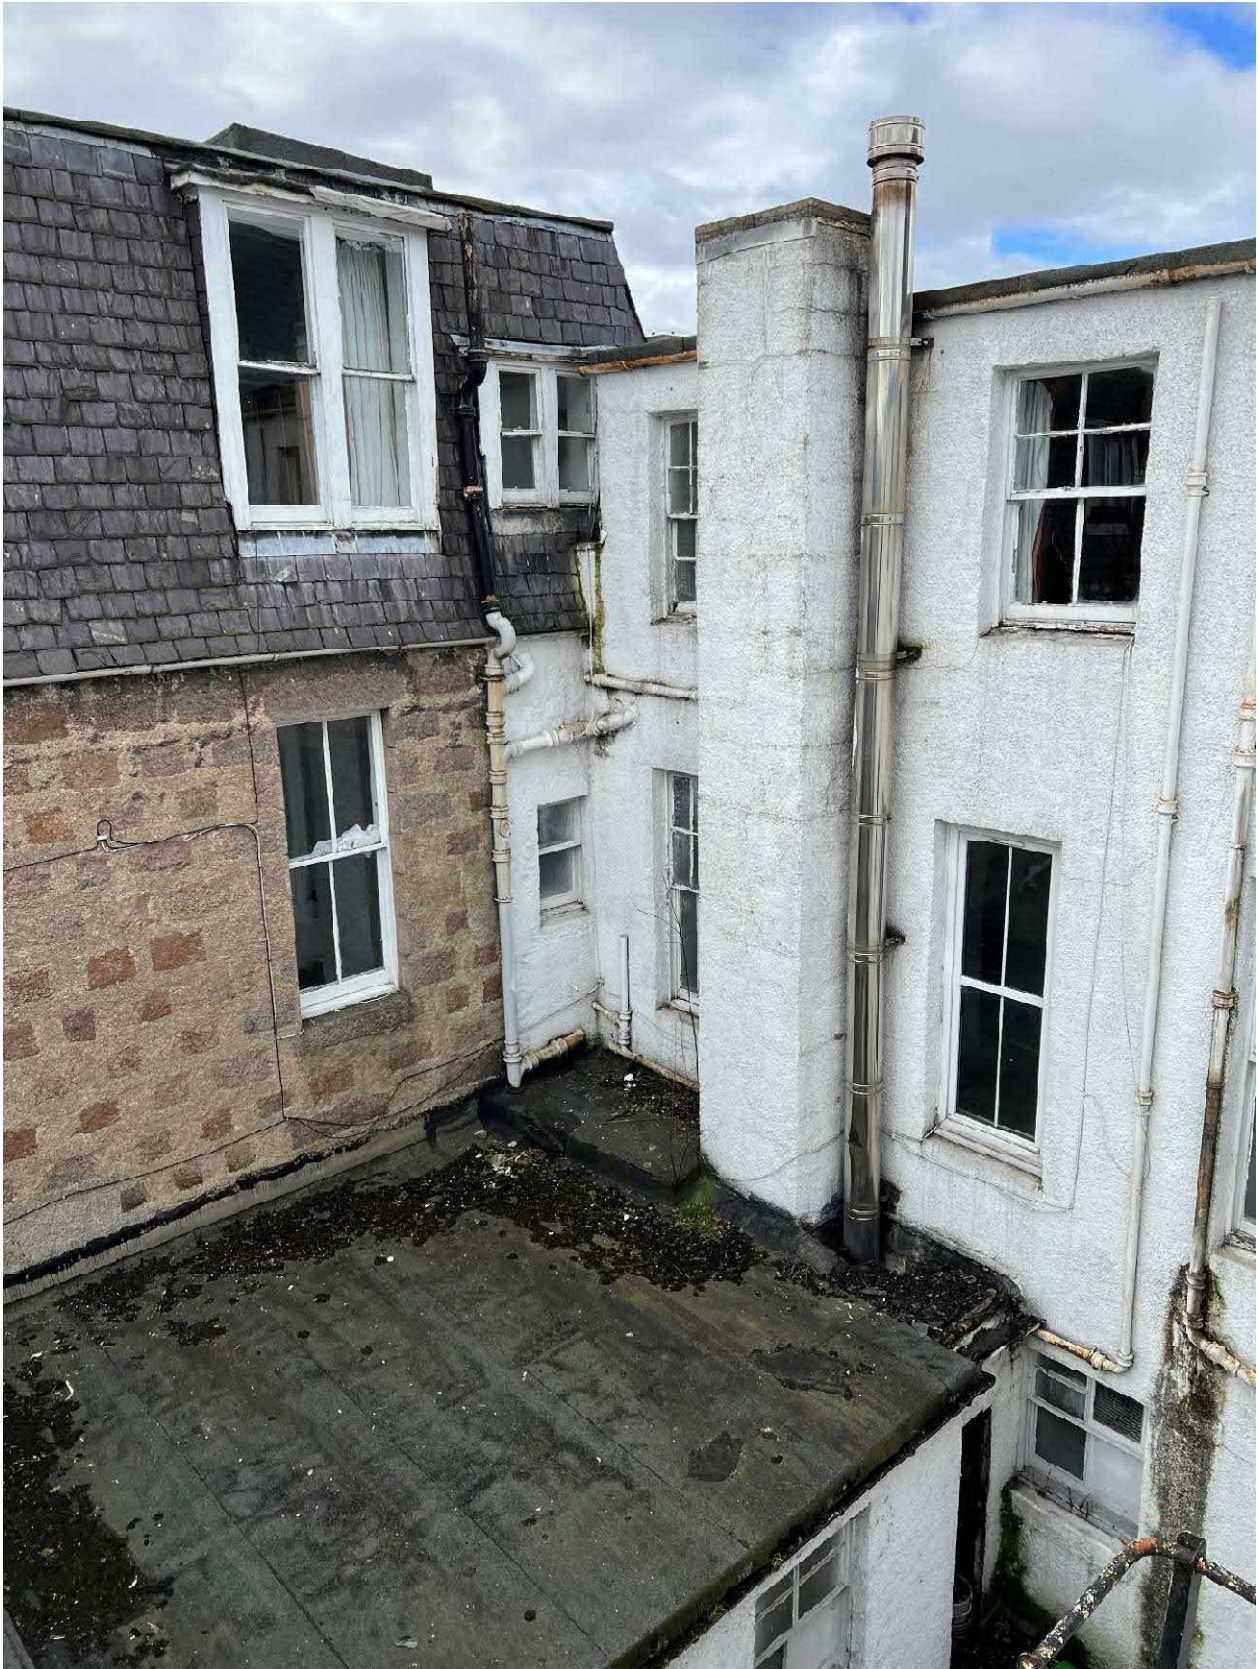
Photo 22 : Photograph of internal rear elevation over courtyard showing the array of window designs and all in extremely poor condition. A mixture of white timber sash and case, white timber casement and white pvc.

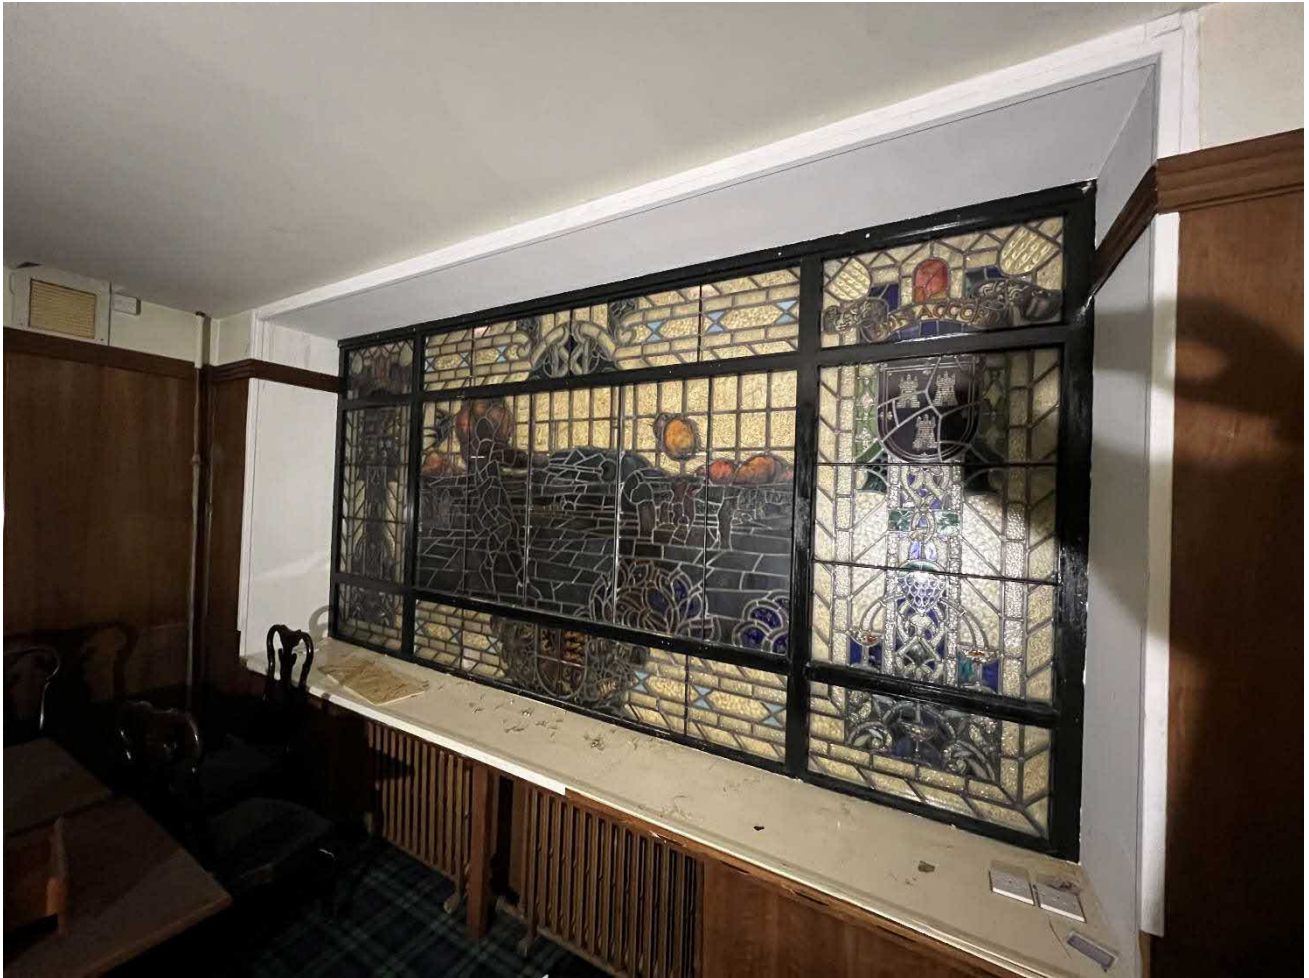
Photo 23 : Photograph of the original Donal Dinnie stained glass window in the existing resident's bar which is currently boarded up externally for protection. It is to be retained in its current position with any recommended refurbishment being carried out as part of works.

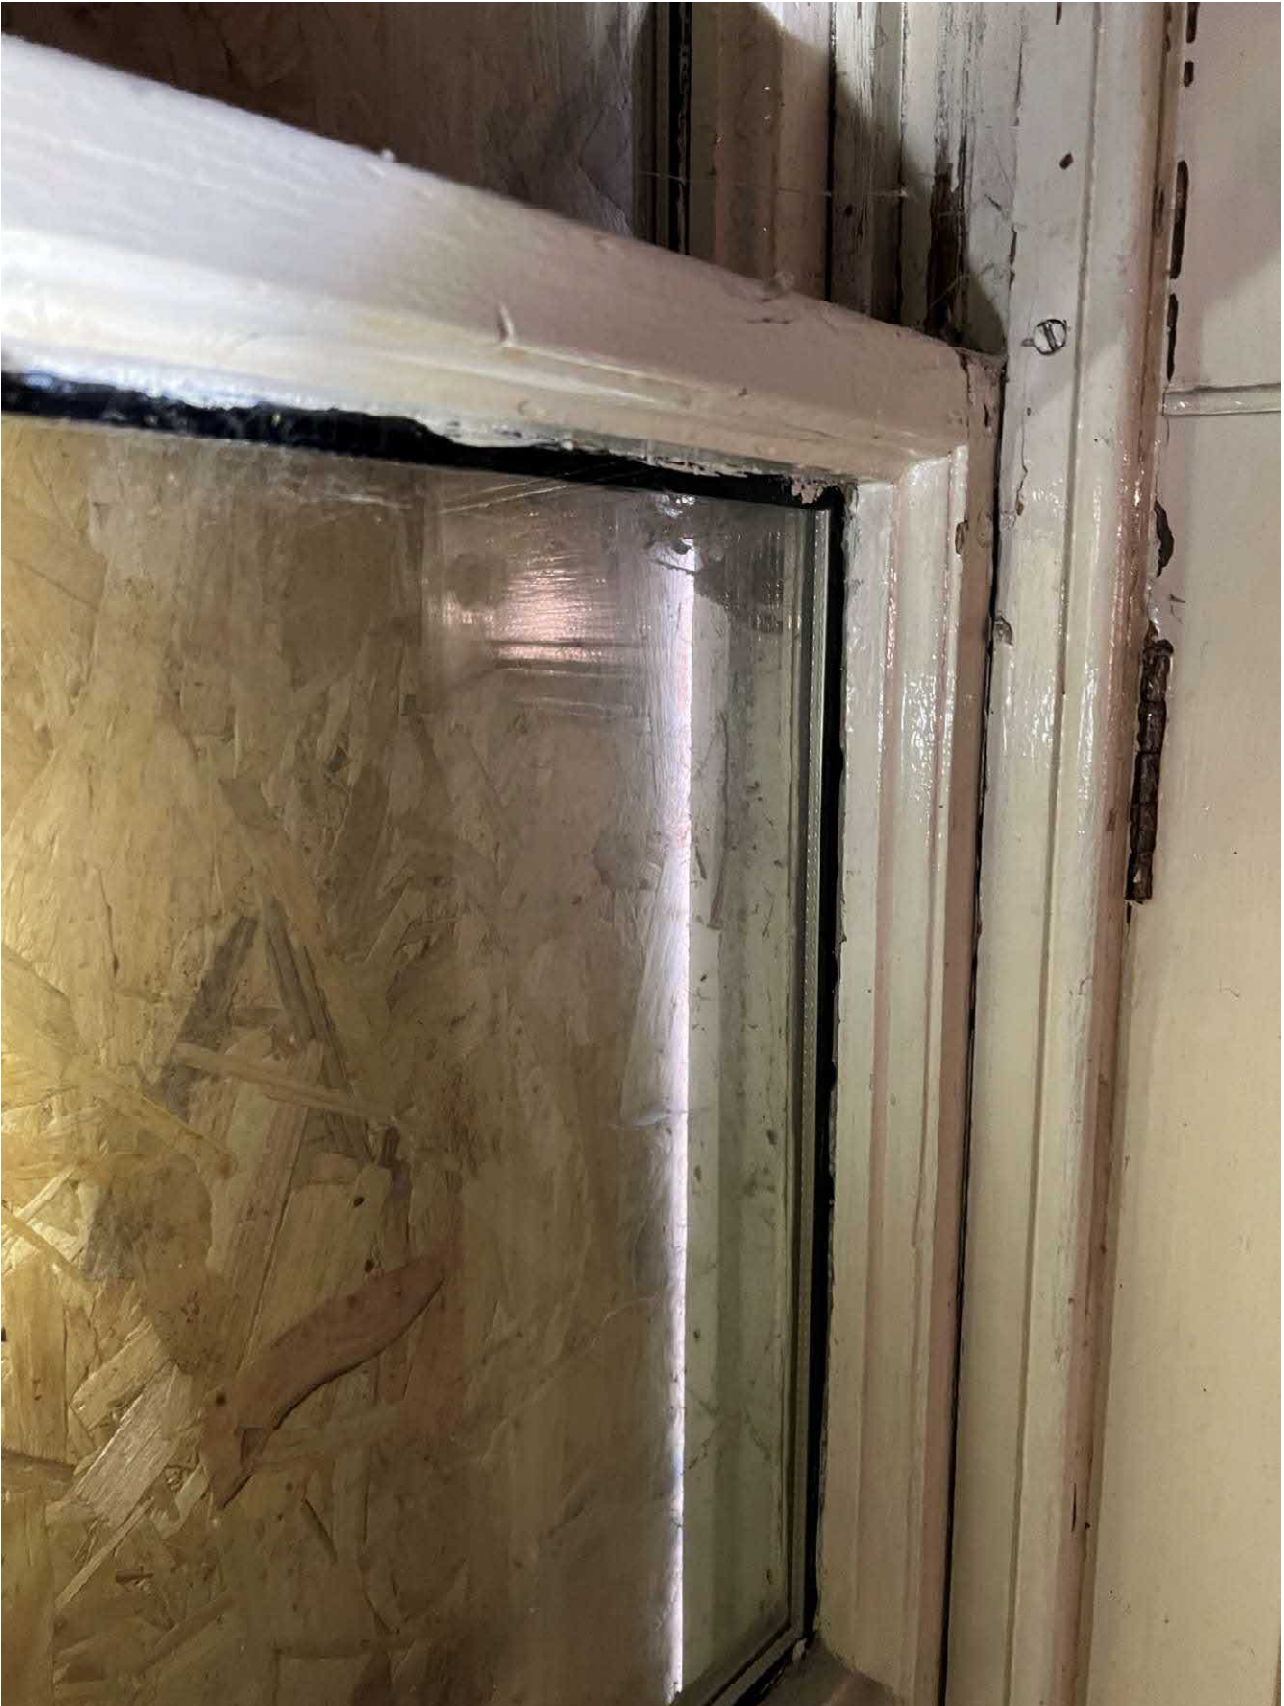
Photo 24 : Photograph of an original sash and case window which has had the glazing replaced with double glazed units and is rotten and heavily overpainted.

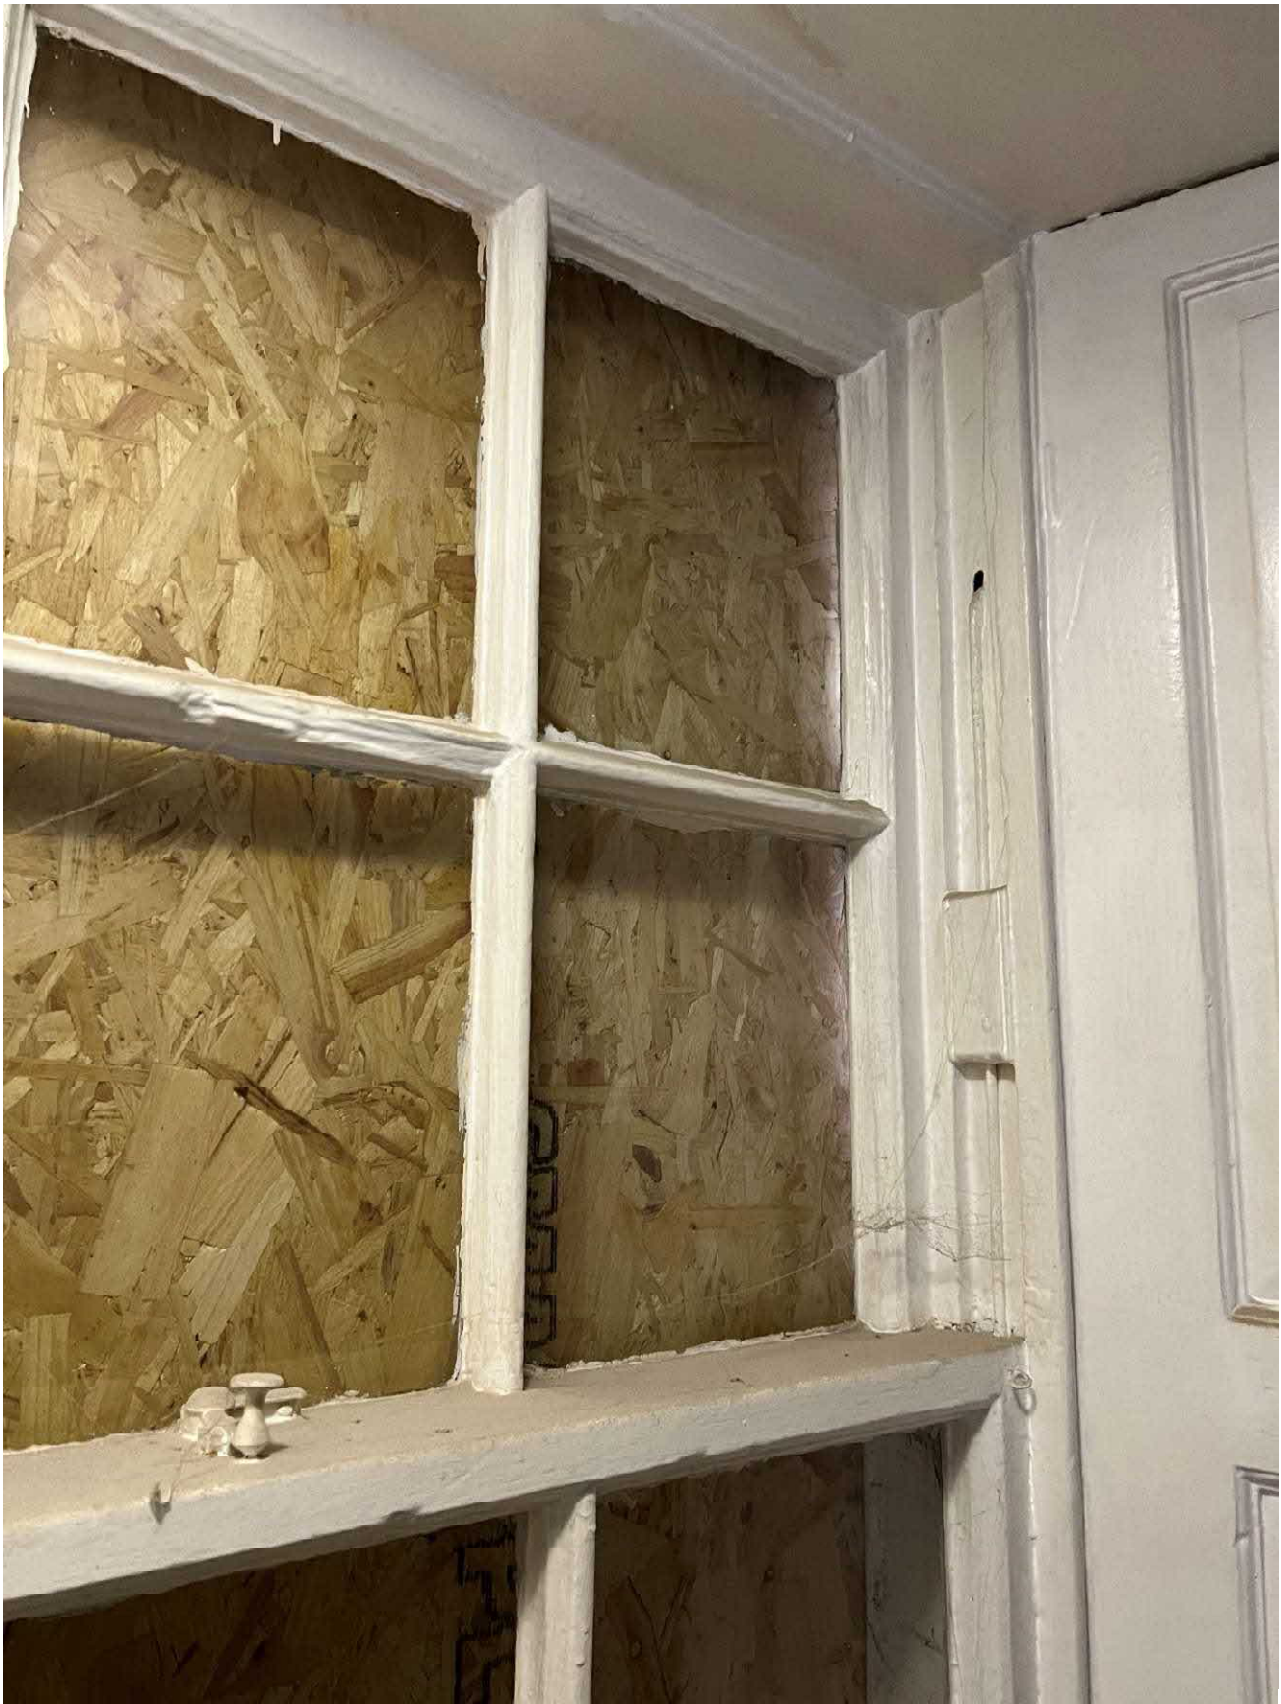
Photo 25 : Example of heavily overpainted window to side of building.
