The Huntly Arms Hotel
Charlestown Road
Aboyne

Windows Survey and Condition Report
27/10/2023 (revised 23/01/24)

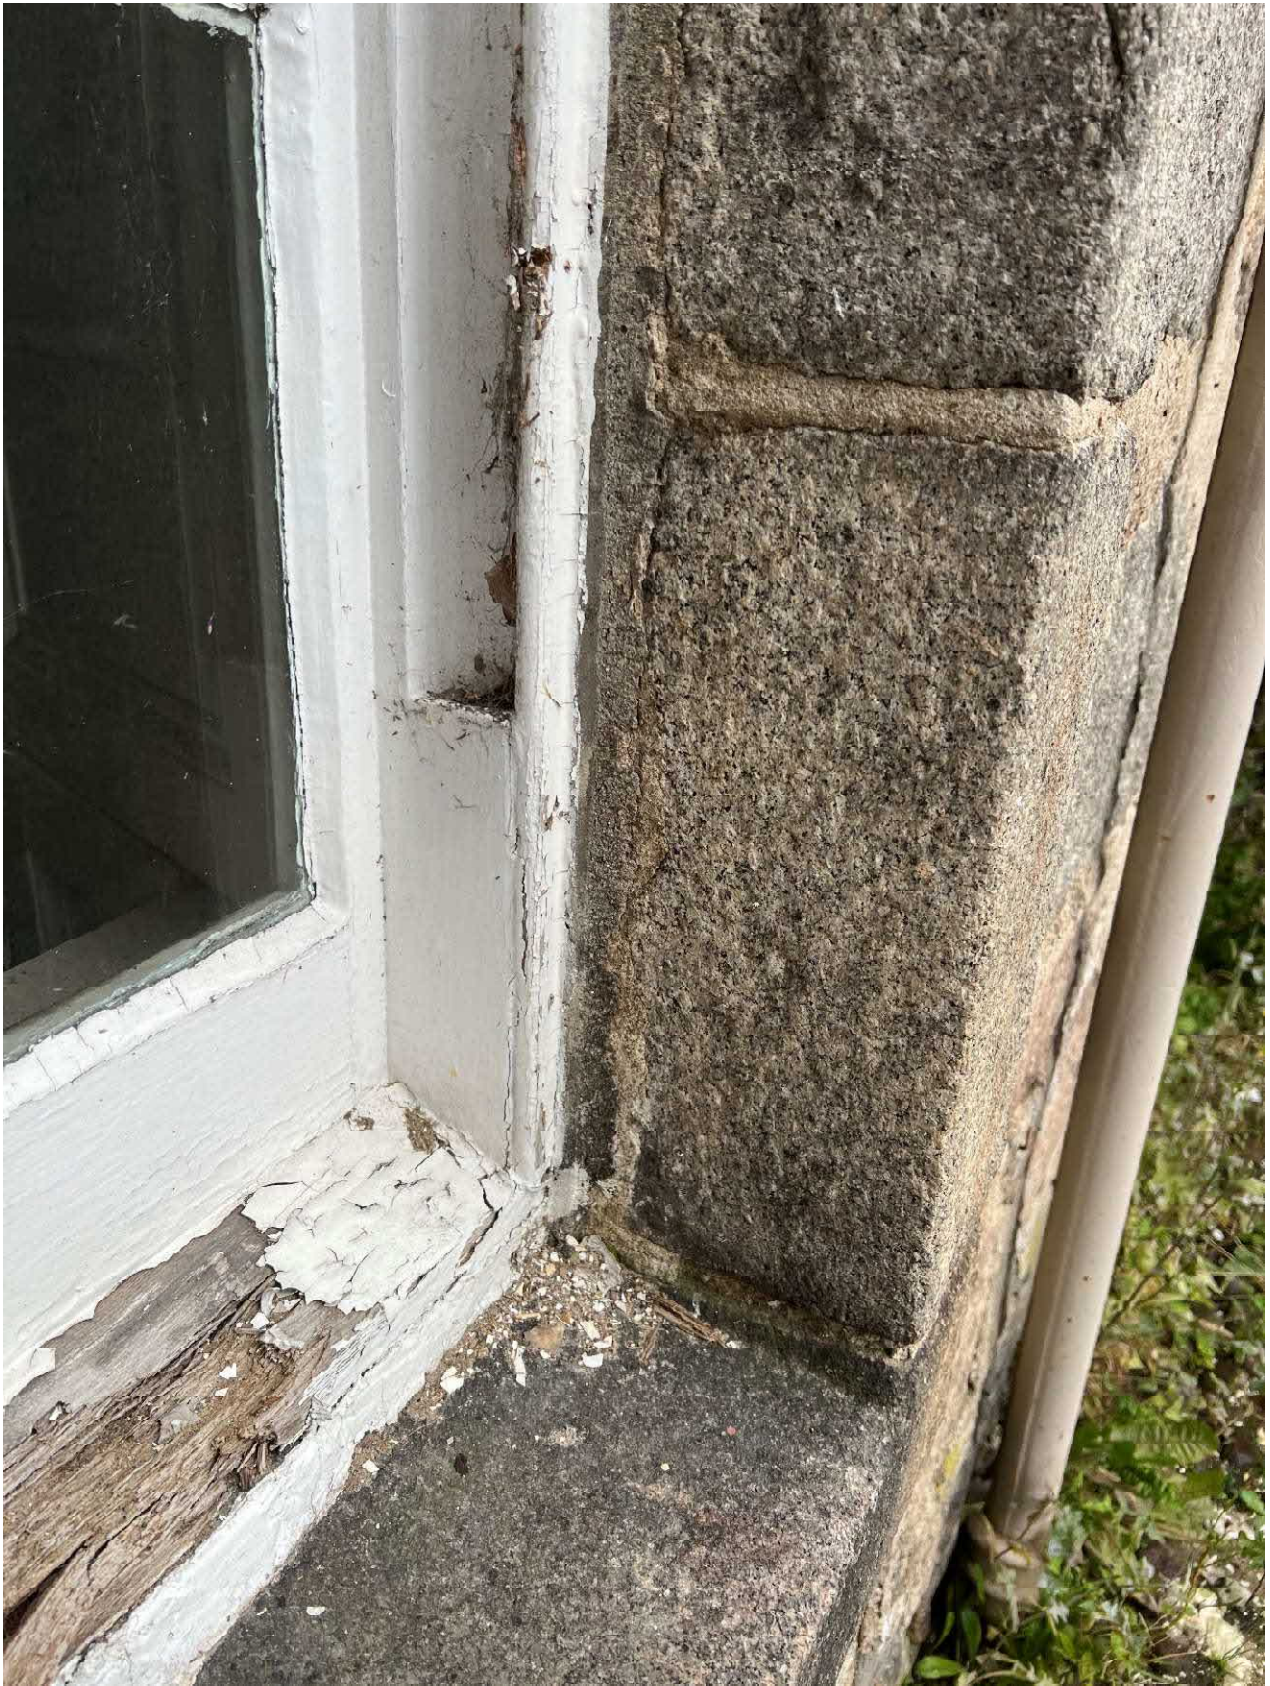
Photo 28 : Example of heavily decayed cill and paint bubbling and flaking along with overpainting and failed putty sealant to window on front of building.

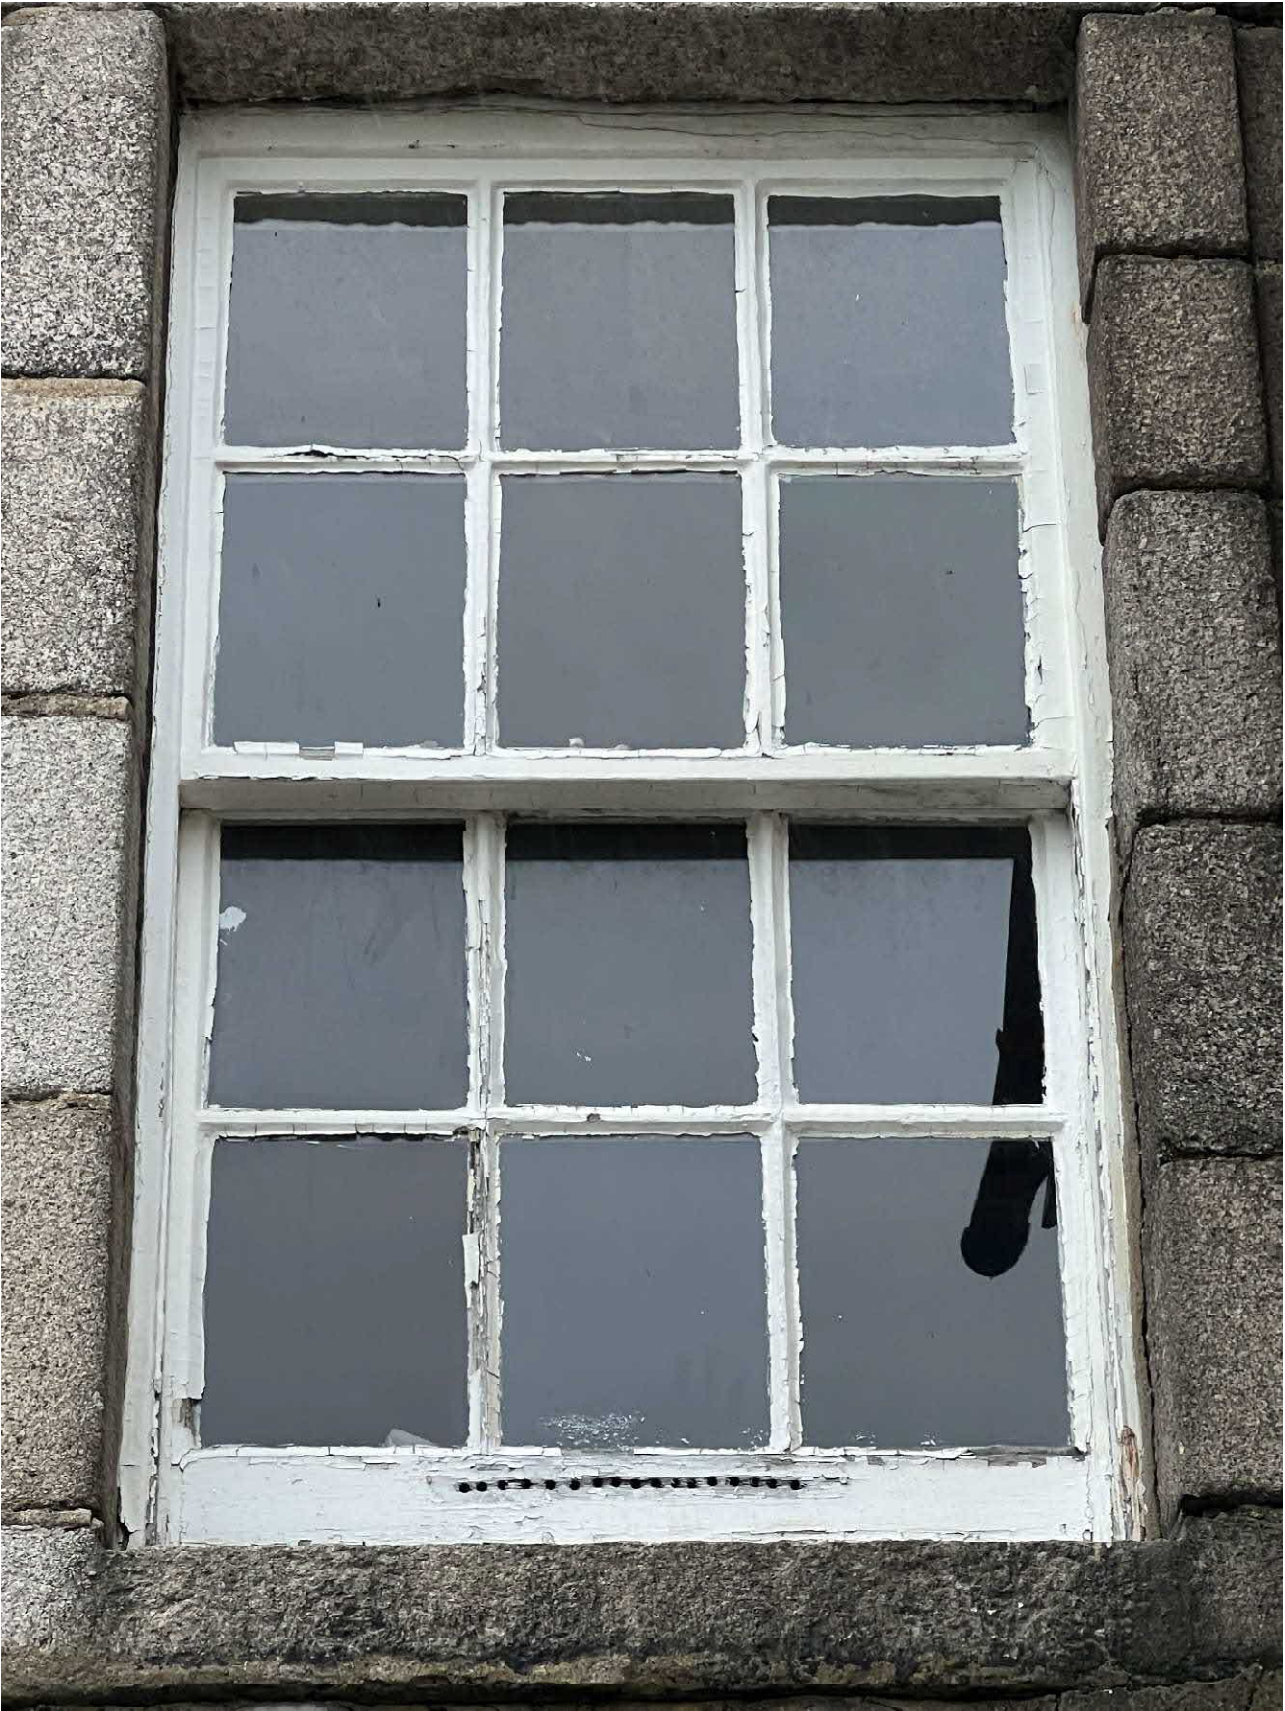
Photo 29 : Example of overpainted window with flaking paint and non-original permanent ventilator that has been fitted in attempt to prevent condensation at front of building.

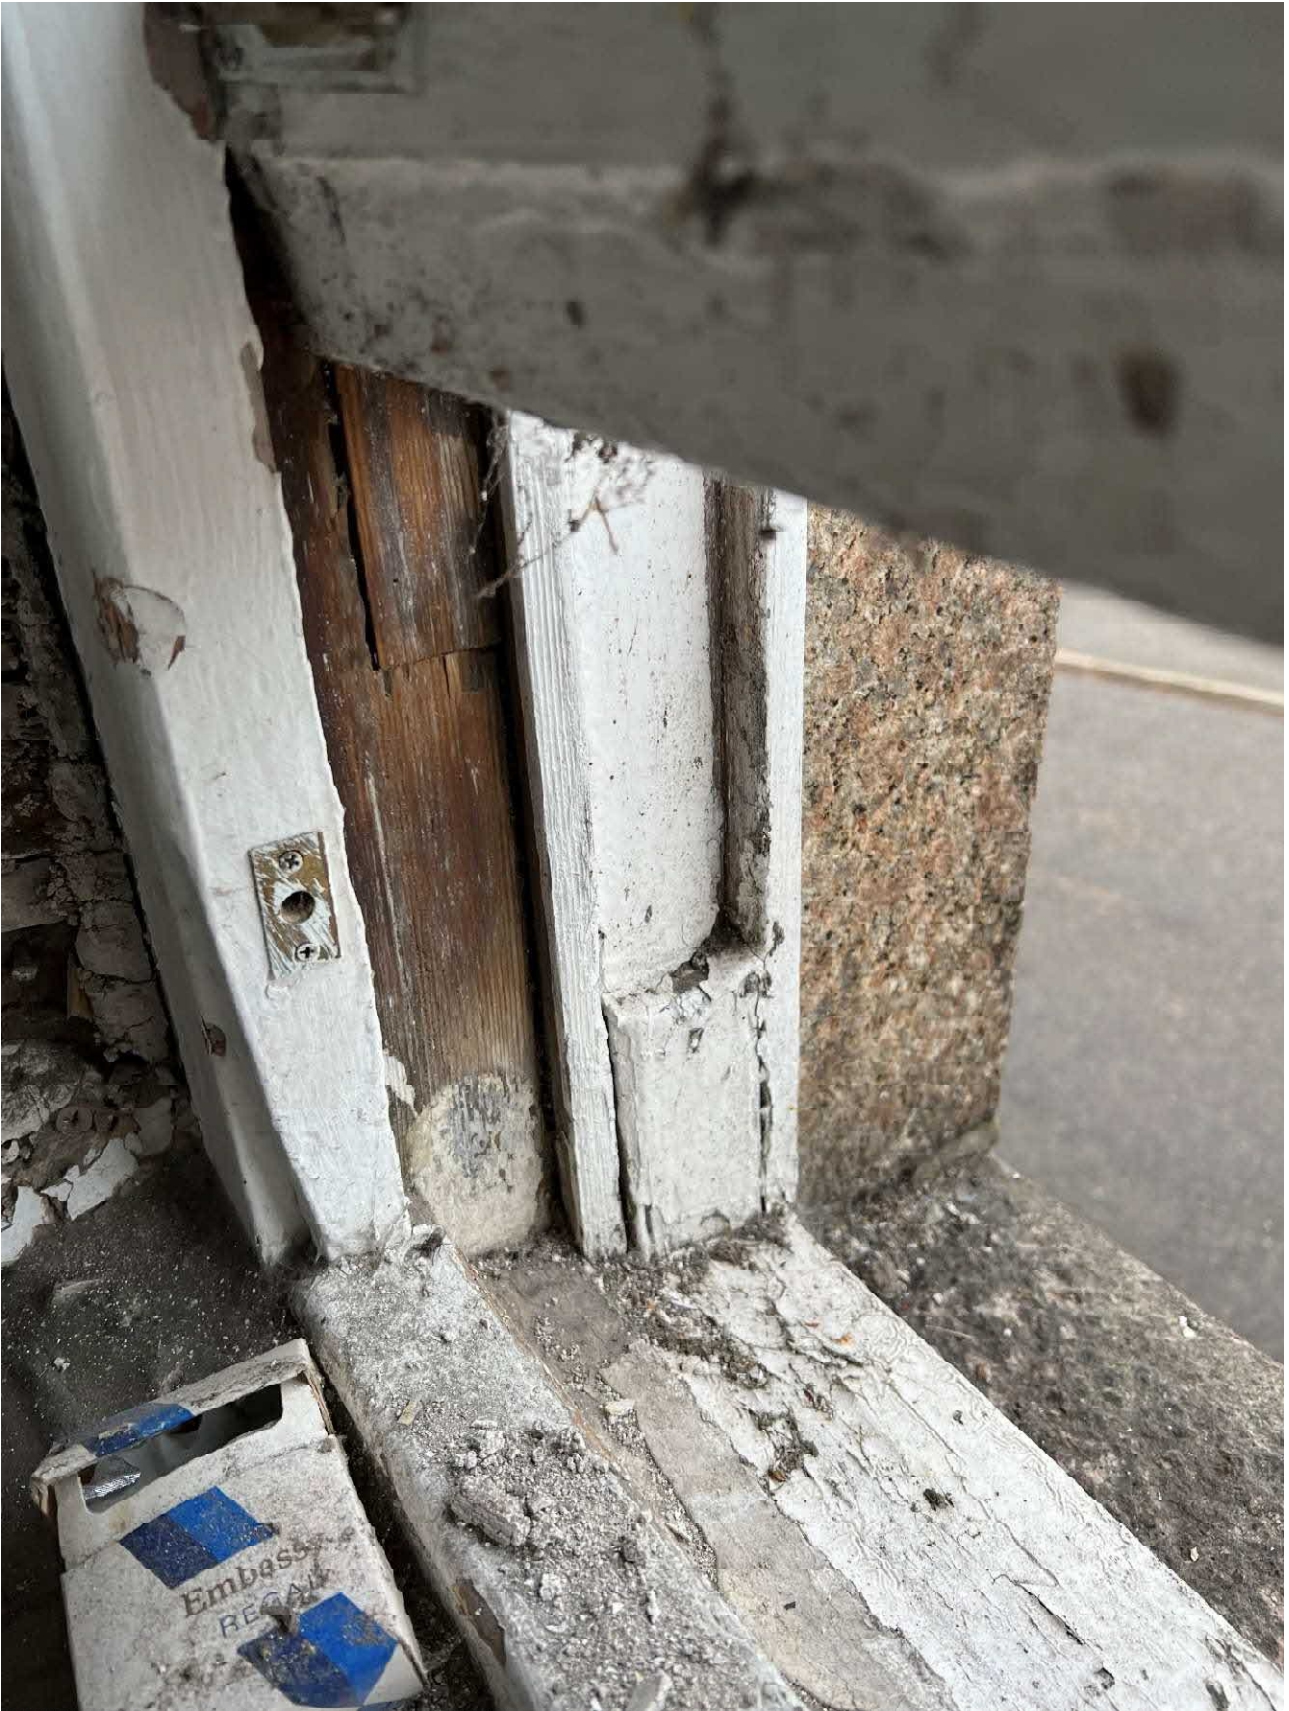
Photo 30 : Example of perished window sash with flaking paint and damaged ironmongery to window on front of the building.

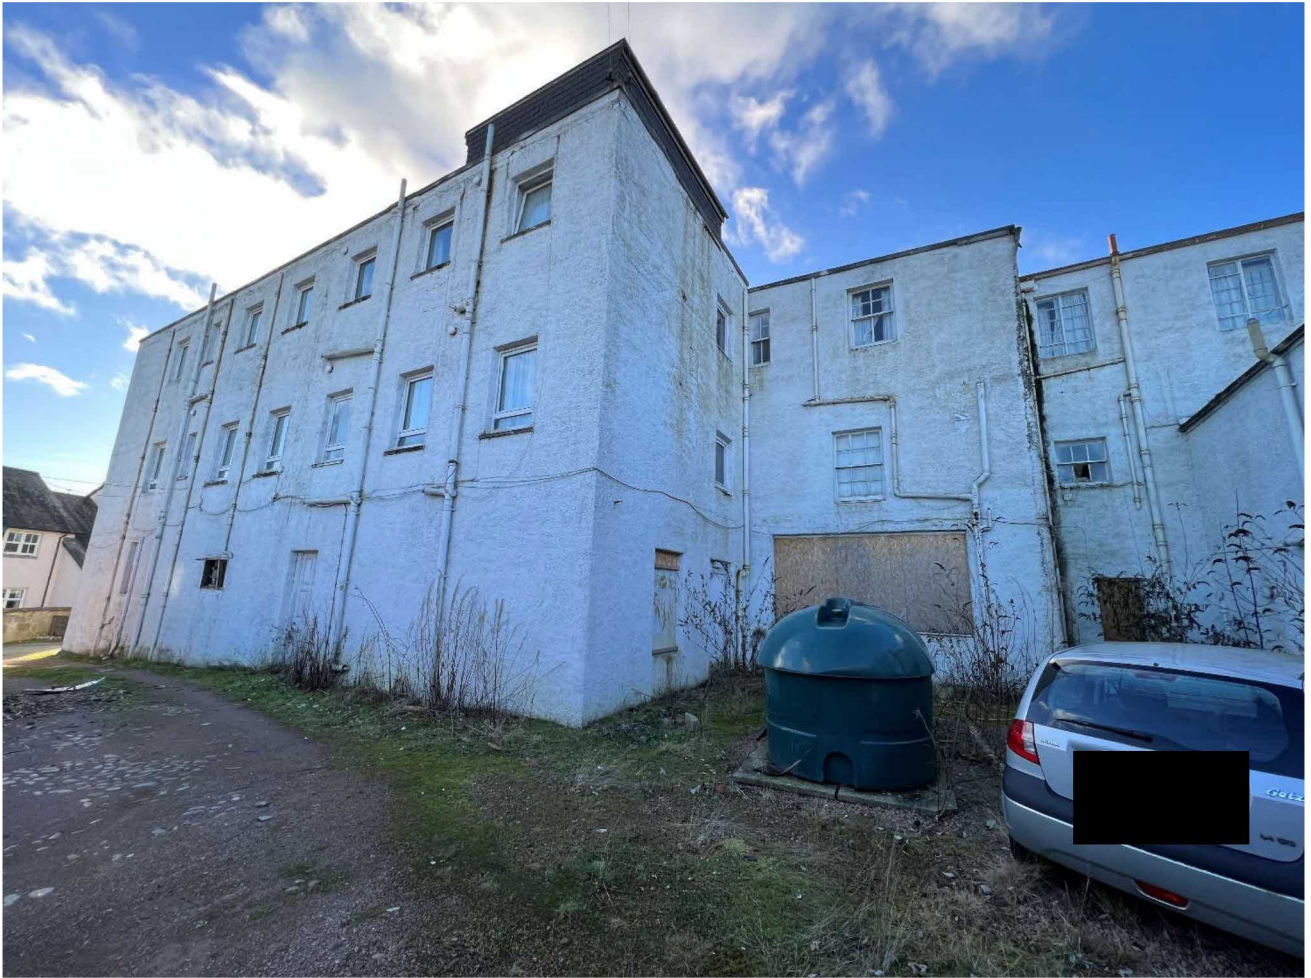
Photo 31 : Photograph of internal rear elevation of rear bedroom block to internal service area showing the array of window designs. A mixture of white timber sash and case, white timber casement, white steel casement and white pvc.

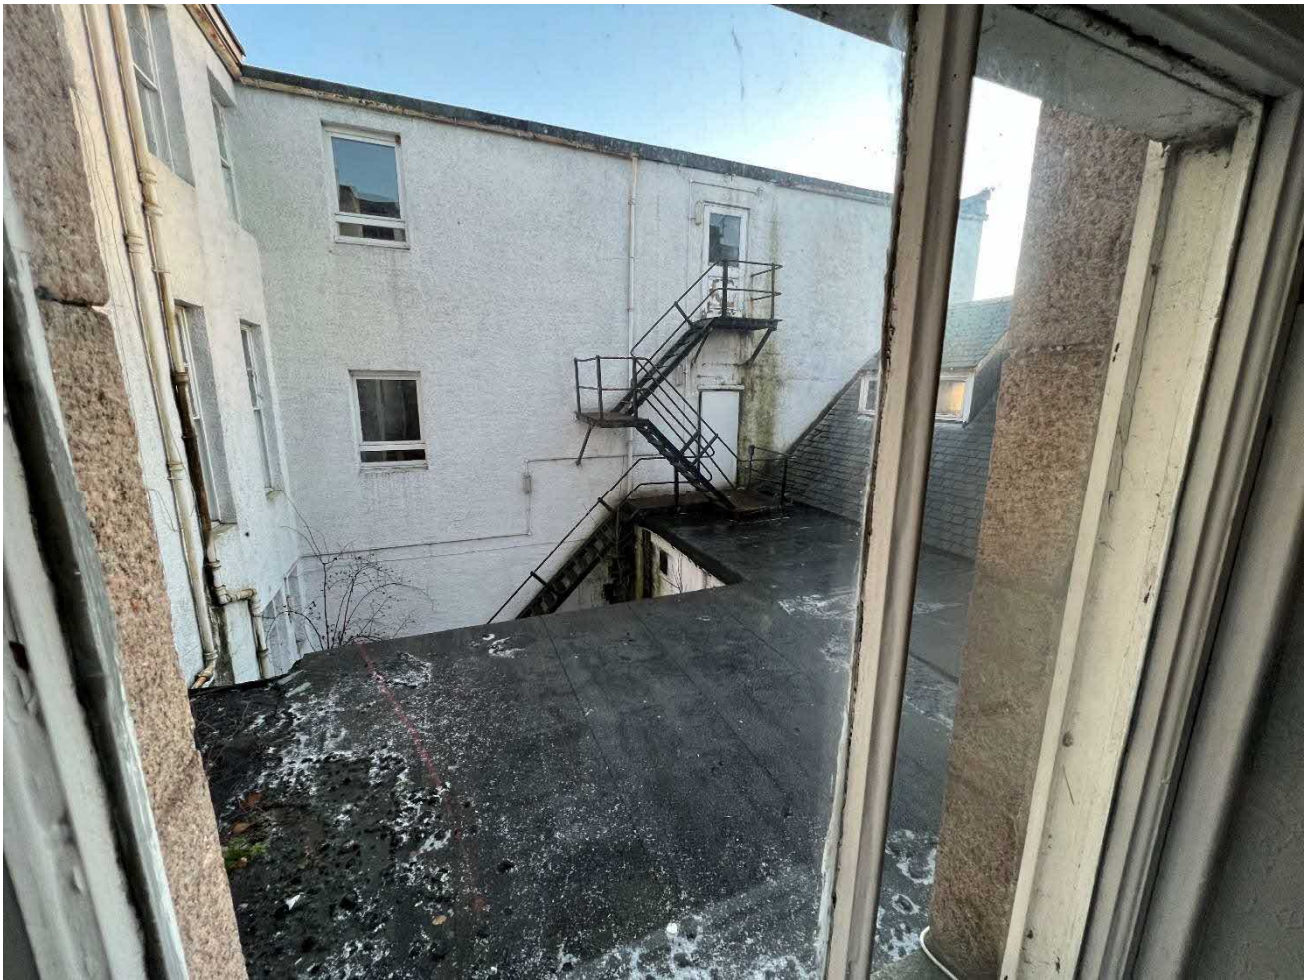
Photo 32 : Photograph of internal courtyard elevation of rear bedroom block showing the existing white pvc windows that are to be either retained or replaced.

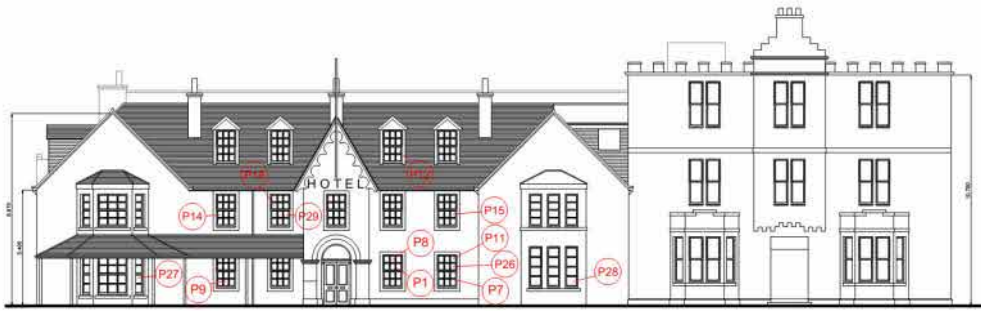
EXISTING WEST ELEVATION TO CAR PARK & CHARLESTOWN ROAD. 1:100.
