ENVIRONMENTAL DESK STUDY AND PRELIMINARY RISK ASSESSMENT

Windlesham Plant Centre
Church Road
Windlesham
Surrey
GU20 6BL

September 2020

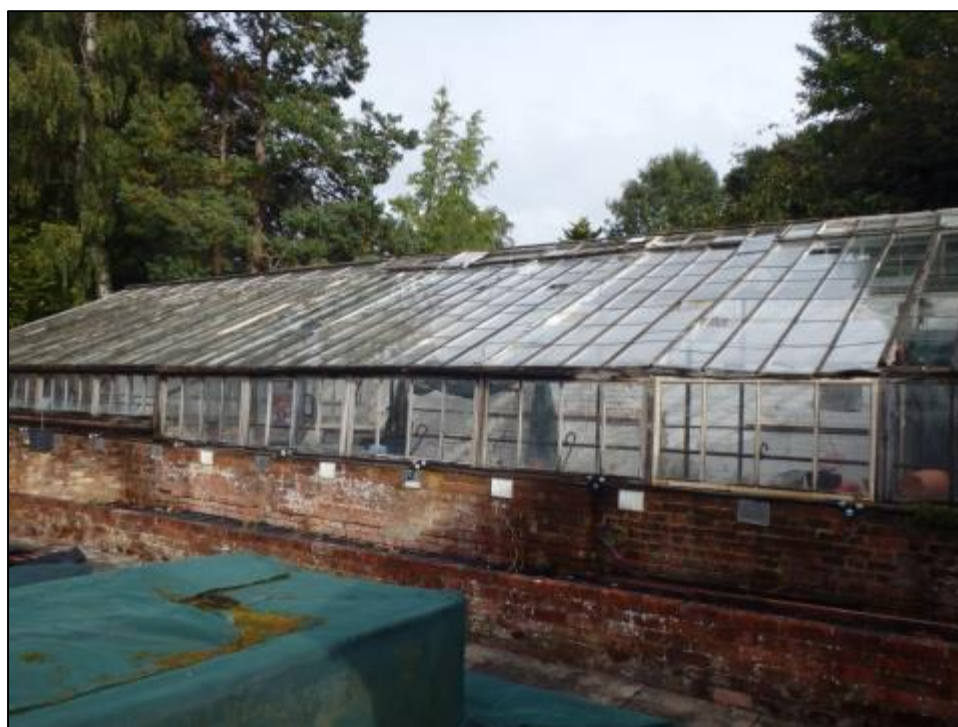
Photograph 1 Showing the greenhouse on the northwestern section

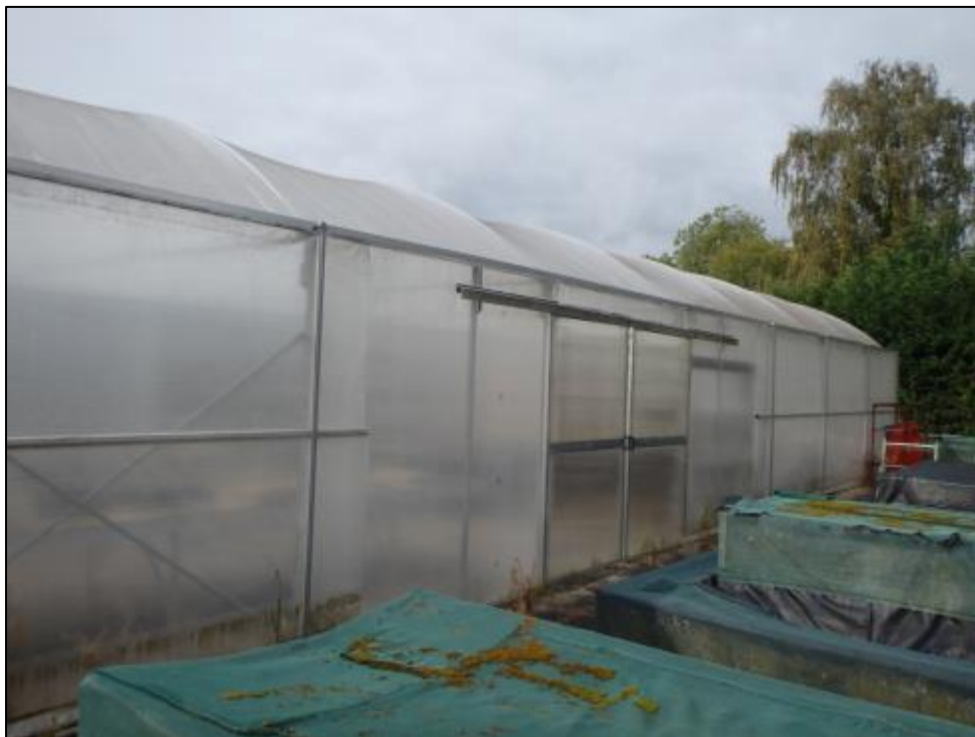
Photograph 2 Showing the poly-tunnel on the northwestern section

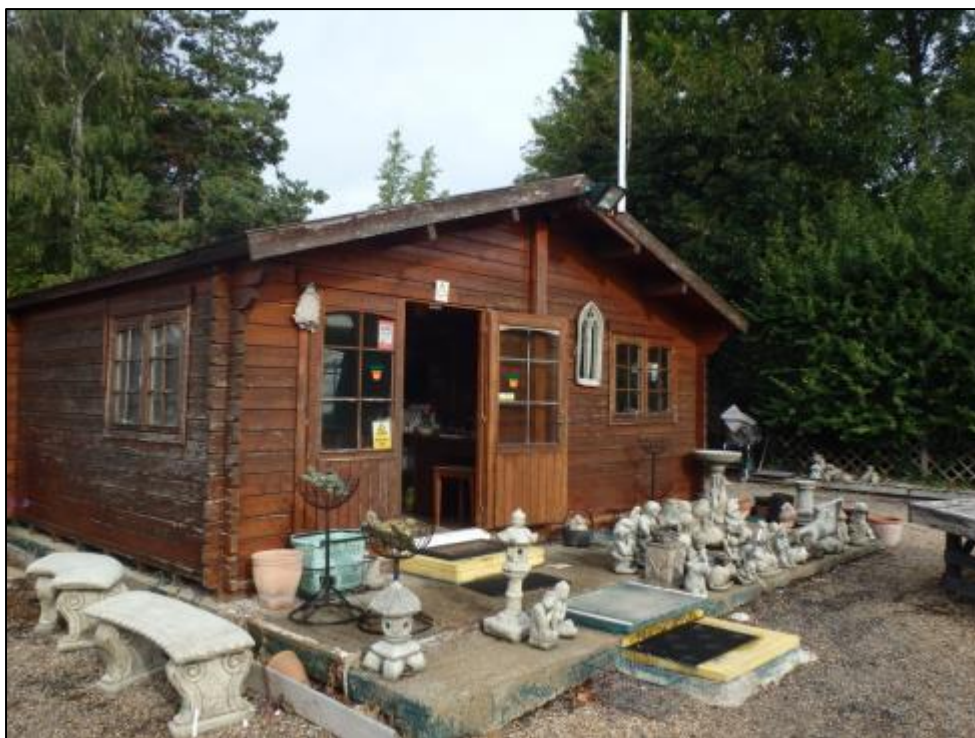
Photograph 3 Showing the timber outbuilding on the northwestern section

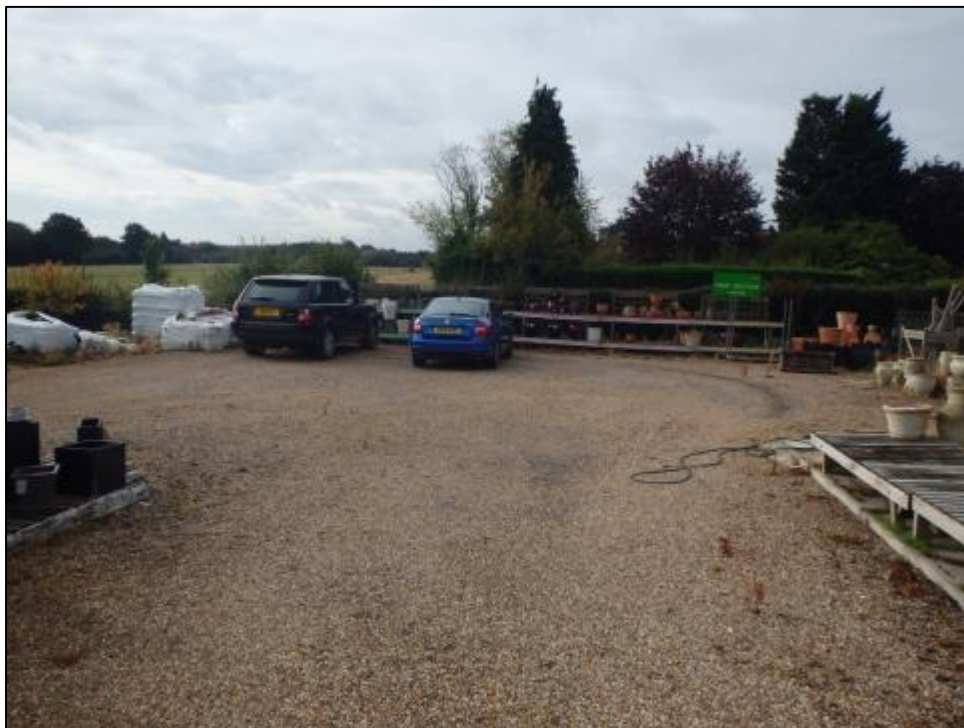
Photograph 4 Showing the parking area

The tarmacadam driveway is in a poor state of repair allowing a direct route to the underlying ground. It is further expected for the hard-surfaced sections of the site to be underlain by made-ground and/or hardcore - either of which could have introduced ground contamination.

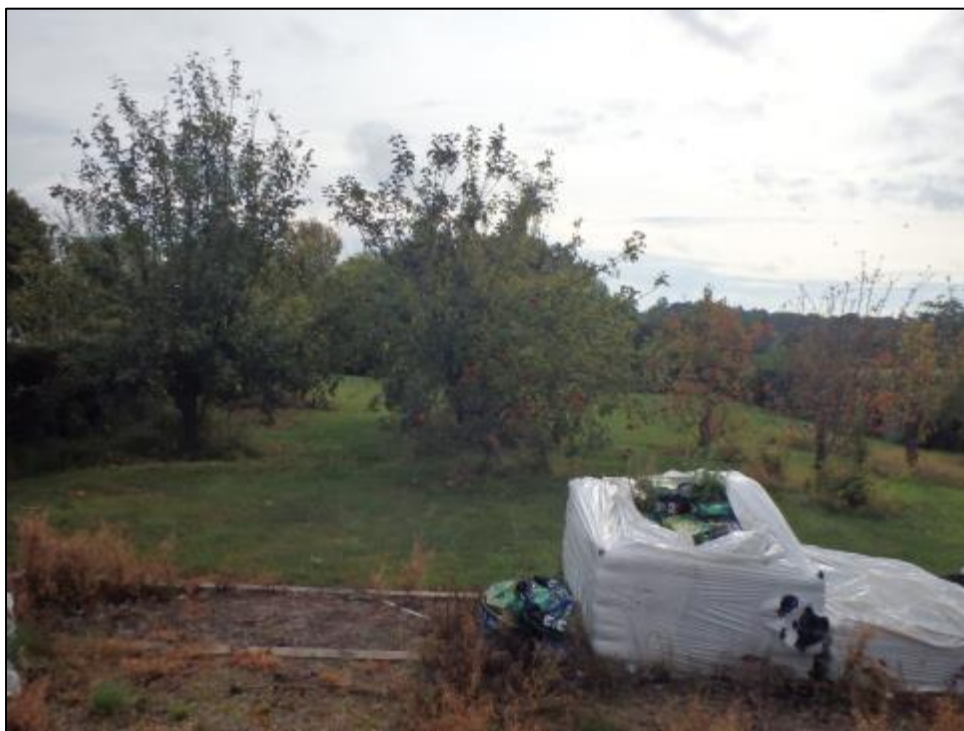
Photograph 5 Showing the orchard on the southern section

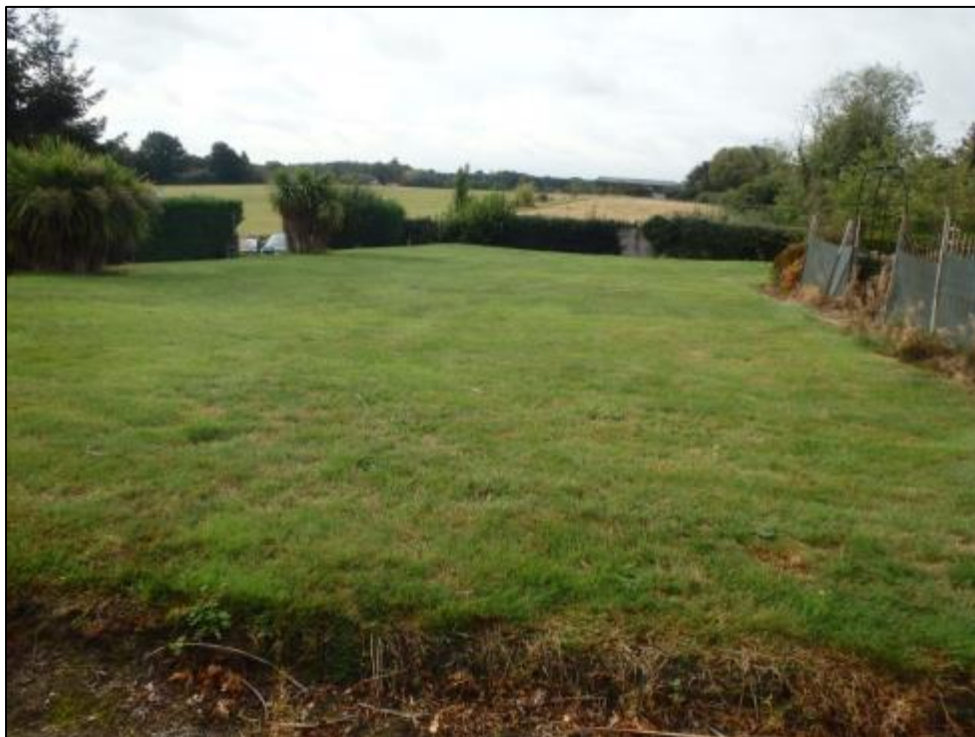
Photograph 6 Showing the existing soft landscaped area

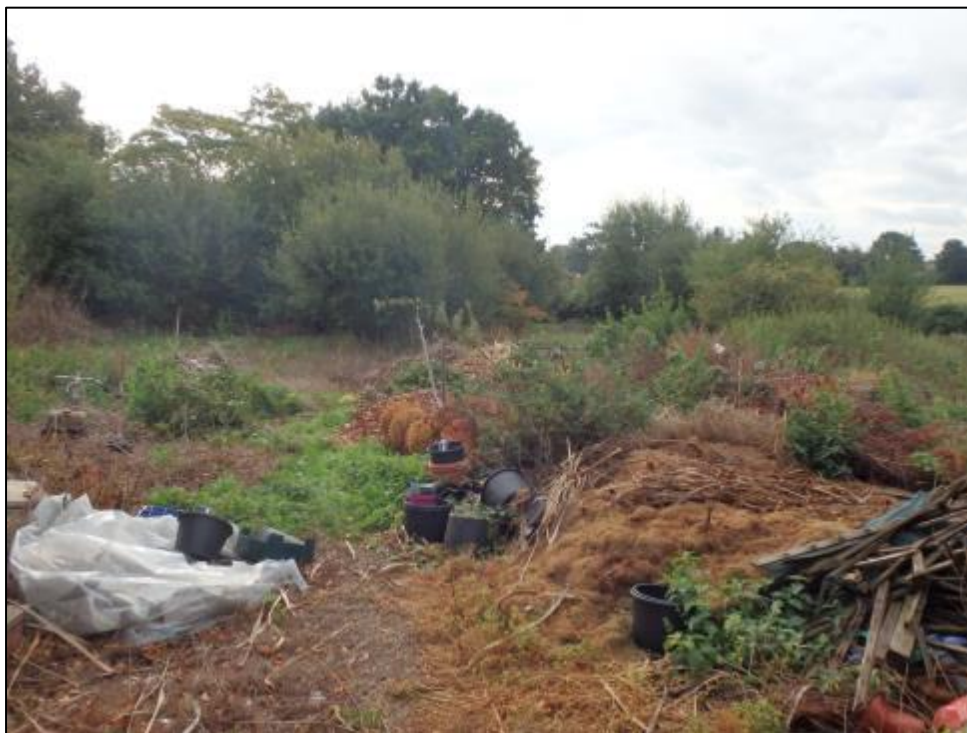
Photograph 7 Showing the eastern section of the site

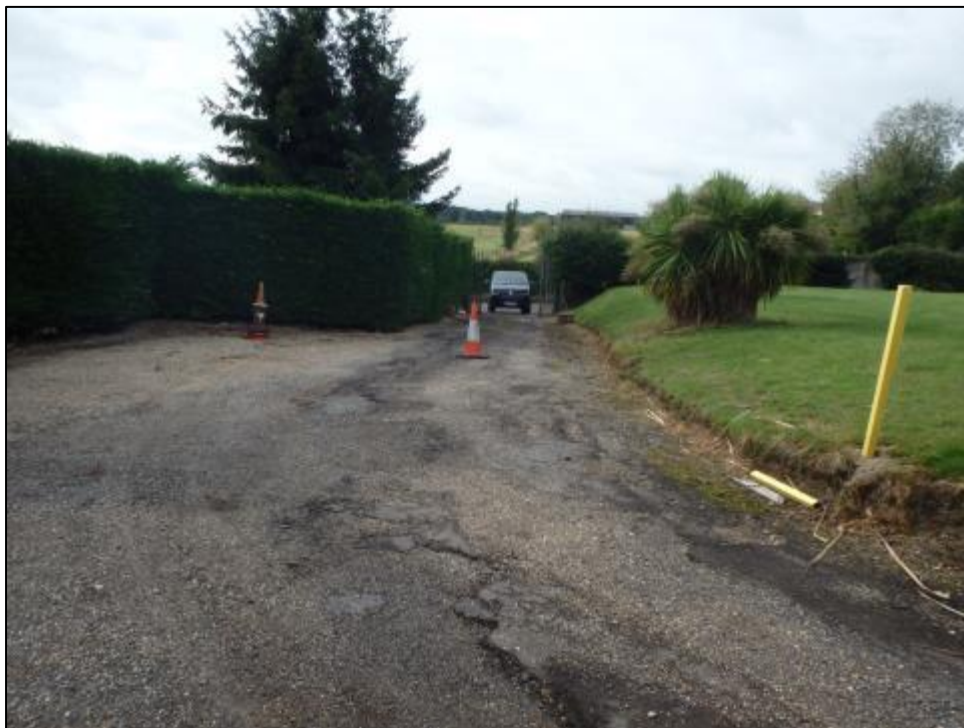
Photograph 8 Showing the access driveway

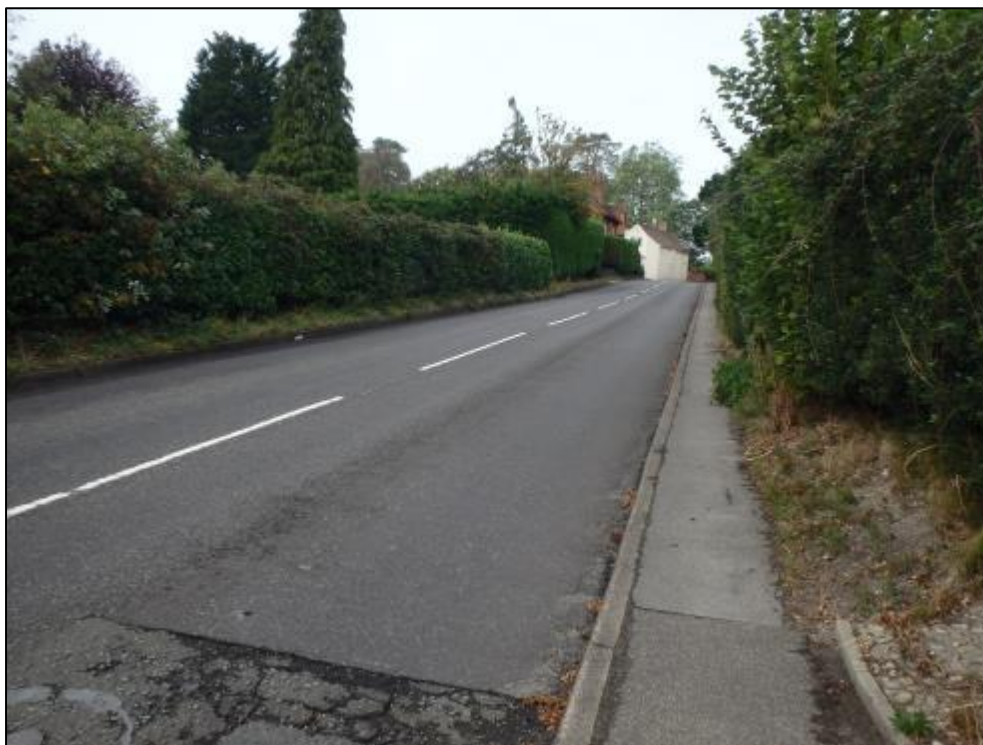
Photograph 9 Showing Church Road looking northwestwards

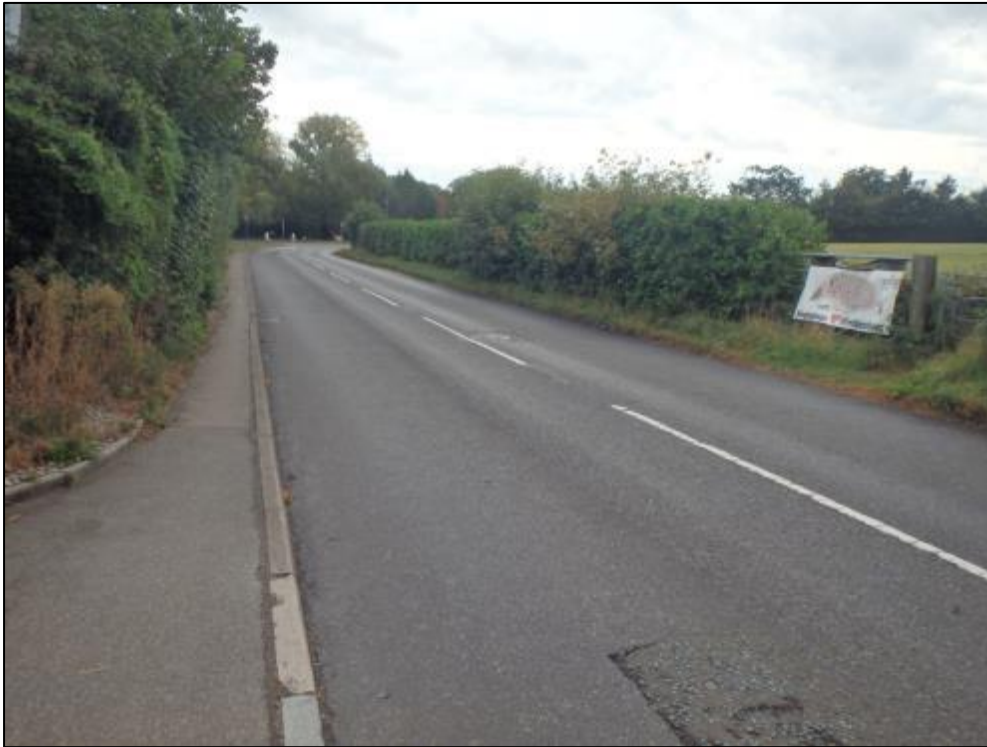
Photograph 10 Showing Church Road looking southeastwards
