**WINDERMERE GRANGE, STOURPORT**

**ARBORICULTURAL IMPACT ASSESSMENT  
TO BS 5837:2012**

**TREE SURVEY TO BS 5837:2012**

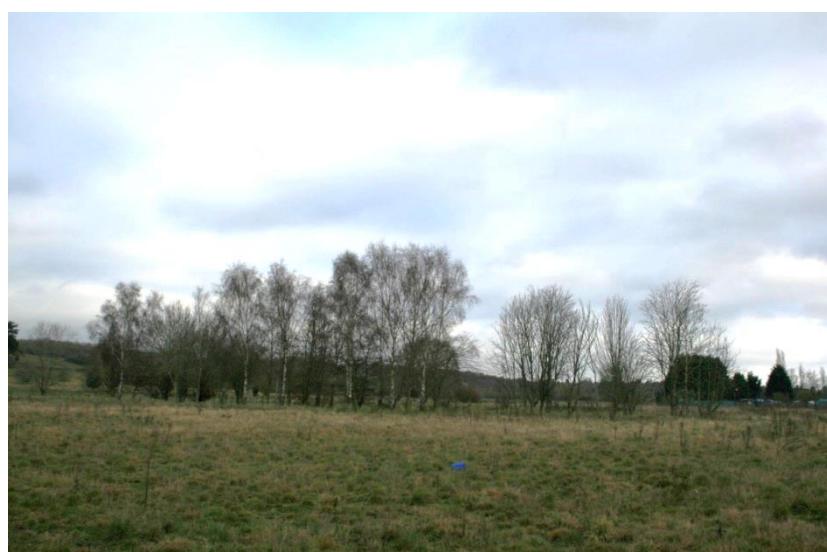
Figure 5. View North towards G19 & G20

- 3.4 Trees G15 and G17 are groups of Field maple tree regrowth from unmaintained hedges with T16 an isolated Crab apple close to the school boundary of moderate quality and value. Groups G18, G19 and G20 are a mixture of young planted Ash, Lime, Rowan, Silver birch, Beech and Crab apple trees of low to moderate quality and value (refer to Figure 5 below).

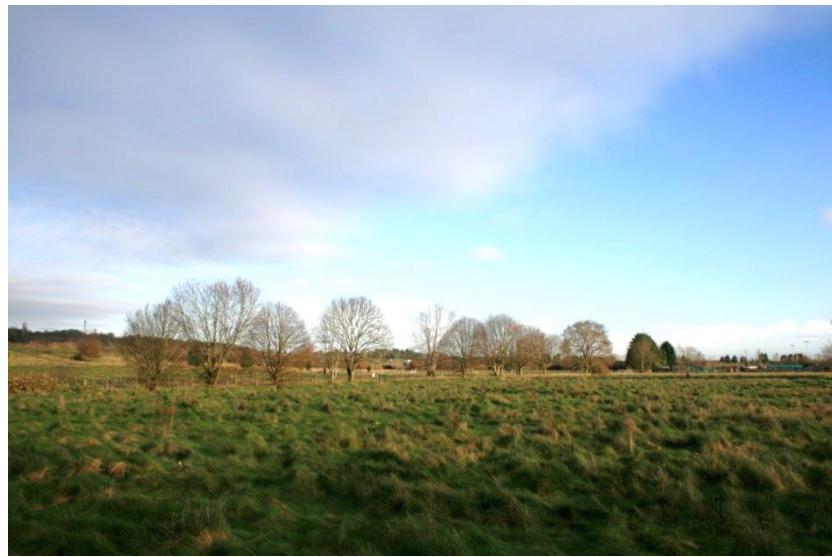
Figure 6. View North towards T27 to G40

- 3.5 To the North western boundary of the survey area (refer to Figure 6 below) is a line of young to semi- mature trees (T22 to T39) of various species including Field maple, Cherry, Turkey oak, Hornbeam, Silver leaf maple, Norway maple, Lime, Elm, Ash and Sycamore considered to be of low to moderate quality and value.

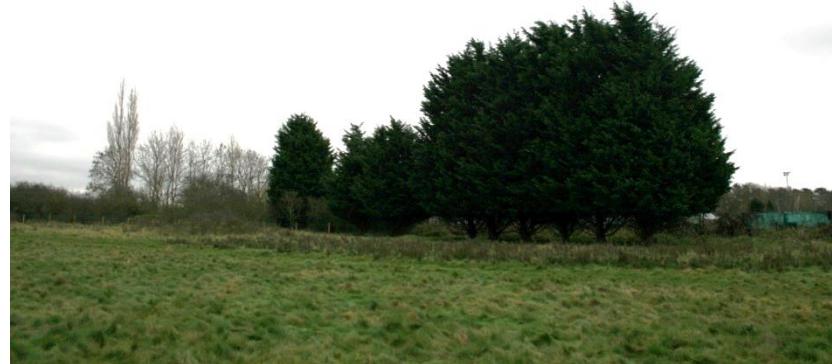
Figure 7. View East towards G40 to G44

- 3.6 G40 , G41 and T42 are a number of mature Leyland cypress to the Northwest of the allotment gardens of moderate quality and value (refer to Figure 7 above), leading to an overgrown area of Hawthorn and Blackthorn scrub with a low quality and value group G44 of young / semi mature Ash and occasional Lombardy poplar to the edge of Kingsway Road,
