Coal Mining Risk Assessment

For development at: 53 Netherton Avenue, Lynn Estate, North Shields, North Tyneside, NE29 8JG

For proposal: New two-storey dwelling adjoining 53 Netherton Avenue and extension to 53 Netherton Avenue

Assessment Result	HIGH RISK
Recommended Further Work	INTRUSIVE SITE INVESTIGATION BEFORE FINALISING LAYOUT

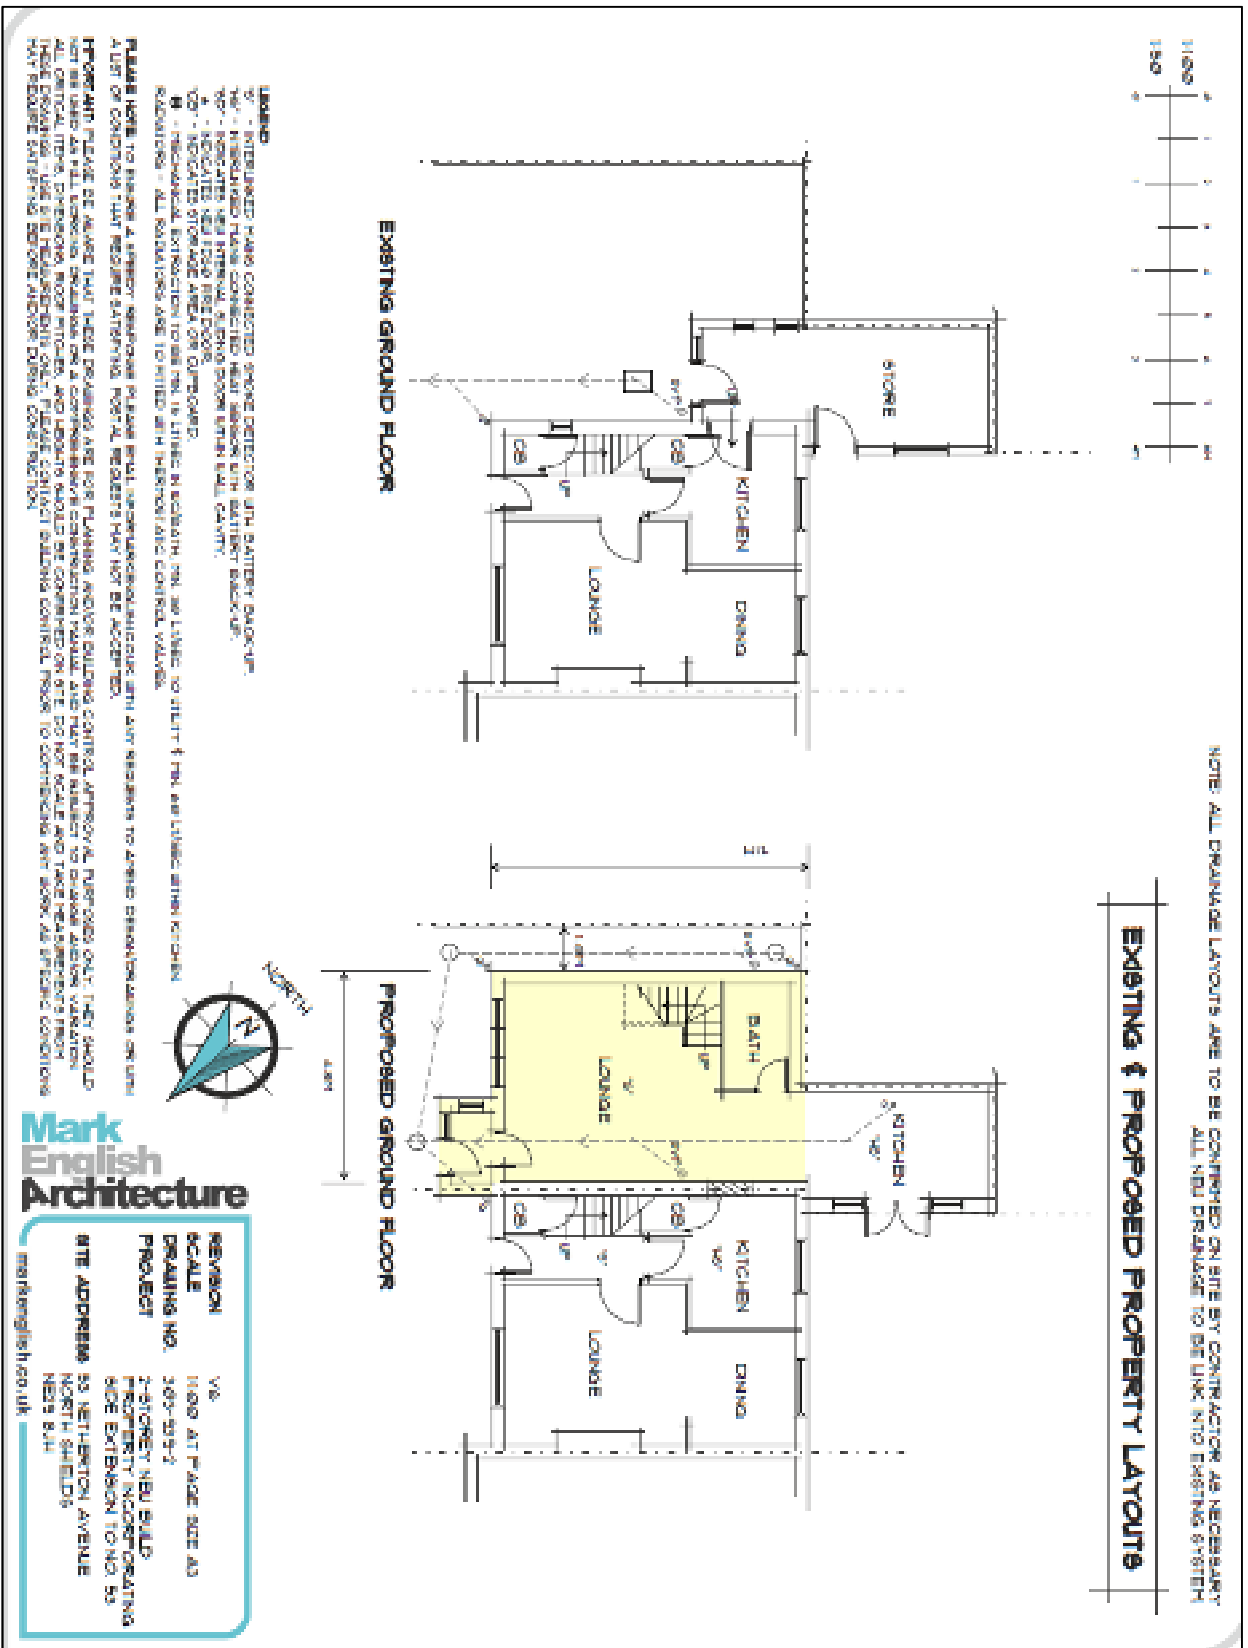
Appendix A – Plan showing proposed development layout

The coal mining legacy issues outlined in this report, particularly 433569-019 will have implications for layout in the proposed development outlined in Appendix A. The positions of these features will have to be delineated by intrusive techniques as far as possible by investigating the departure area that exists within the site boundary. If found, the size and position will need to be proven to allow appropriate adjustments in layout to be made and to inform any pre-treatment or ground improvement deemed necessary along with foundation design. As the mine entry is recorded to be located off site, if the full departure area cannot be searched it should be considered possible that the mine entry is present immediately beyond the site boundary. At this time the zone of influence for this mine entry may incorporate the entire development site area an engineering solution is likely to be required.

The intrusive investigations recommended in Section 4a of this report should be undertaken prior to the layout of the development being confirmed.
